Structural Condition Report

Project: 39 Marchmont Street, London, WC1N 1AP

Reference: 20076-REP-001

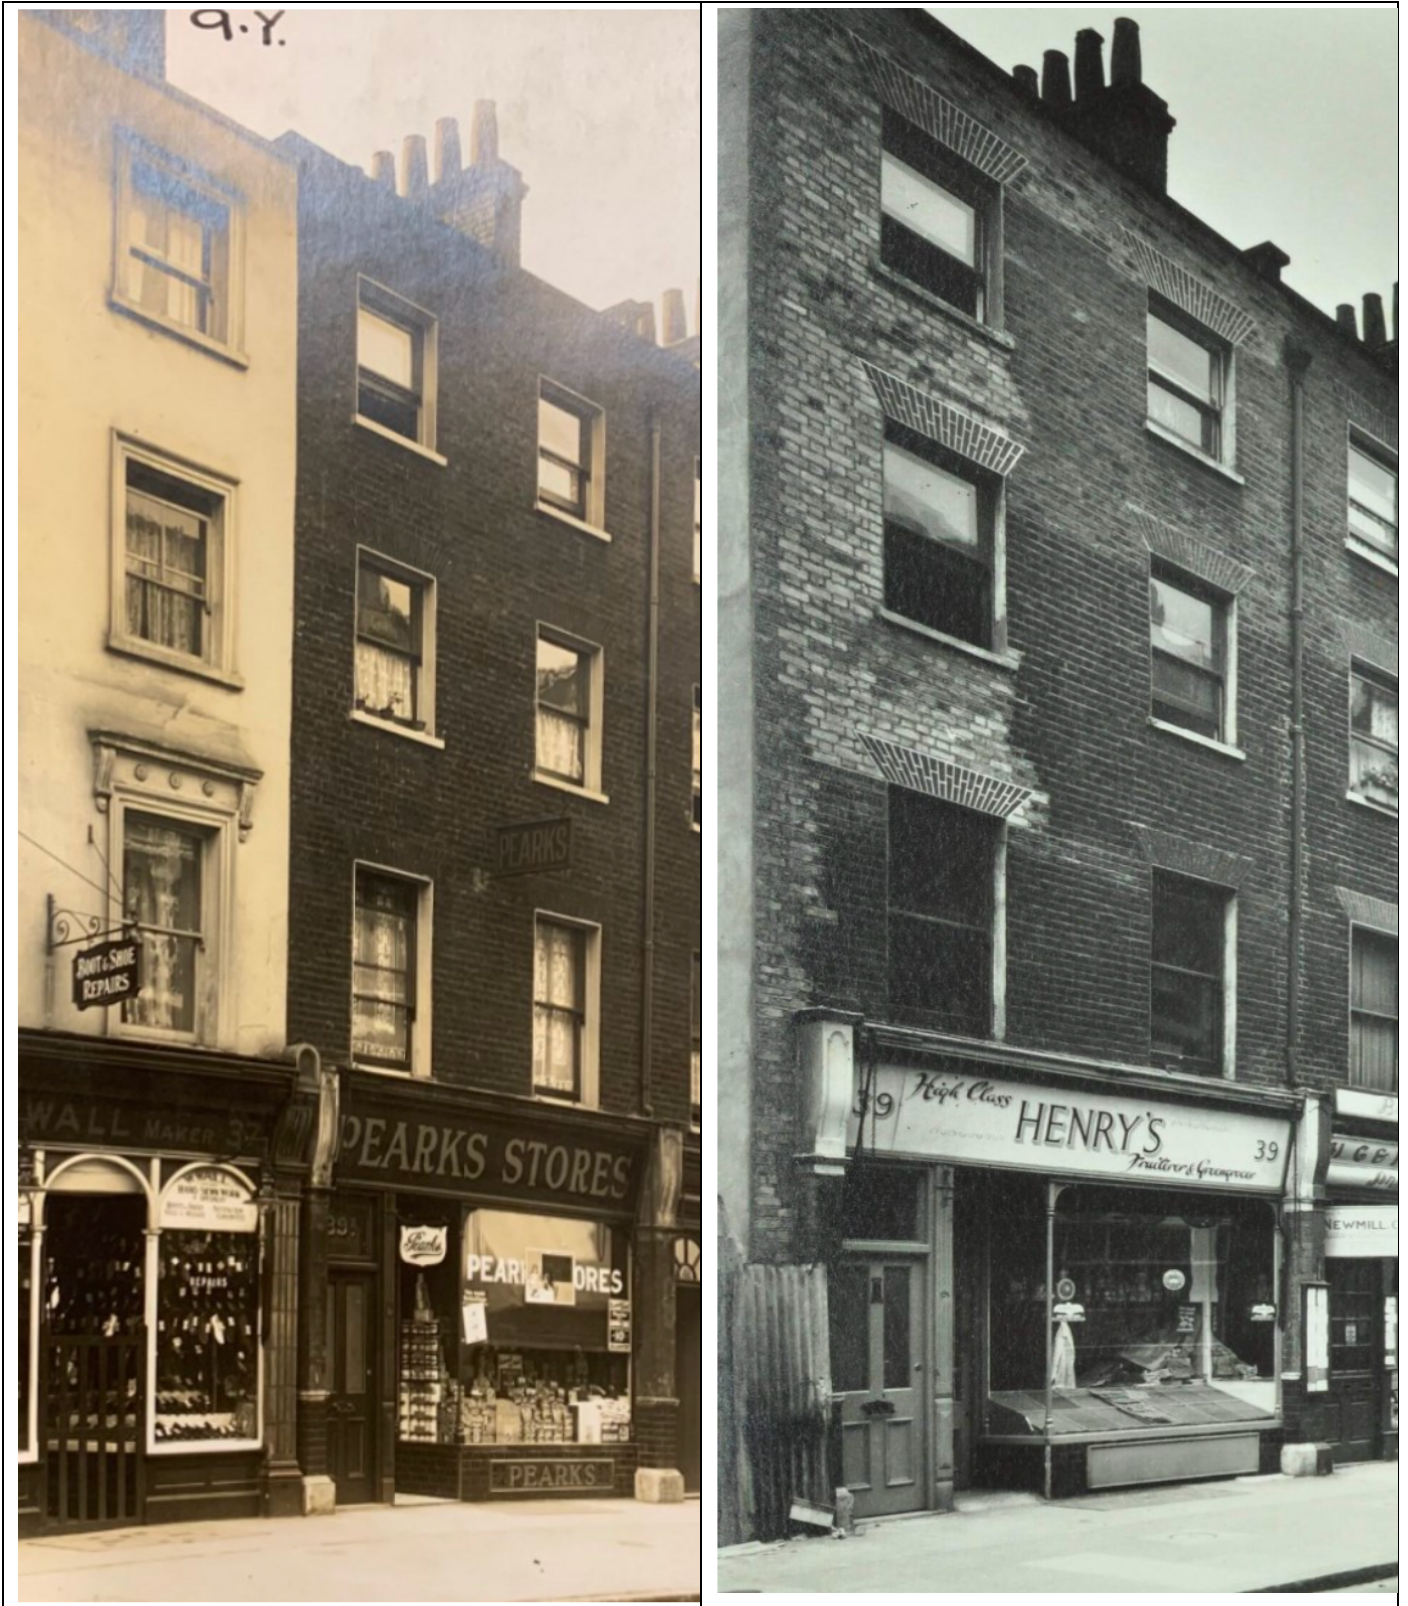
Figure 2: Credit Jon Lowe Heritage Report. Left: Picture of 39 Marchmont Street elevation dated 1930 (pre WWII) the adjacent building is still present and the façade brickwork is uniform. Right: Picture taken 1956, façade brickwork has been extensively replaced and the party wall has been rendered, the adjacent building has been demolished

In both photographs the brickwork above the shop signage appears uniform and level. In our modern assessment the brickwork is cracked and visibly dipping towards the centre of the building. Settlement of the façade is evident. Removal of the shop front signage reveals a supporting RSJ spanning across the full width of the building frontage. The RSJ is corroded in places, has limited bearing and the brickwork above the RSJ is of poor condition with areas of local loose or missing mortar. The support packing between the top of the RSJ and the brickwork above is also of poor condition. We speculate that the beam itself may not be the original, for a building of this age it may have been more conventional to use a large timber section for support. The RSJ may have historically been introduced to replace the timber. Part of the distress to the front façade may have been caused when the RSJ was installed. It is not uncommon for these RSJ beam to be unprotected and exposed to the elements, thus suffering serious corrosion over the life span of the structure. Corrosion and loss of steel section can lead to reduction in stiffness and subsequent deflection of the beam. This can manifest in ongoing settlement of the façade brickwork.

- Steel beam over shop frontage to be replaced with a new modern steel beam with adequate corrosion protection, bearing and packing to support wall above. All existing signage and decoration to be locally removed. Historic features to be retained if possible or otherwise recorded for later reinstatement. The masonry façade above shall be propped using temporary works including needles and props through the masonry above the existing beam. Once the façade is safely supported, the beam is to be removed and replaced with a new steel beam with suitable corrosion protection. The beam to be sited on new padstones or structural steel columns at each end. Brickwork, signage and decoration to be reinstated.
