39 Marchmont Street, London

Structural Condition Survey

Project Code:
20076

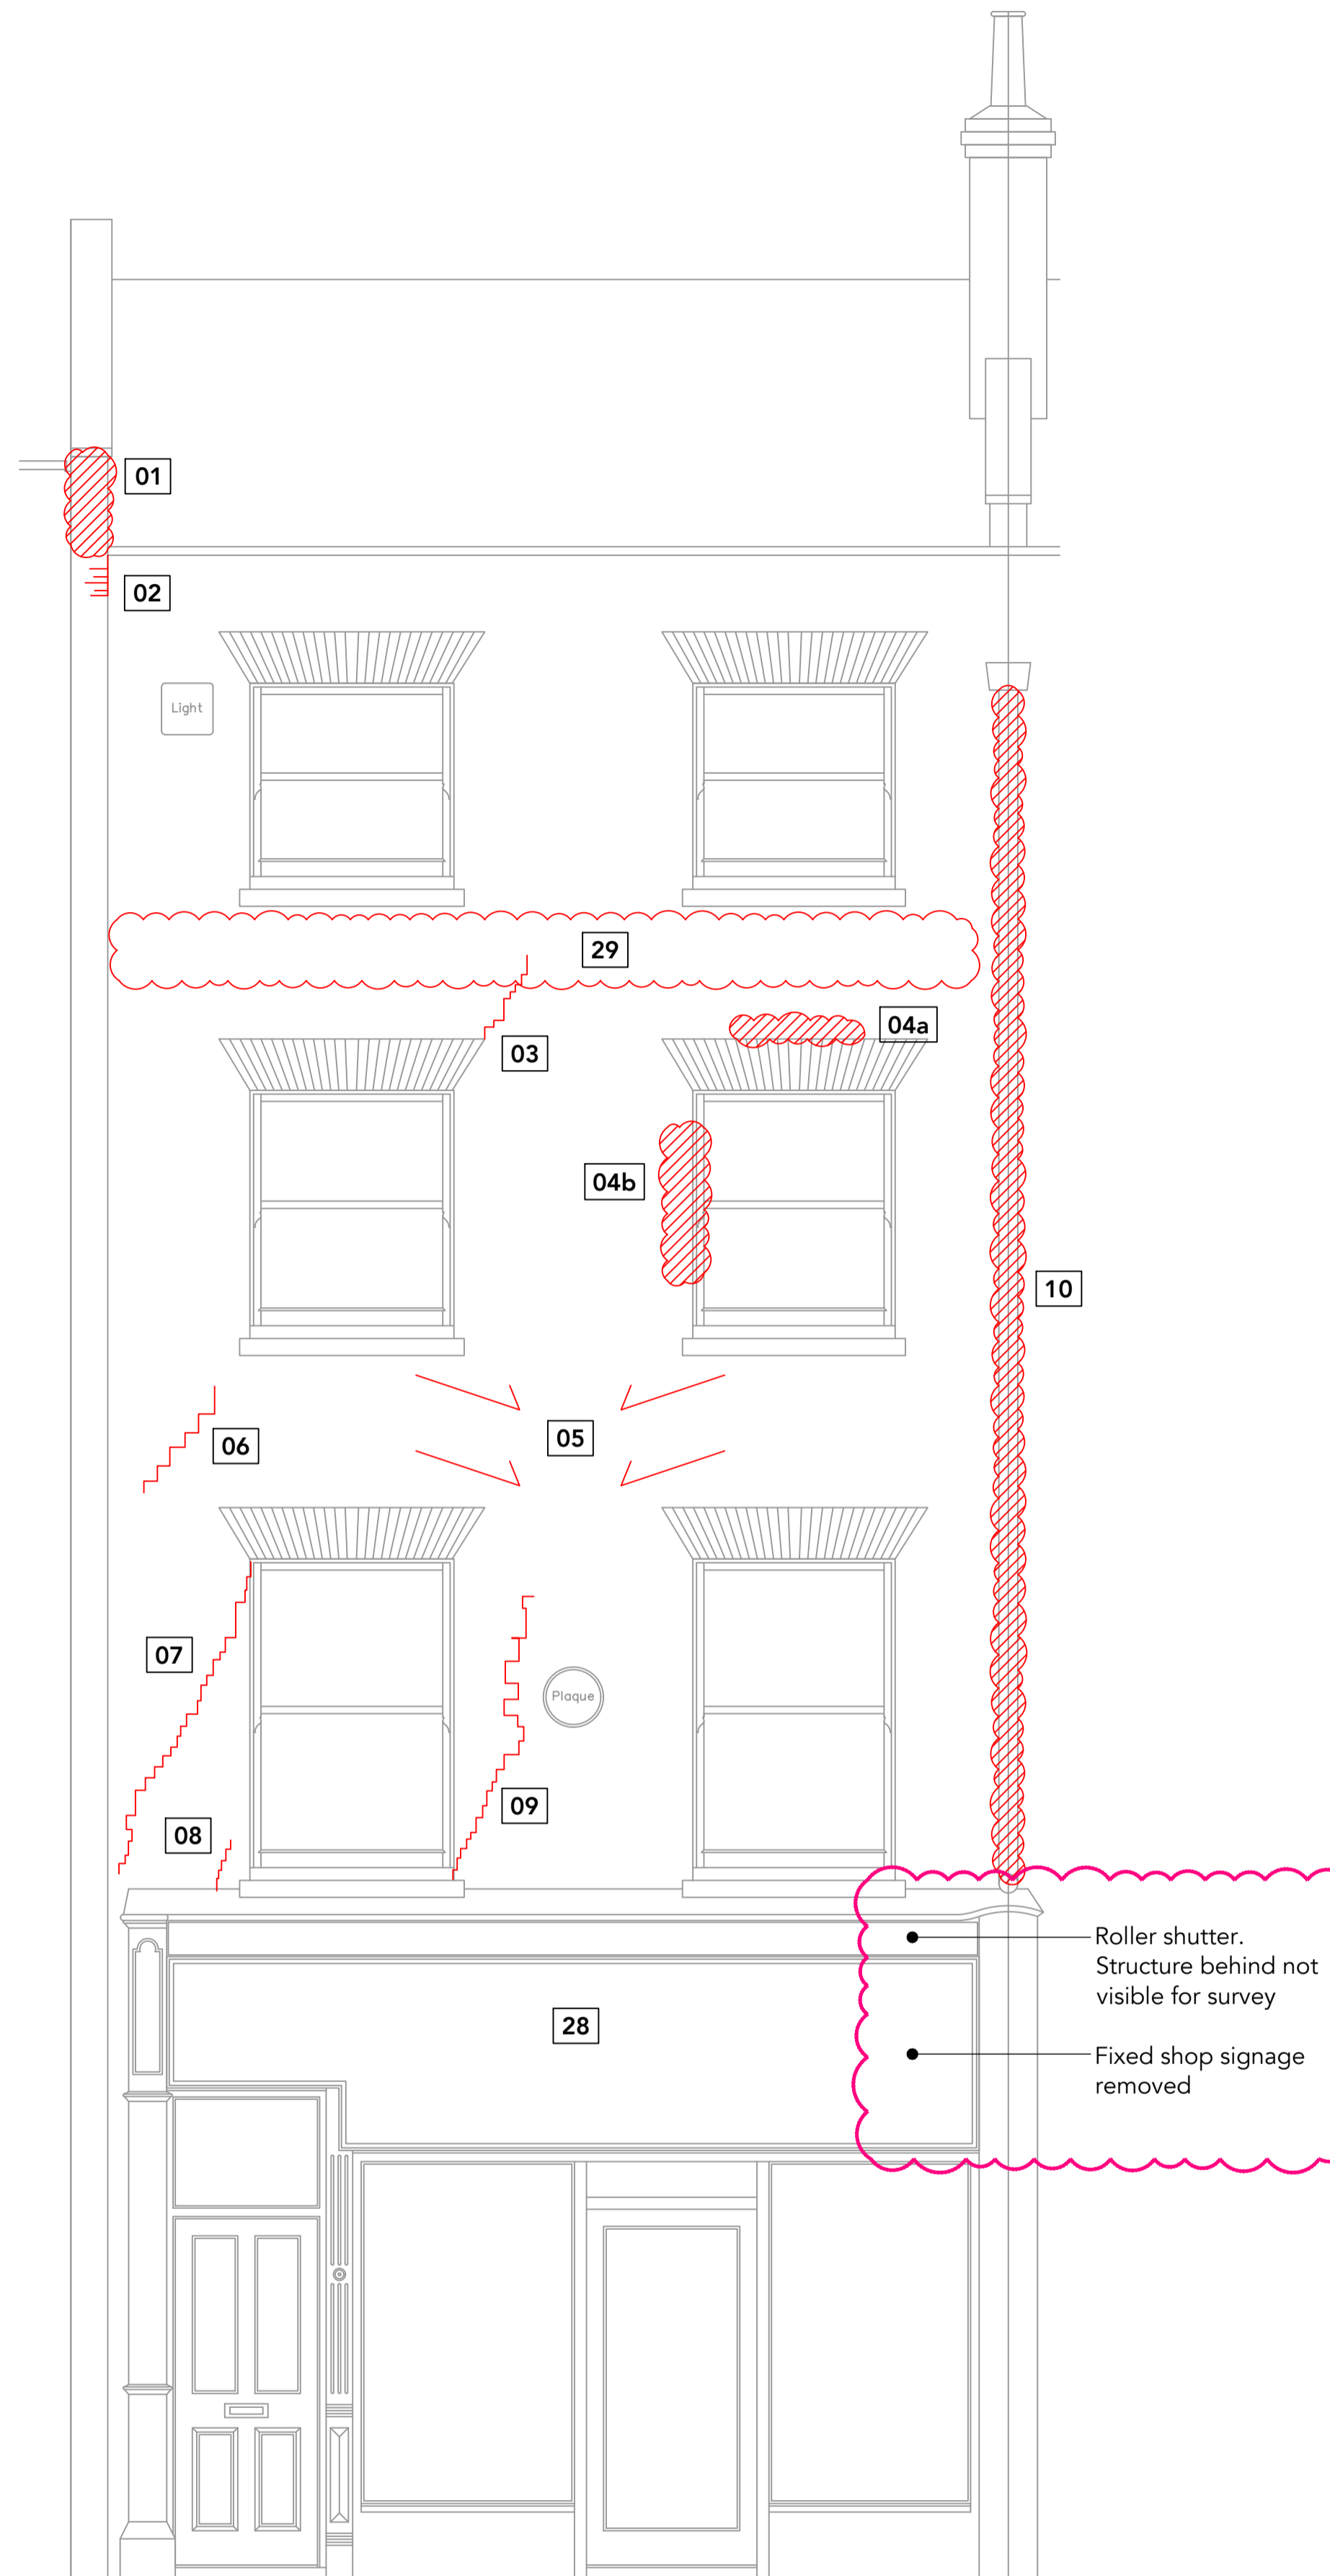
00 Front Elevation
(Not to Scale)

1. Brick parapet leaning inwards. Loss of mortar locally below coping stone. Evidence of some historic cement based repairs to mortar
2. Cracks in brickwork below parapet

3. Diagonal crack through brickwork extending from corner of lintel
4. a - modern cement based repair made above lintel. b - modern cement based repair made to side of window jamb

5. Brickwork is visibly dipping in direction of arrows between windows - evidence of facade settlement
6. Diagonal crack in brickwork
7. Diagonal crack in brickwork extending from bottom corner of lintel downwards

8. Small vertical crack
9. Diagonal crack extending from cill
10. Water damage behind rain water pipe. Missing or loose bricks. Missing and cracked mortar. Some historic signs of repair using cement based mortar

11. Cracked and spalling cement based render
12. Stock facing brick sits proud of the neighbouring facade by approximately 20-25mm. Unclear if the wall has been rebuilt historically

13. Loose / missing brickwork
14. Failed or loose mortar below the parapet coping stones
15. Diagonal crack extending across facade from corner of brick arch lintel. Some historic signs of cement based mortar repairs

16. Vertical crack in masonry behind soil pipe
17. Diagonal crack extending from corner of cill behind drain pipe and down to top of roof level
18. Failed lintel, vertical crack through the end of lintel, failed bearings locally

19. Dip in masonry locally showing evidence of settlement likely due to failed lintel
20. Diagonal crack extending from corner of the cill downwards. Evidence of historic cement based repair

21. Brick parapet leaning inwards with localised cracking in mortar below coping stone
22. Localised infill / patch repair to old opening in brickwork. Poor quality and cement based repair

23. Failed lintel. Vertical cracks in brick and cracking at end bearings. Lintel currently propped with timbers
24. Limited visibility from ground level. However there is an apparent lean on the chimney, loose / missing mortar and possible sulphur damage. The same is evident to the party wall parapet and copings

25. Limited visibility of roof from ground level. However there appears to be significant deterioration of the timbers framing around the dormer windows

26. a - Failed lintel over head of bricked up window opening. Lintel repair required. b - failed lintel over door opening. Repair required
27. Crack in brickwork above door opening, likely due to failed lintel below. Repair required

28. Shop signage removed to reveal RSJ behind supporting masonry elevation over. RSJ is badly corroded, has insufficient bearing onto supporting brick piers and is poorly packed / filled to underside of the brickwork over

29. Internal investigations suggest the wall reduces to single brick thick at the level of the floor joists. Full extent unclear but could be over full elevation. Introduces weakness in wall, requires repair / infill from inside

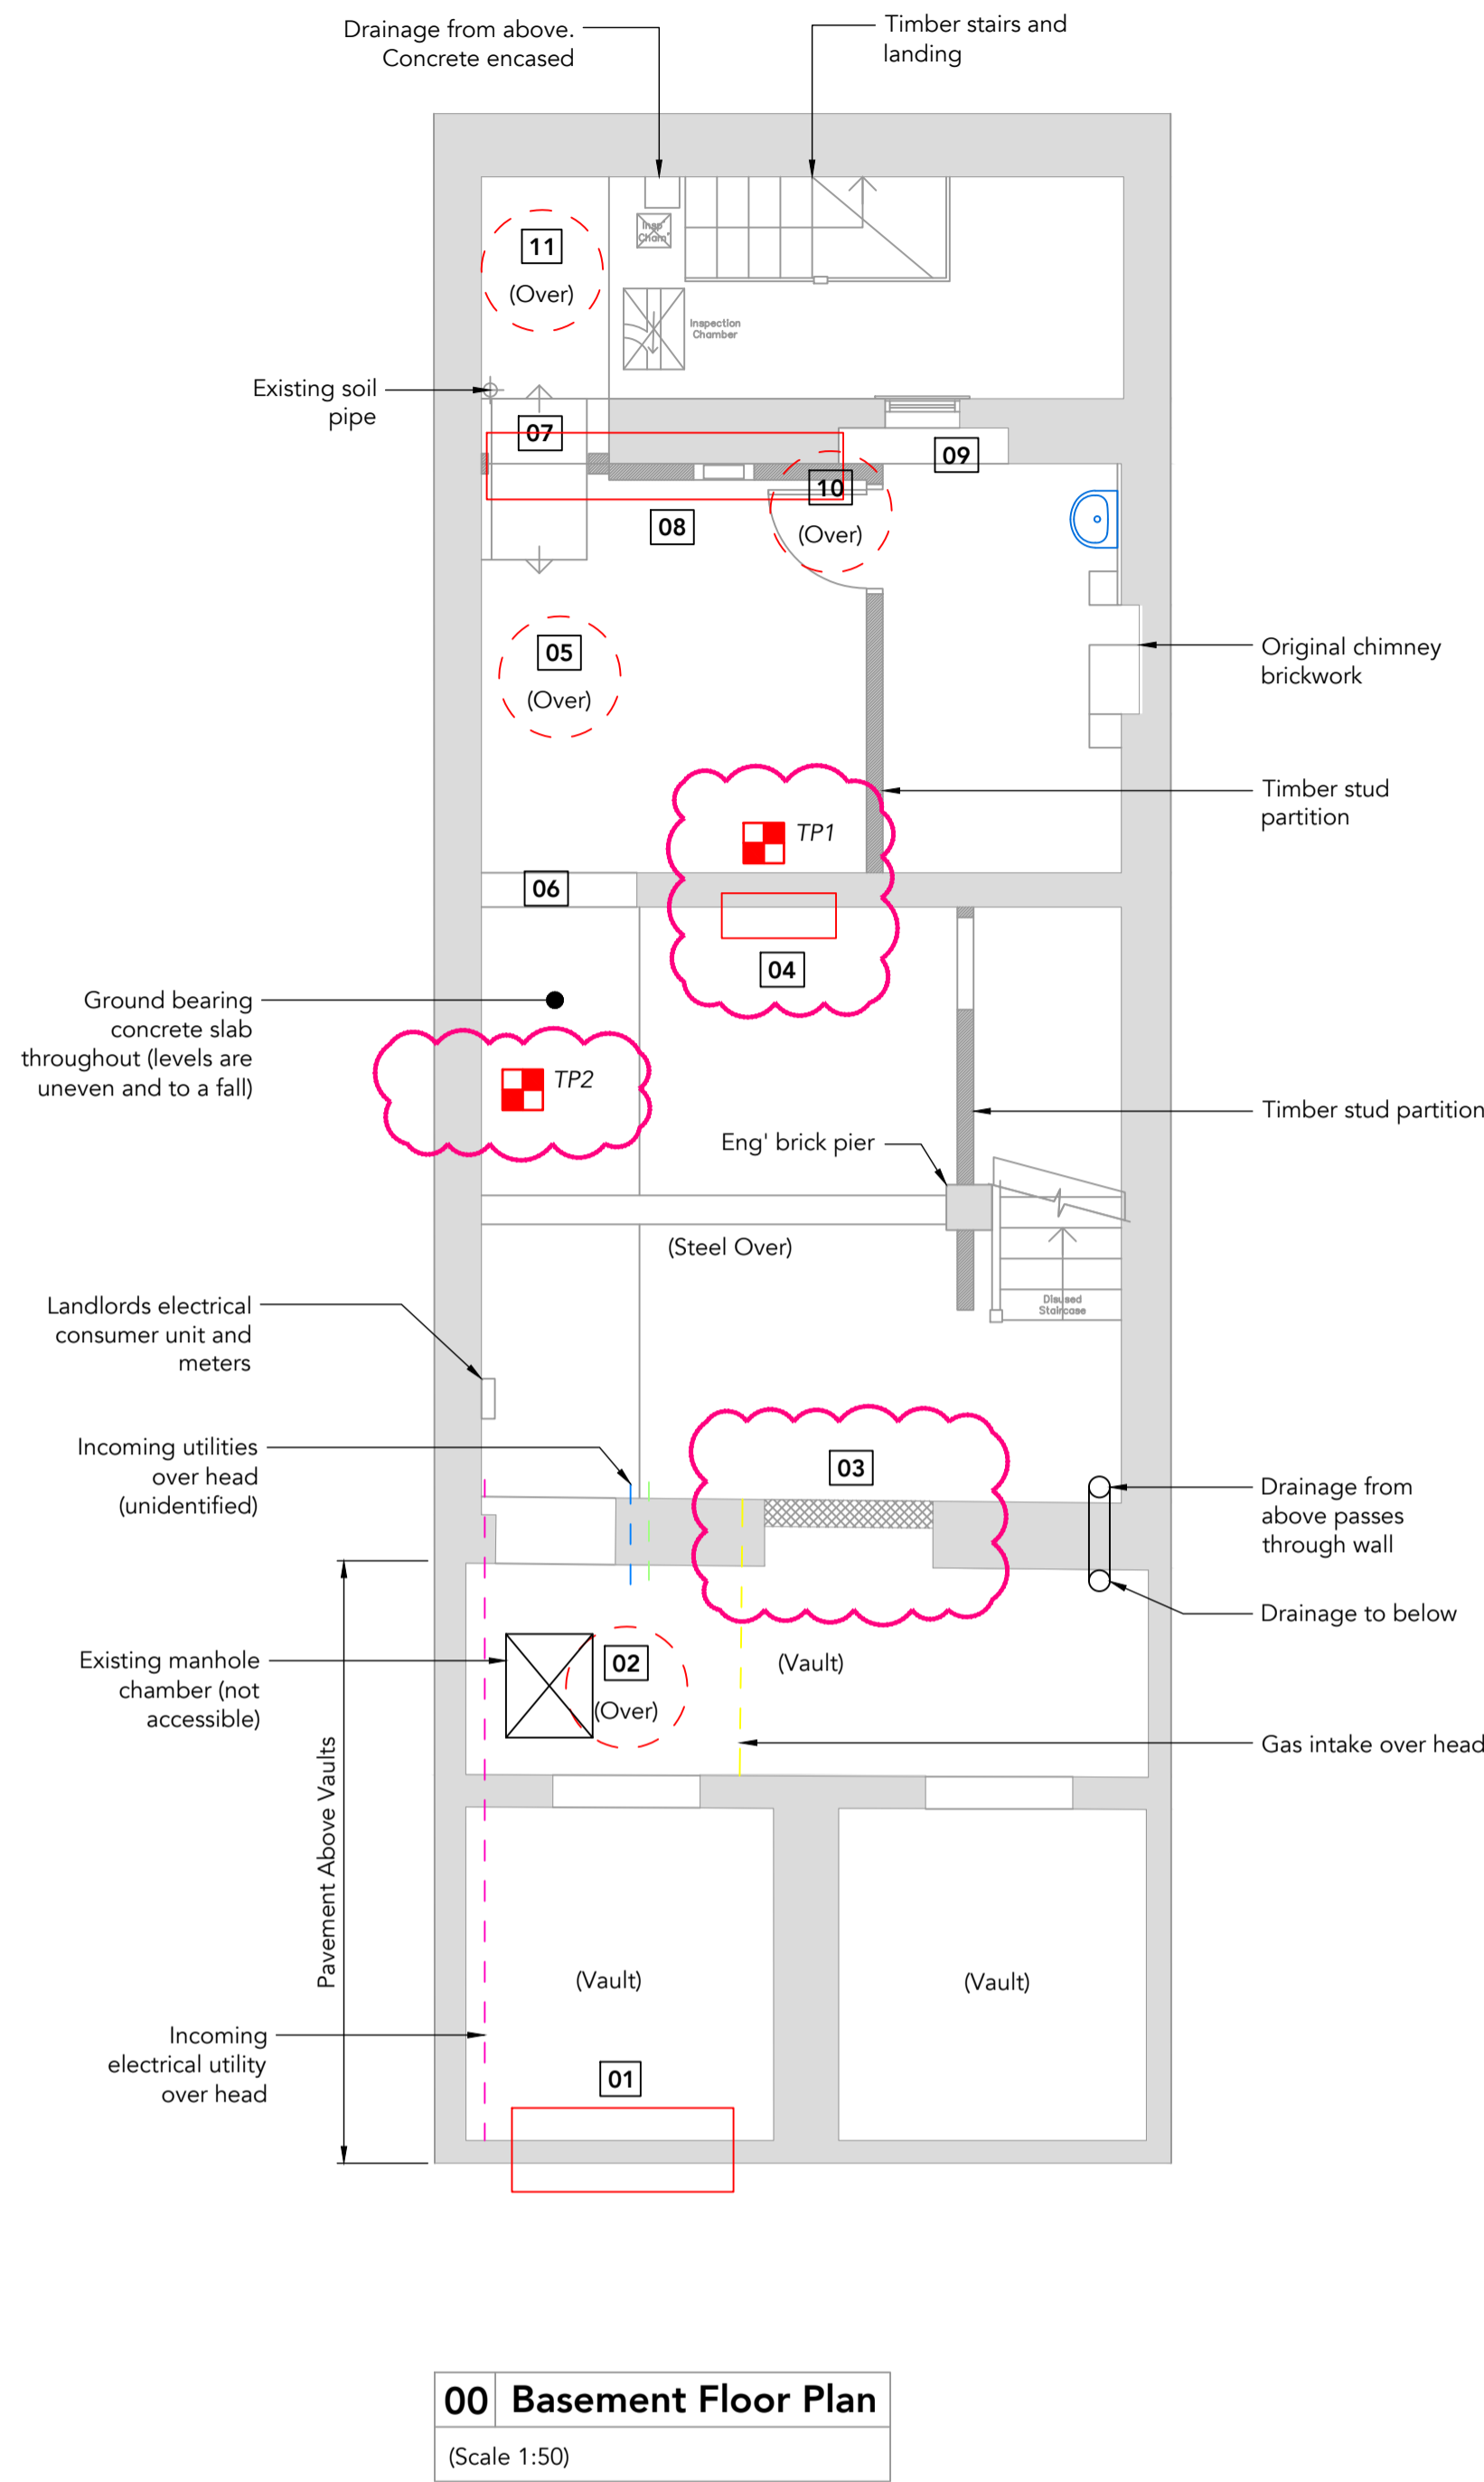
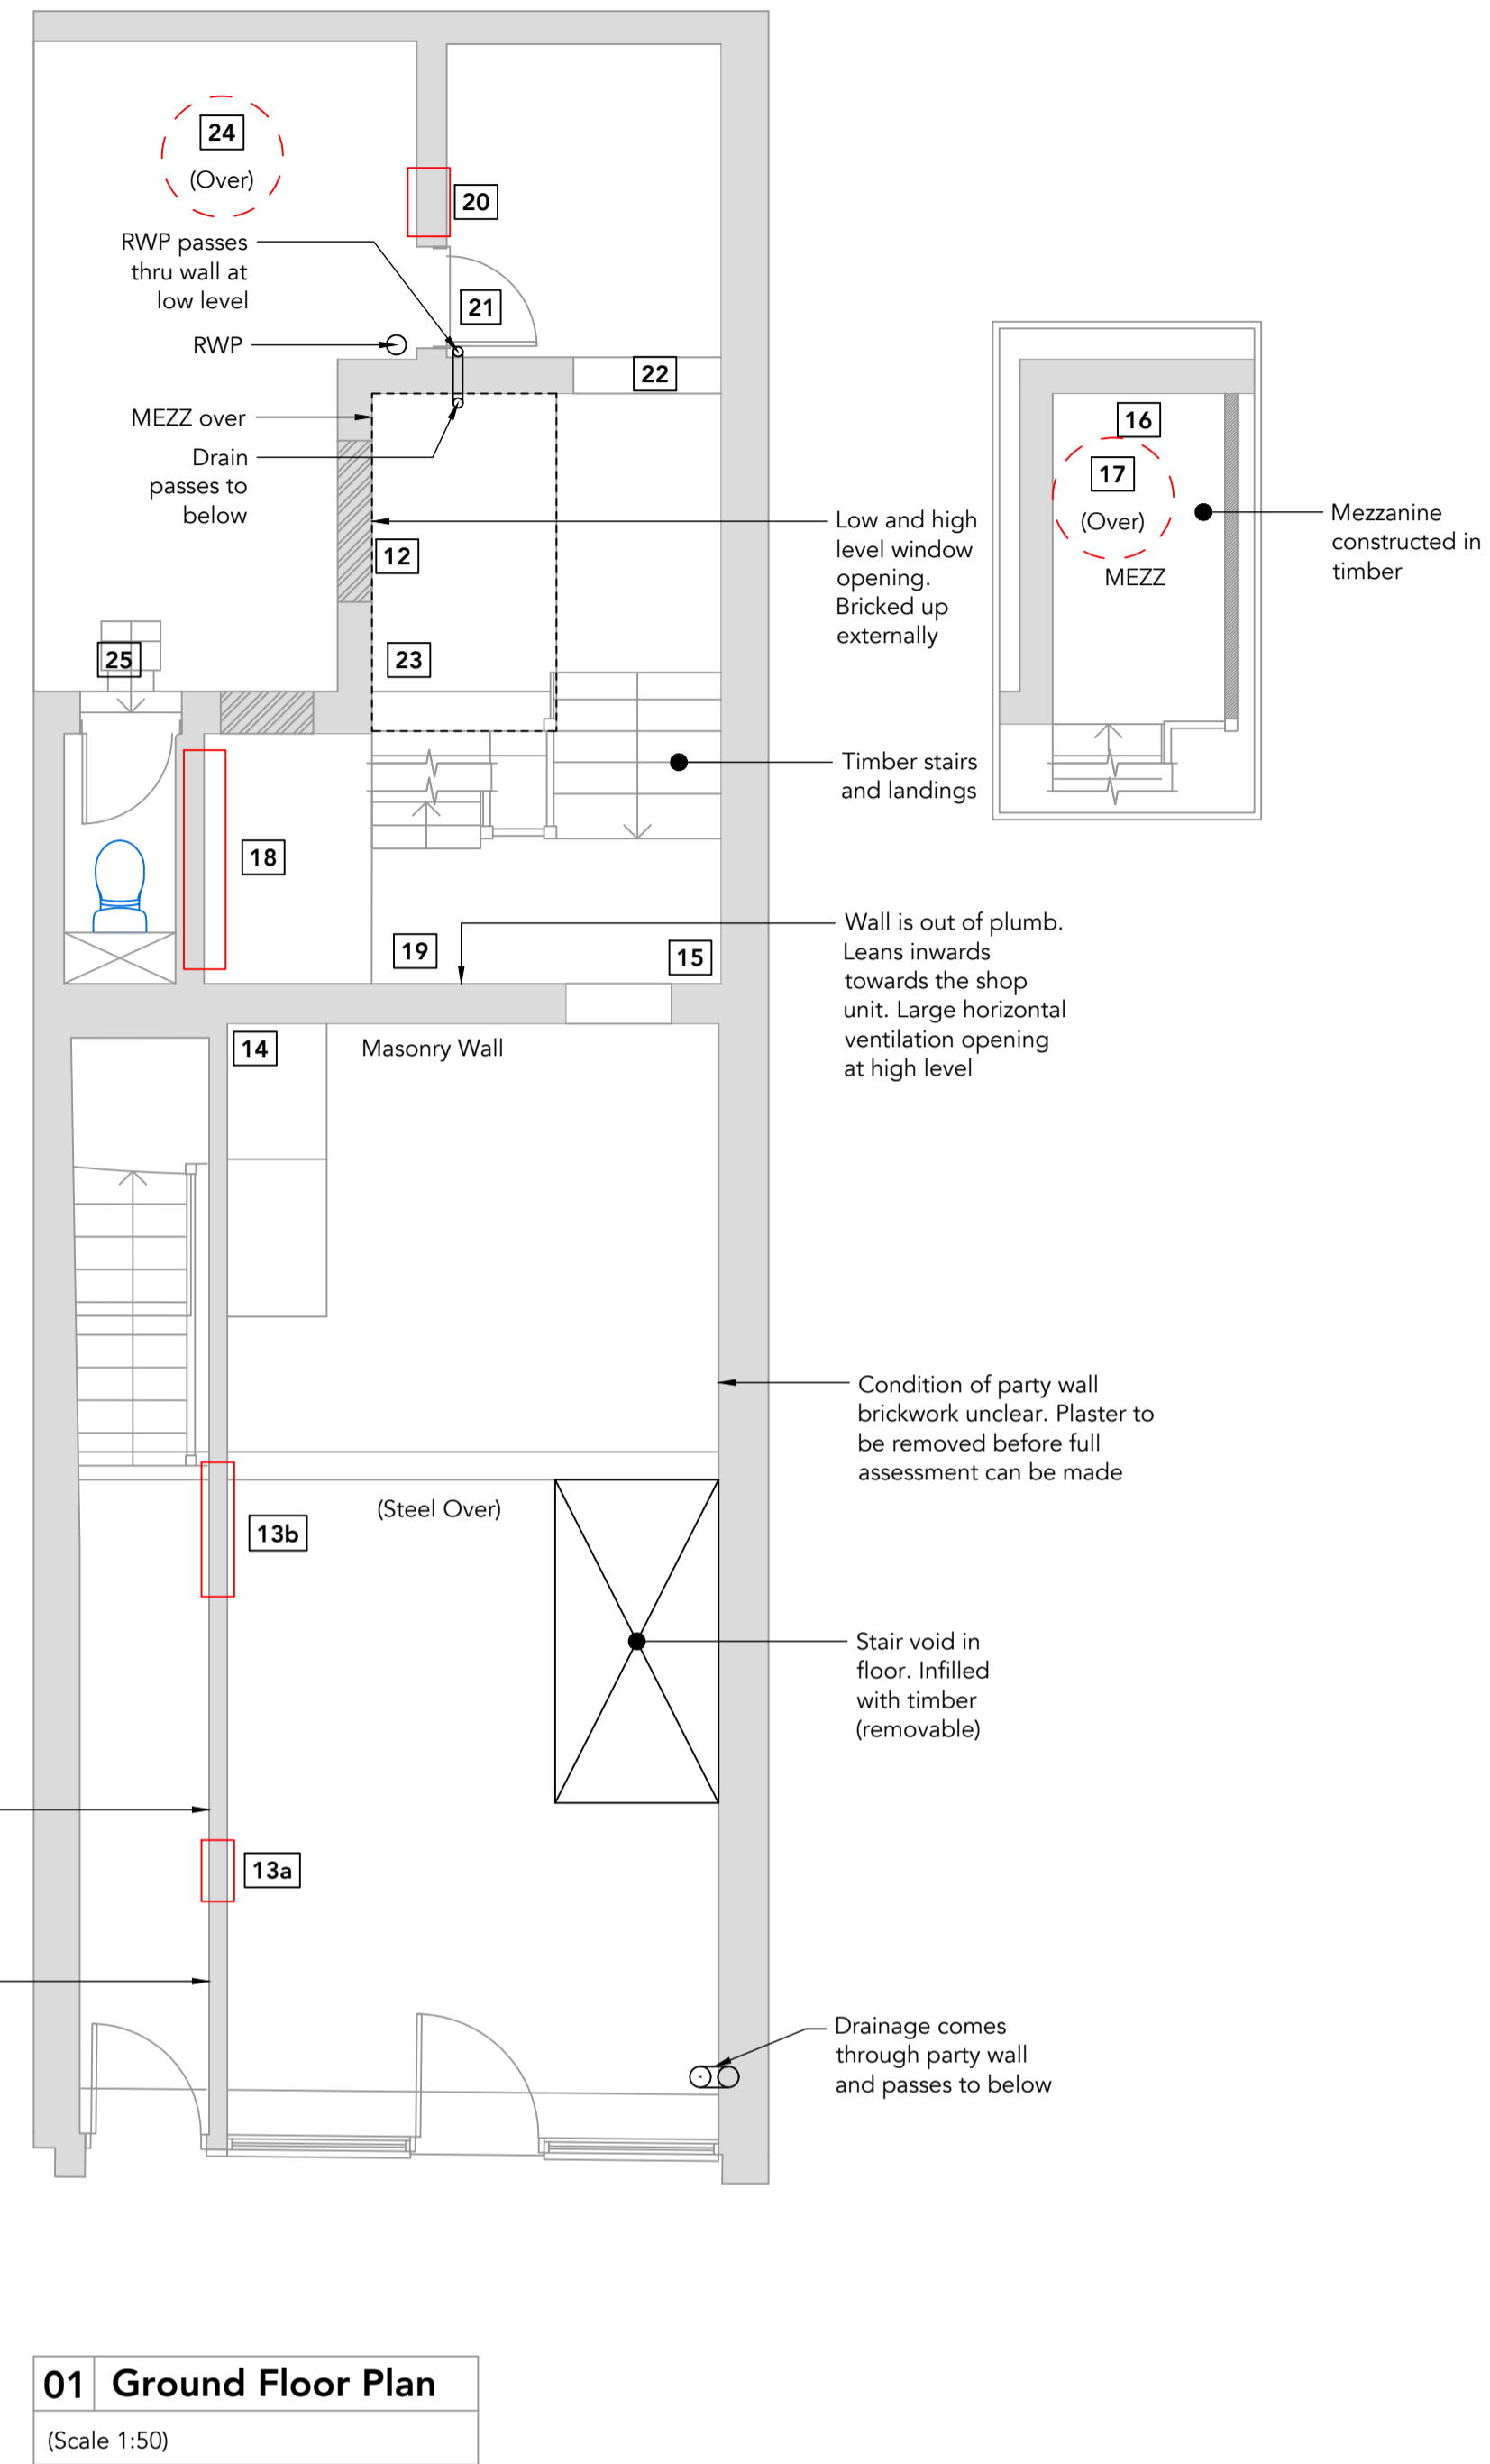
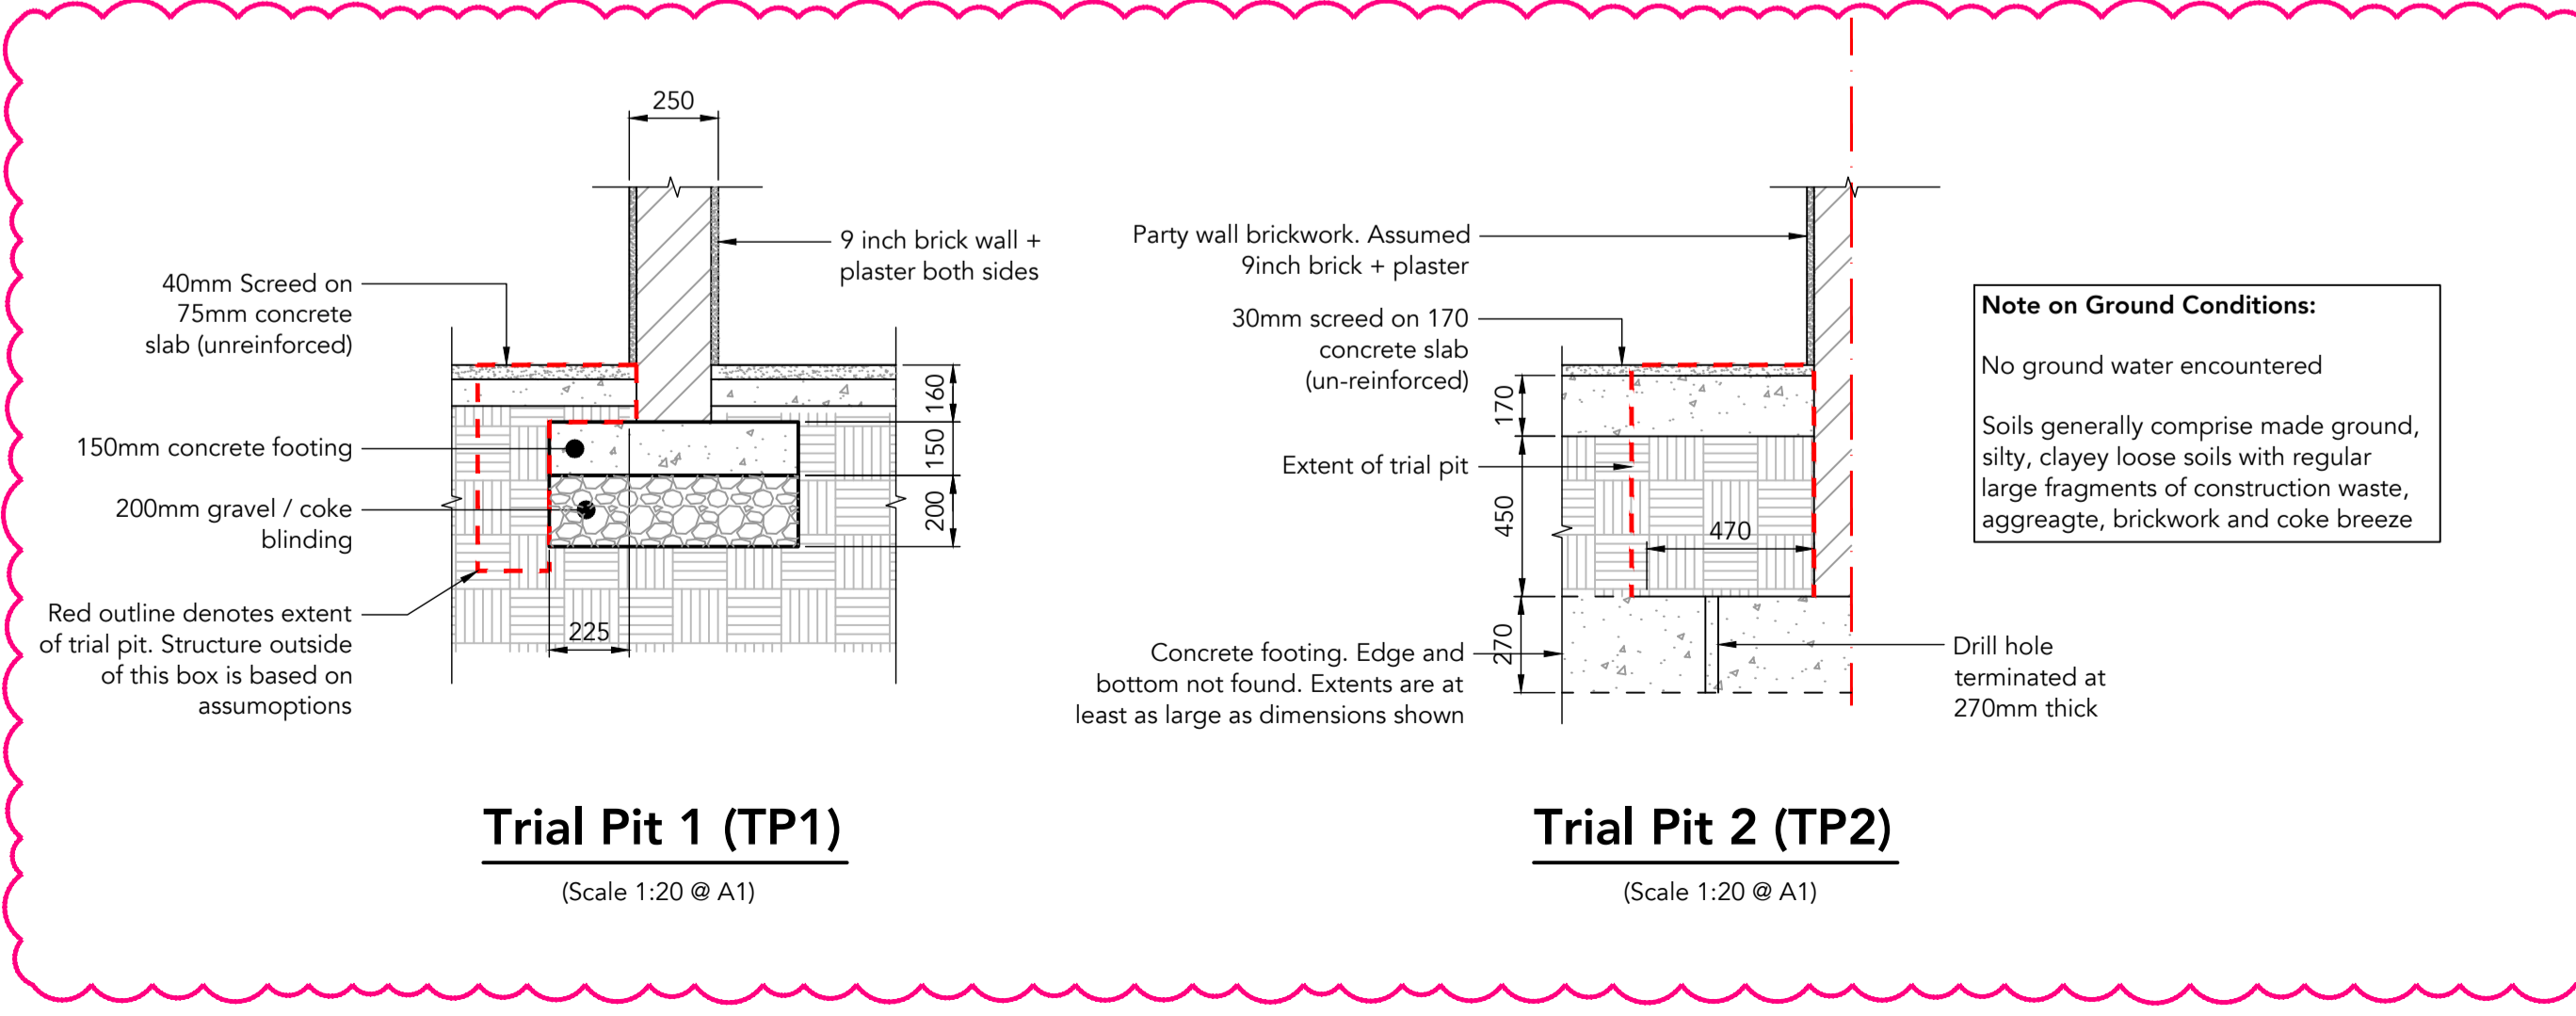
Drawing Title
**Existing Building
Ground Floor and Basement**

- Partial collapse to rear wall of brick arch vault. Earth exposed behind, brickwork has fallen into the storage room. Repair required to make safe
- Overhead the existing brick arch has collapsed exposing part of the pavement and utilities (green duct). It is assumed the top of the brick arch was damaged from pavement level when new fibre or similar utilities were laid. Temporary works have been installed to support the arch and pavement locally. Repair required to make safe.

- Cracks to inside face of wall around location of historic block infill of doorway - superficial
- Vertical crack in middle of wall over full height, partial diagonal cracks top and bottom third of wall. This wall supports ground floor timber joists and lintel to adjacent doorway. Plaster removed, cracking manifests through brickwork.

- Ceiling missing and exposes staircase to communal residential entrance over. Possible fire safety risk. Client to seek further advice. Block wall over is only supported on timber floor joists / boards. No dedicated structural support

- Lintel over head has dropped towards the centre of the room. Possibly linked to distress / cracks in supporting wall as per item 4 above. Possible overloading of lintel from concrete block wall at ground floor over

- 4no lintels over from front to rear: Steel, Timber, Timber, Timber. All lintels in poor condition and require replacement with new suitably durable lintels with sufficient strength to support loads over

- Large horizontal crack in wall just above top of door level. Extends over full width of wall. This wall supports original back wall of building over and ground floor timber joists. Plaster removed showing various different ages of brickwork. Evidence of historic modifications. Brick and lintel repair work required

- Steel lintel over new opening. Not possible to fully observe lintel during survey. Further investigation required after timber panels are removed
- Insufficient bearing length to timber joists over. New bearing detail / possible joist sistering required

- Filler joist concrete floor over. Very badly corroded steel joists, spalled concrete. Unsafe - risk of collapse! Temporary acro props and spreader boards have been introduced to temporarily make safe. Replacement floor required. It is assumed the concrete floor supports the toilet space above (as accessed from the courtyard). Steel beam on edge of floor acts as lintel which supports brick wall over (side wall of toilet). Lintel is badly corroded and bearing has completely rusted away. Replacement required. Temporarily propped to make safe

- Openings at high and low level. Timber lintels in poor condition. The openings have been bricked up externally. Lintels to be replaced or internal openings to be similarly bricked up

- a - large vertical crack in wall over full height. b - large vertical crack in wall becomes diagonal at high level and ends at bearing location of assumed steel beam over. Crack widths are large between 3 - 5mm. Investigations show wall is only supported on the timber joists / floorboards below. Inadequate support provided

- Corridor wall not tied into return wall. Walls are pulling away from each other. Repair tying detail required
- Large vertical crack between party wall and rear wall. Spine wall has pulled away from rear wall. The pier below the door lintel has damaged brickwork / loose and missing mortar joints. Pier requires to be rebuilt

- Vertical crack in rear wall above mezzanine level. Plaster removed - crack is superficial
- 2no joists to first floor level have been sistered, insufficient bolting detail. New joist or appropriate timber sistering detail to be introduced

- Multiple cracks in masonry wall. This wall is supported on the steel lintel beam noted in item 11 above. The cracking is likely due to failure and movement of the lintel under. Repair works required to lintel under and the masonry wall.

- Timber lintel at high level over vent. Lintel has been drilled through at multiple locations to pass electrical services. Recommend for lintel to be replaced

- Missing mortar / failed brickwork. Repair required
- Internal timber lintel and external flat brick arch lintel have both failed and dropped causing a slope in the brickwork over the door opening. Replacement lintels required

- Opening has been cut into existing rear wall brickwork. Unsuitable timber lintels installed to support brick over. Lintel to be replaced with new steel solid wall lintel

- Diagonal cracks in wall. Plaster removed - superficial cracks.
- Delapidated roof to courtyard over. Requires complete removal and reinstatement
- Failed flat brick arch lintel over door opening. Requires repair

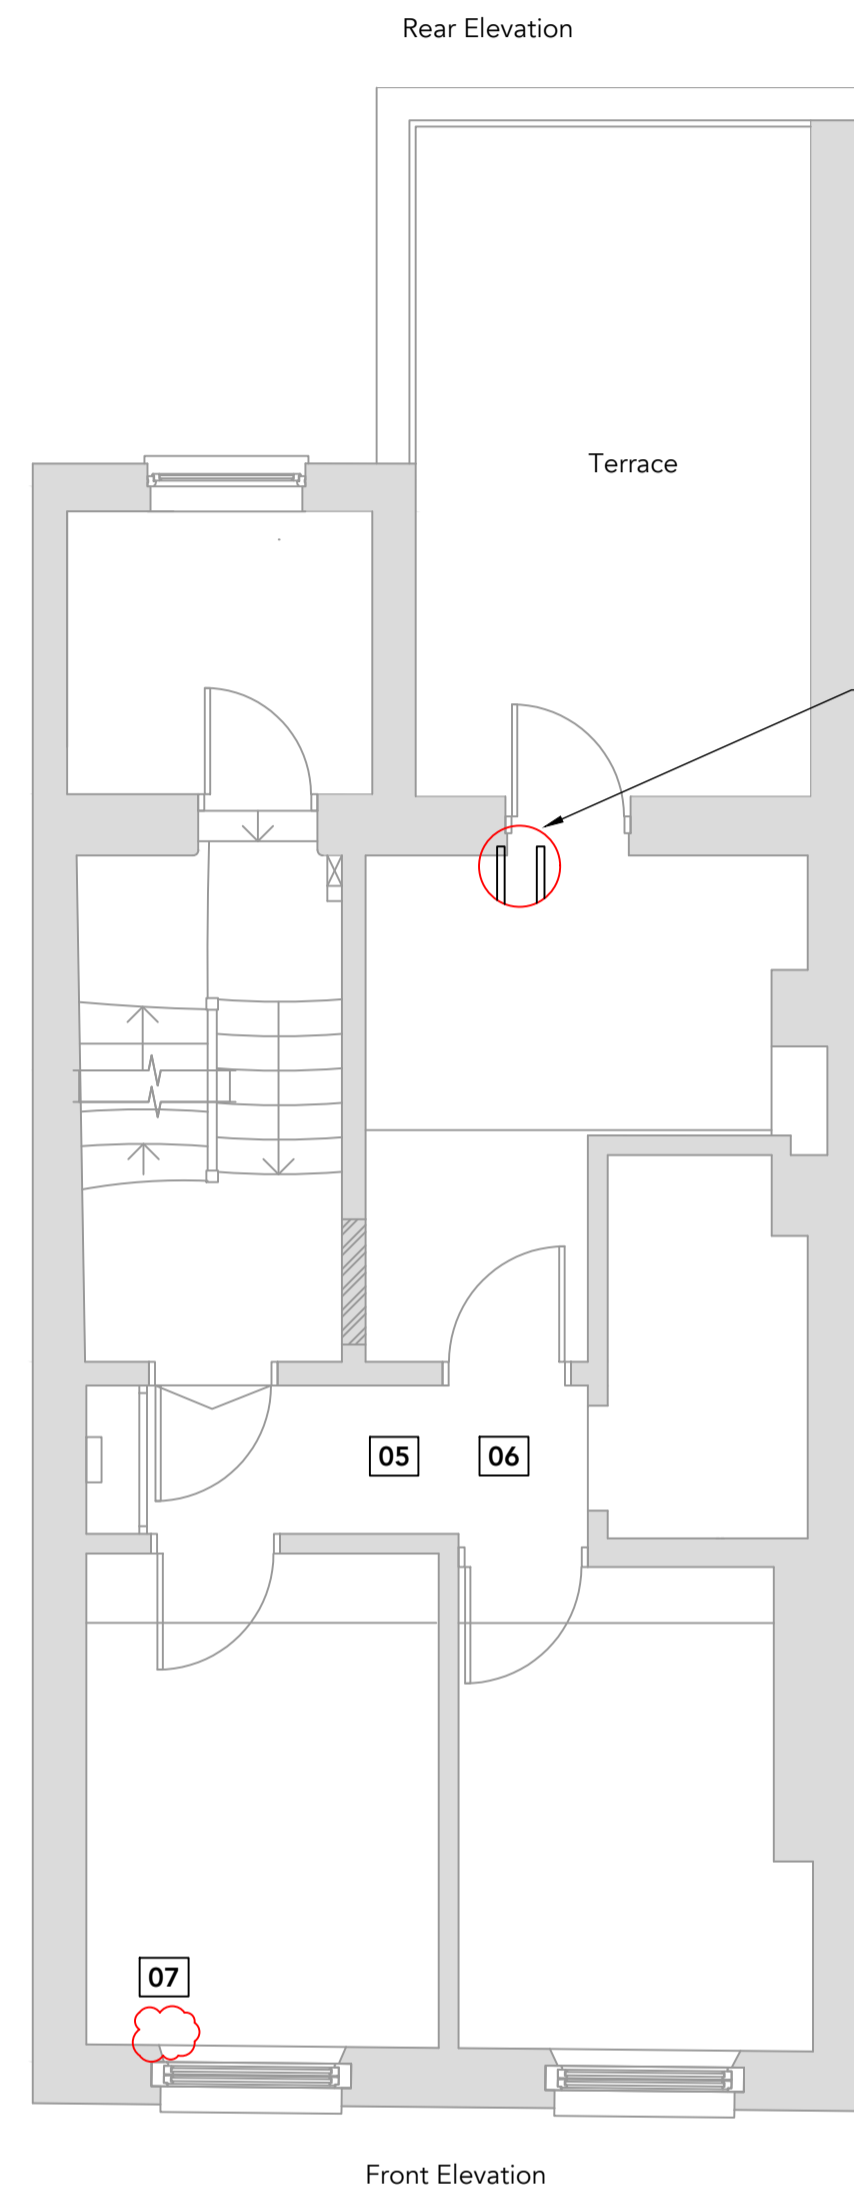
00 First Floor Plan
(Scale 1:50)

- Evidence of water damage / stains to ceiling and corners of rear bedrooms along eaves of dormer
- Evidence of water damage / stains to ceiling in corner of kitchen along line of dormer eaves

- Vertical cracks in corner of kitchen between party wall and front elevation. Damaged brickwork beyond likely due to settlement of facade and cracks developing on external face. Crack stitching / repair works required

- Cracks to side of window in rear bedroom. Details as (3) above
- Significant deflection of floor joists. Applies to all levels and is widespread across the entire floor. Investigations have been made to locally remove the floor boards at discrete locations across each floor. Several observations are made that are symptomatic to the sagging / deflecting joists:

- Excessive notching of joists to run services has reduced section and stiffness of joist
 - addition of partitions has increased floor load
 - notching at the support location has reduced joist stiffness at the support

- age of joist likely resulting in long term creep deflection effects
- Ceilings at all levels have various cracks, unclear at this stage whether cracks are superficial or linked to the deflection observed in the floor joists. Further investigation required

- Small diagonal downward crack extending from corner of the window sill towards floor. Details as (3) above
