Arboricultural Appraisal Report

Subsidence Damage Investigation at:

7 & 9 Pond Street
London
NW3 2PN

CLIENT: Crawford & Company
 CLIENT REF: [REDACTED]
 MWA REF: [REDACTED]
 MWA CONSULTANT: Andy Clark
 REPORT DATE: 02/07/2024

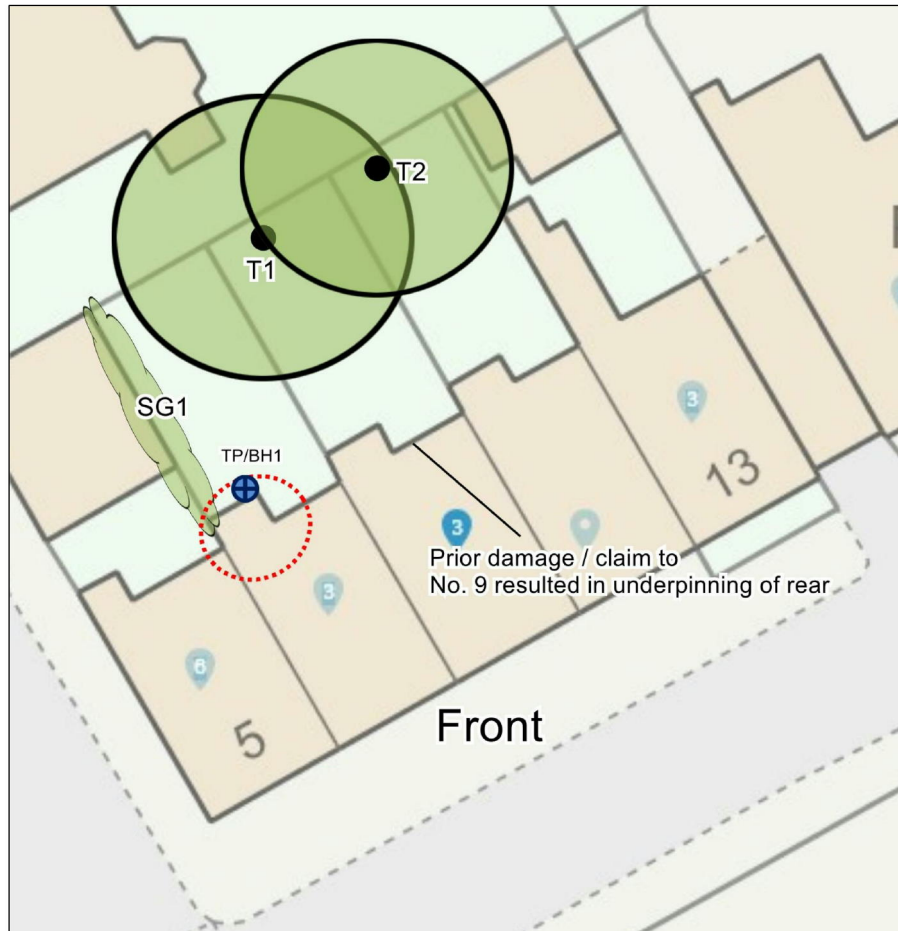
Site Plan

Approximate areas of damage

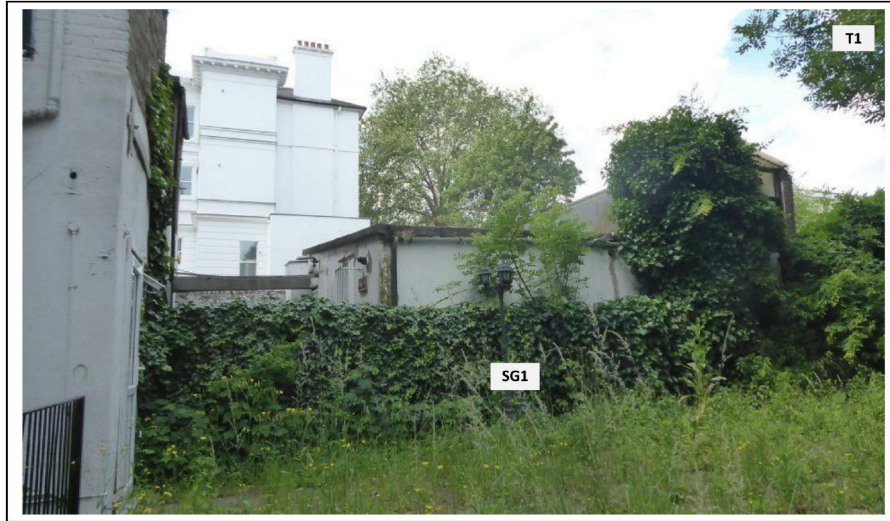
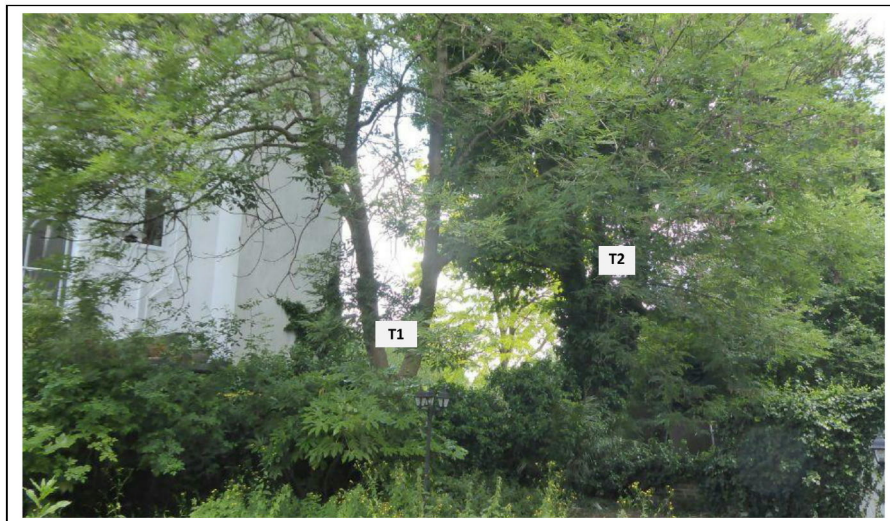
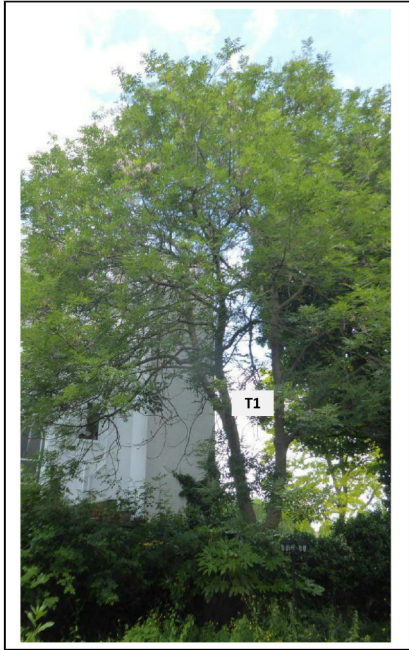
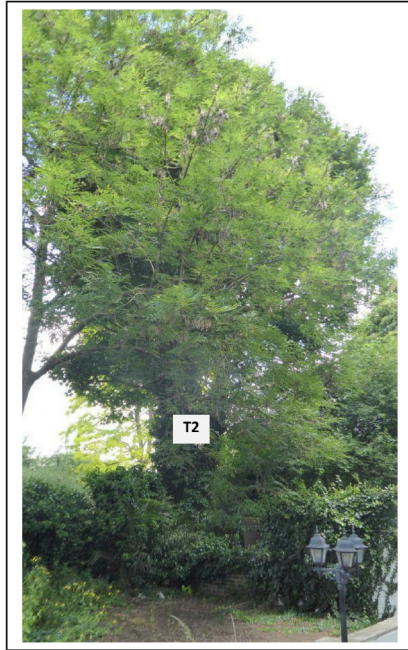
Roots were observed below foundation depth in TP/BH1 and recovered samples have been positively identified (using anatomical analysis) as *Fraxinus* spp., the origin of which will be T1 Ash, confirming its influence on the soils below the foundations.

Based on the information currently available, engineering opinion and our own site assessment we conclude there is damage consistent with shrinkage of the clay fraction exacerbated by the soil drying effects of vegetation.

Tree No.	Species	Ht (m)	Dia (mm)	Crown Spread (m)	Dist. to building (m)	Age Classification	Ownership
T1	Ash	16.5 *	560	12.5	11.6	Younger than Property	Policy Holder
Management history		Subject to past management/pruning - previously crown reduced.					
Recommendation		Remove (fell) to near ground level and treat stump to inhibit regrowth.
