**TECHNICAL REPORT ON A SUBSIDENCE CLAIM**

**Negrar UK Ltd  
7 & 9 Pond Street  
London  
NW3 2PN**

**SUBSIDENCE CLAIM**

DATE: 29<sup>th</sup> September 2023

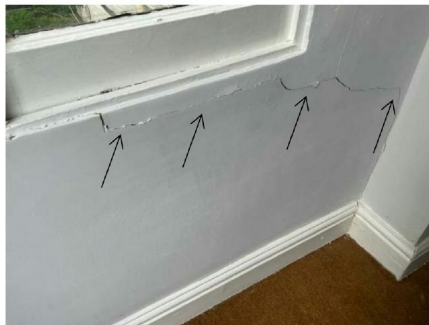
Cracking noted beneath the rear left side hallway window

- Distortions found by the left side of the hallway window, which is also contained within the projection
- Vertical cracking found adjacent to the previous window
- The same cracking, then extends beneath the window in a diagonal manner
- The previous crack heading down to skirting level

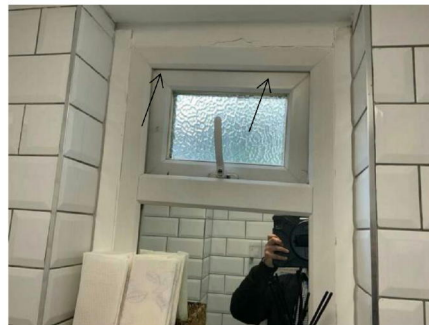
Distortions noted to the rear left WC window

- Distortions confirmed internally to the WC window

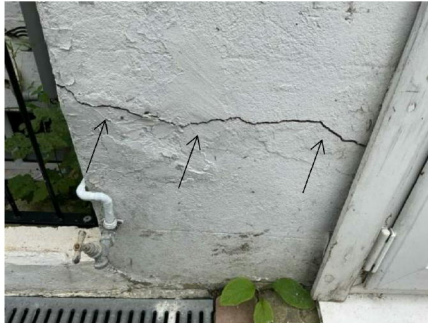
Cracking to the left side of rear external door

- Multiple diagonal cracks noted above the rear left side of the external door
- Multiple cracks found below the left side of the external door
- Cracking by the left side of the rear external door

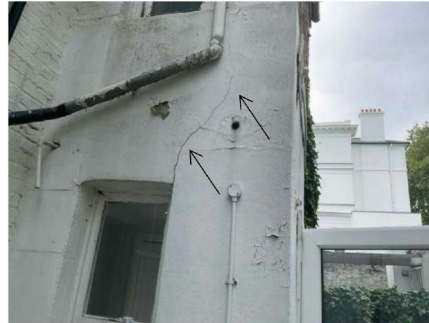
Cracking to the left side of projection heading diagonally above and below side window

- More cracks noted by the left side of the projection at the rear
- Distortion noted to the ground floor rear WC window which is located within the projection
