10 ABBOTS PLACE - LONDON - NW6 4NP
DRAINAGE LAYOUT SKETCH - N.T.S - 2409CC

Our Ref: 2409CC
Your Ref: Emailed Instruction
Date of S.I: November 2023
Site: 10 Abbots Place, London, NW6 4NP
Clients: James Wainwright

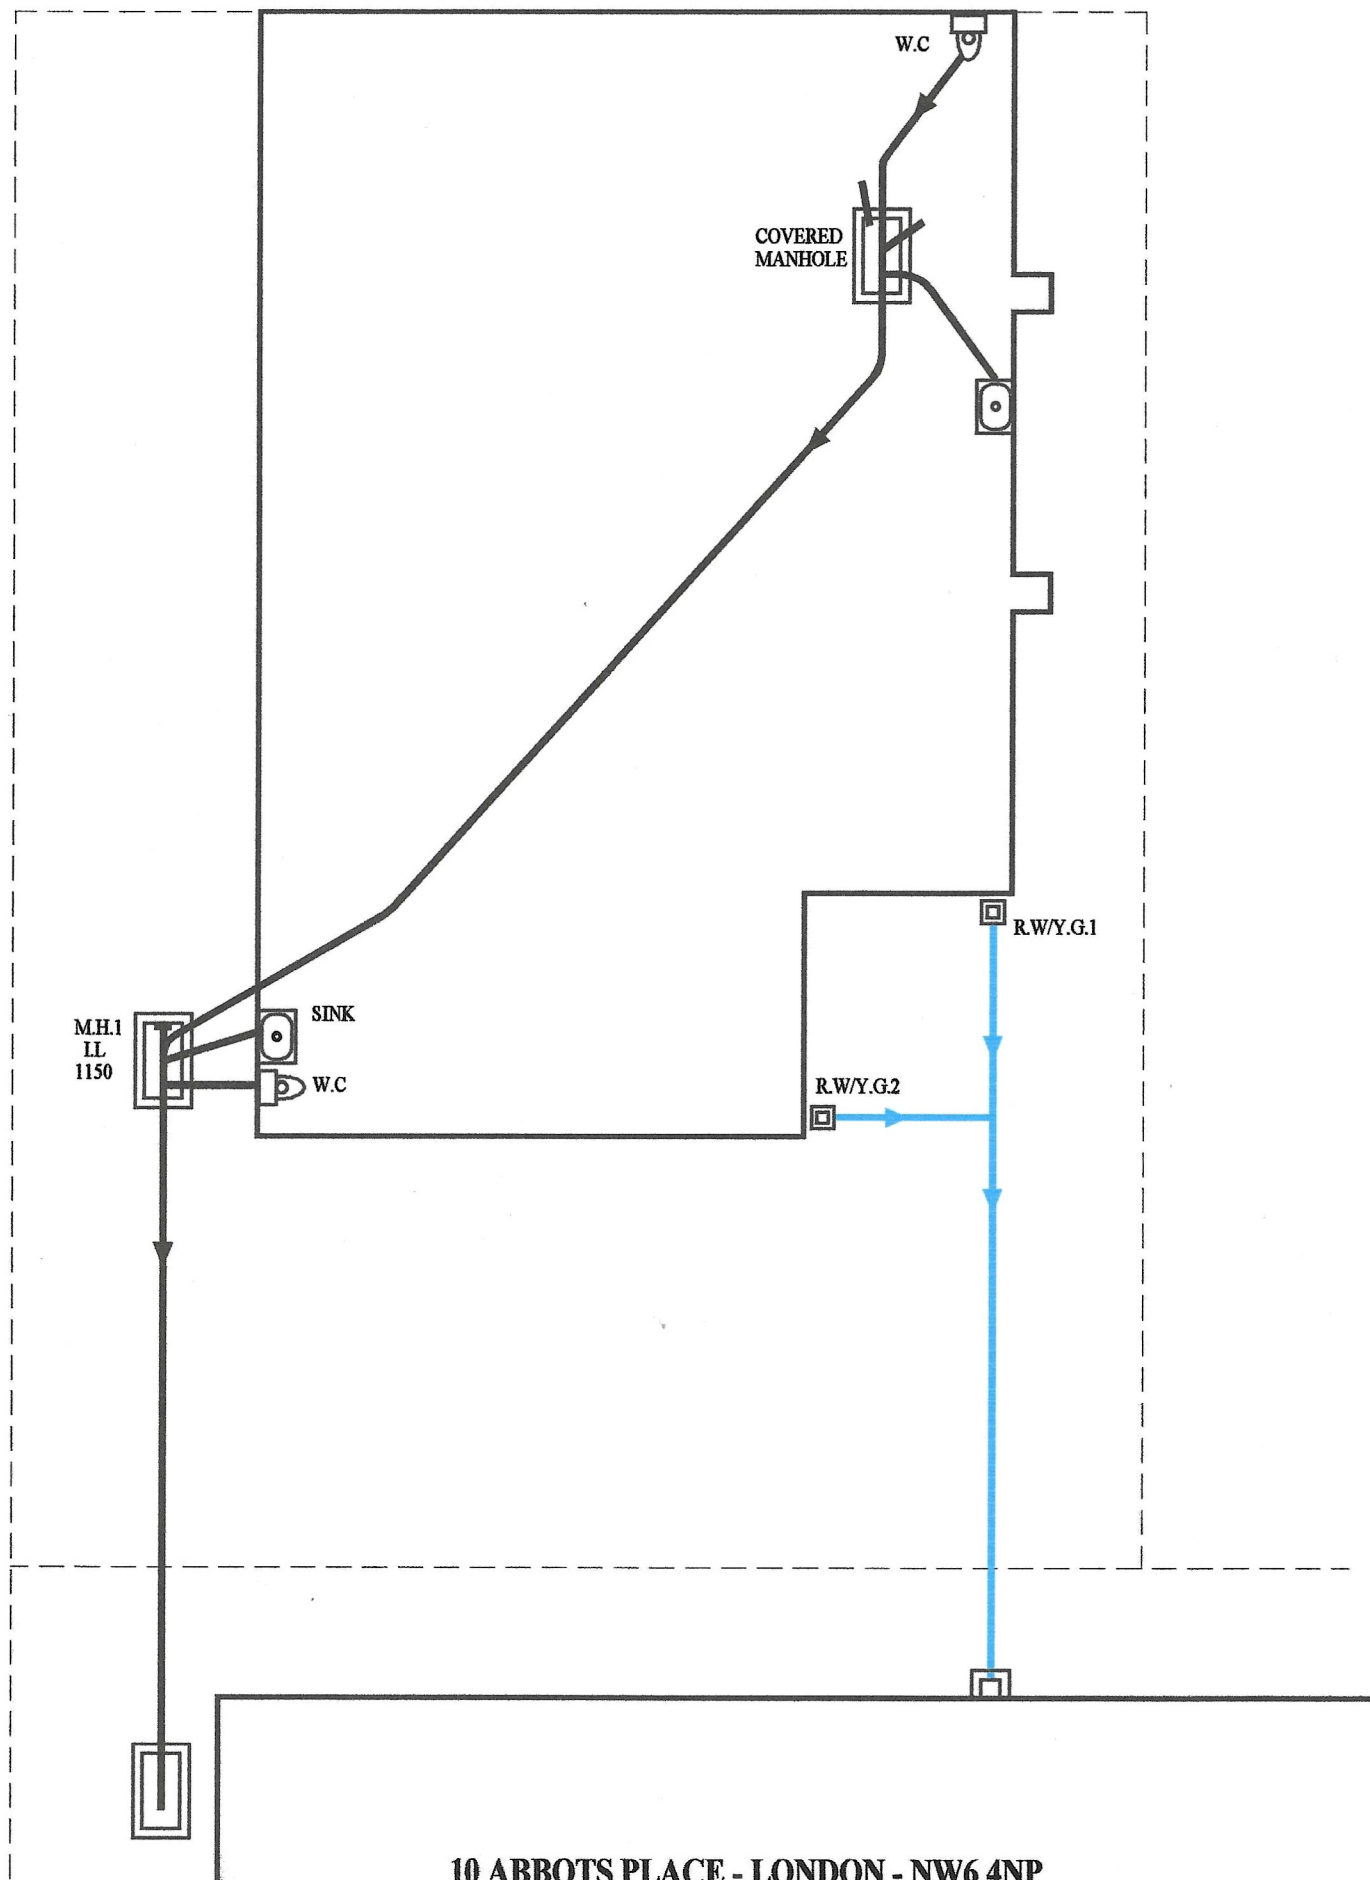
Pipework visually in a serviceable condition, however the collar to the W.C is fractured and leaking

Pipework visually in a serviceable condition apart from the large offset joint which will be located under the decking in the rear of the house located on the corner of Abbots Place and Priory Road
