**Structural Report on  
Spring Walk Boundary Wall**

**Abbey Rose,  
82 Fitzjohn's Avenue,  
London  
NW3 6NP**

**July 2024**

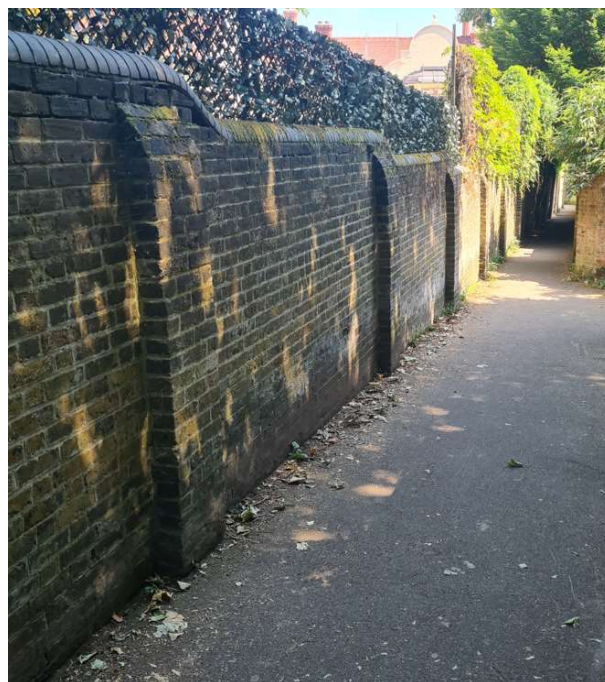
The boundary wall along Spring Walk consists of a solid masonry construction which is 9 inches thick with piers which vary in spacing of 4 to 5m. The top of the wall steps up at approximately the same location of the piers following the fall of the route as it drops from the western to eastern end.

The average height of the wall outside Spring Walk ranges from 2.2m at the top end down to 2.6m at the bottom of the site.

Photo of Wall along Spring Walk

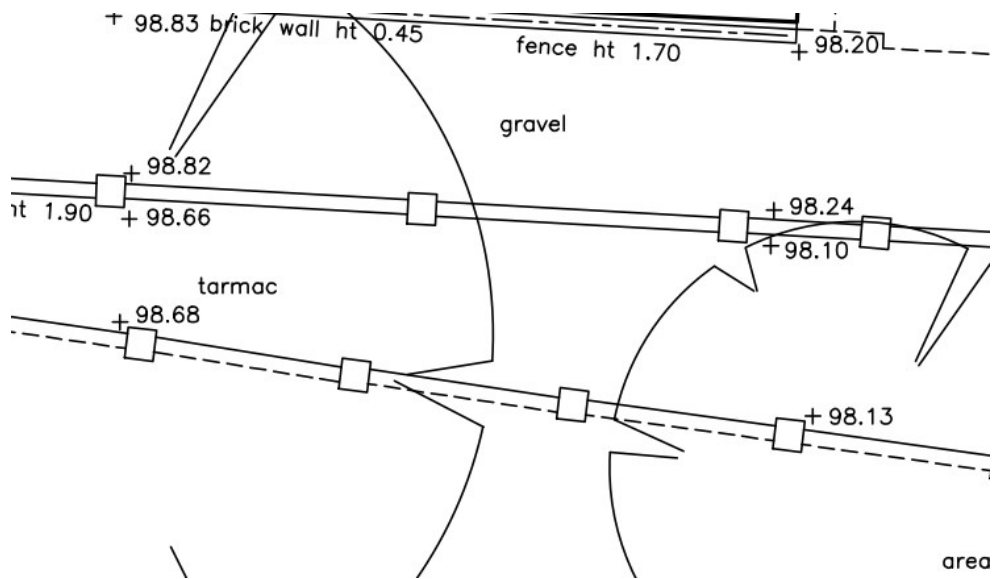
Capture of Survey showing slight difference in levels at top section of Spring Walk

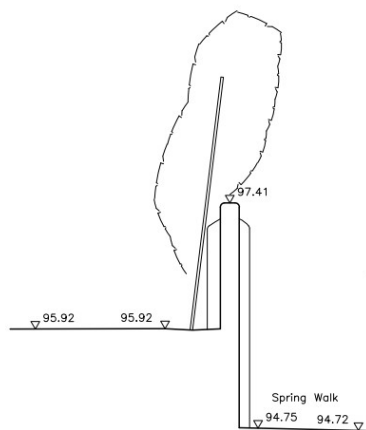
SECTION L-L  
Δ 93.00m A.O.D

Section taken from Survey of Typical Retaining

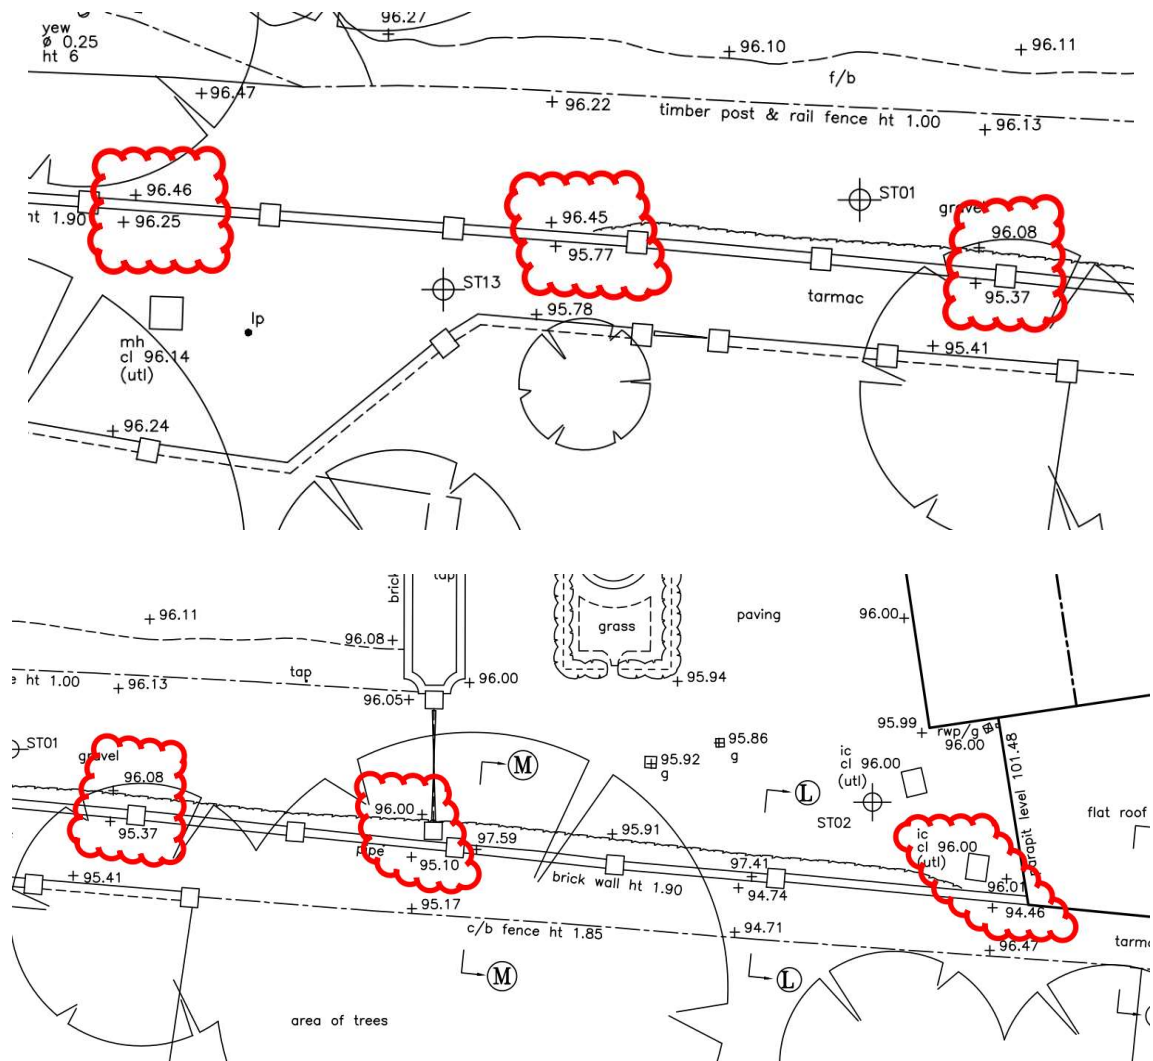
Internally within the property, the existing site levels from the survey drawing that has been provided, show the ground falling similar to the adjacent Spring Walk at the top of the site. However, the ground starts to flatten out 60m within No. 82 and 84 which begins to mark a change in height difference from the external levels out on Spring Walk. At the bottom end of the boundary wall, there is a 1.54m difference in height.

Capture of Survey showing increasing difference in levels at bottom section of Spring Walk

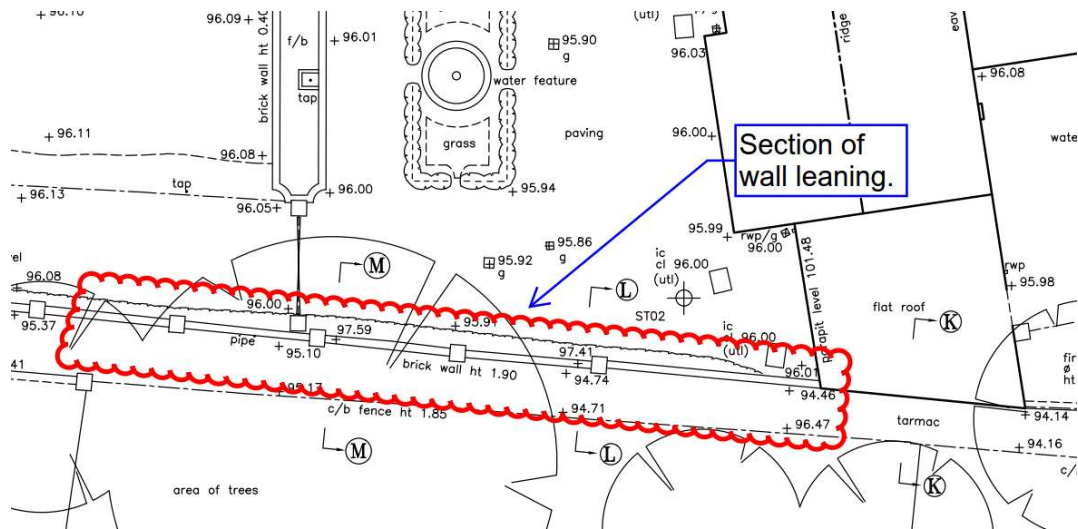
From inspection of wall externally from Spring Walk it is quite evident that the wall is leaning outward for the bottom 20m along Spring Walk. A 3D survey of the wall was carried out on the 26<sup>th</sup> of June 2024 by Vessell Ltd, which shows the wall leaning a maximum of 157mm from top to bottom. A survey was also carried out back in 2020 by On Centre Surveys Ltd. which also identified the wall as leaning approximately 130mm. This is a difference of 27mm in the 4-year period for the same section of wall which confirms that the wall is constantly moving.

Section of Boundary Wall leaning

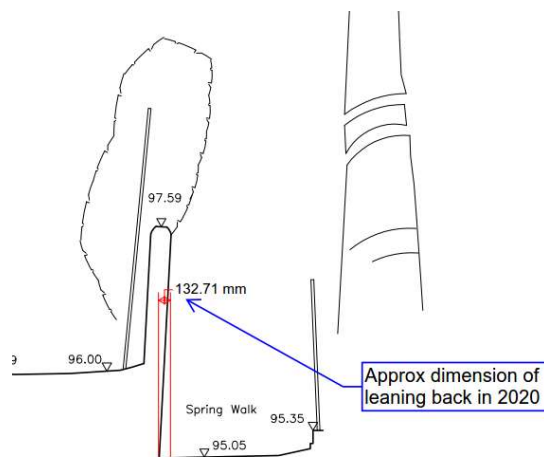
SECTION M-M  
Δ 93.00m A.O.D

### Section of Boundary Wall leaning from Survey in 2020

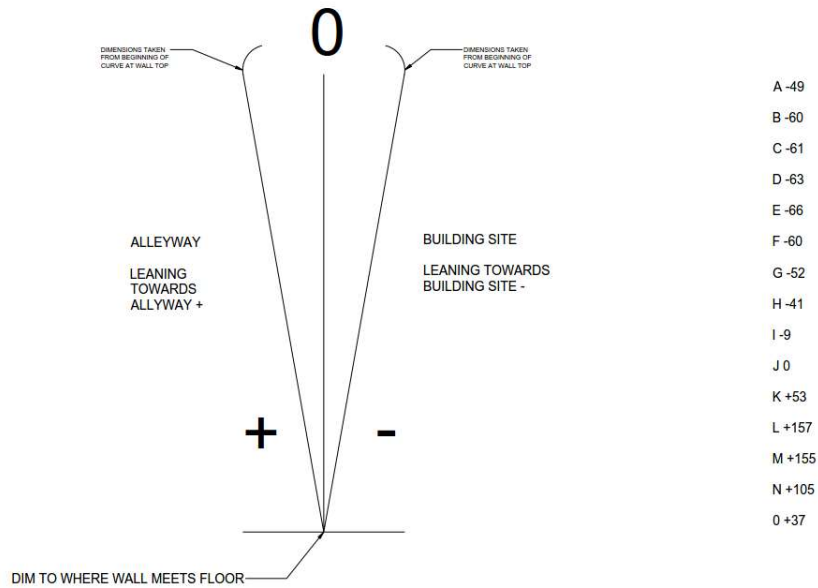
LOOKING AT WALL FROM ALLEYWAY

Extract from Survey completed in June 2024  
Bay M same location as Section M-M on original survey

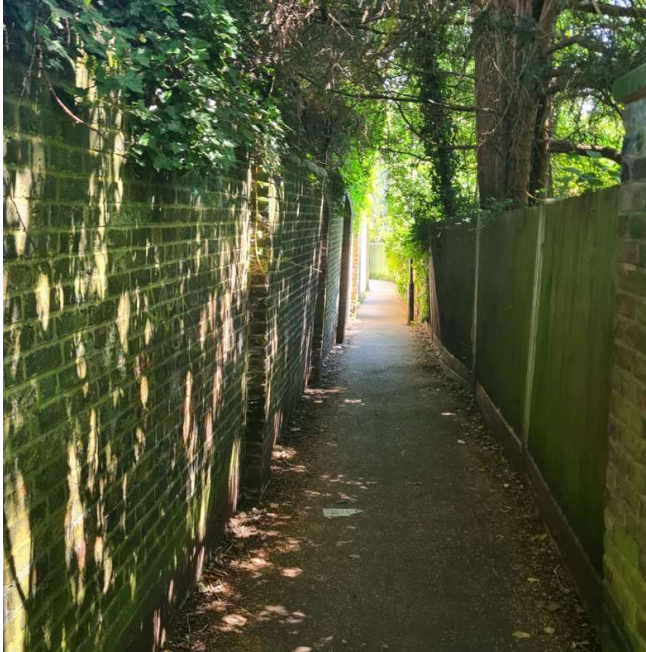
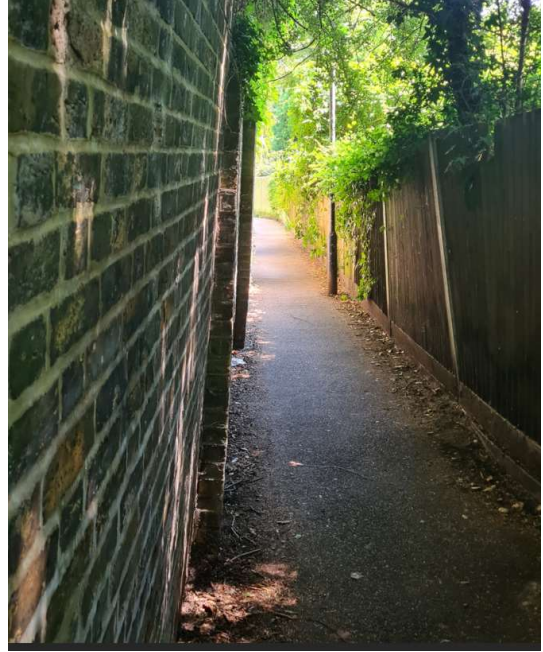
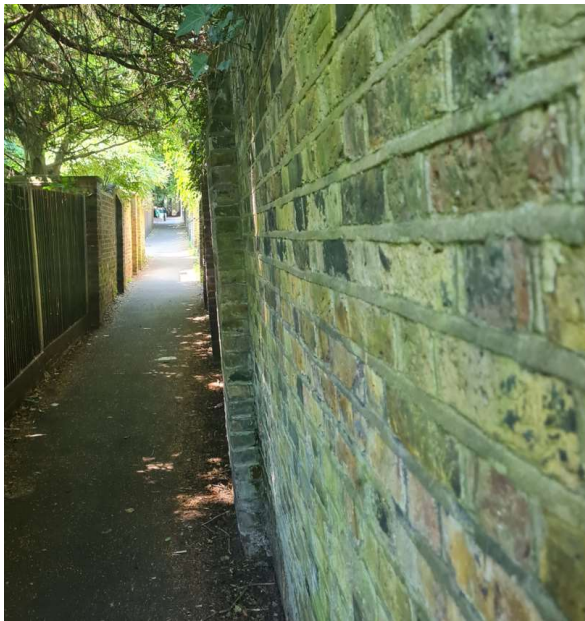
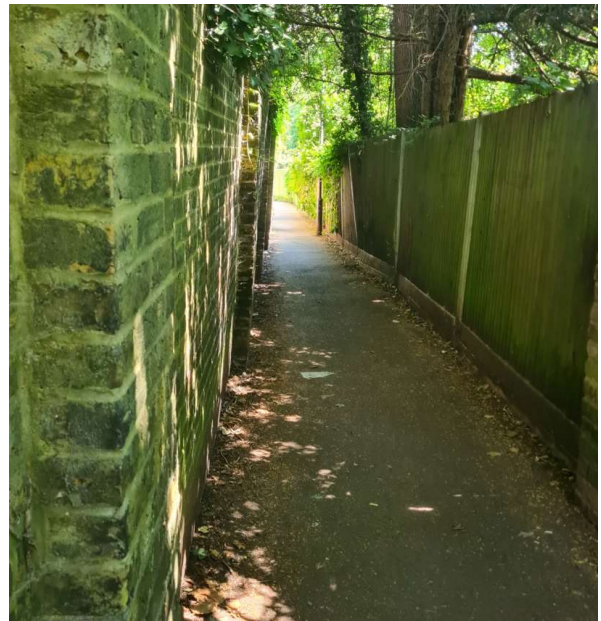
Photo Evidence of Wall leaning

It is our recommendation that this wall is demolished and replaced with a new concrete retaining wall system.

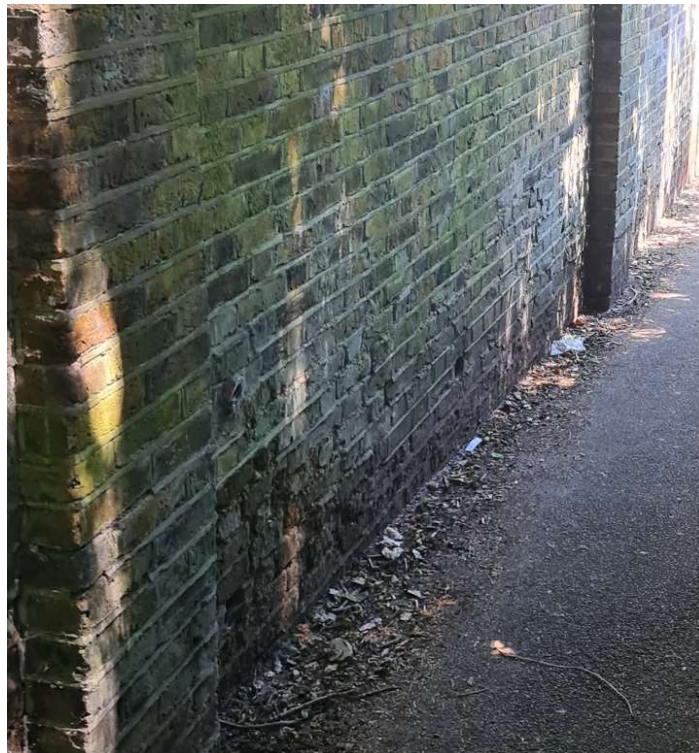
Weep Holes

Weep holes in the boundary wall are visible at the bottom end of Spring Walk (where the leaning is occurring) and are placed sporadically along the wall and varying centres of roughly 2.0m. It is also evident that these weep holes have been installed post construction as they seem to have been cored through the wall. This confirms to us that these weep holes were installed as a post construction measure due to the leaning of the wall. However as per building regulation (BRE GBG 27), weep holes should be at a maximum of 1.0m centres. Therefore, any water behind the wall is not discharging sufficiently due to the lack of free draining soils.

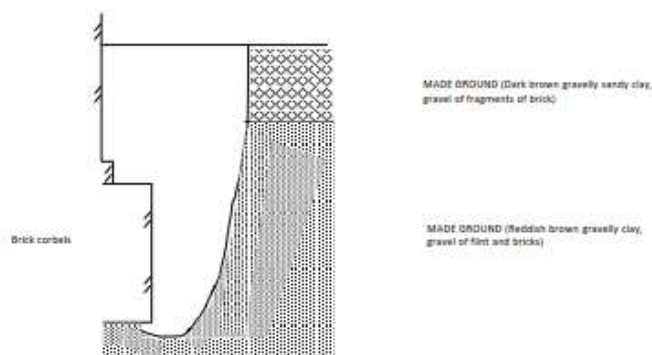
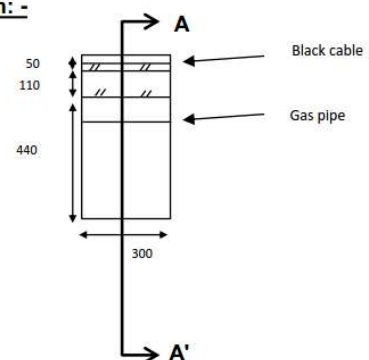
#### Trial Hole along Boundary Wall

On review of the soil investigation report, it can be assumed that the boundary wall is sitting on the made ground above the clay level. Trial Pit 12 was carried out at the top end of Spring Walk (see below). The edge projection of the corbelled base is only 160mm. It is assumed that this is the same profile along Spring Walk. The clay profile is assumed to be just below the foundation level.

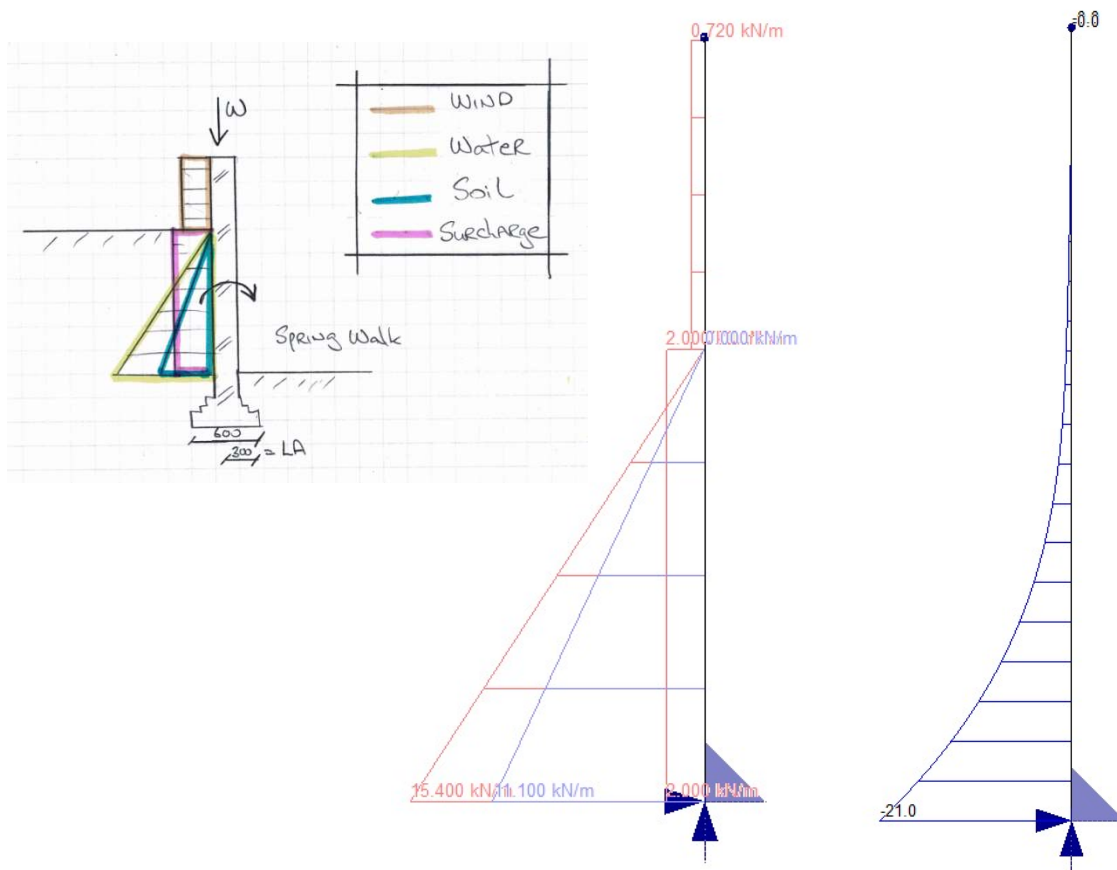
Maximum Overturning Moment of Wall = 21 kNm/m excluding moment from out of plumb wall.

Which is therefore considerably less than than the Overturning Moment
