PROJECT ADDRESS: 38D DELANCEY STREET, LONDON NW1 7NH

DRAWING TITLE: EXISTING THIRD FLOOR PLAN SCALE: 1:50 at A3

DRAWING NO.: P0113_00A_103 REVISION: / DATE: 09/2024

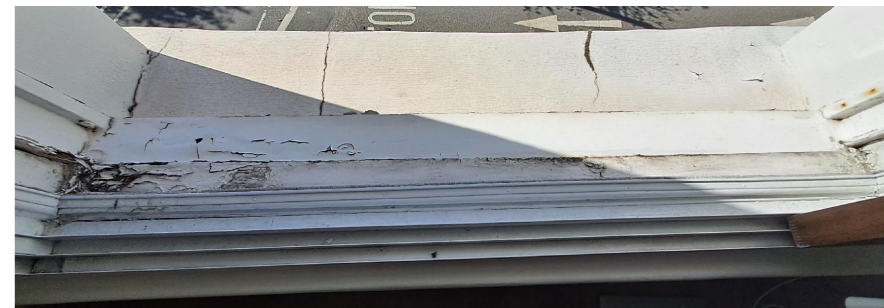
SINGLE-GLAZED TIMBER SASH WINDOW WITH DAMAGED SILL AND FRAMES. WITH CONTEMPORARY INTERNAL SECONDARY GLAZING

PHOTOGRAPH OF EXISTING SINGLE-GLAZED SASH WINDOWS IN LIVING ROOM, SHOWING ROTTEN SILL AND FRAME, AND CONTEMPORARY INTERNAL SECONDARY GLAZING

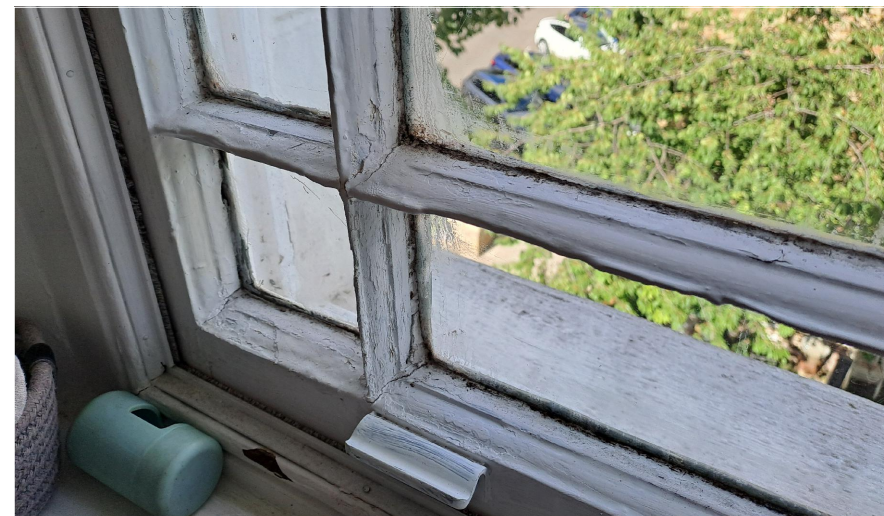
SINGLE-GLAZED TIMBER SASH WINDOW WITH DAMAGED SILL AND FRAMES. NO SECONDARY GLAZING

PHOTOGRAPH OF EXISTING SINGLE-GLAZED SASH WINDOWS ON STAIR LANDING IN BAD CONDITION AND WITHOUT SECONDARY GLAZING.

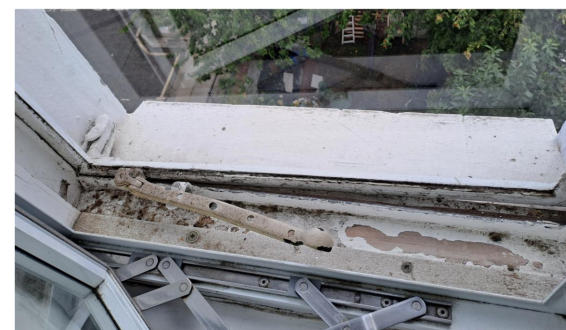
SINGLE-GLAZED METAL WINDOWS SEVERELY DAMAGED THROUGHOUT. WITH CONTEMPORARY INTERNAL SECONDARY GLAZING

PHOTOGRAPH OF EXISTING SINGLE-GLAZED METAL WINDOWS IN BEDROOM WITH SEVERELY DAMAGED FRAMES AND CONTEMPORARY INTERNAL SECONDARY GLAZING
