5 The Grove
Highgate Green - Railing
Railing Condition Study
September 2024

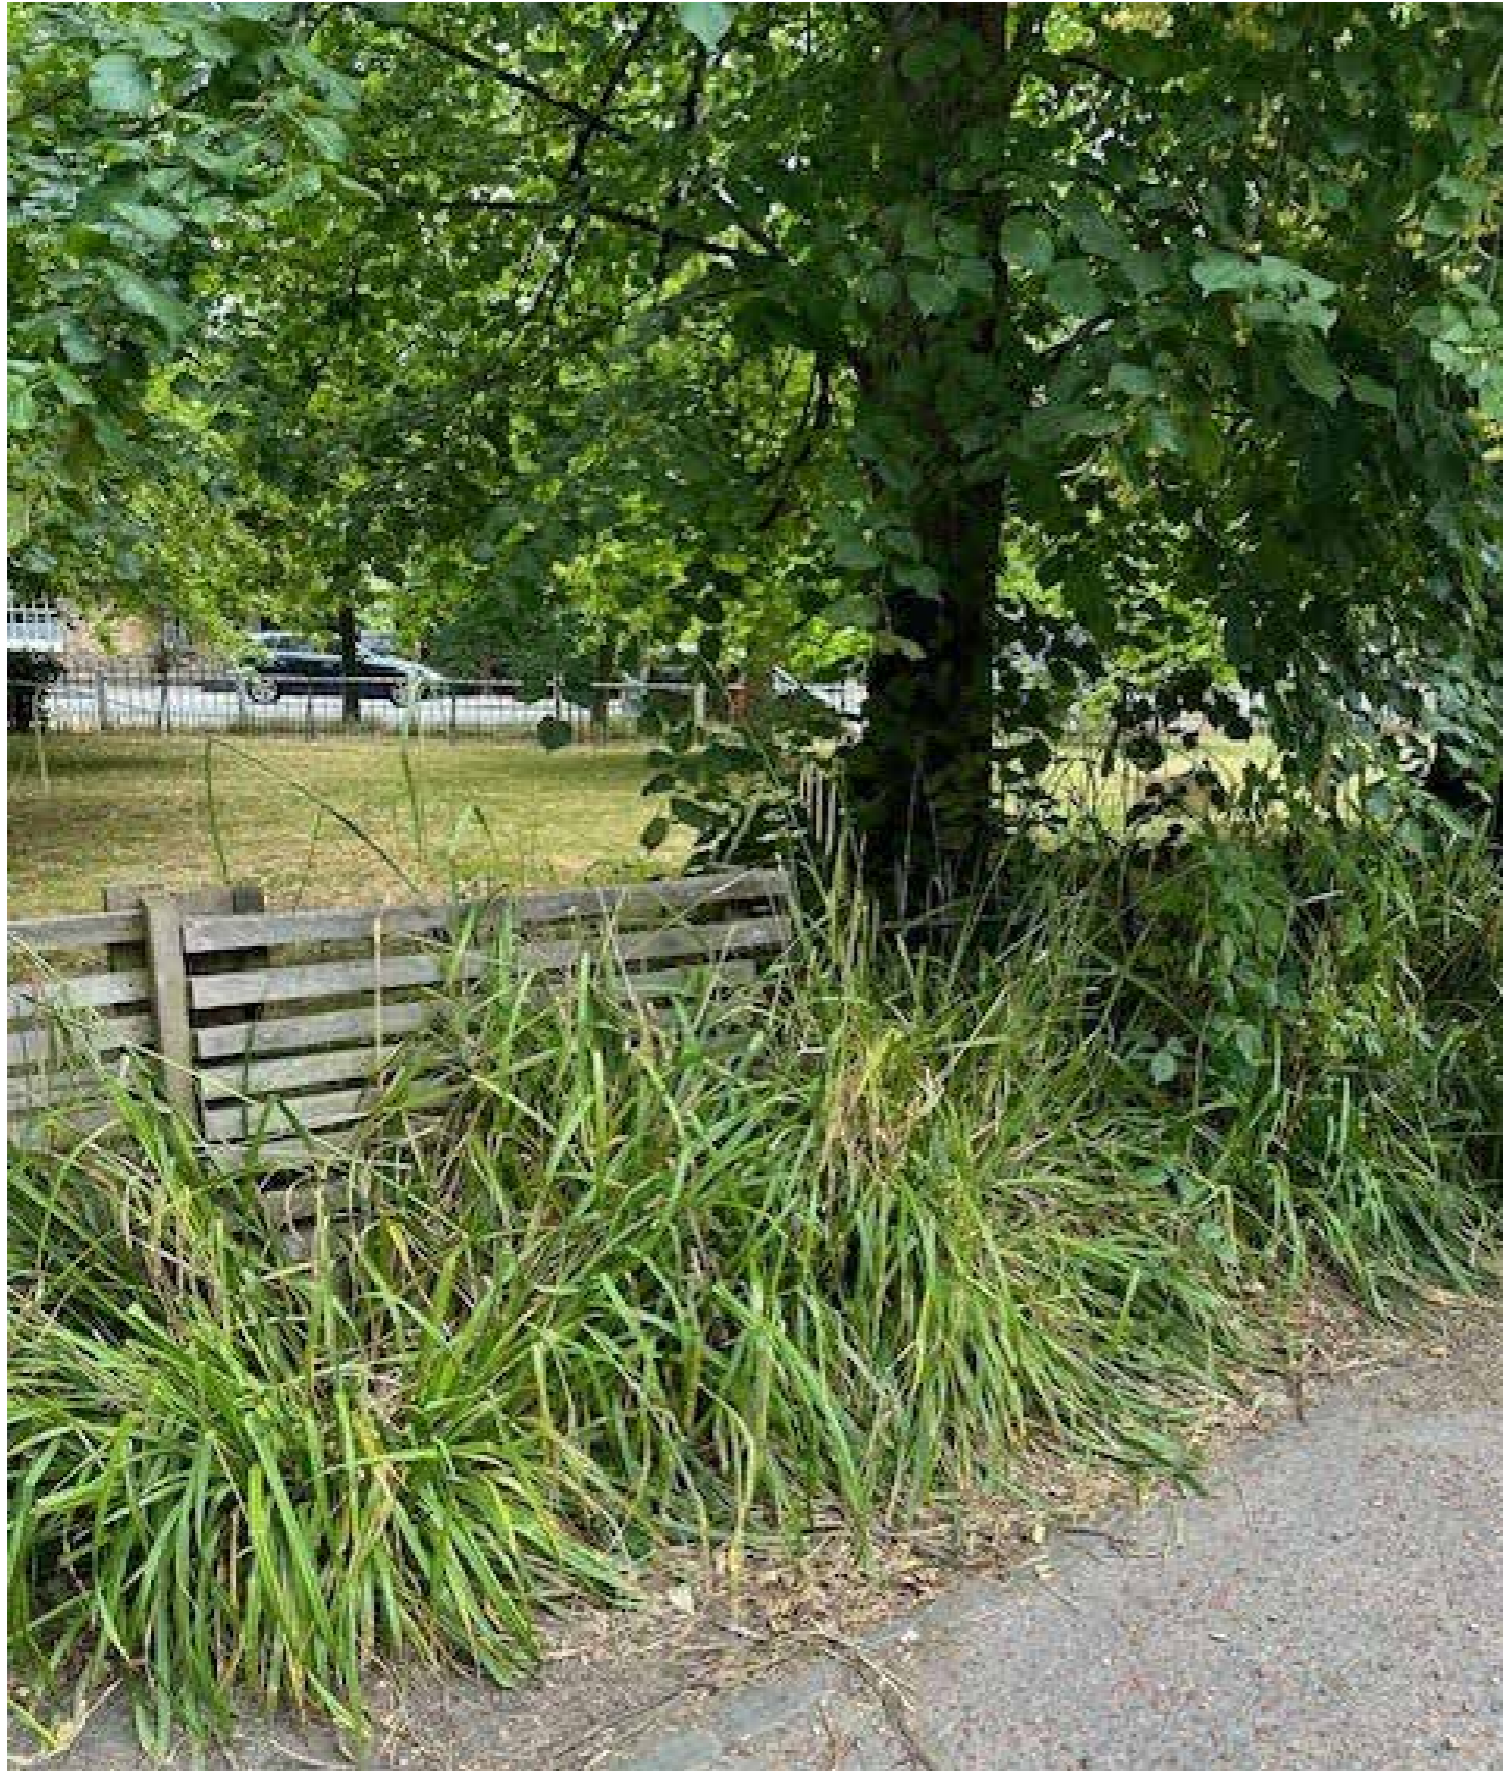
1. Circa. 4.4m length of panel missing

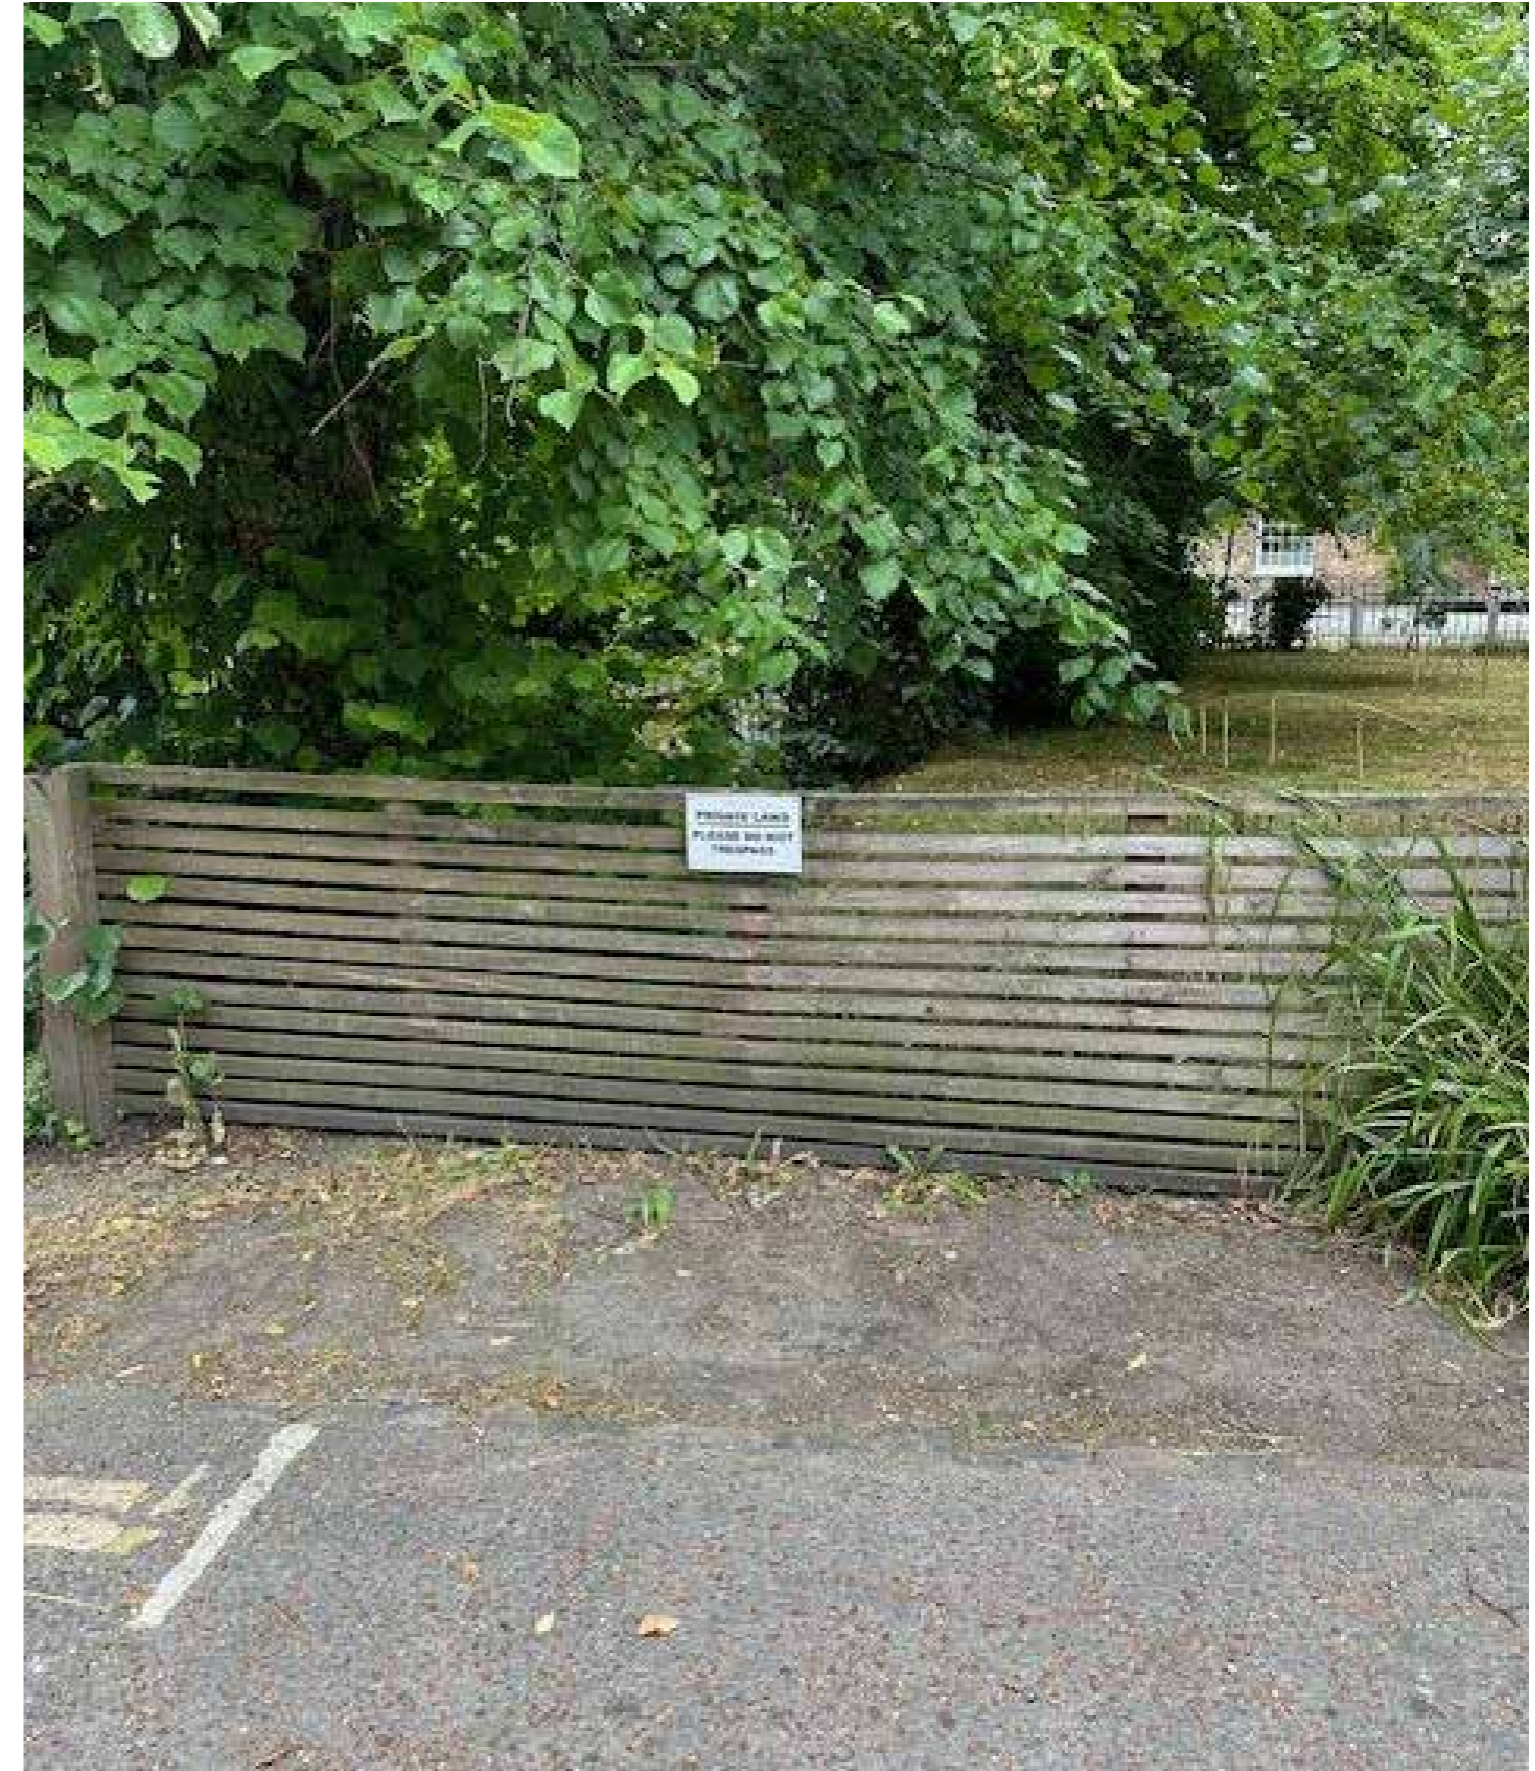
2. Circa. 4.4m length of panel missing (continued)

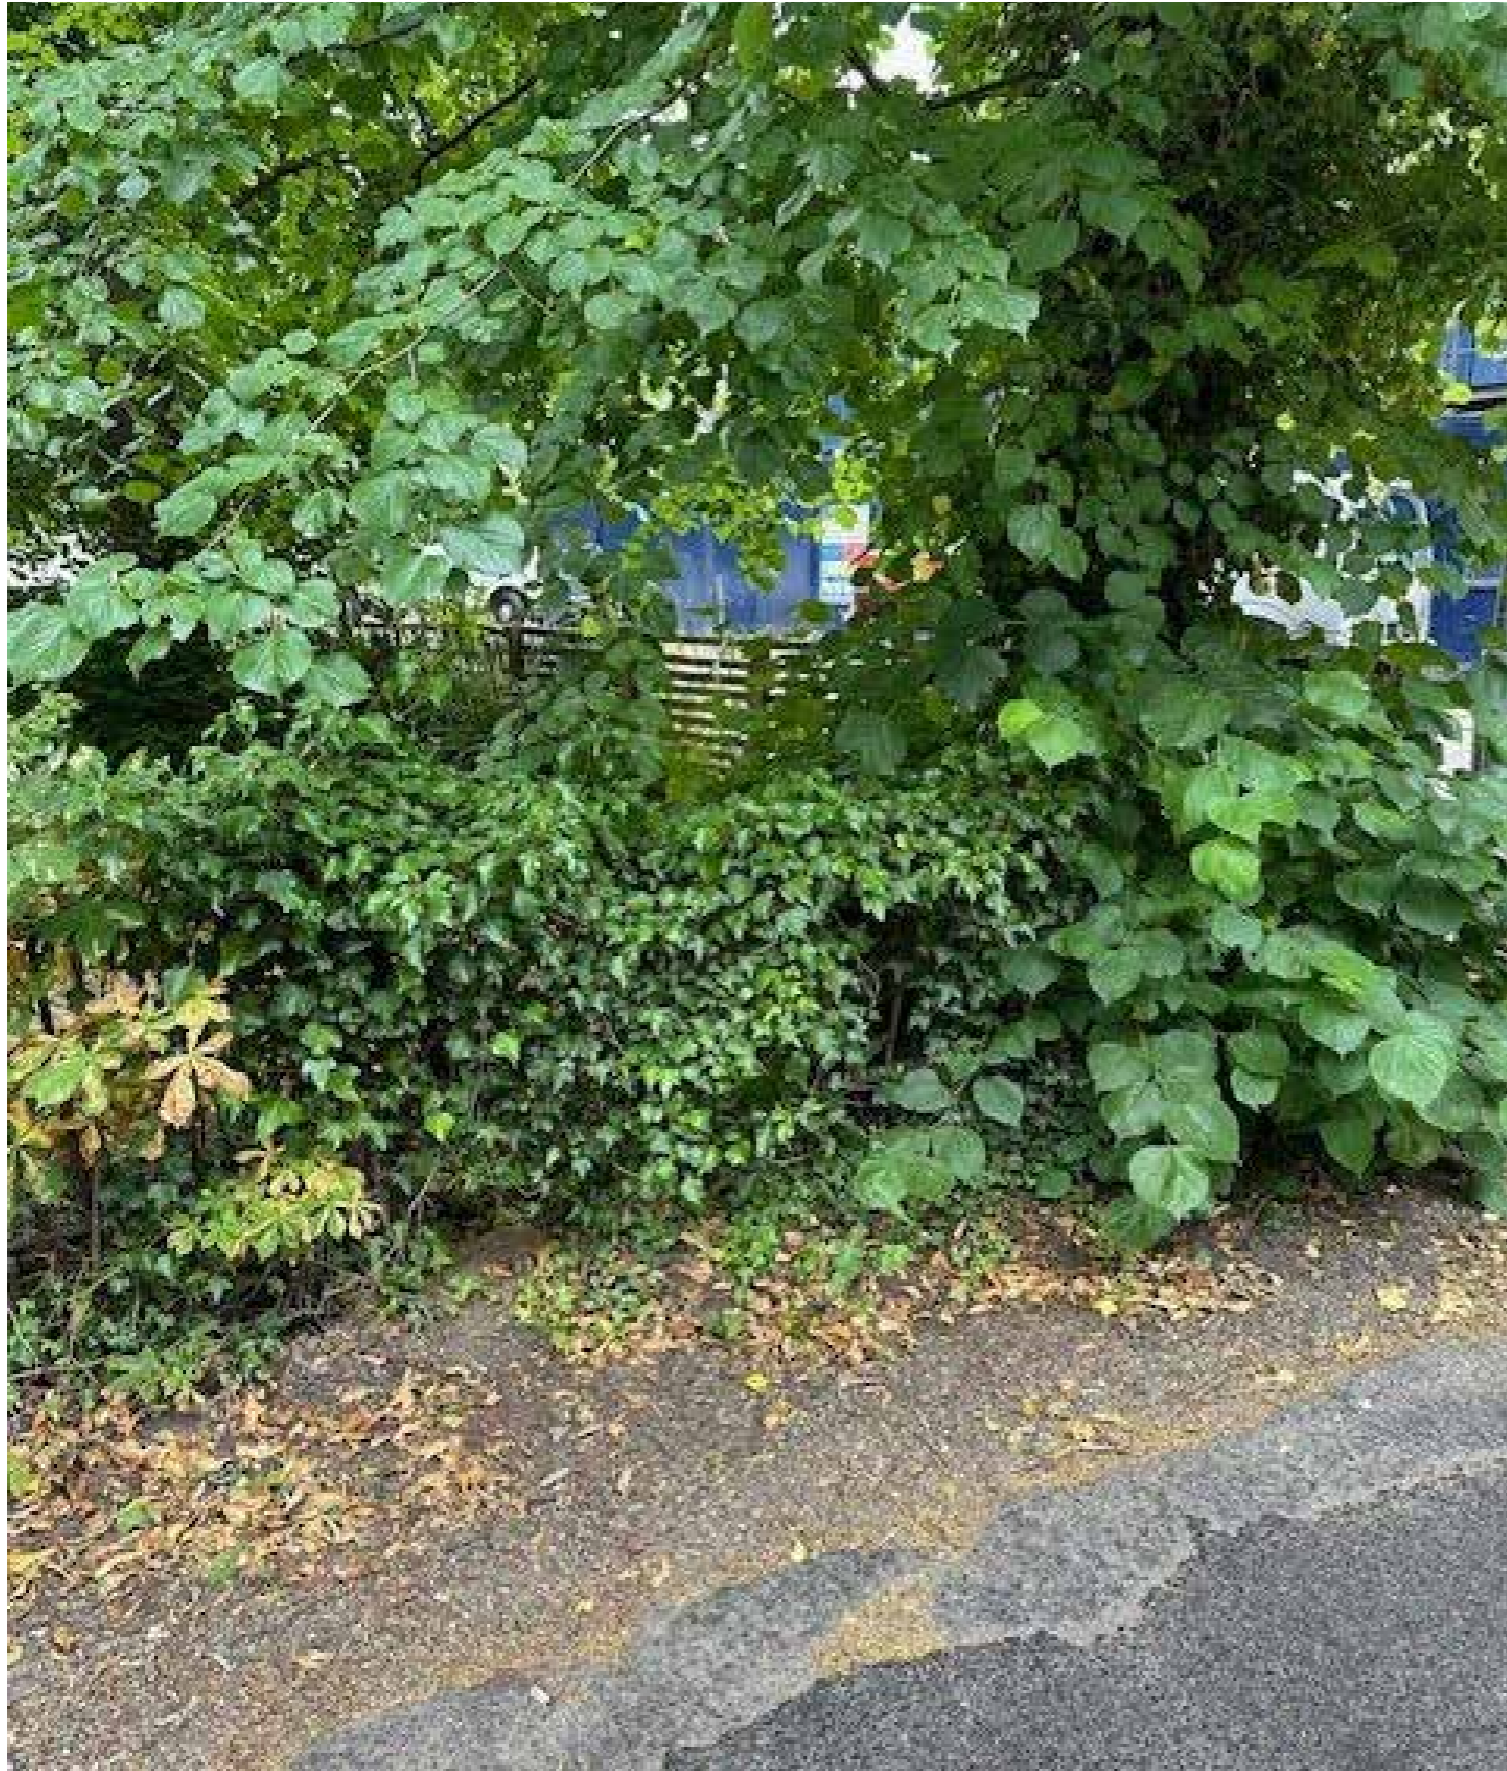
3. Broken panel

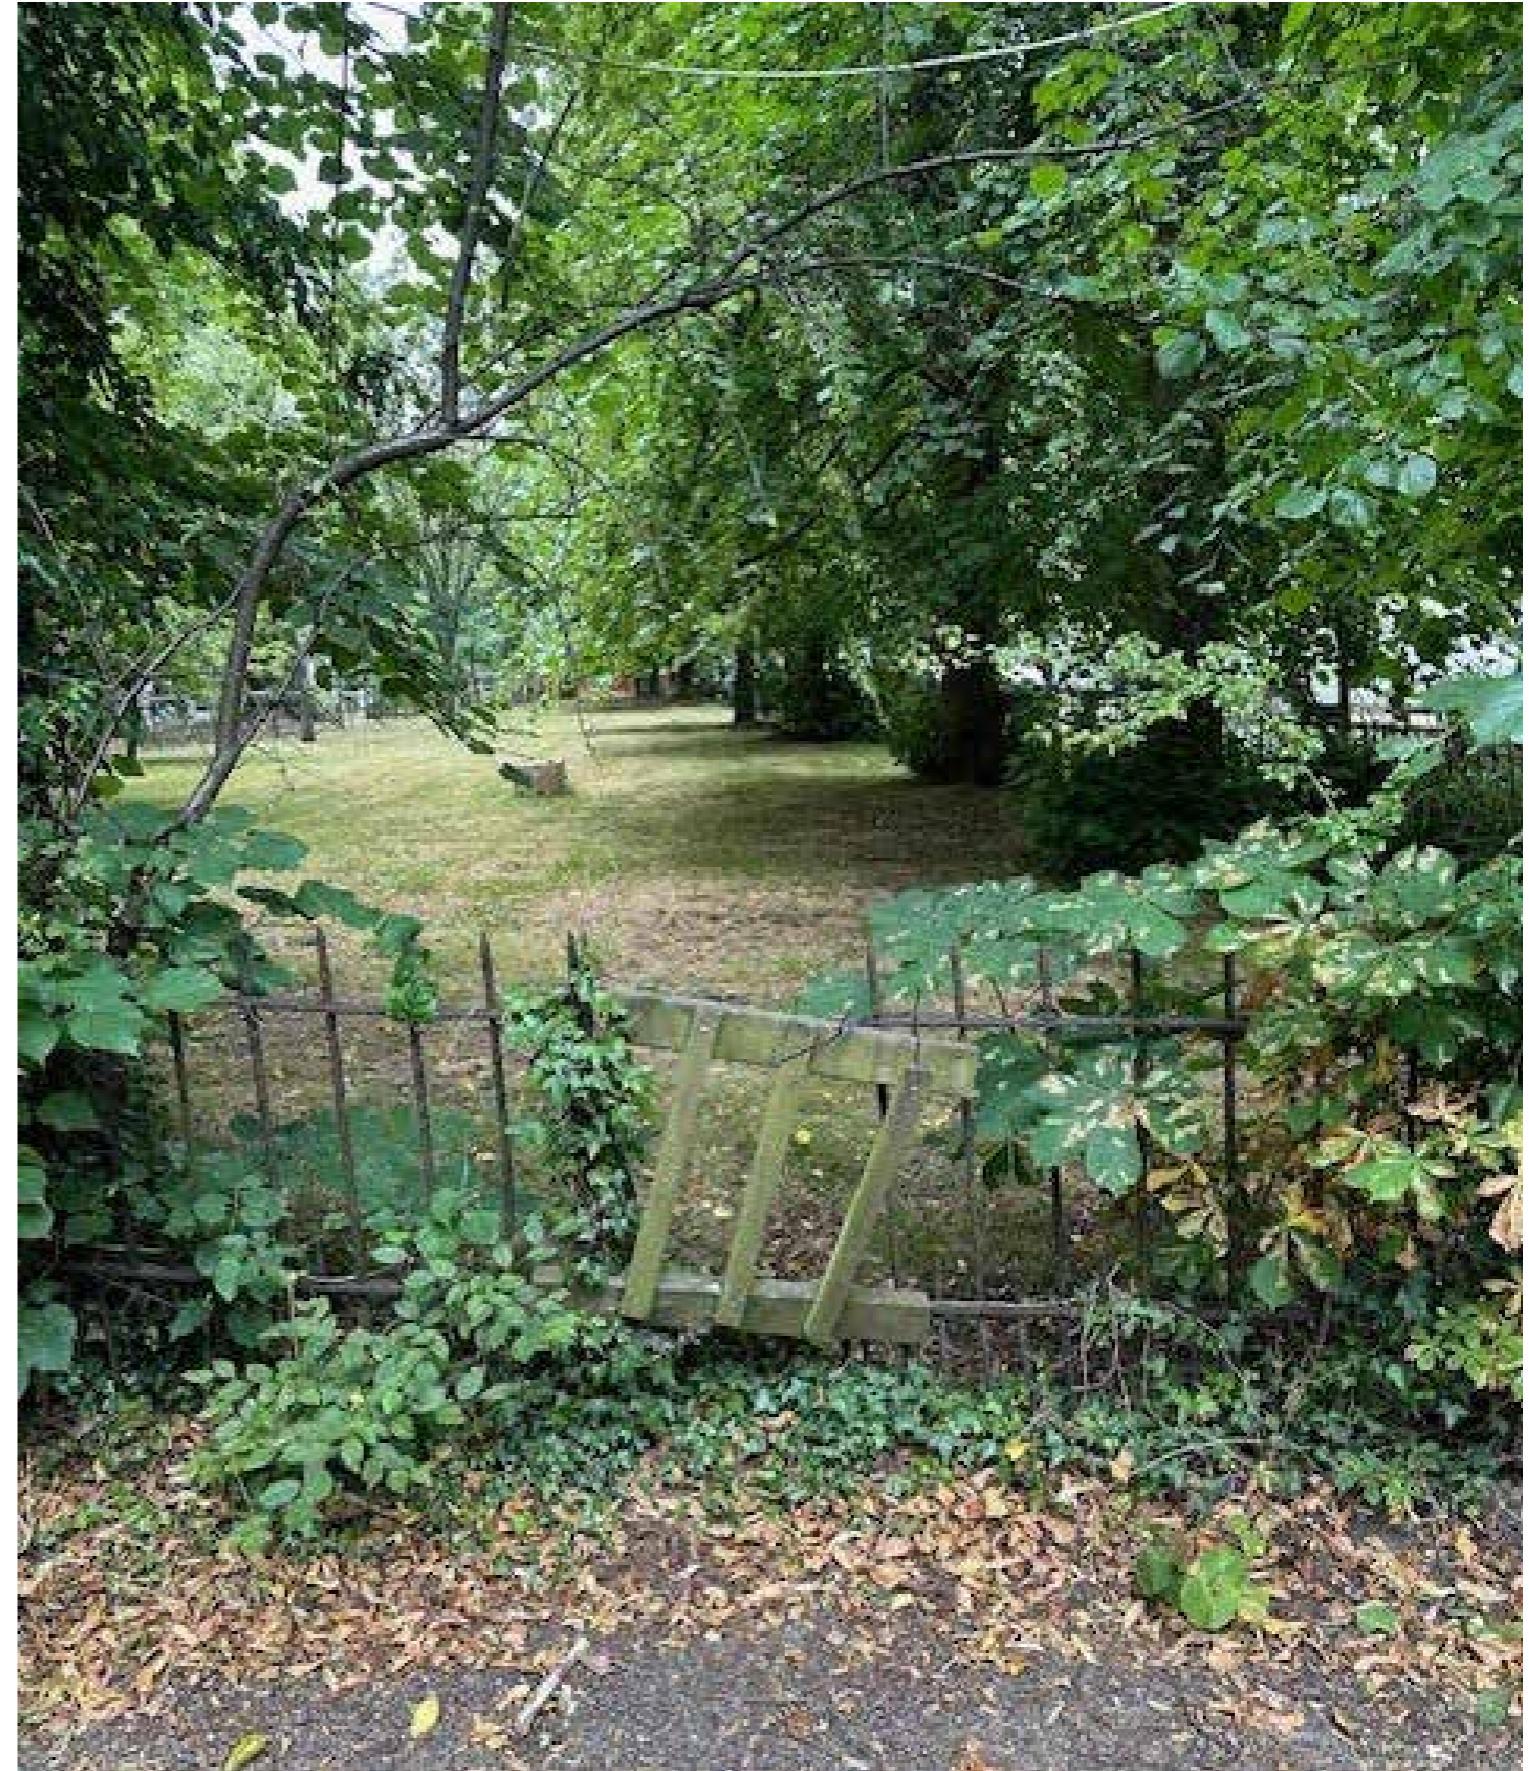
4. Broken panel

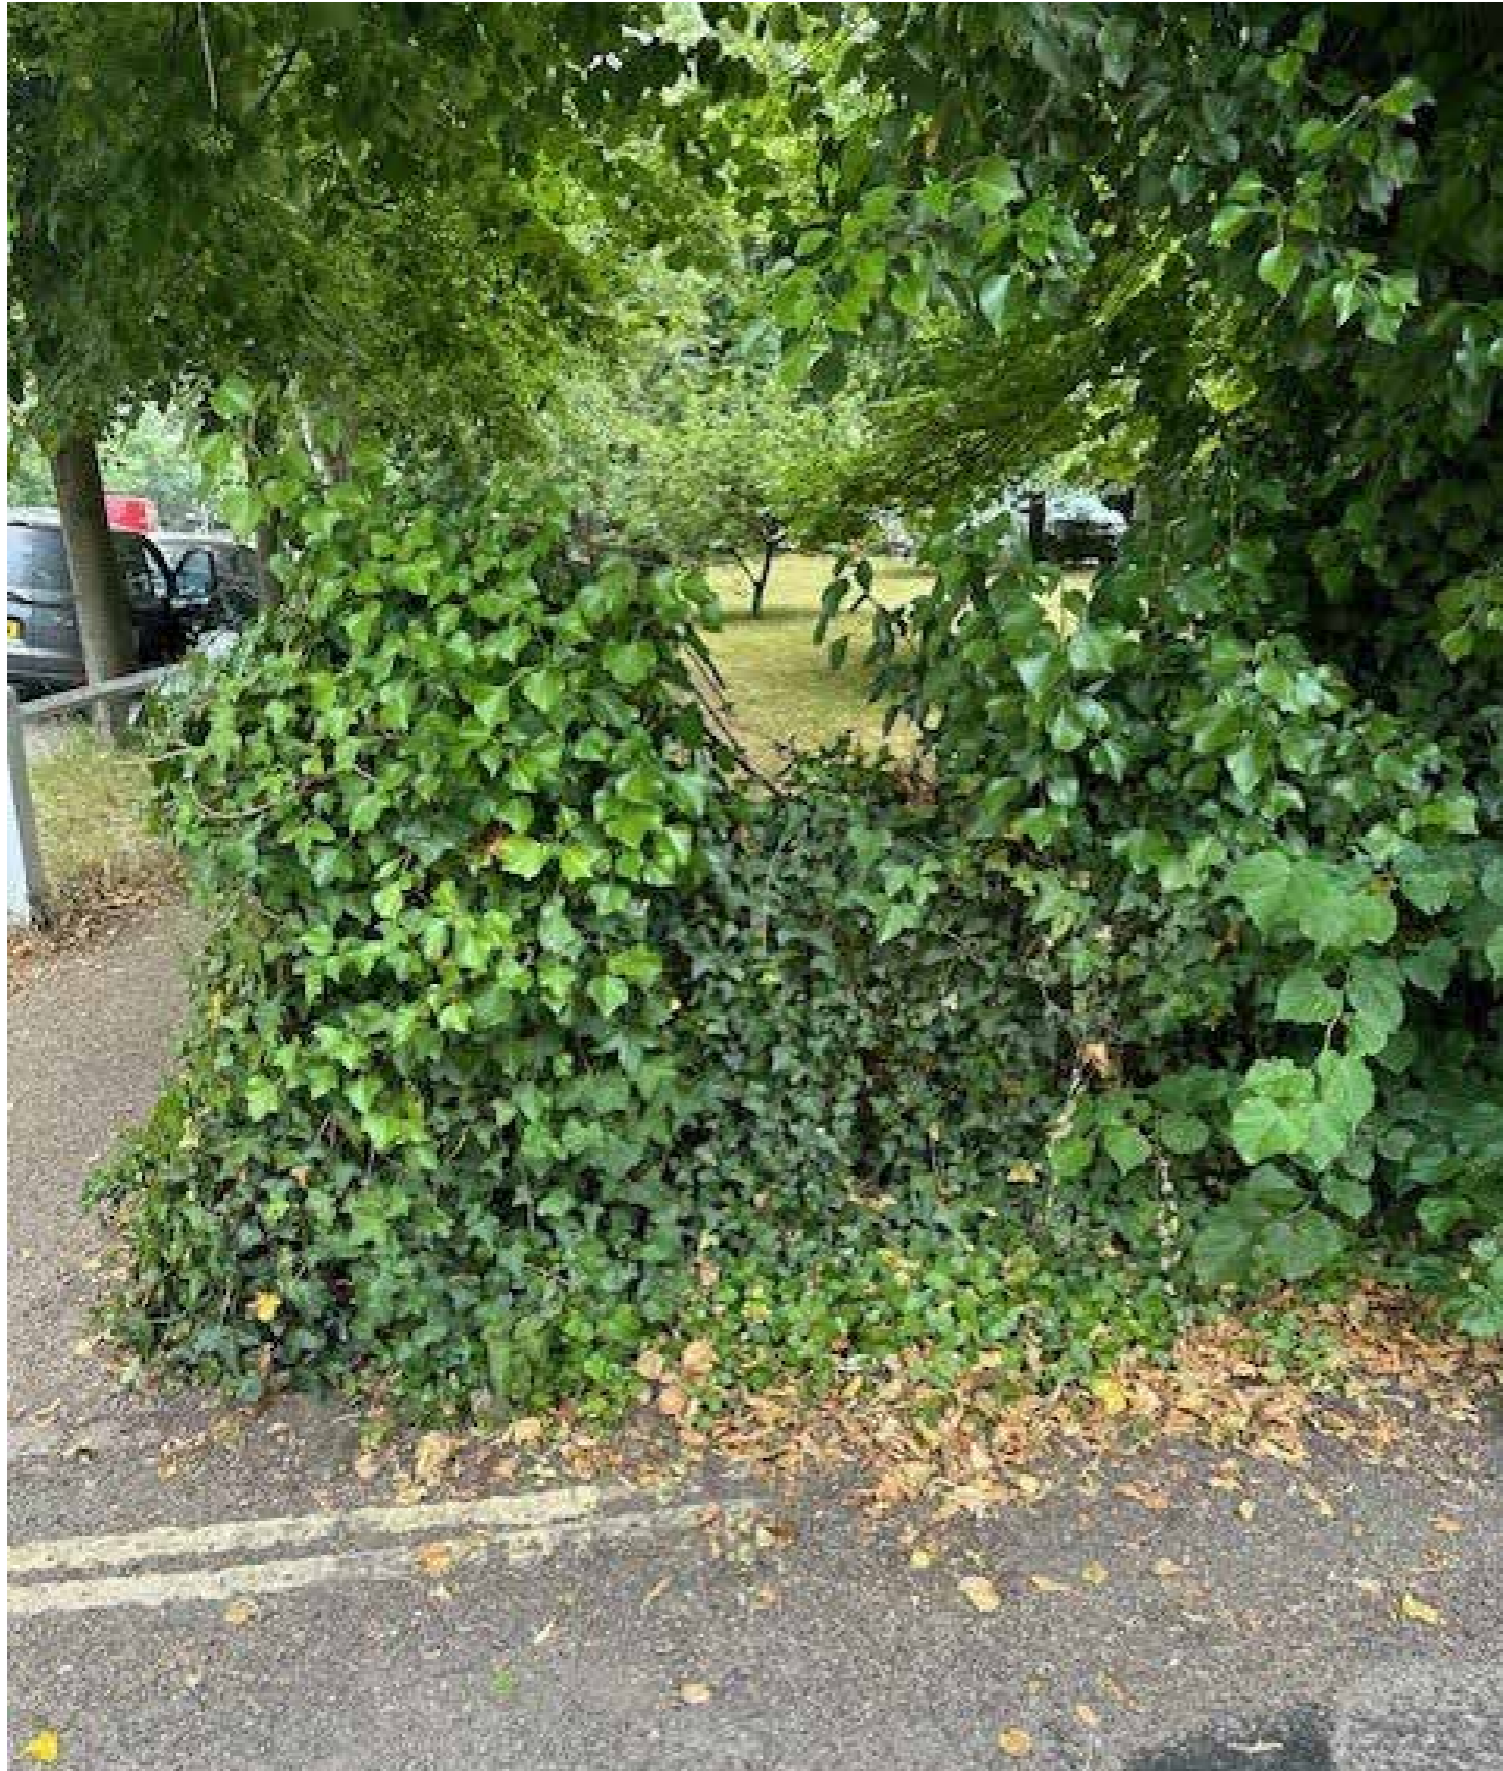
5. Broken connection between panels

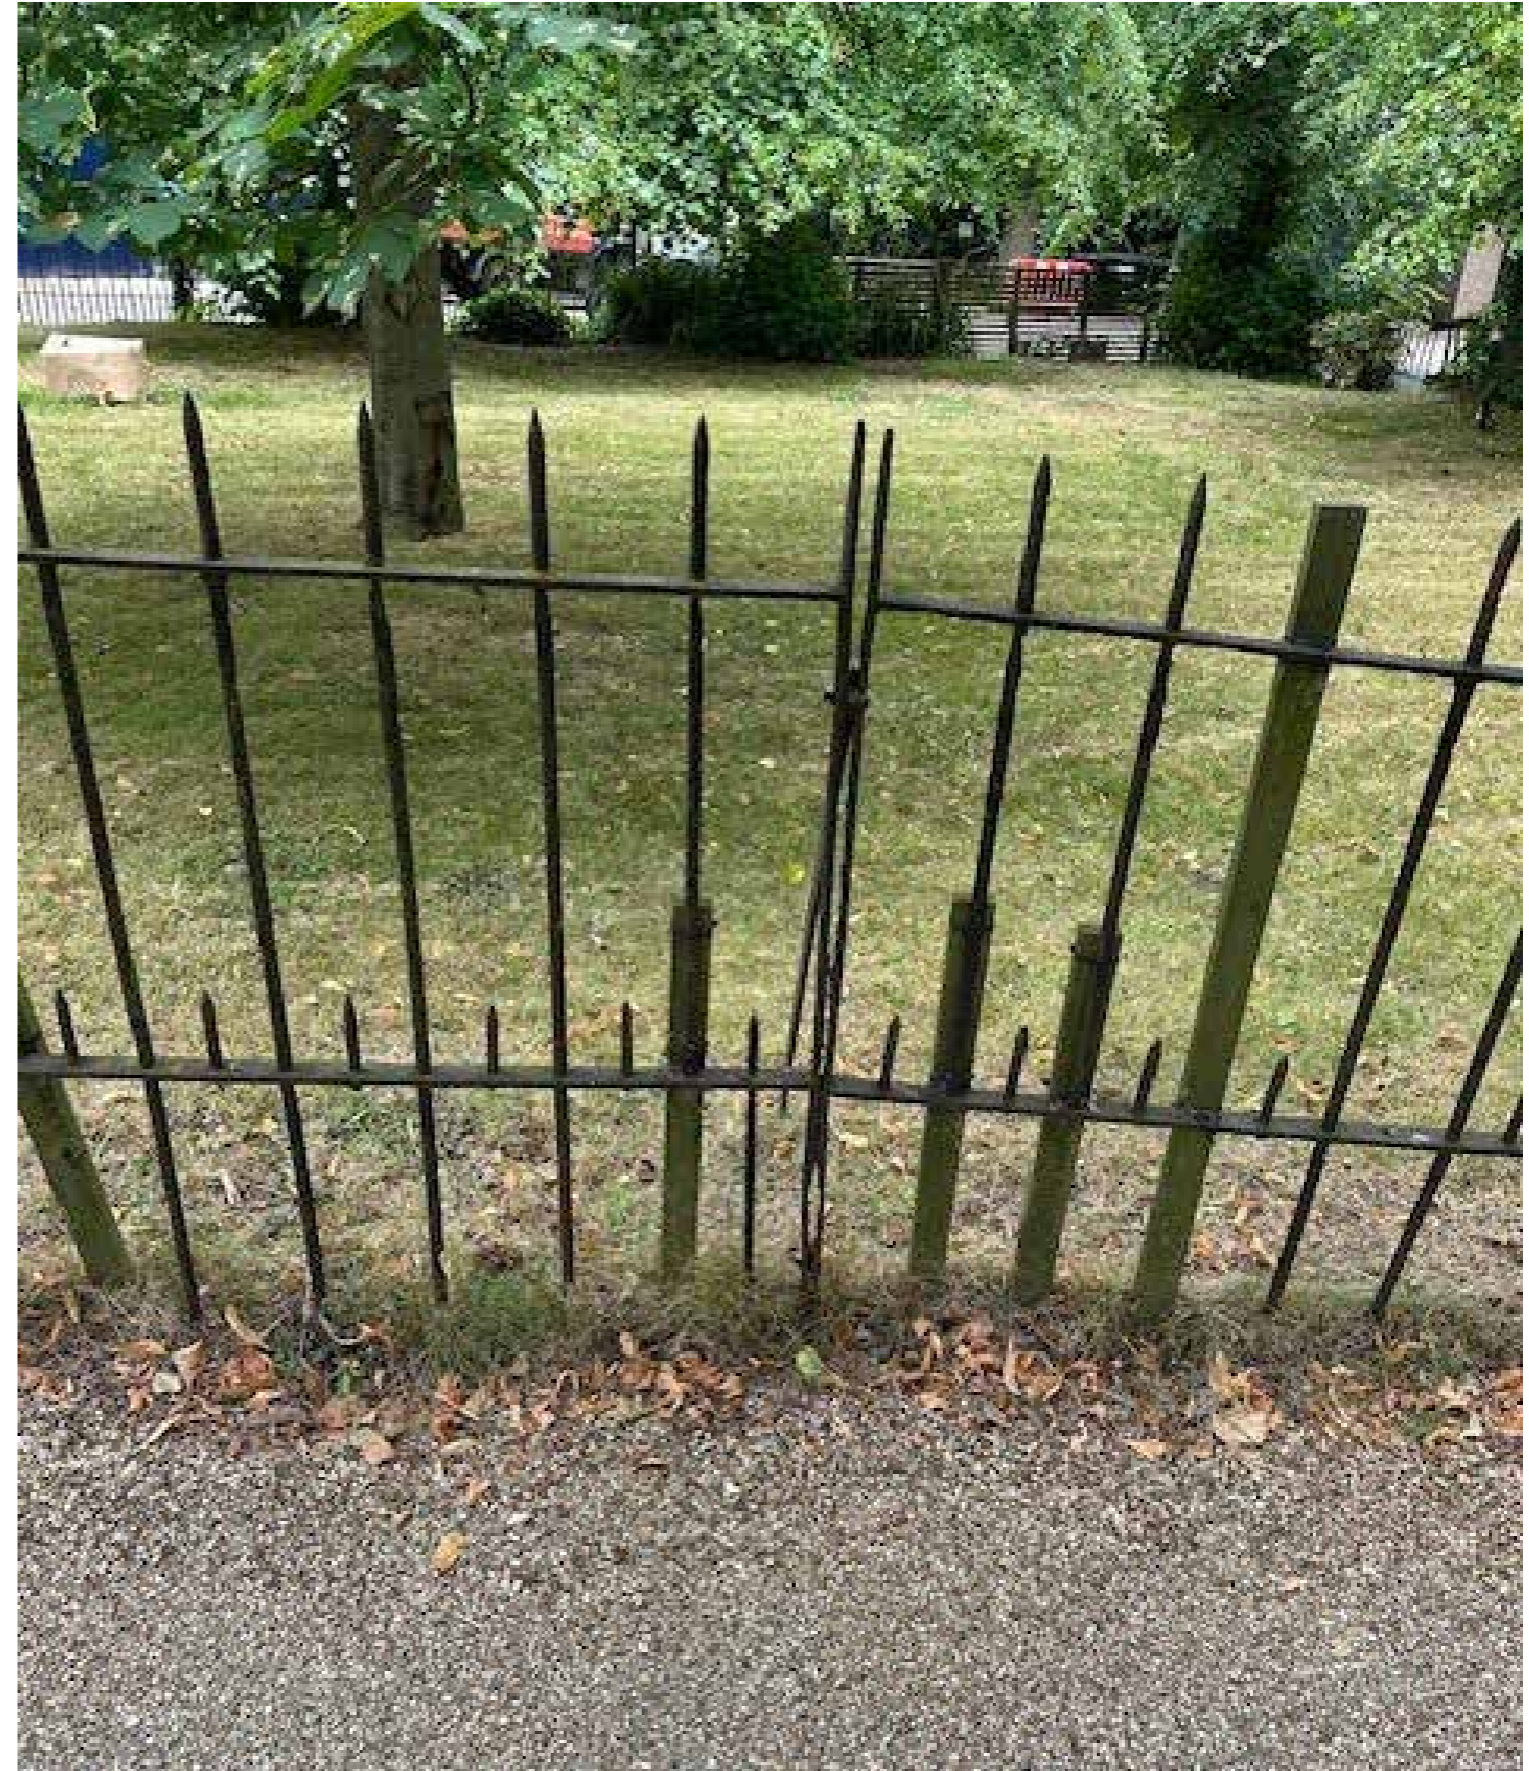
6. Panel with missing upright and dog rails

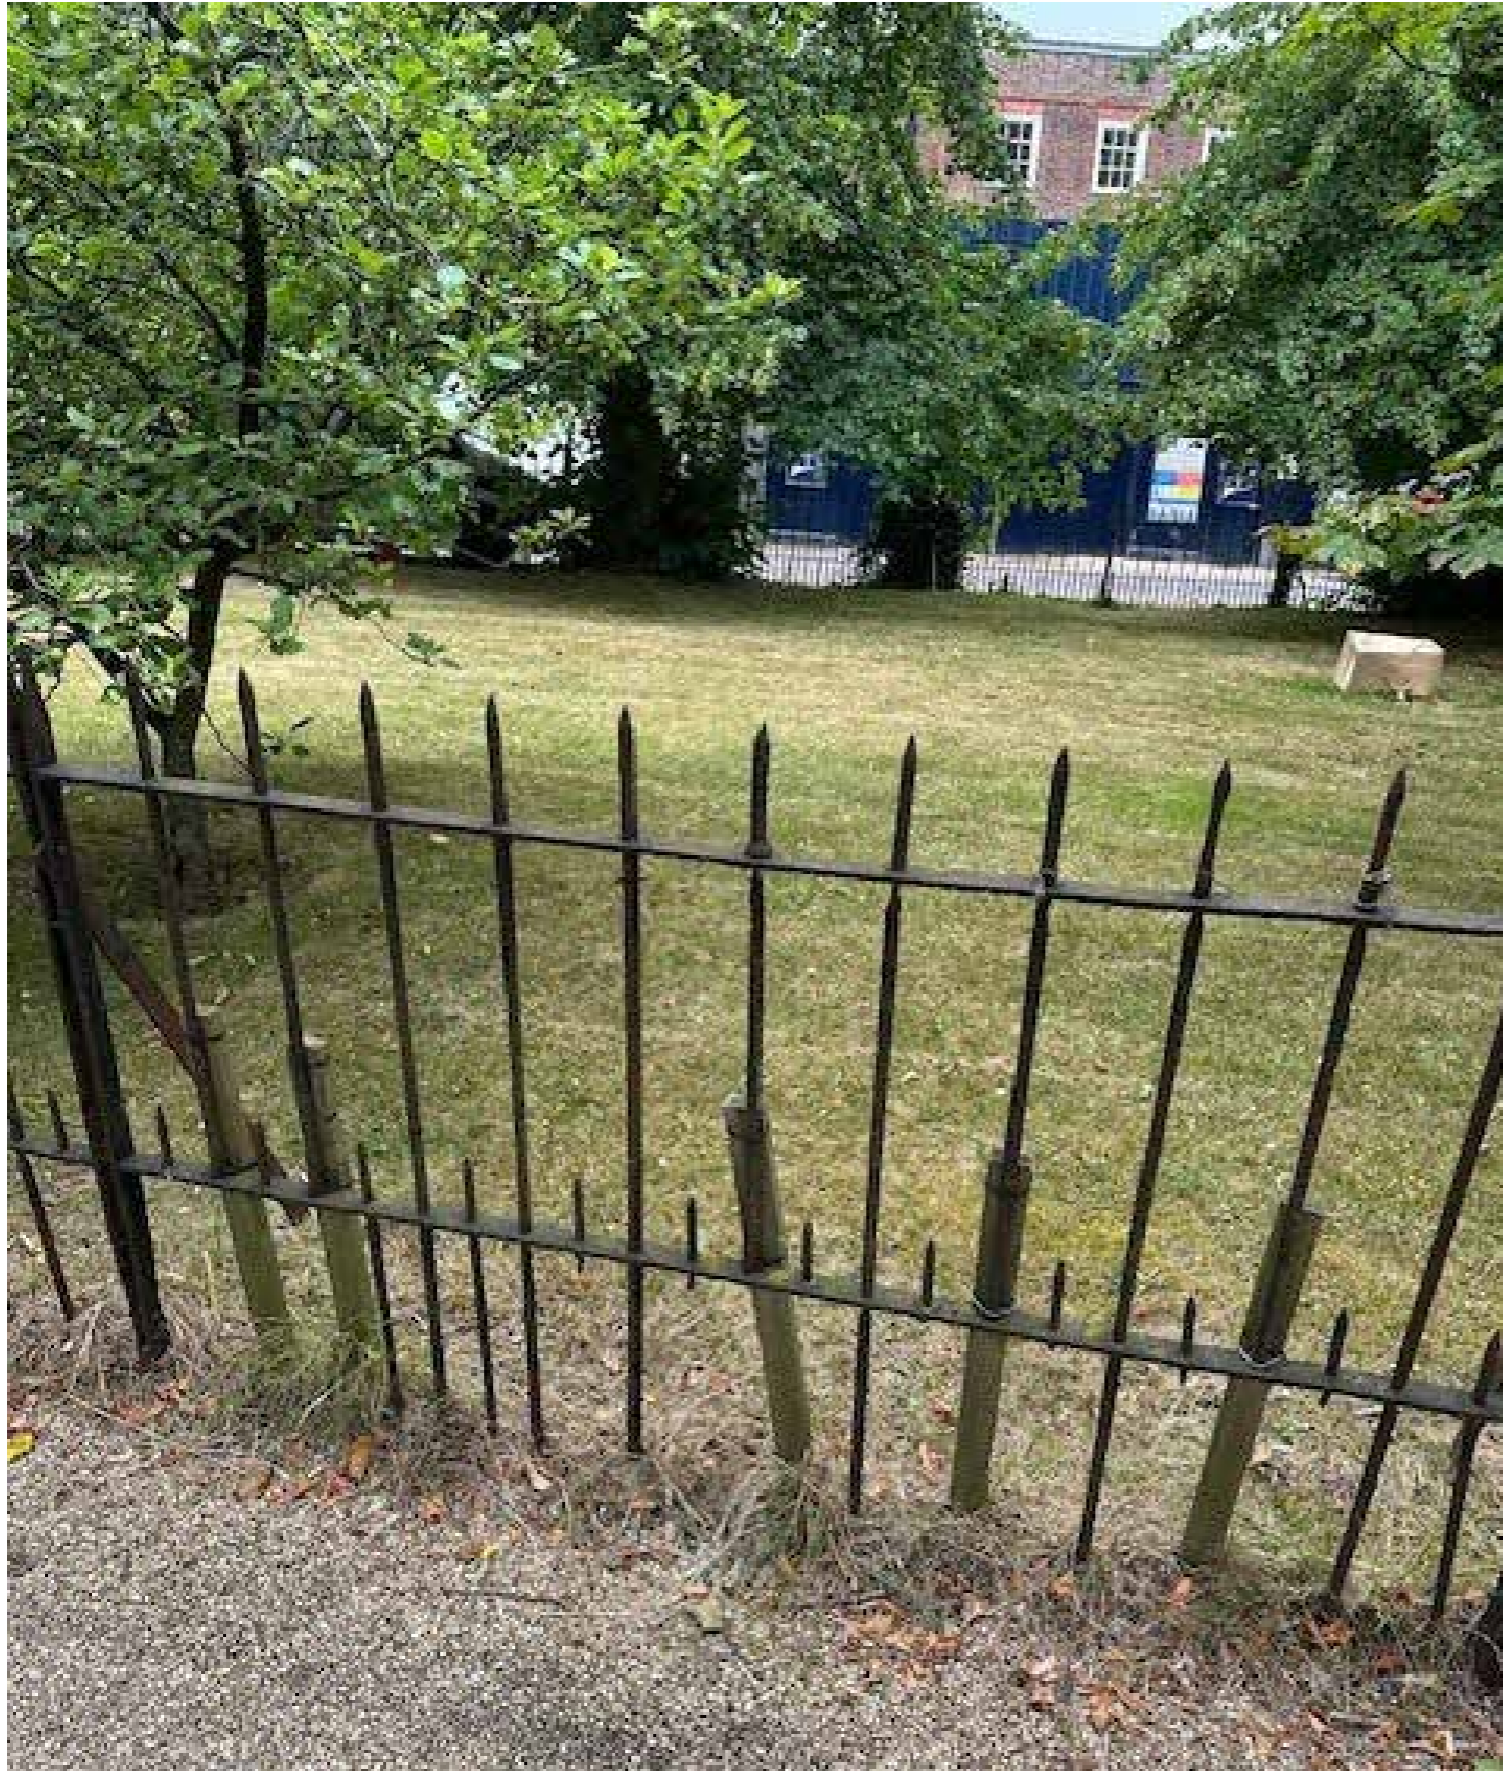
7. Panel with missing dog rails replaced

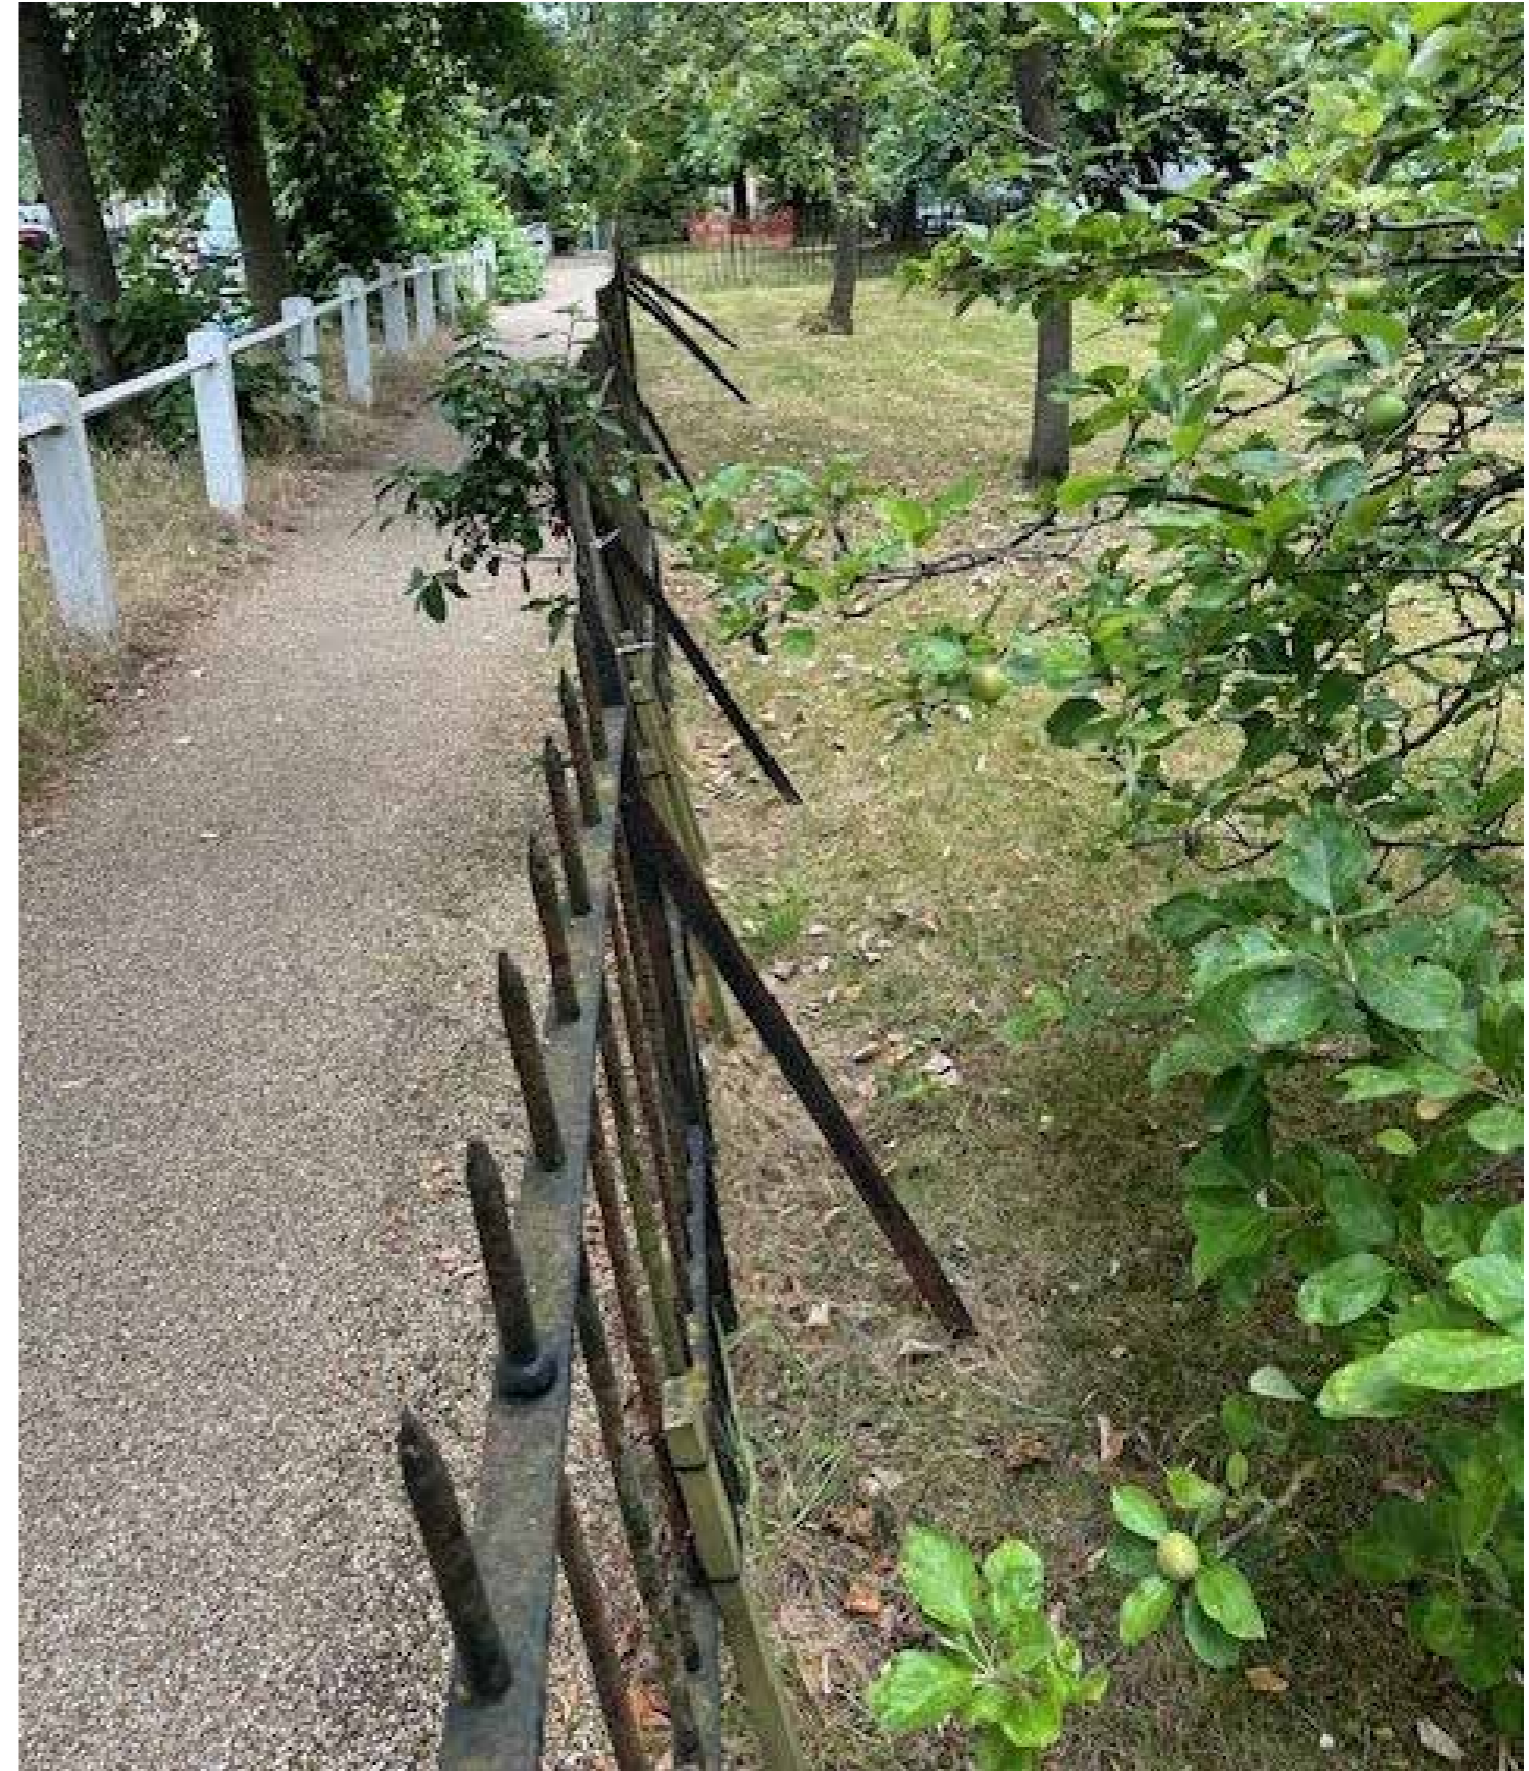
8. Remaining railings are bowed out and impede on to the adjacent footpath
