5 The Grove
Highgate Green - Railing
Railing Condition Study
September 2024

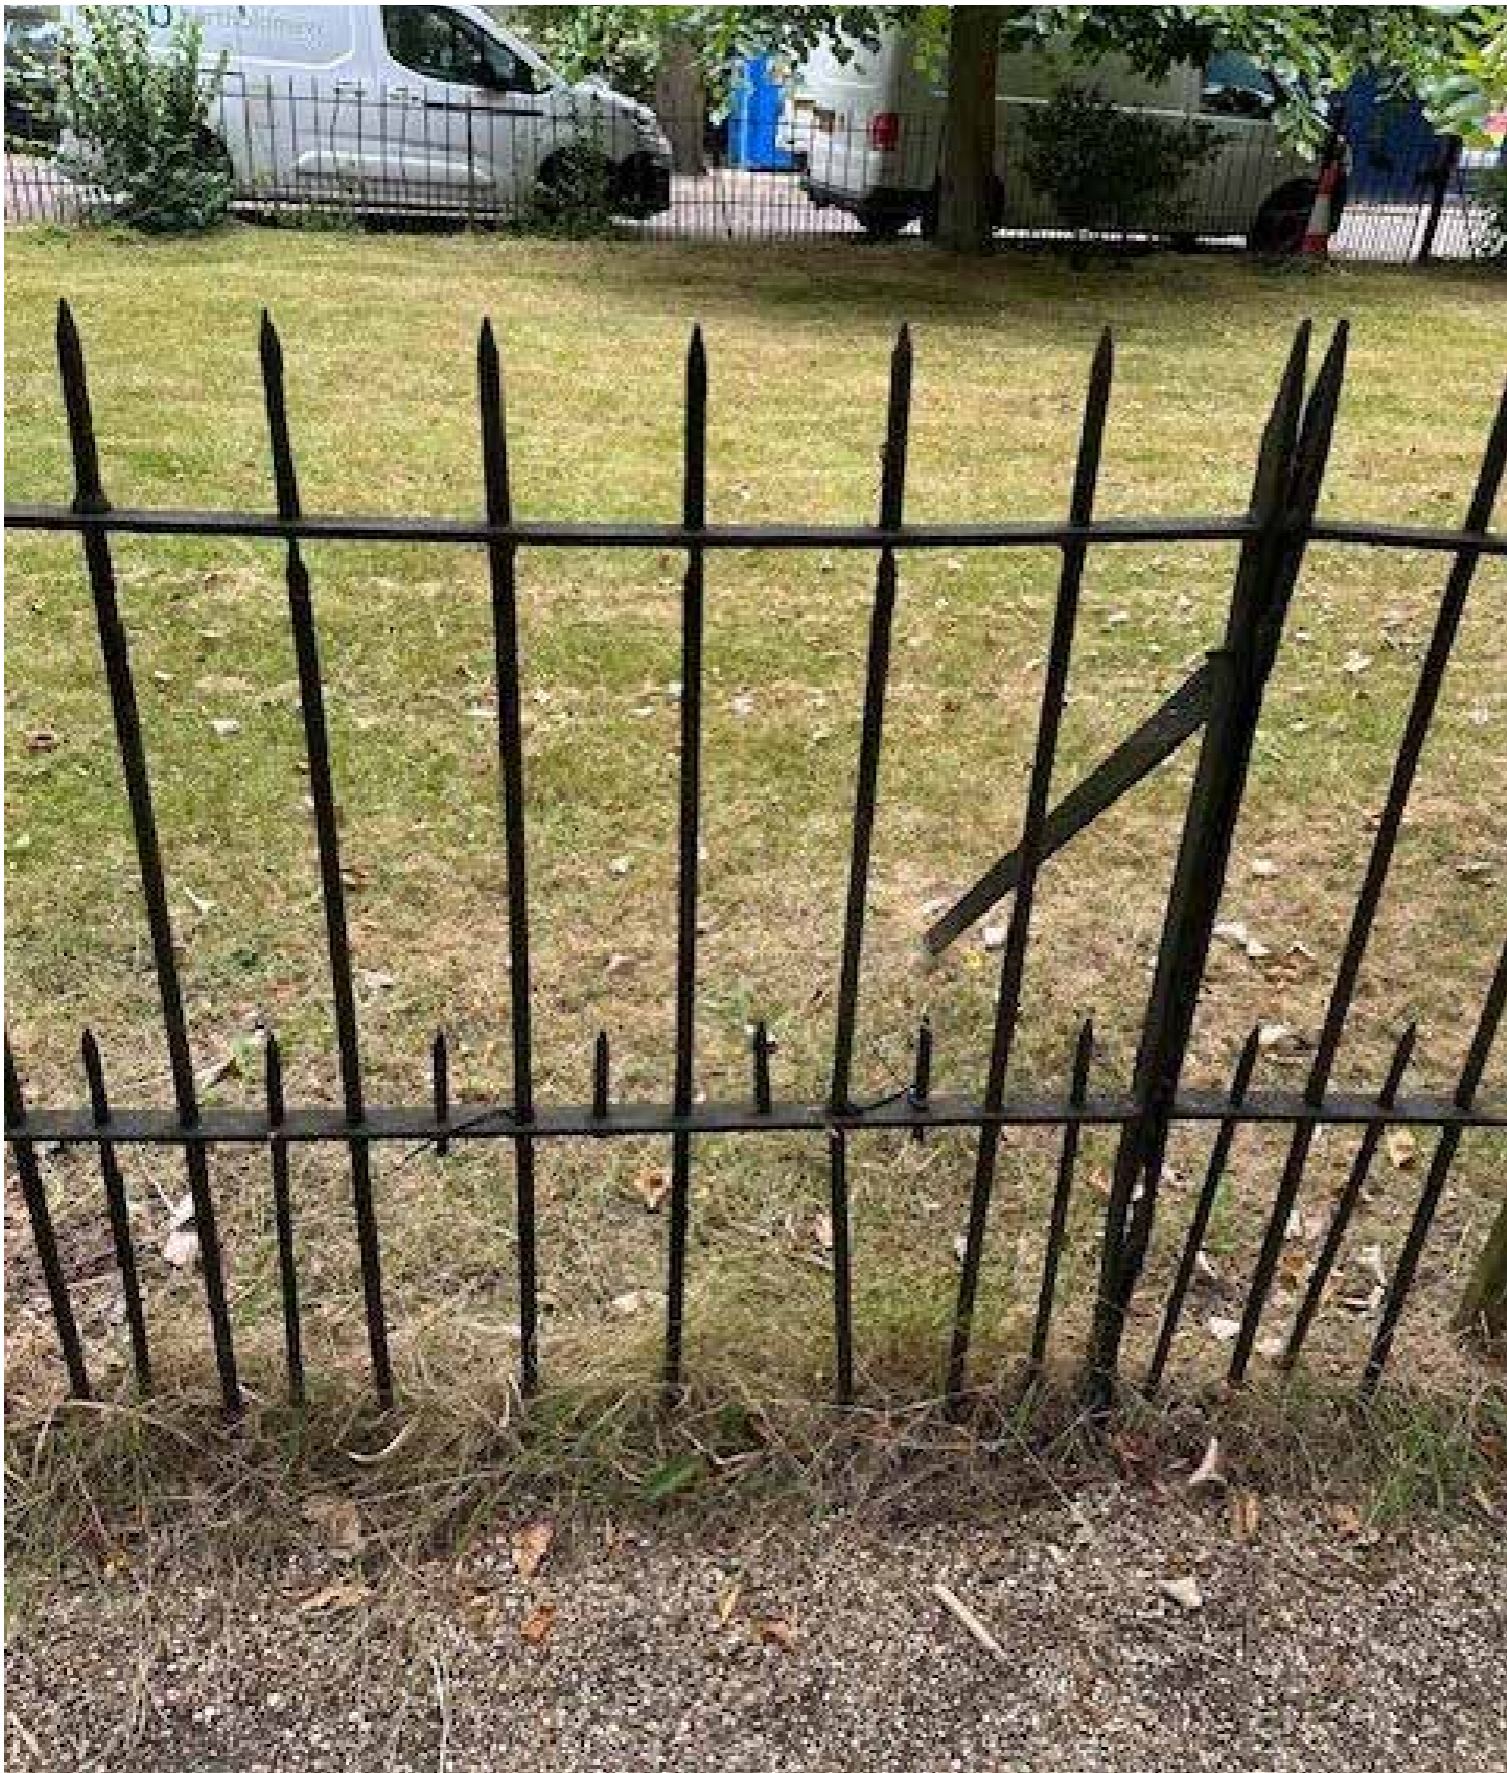
9. Connection is broken and bowing out

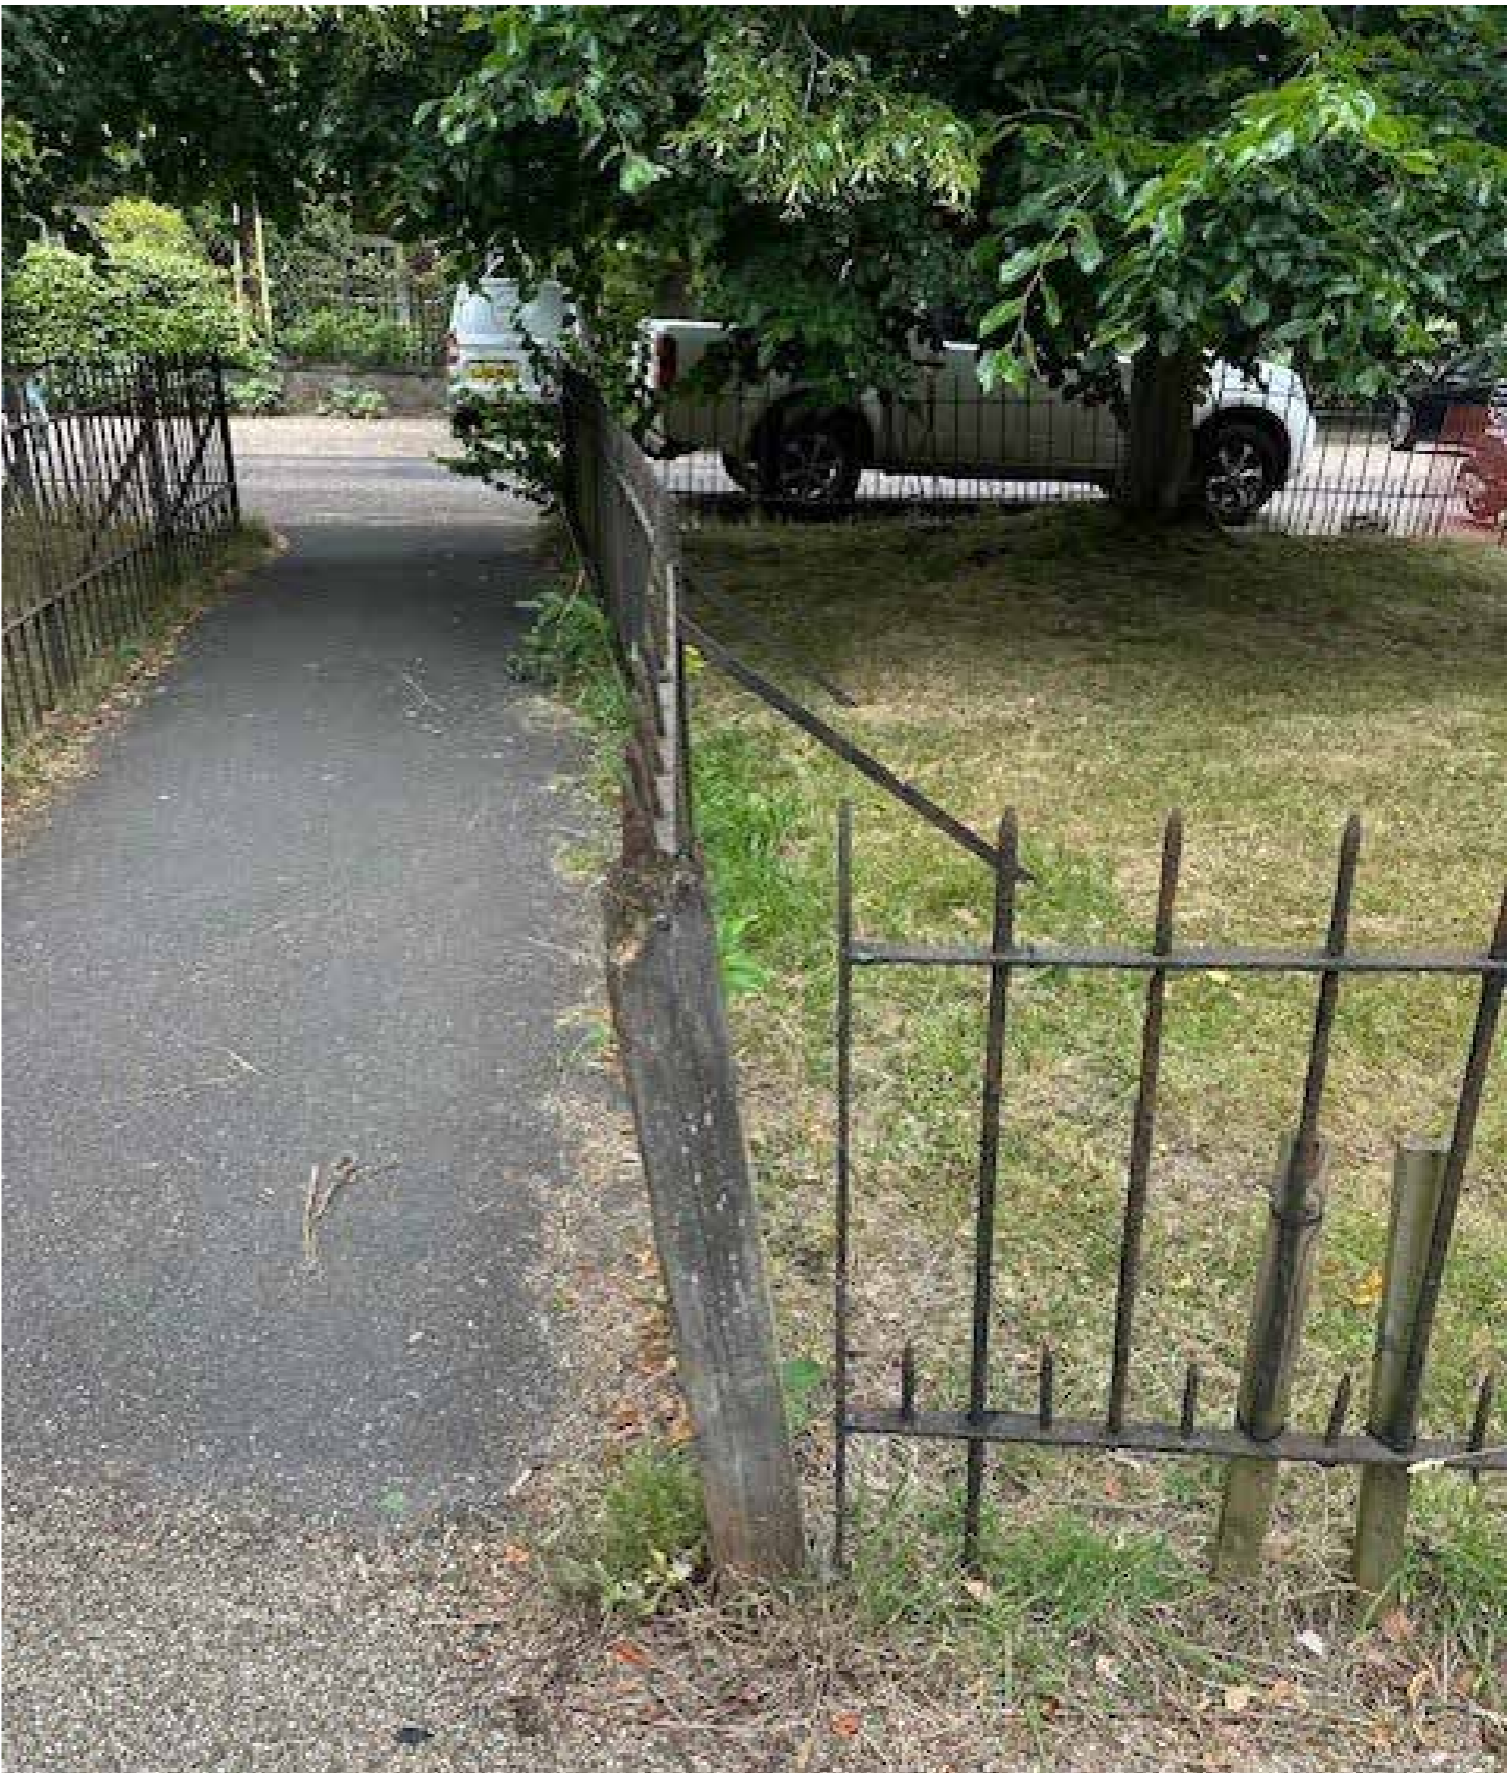
10. Small corner unit with missing upright and dog rails

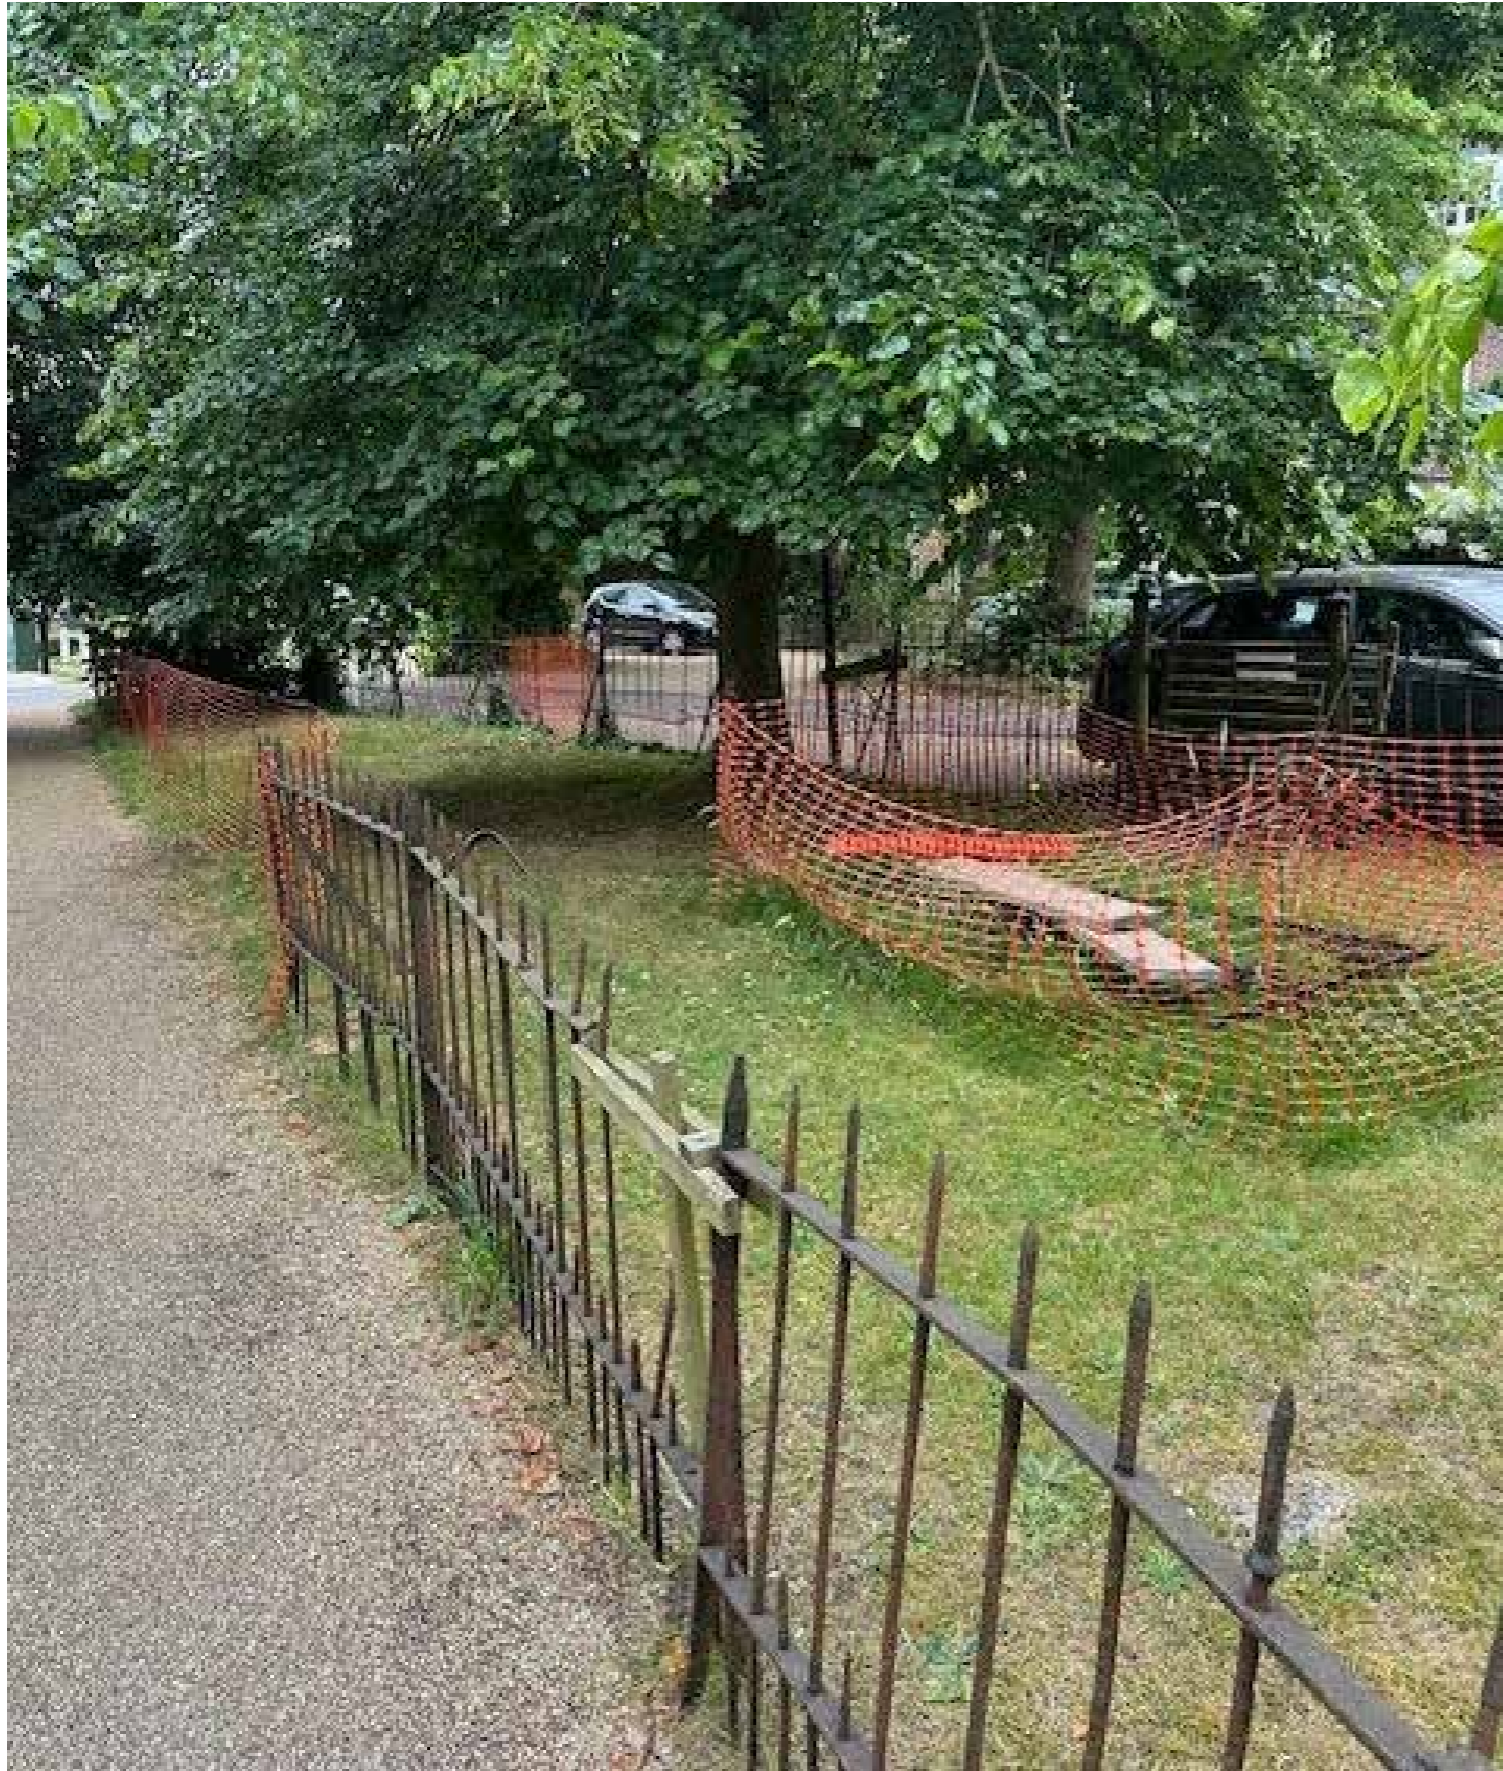
11. Broken panel

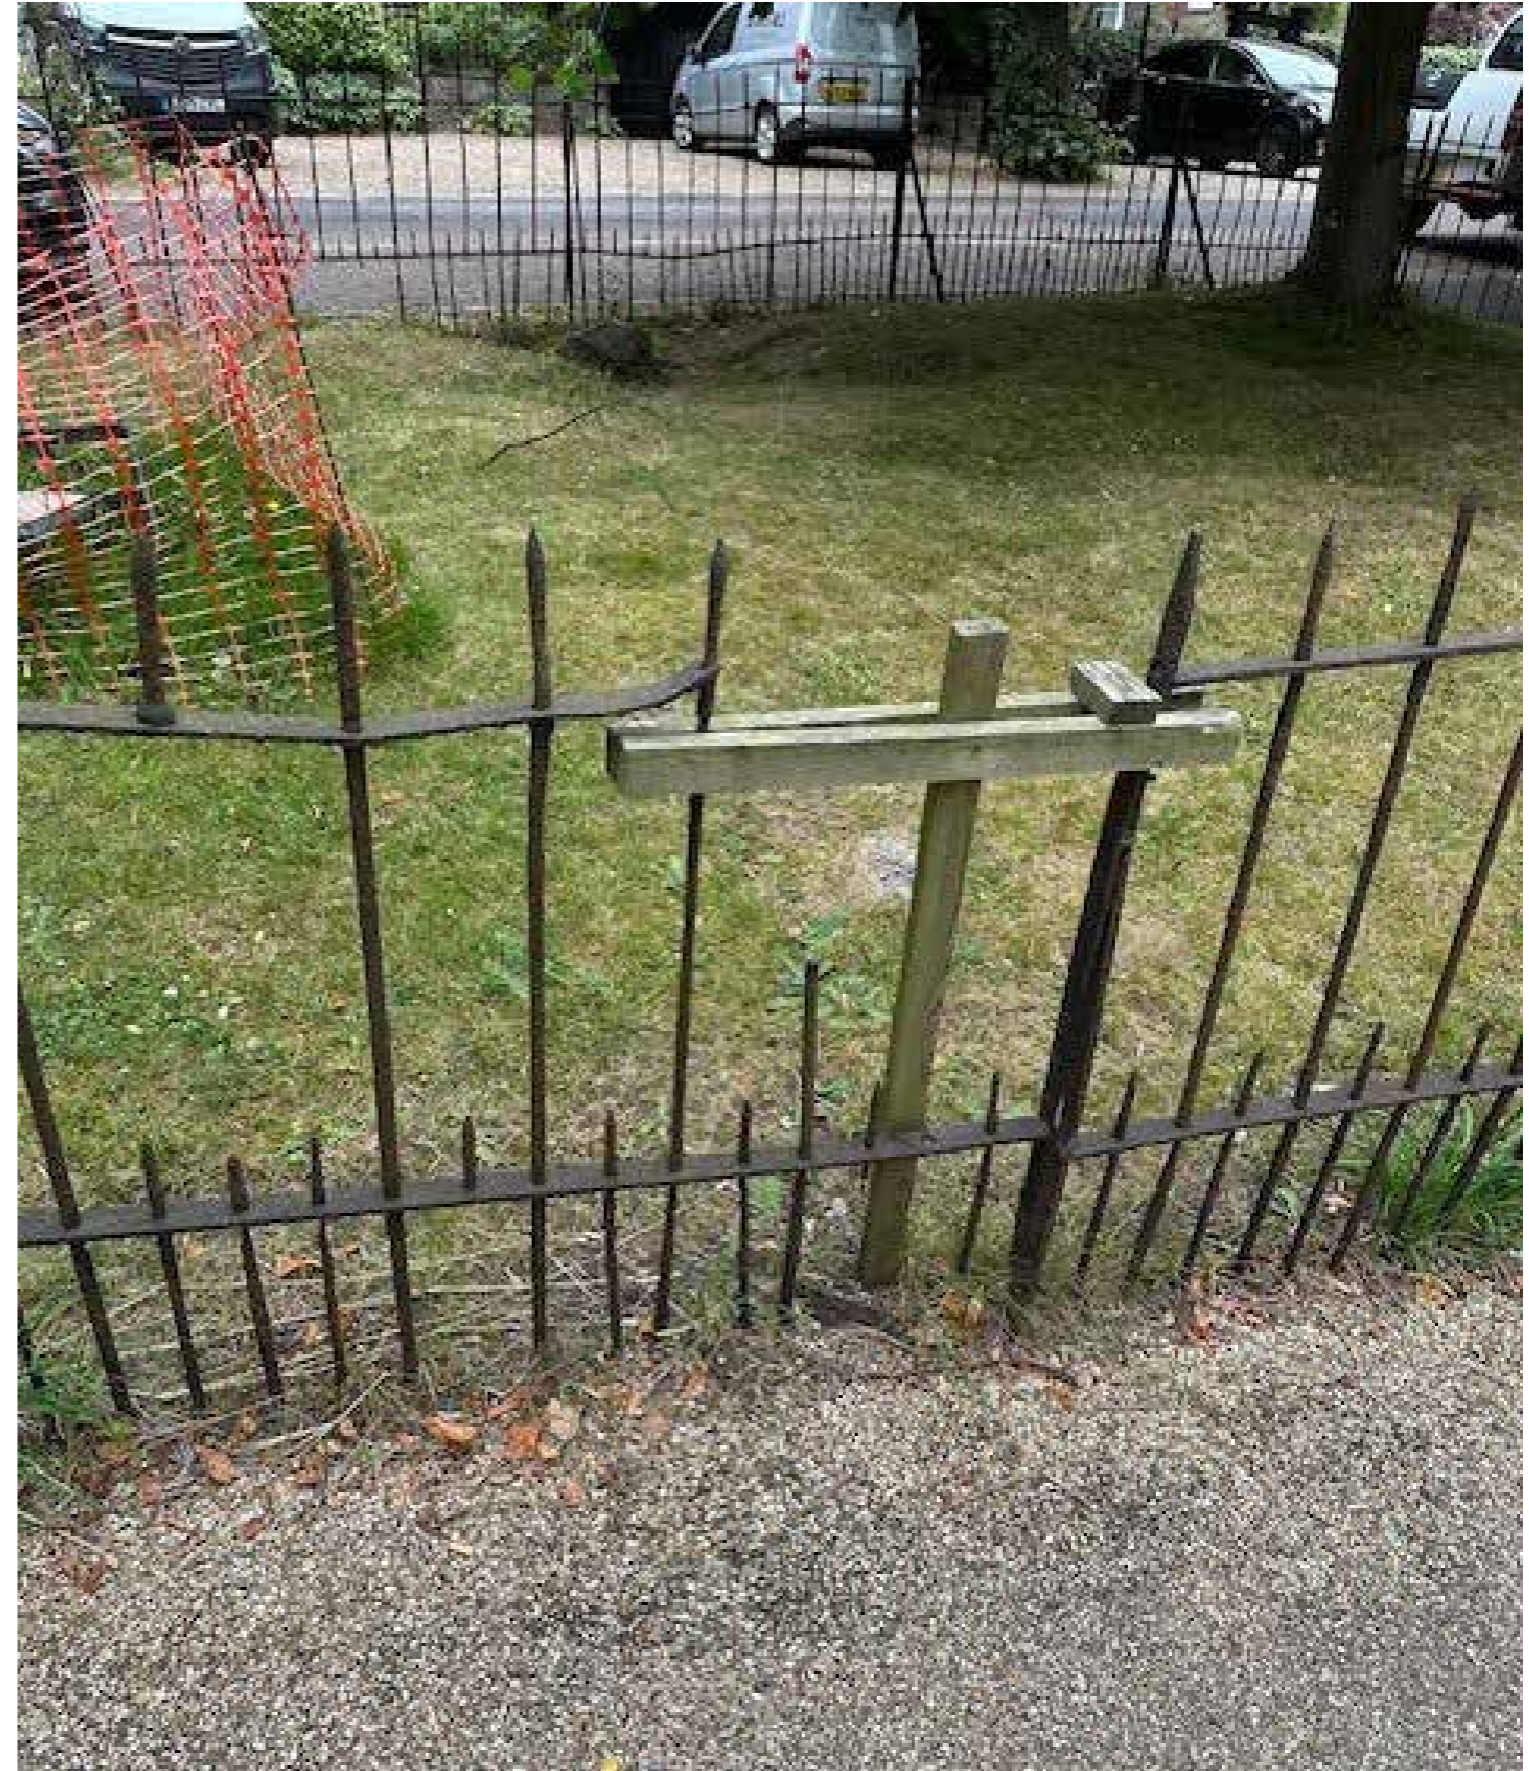
12. Broken panel (continued)

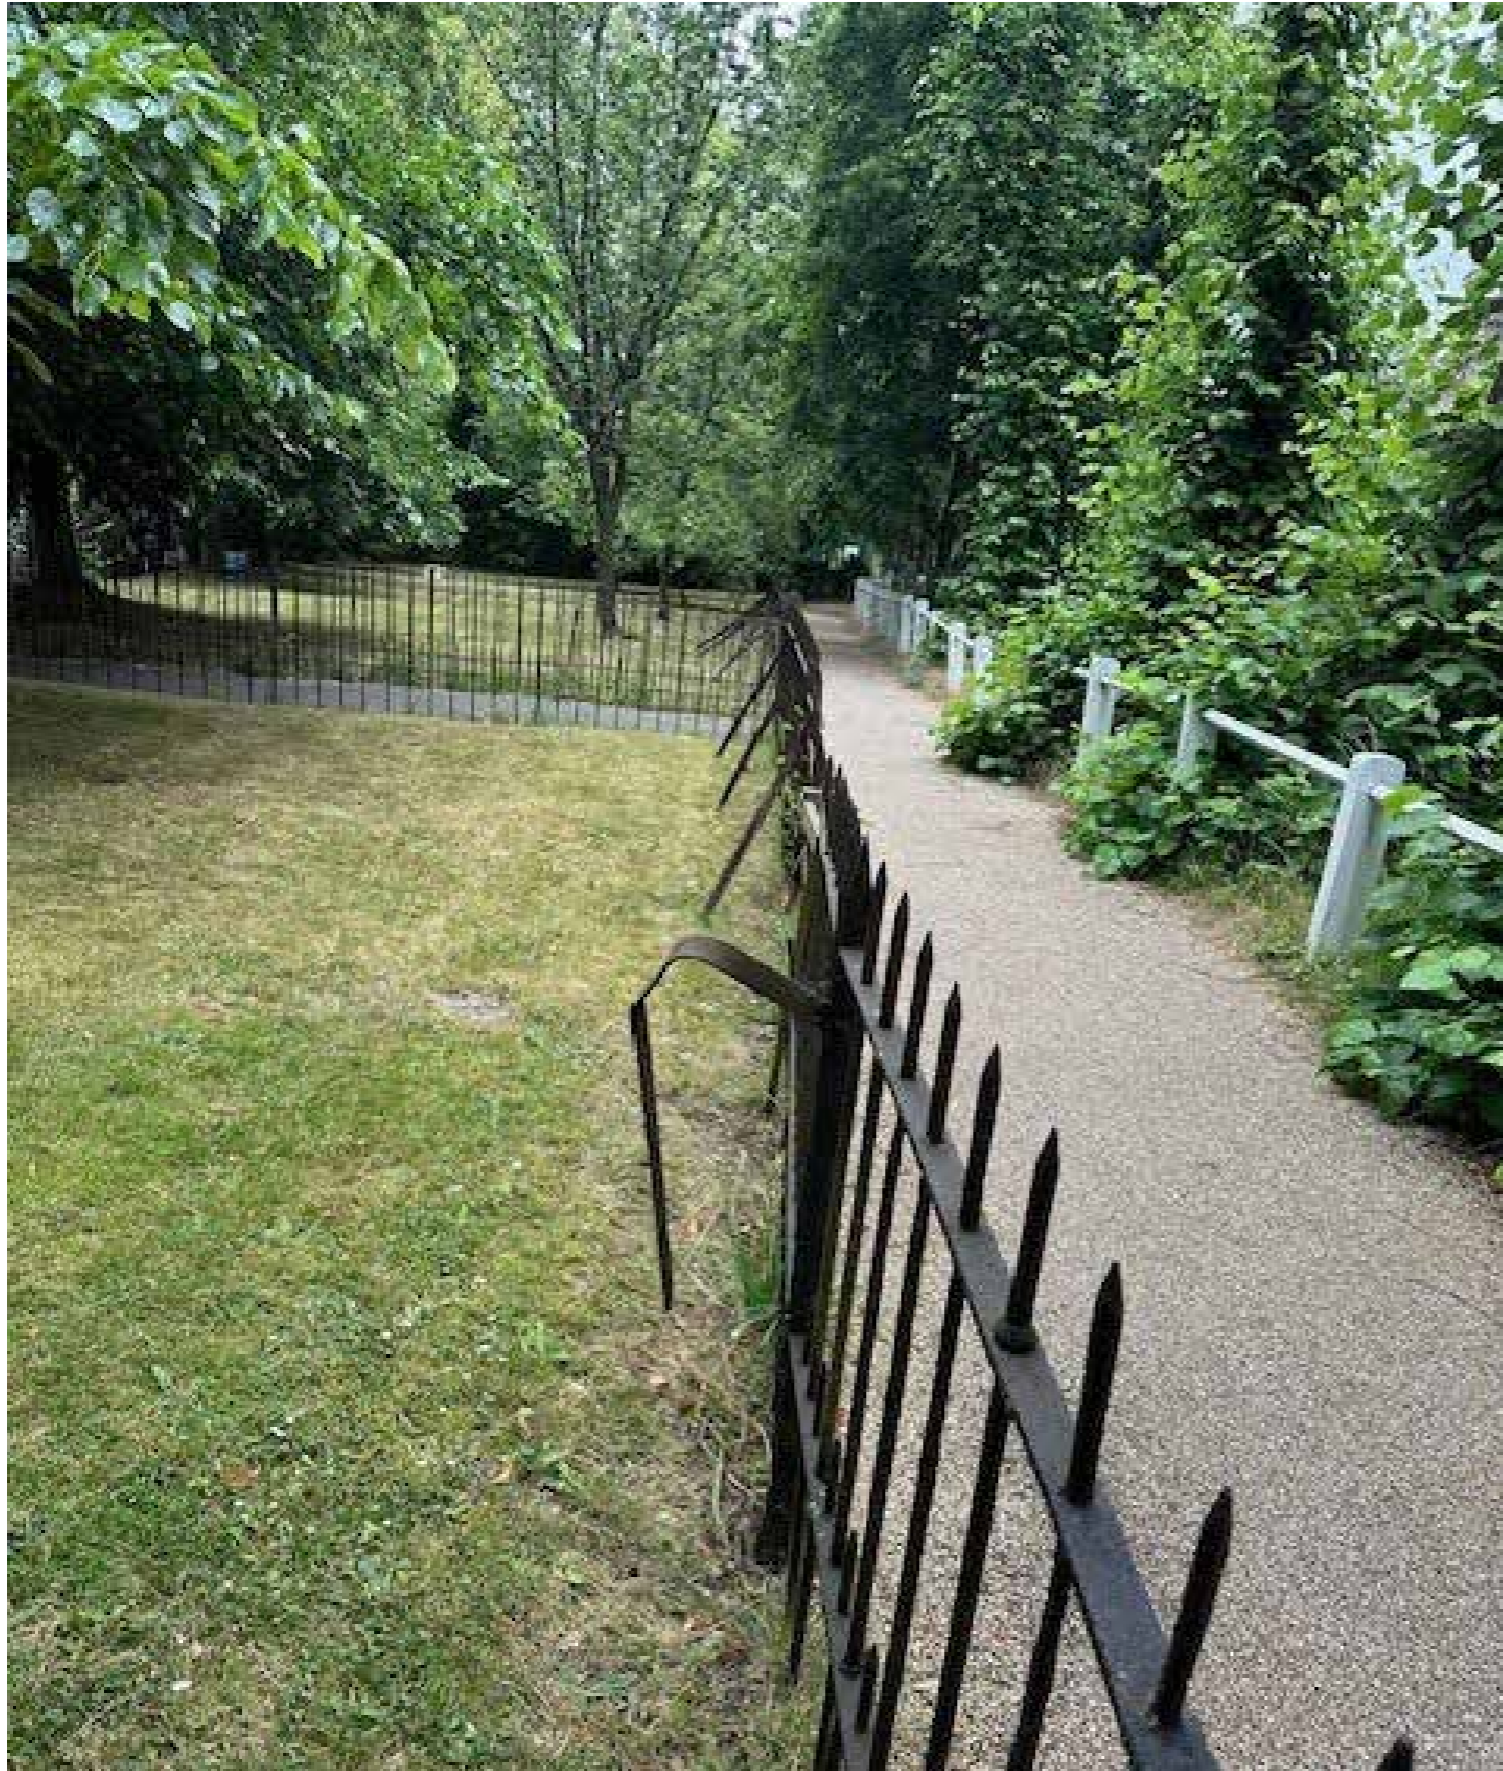
13. Damaged strut

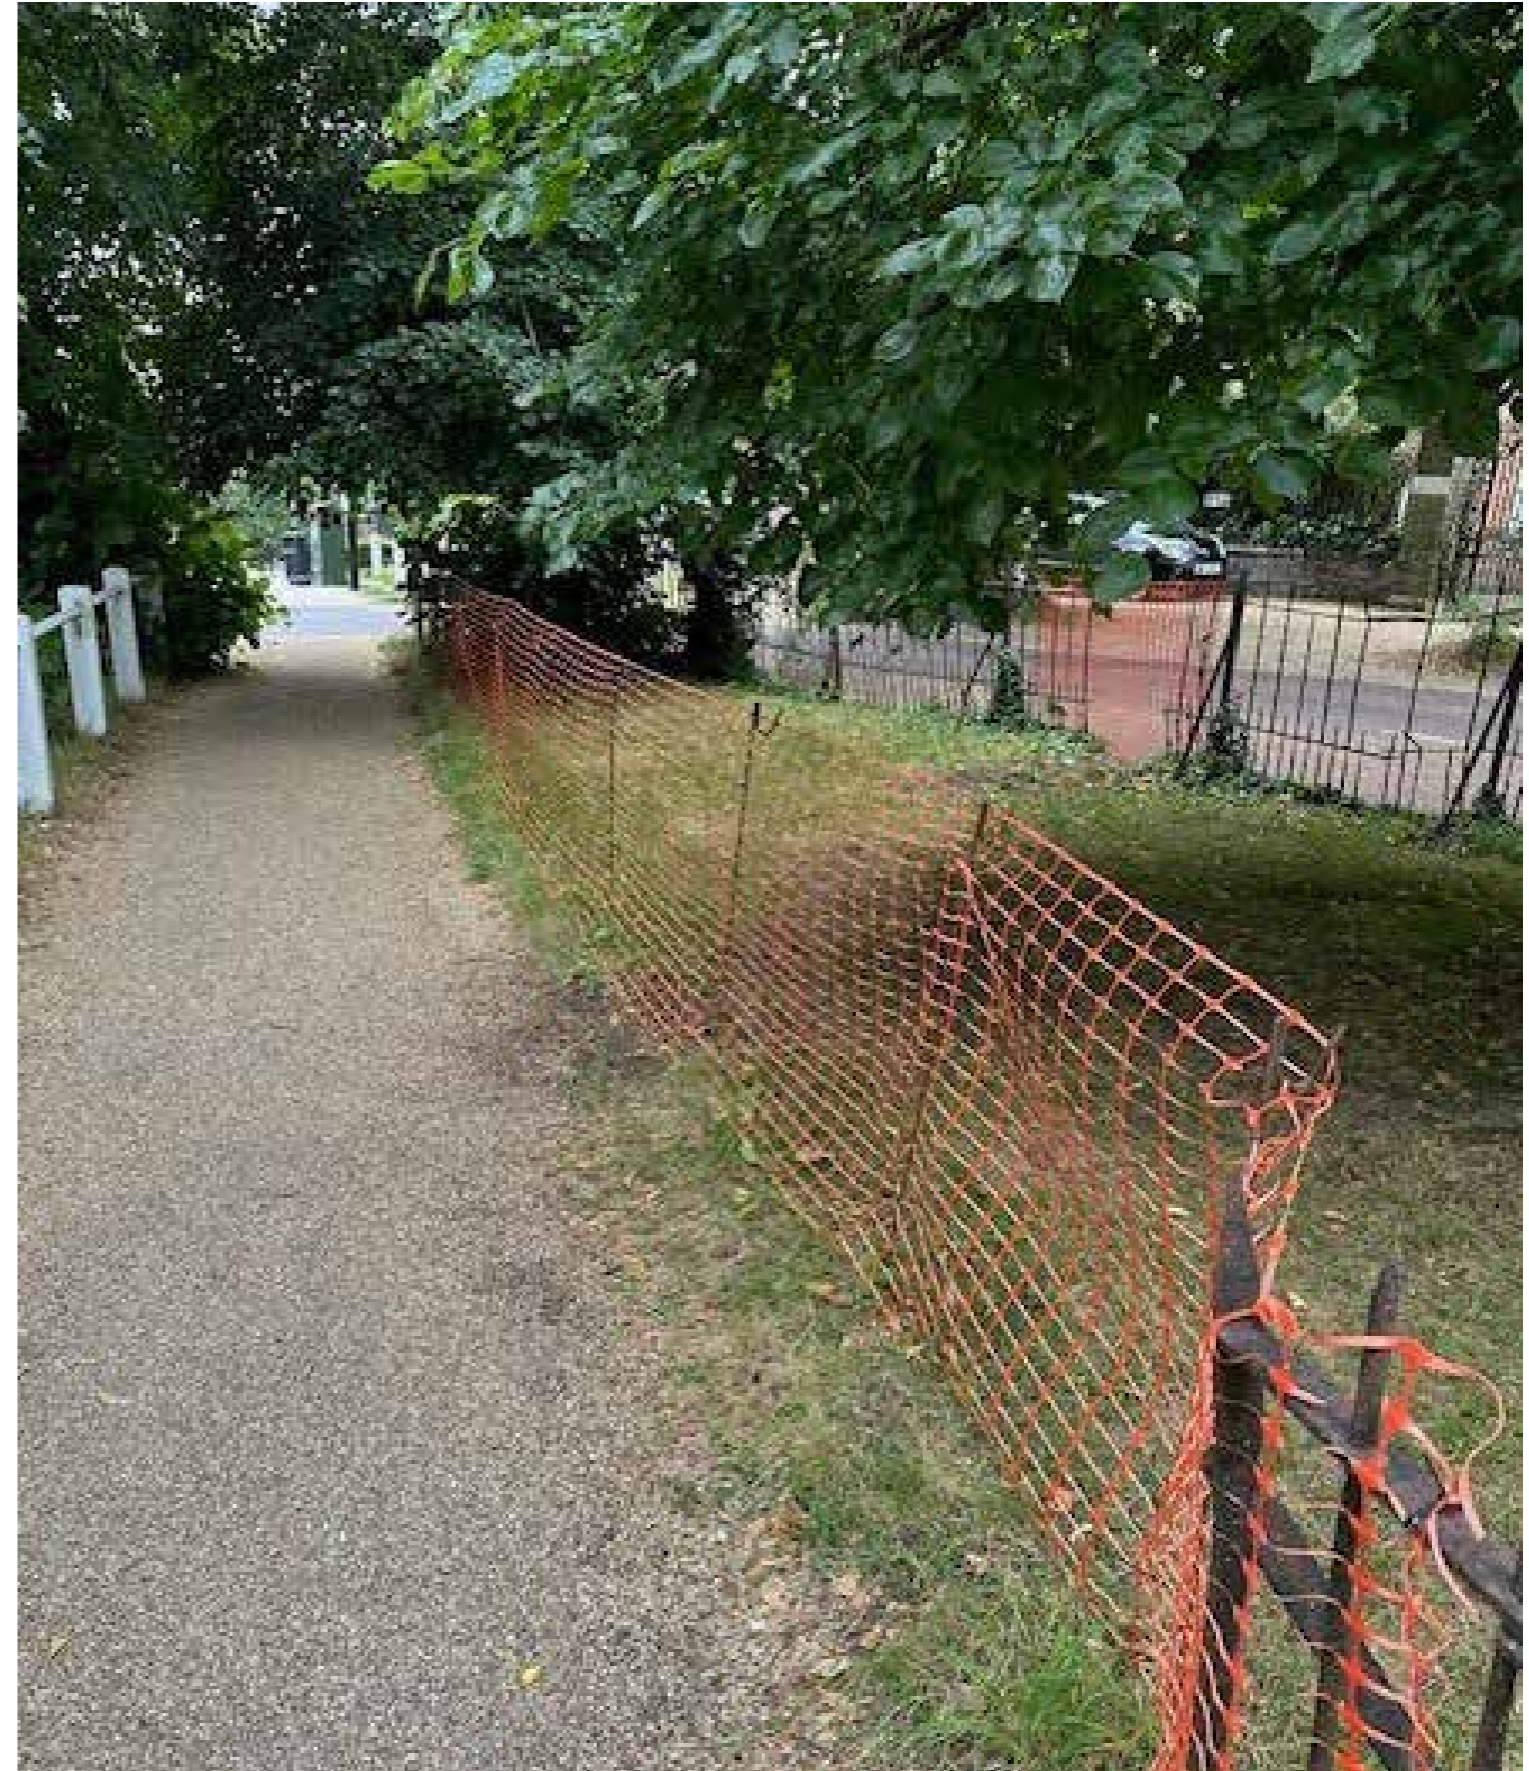
14. Extensive section of missing panels

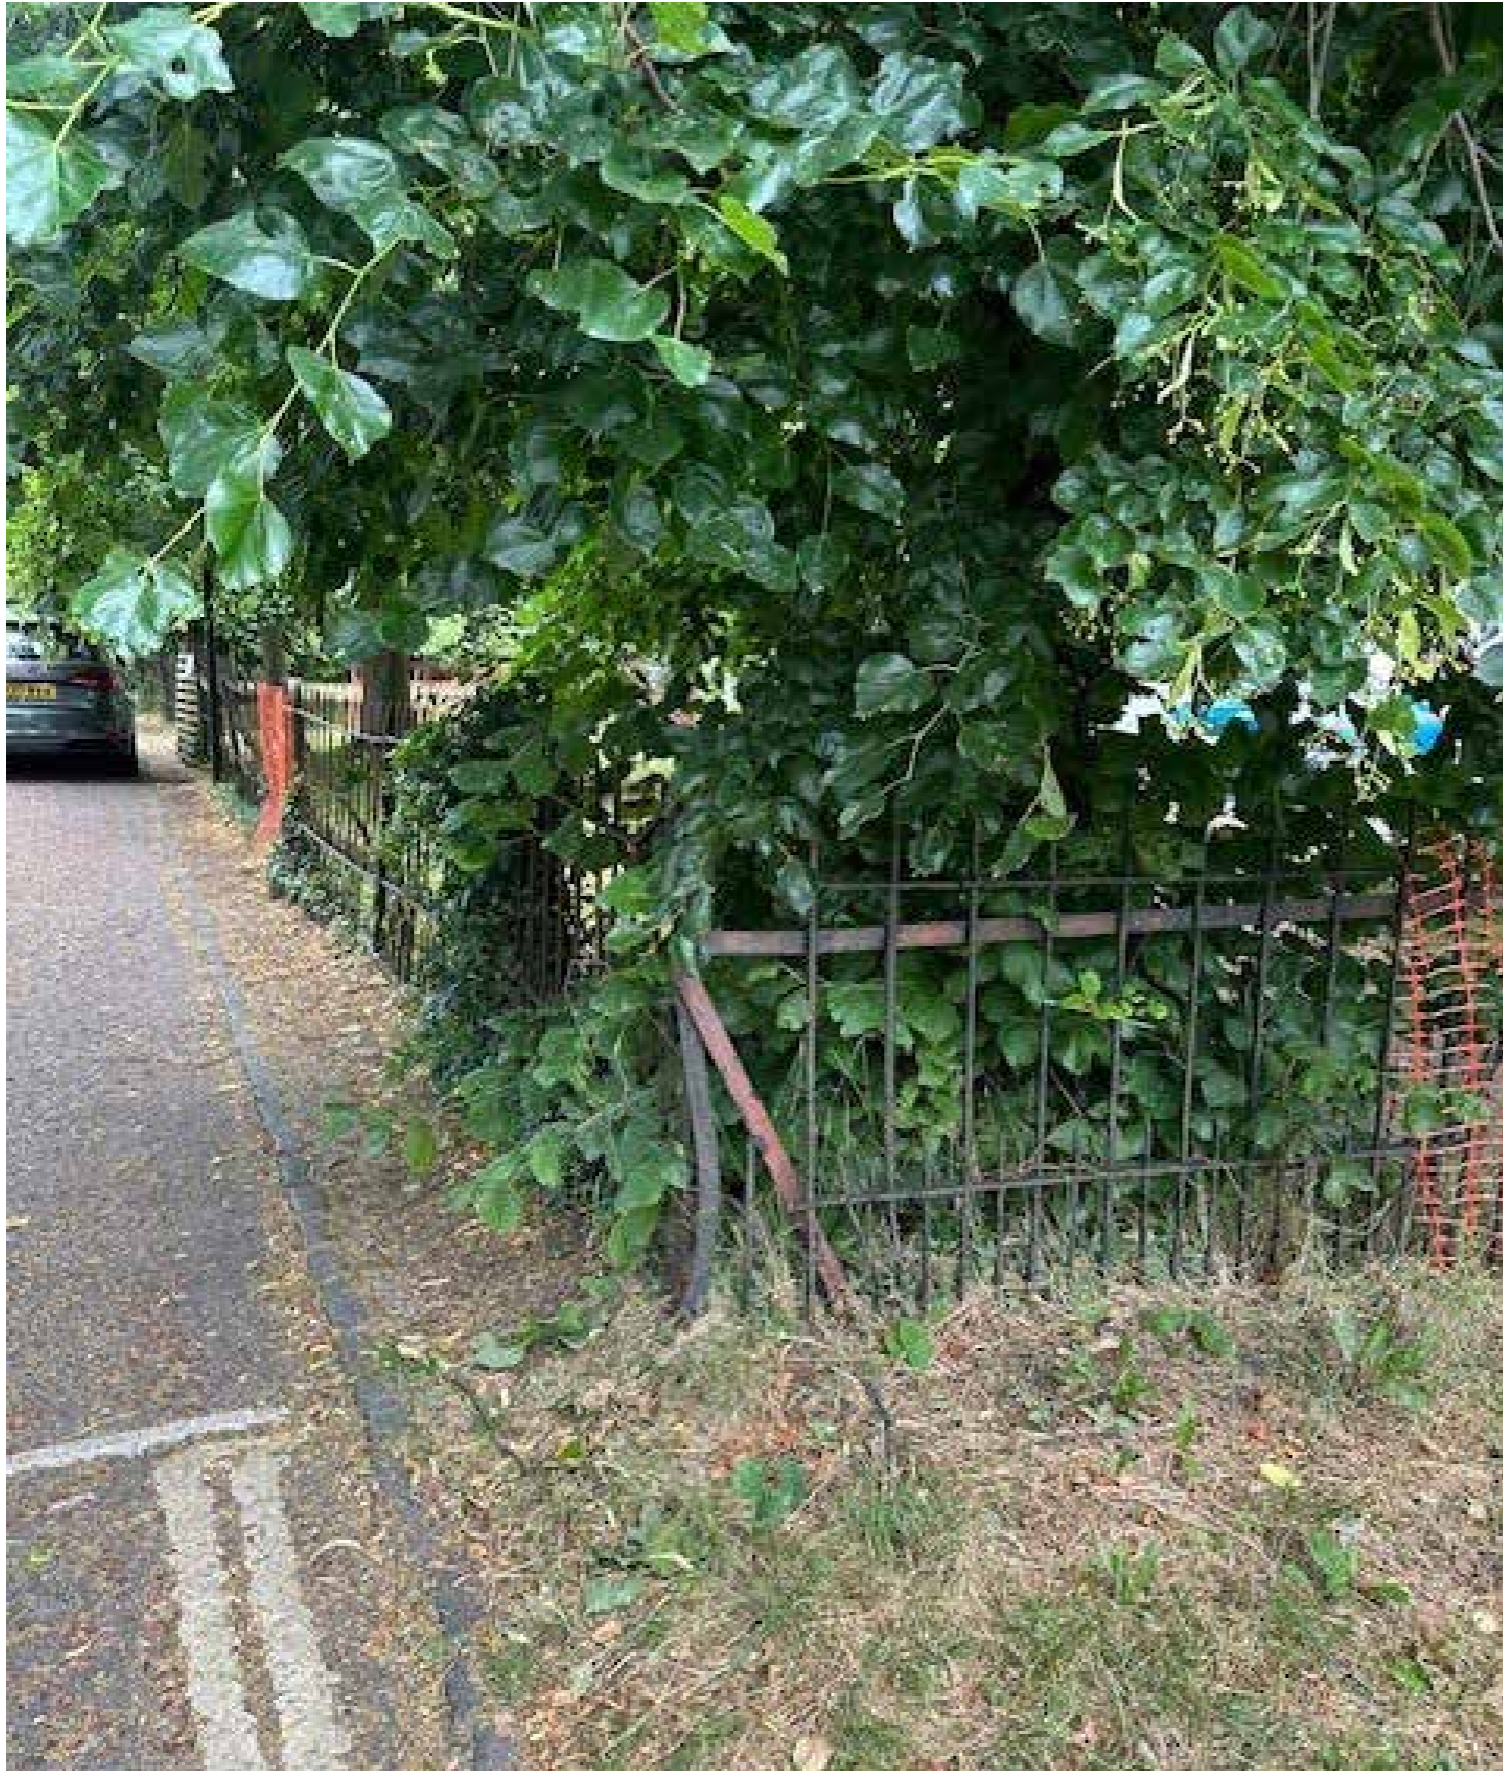
15. Broken connection

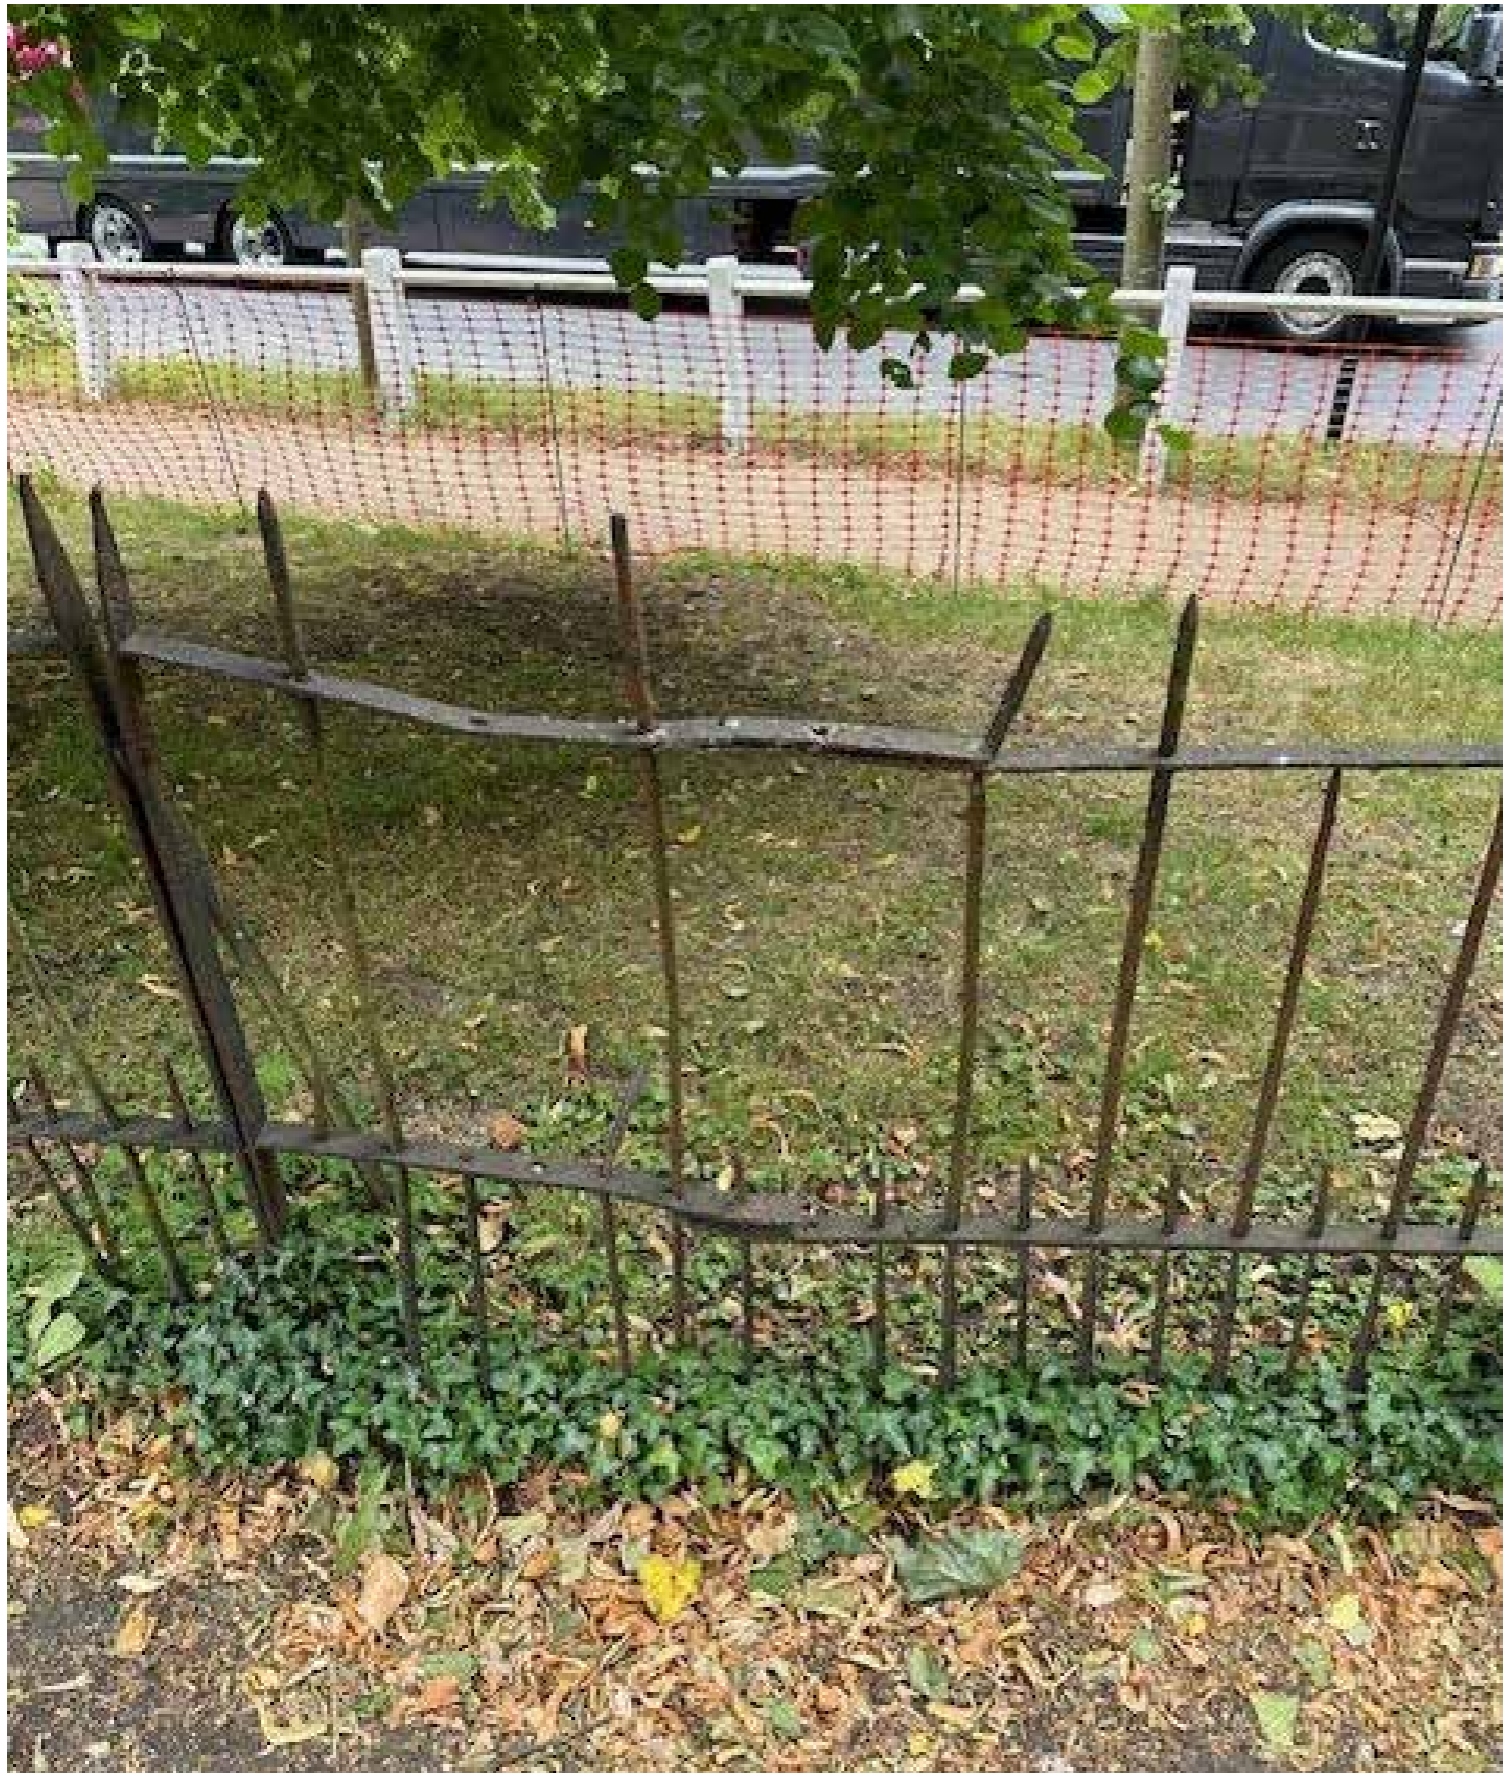
17. Panel Swith missing dog rails and upright
