5 The Grove
Highgate Green - Railing
Railing Condition Study
September 2024

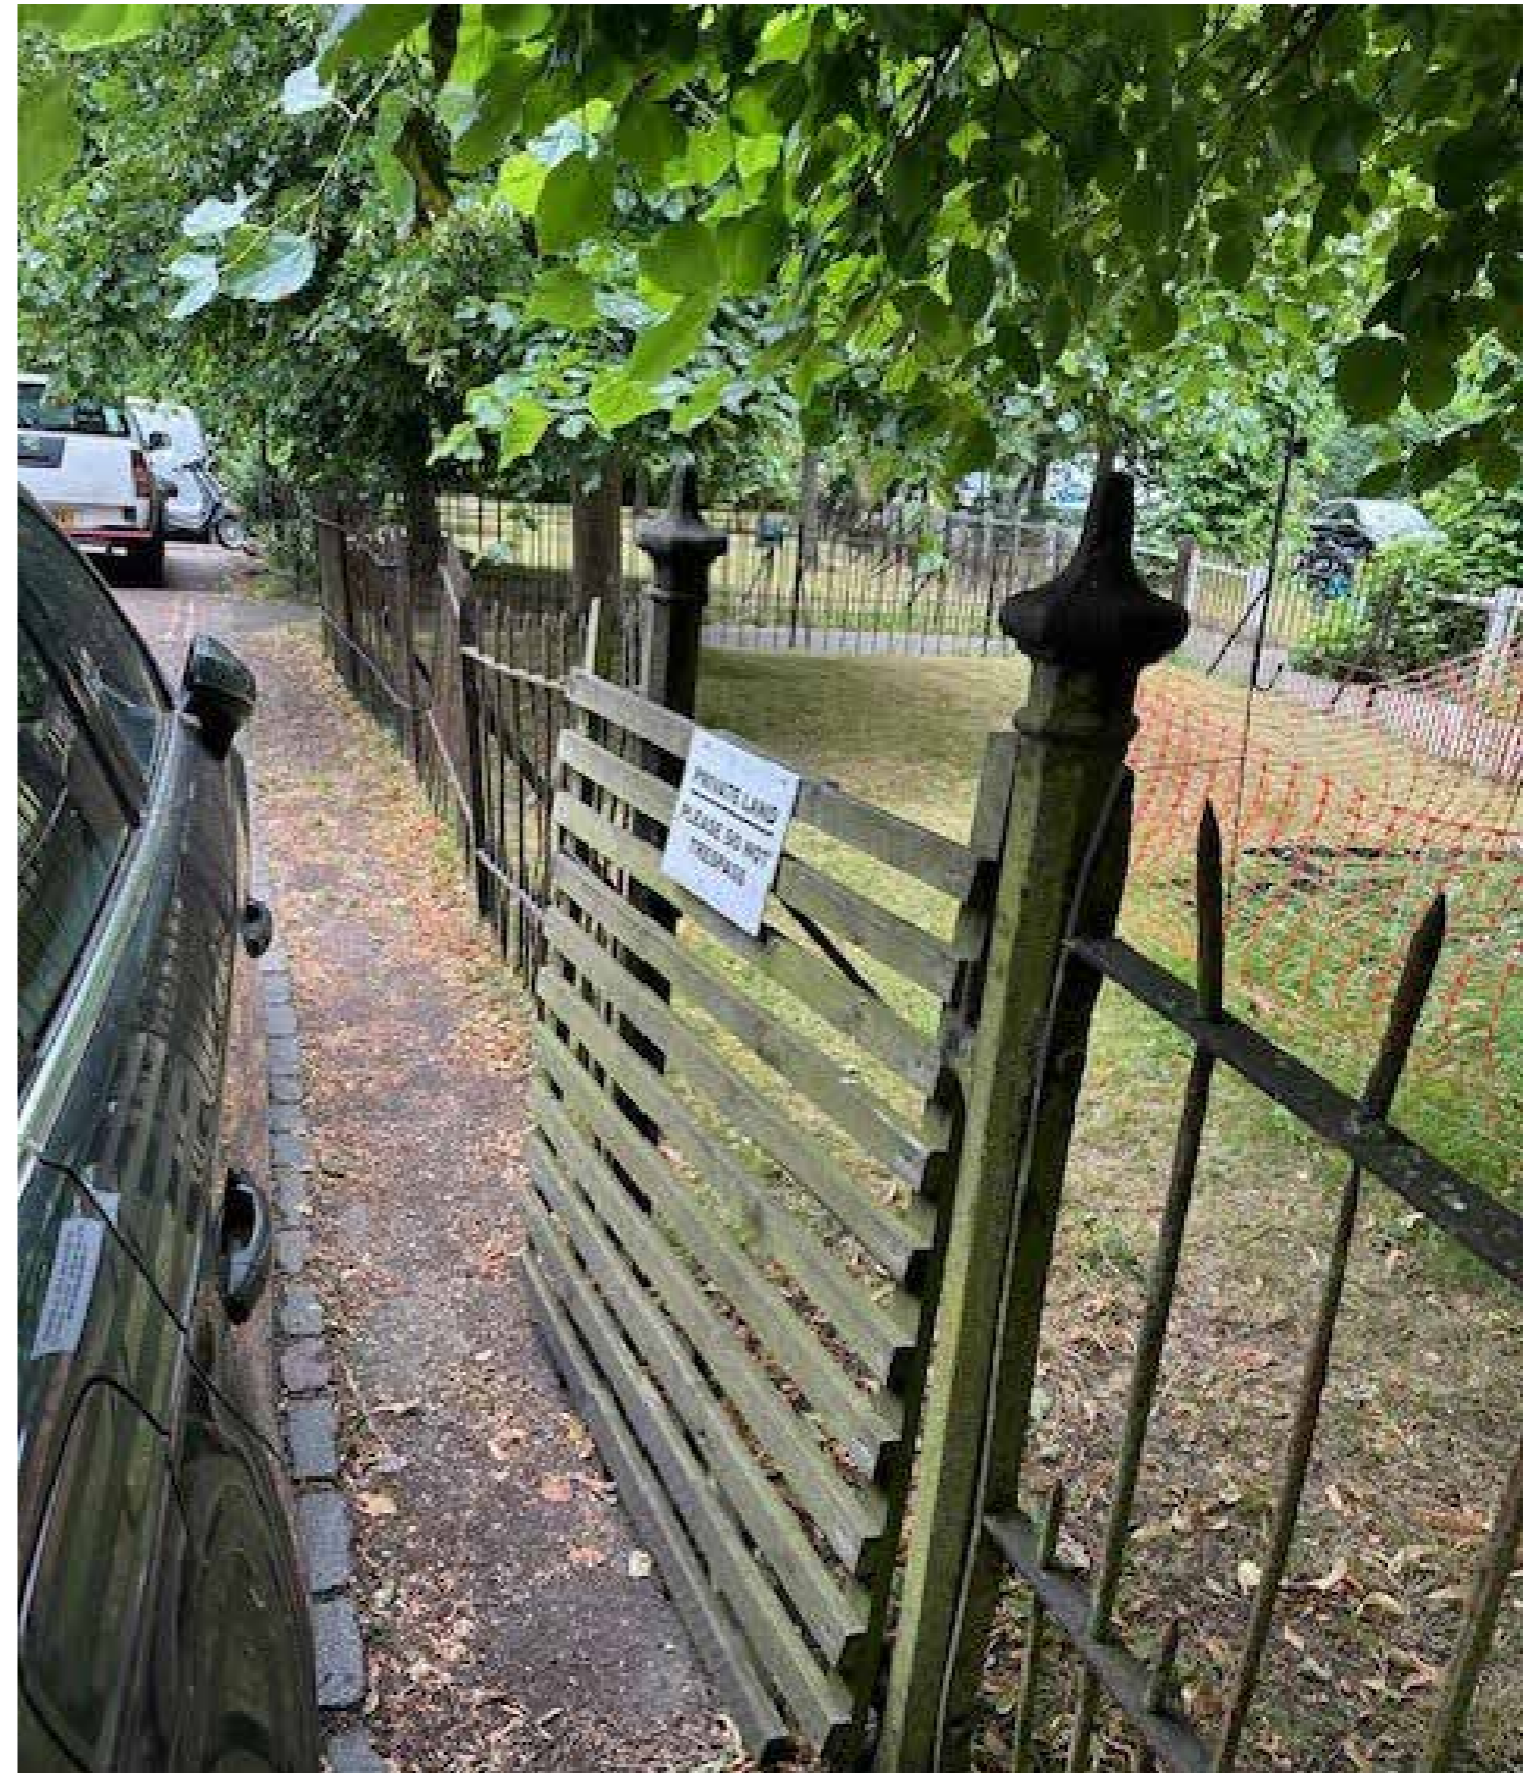
18. Gate missing

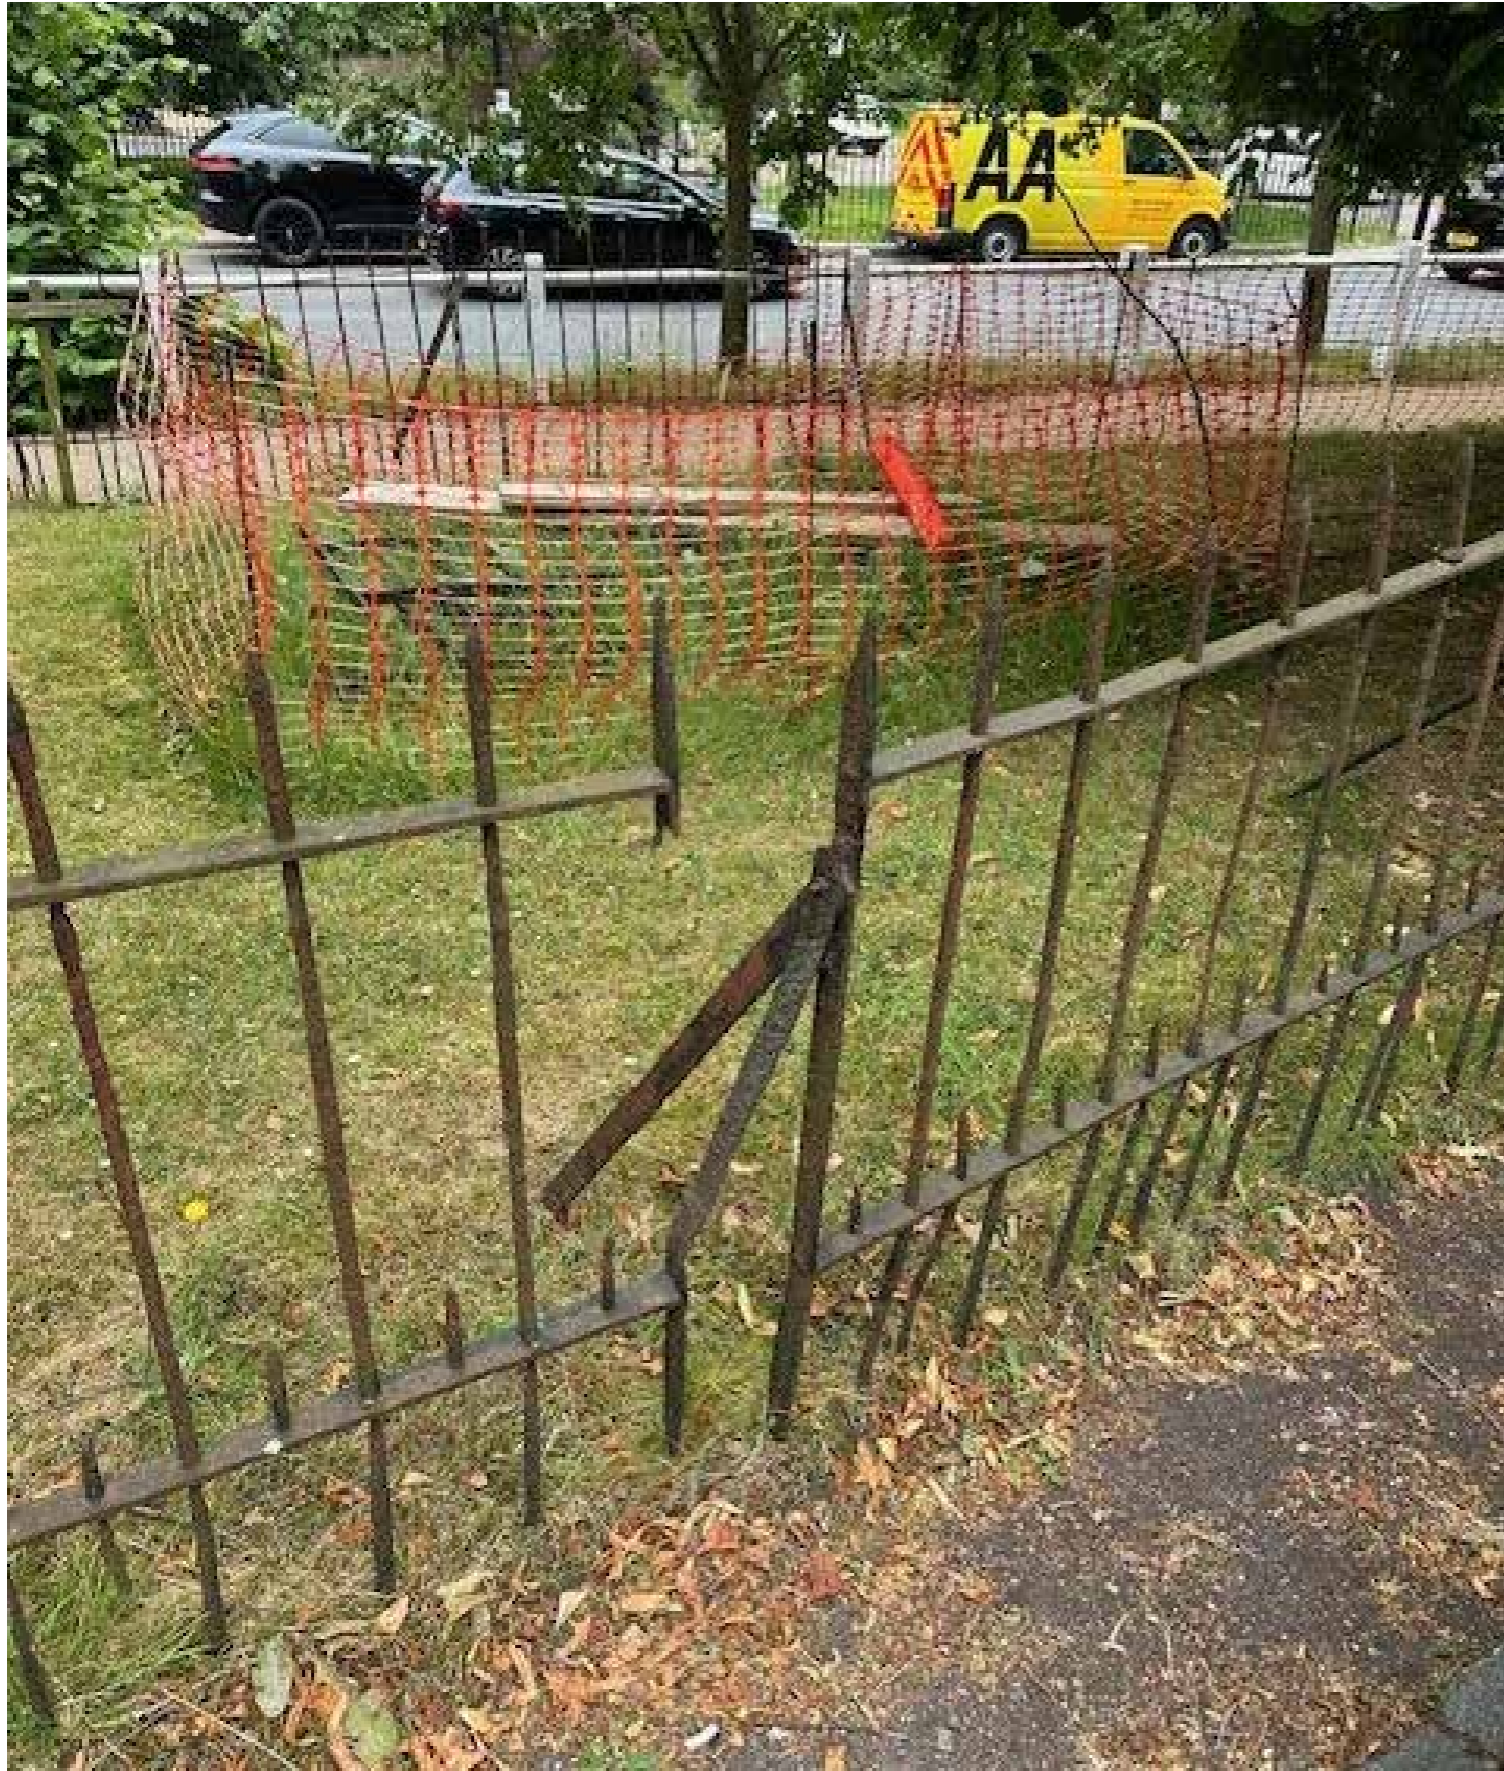
19. One panel missing end frame

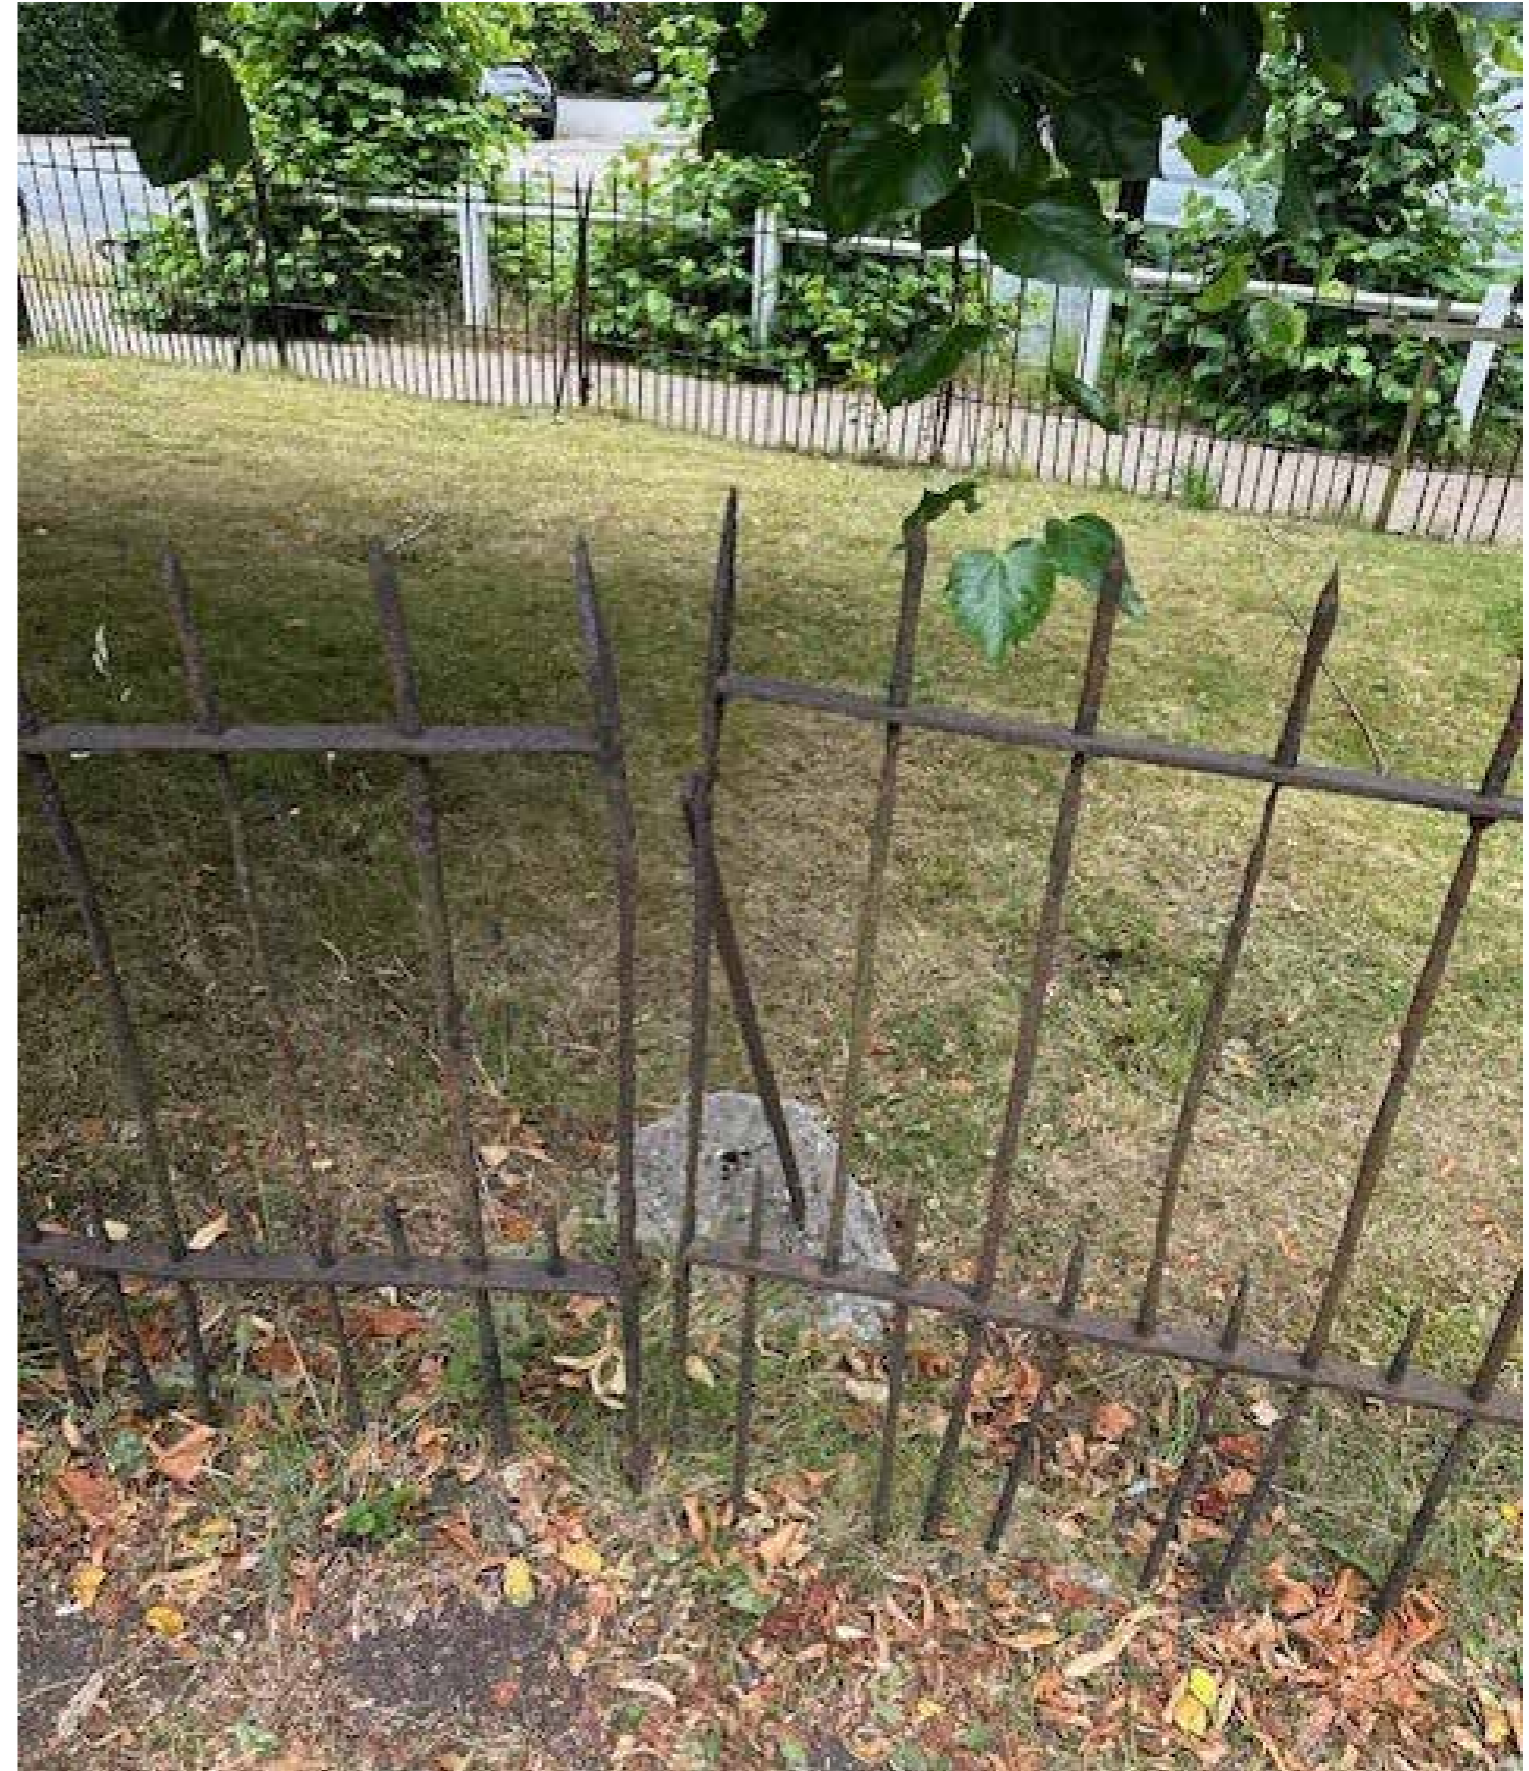
20. Broken connection between panels
