5, BACON'S LANE, HIGHGATE, N6 6BL.

Condition & Feasibility Study (Options Appraisal)

Document No.: 5BL-PP-9020 (Rev A)

RATIONALE FOR DEMOLITION AND RE-BUILD

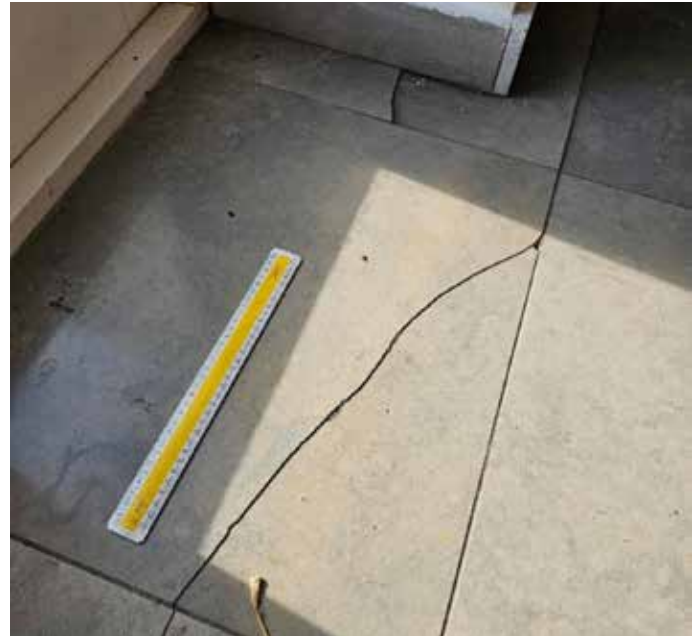
The existing building has previously suffered movement causing damage to the property. Today the building shows signs of further movement. This suggests that movement, albeit slight, is ongoing. The cause of the ongoing movement could be investigated further, and remedial works outlined to repair the damage caused. However, this has been done before and proven not to be adequate.

Photograph of cracks in floor showing ongoing building movement.

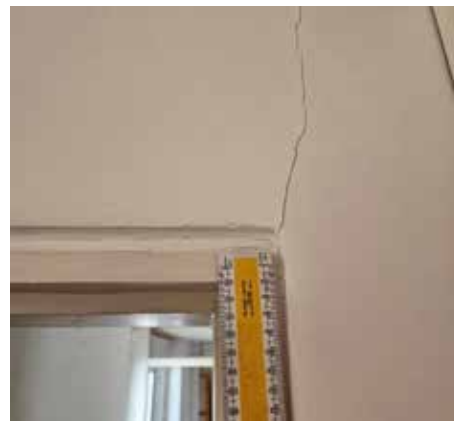
Photograph of cracks in wall showing ongoing building movement.

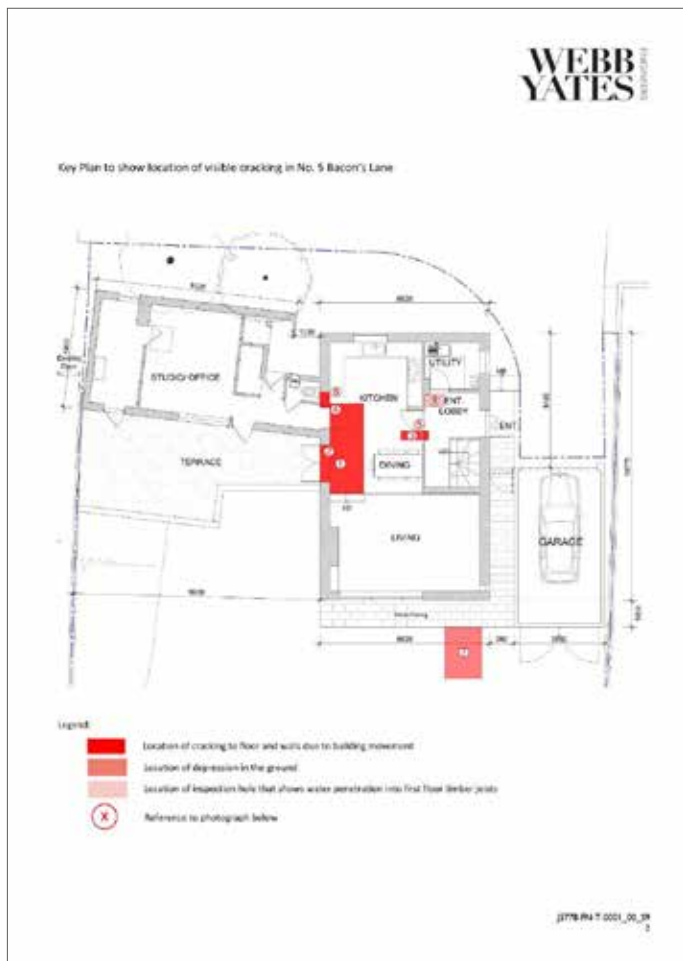
Extract of WYE's 'Rationale for Demolition and Rebuild' document
 Identifying recorded instances of building movement & cracking.

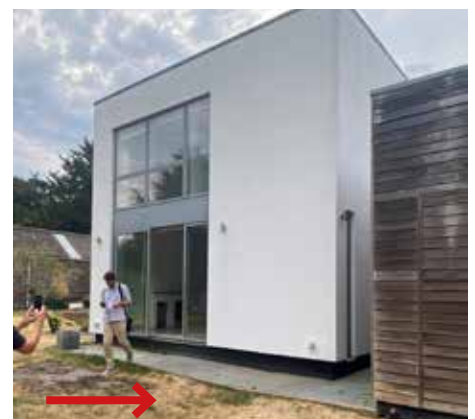
Photograph showing depression in ground.

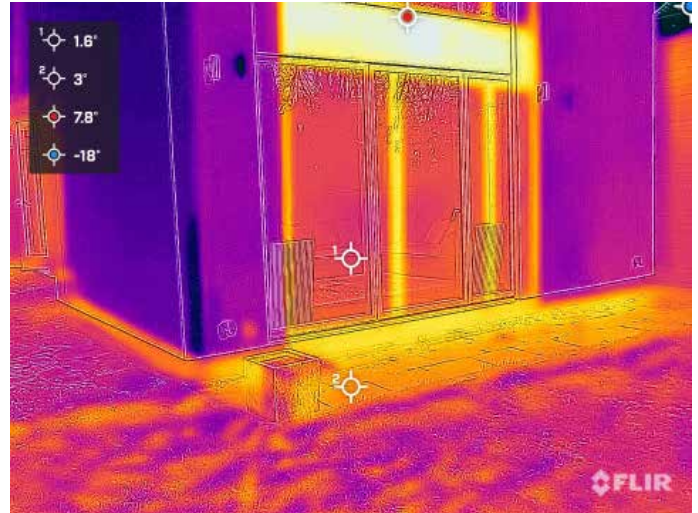
It was explored that part of the north and west elevations could potentially be incorporated in the new layouts as they align with the new proposals. However, the existing cavity walls do not meet current building regulations for thermal performance (calculated at between 0.30 and 0.35 'U' value) and would require substantial upgrade to achieve the requirements (0.15) e.g. in addition to the existing Sto render, further adding a better performing over-cladding which is appropriate to the Conservation Area.

TIA of heat loss to No. 5 ground floor and windows

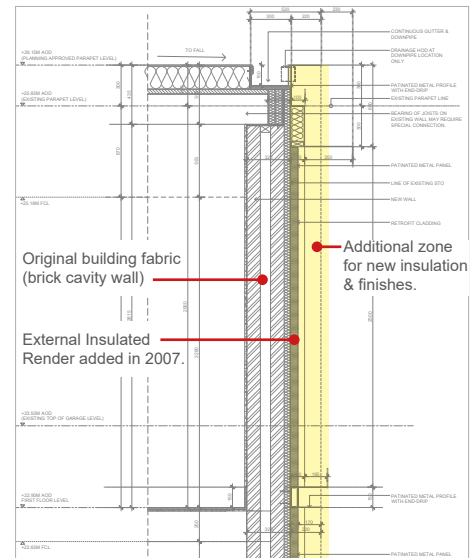
Envelope Study showing existing build-up.
Detail complexity 'adding' to 2007 modifications.

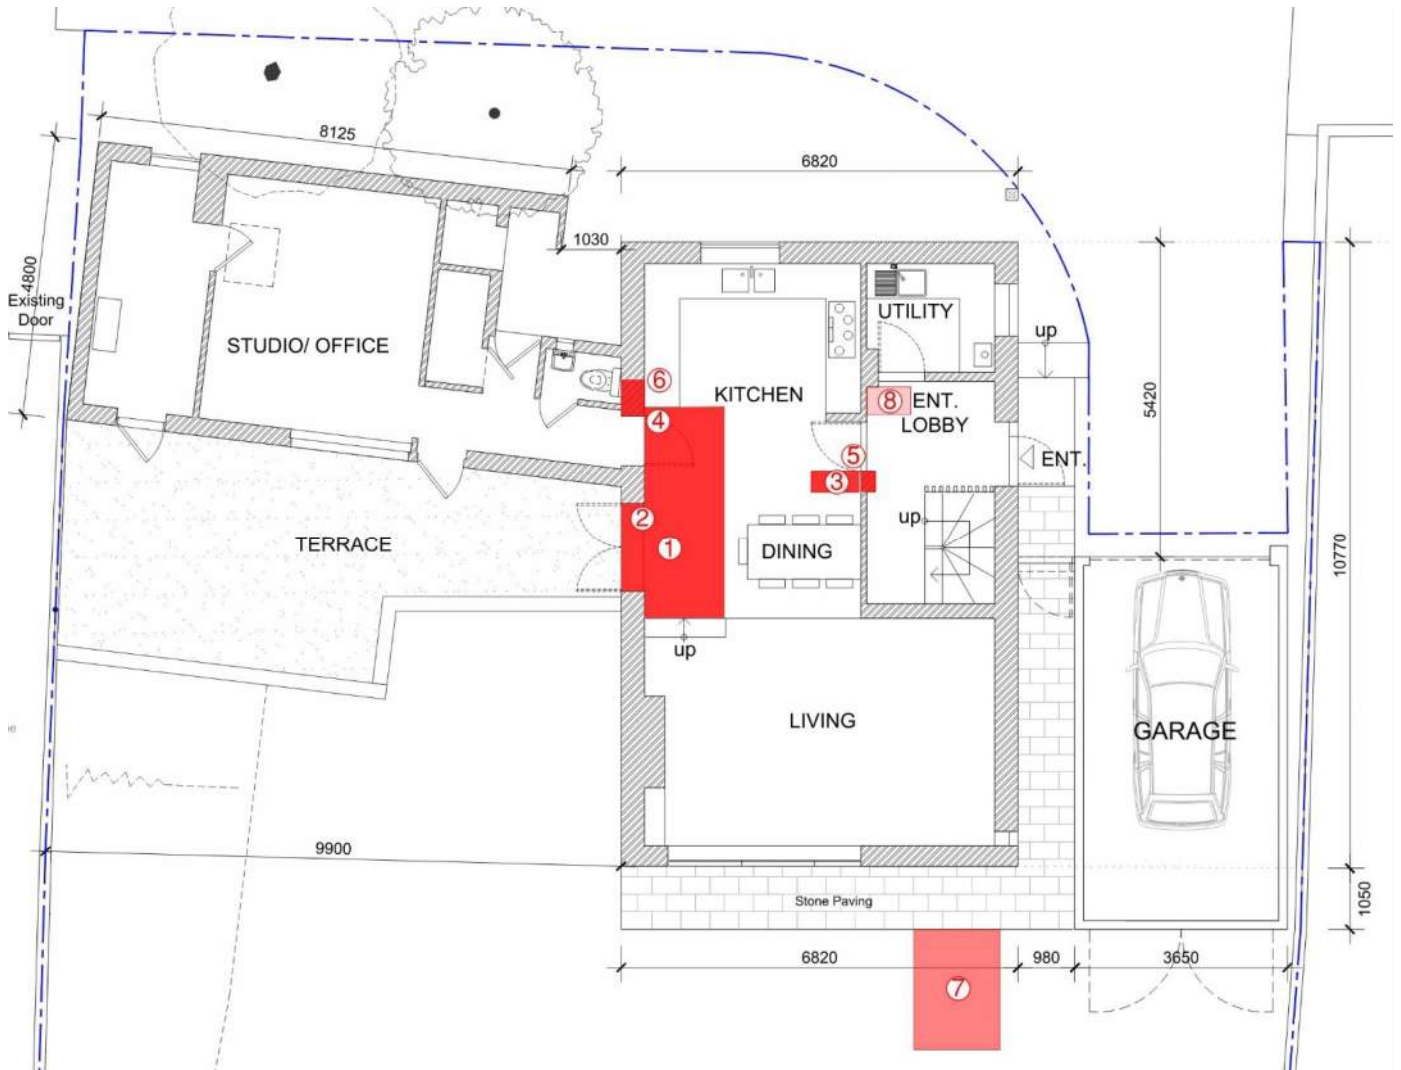
Key Plan to show location of visible cracking in No. 5 Bacon's Lane

Today the building shows signs of further movement; apparent with cracks visible in the floor finishes and in the walls of the property, as well as a depression in the external ground (refer to the photographs below). This suggests that movement, albeit slight, is ongoing. The cause of the ongoing movement could be investigated further, and remedial works outlined to repair the damage caused. However, this has been done before and proven not be adequate. There is also evidence of water penetration into the first-floor structural timber joists.

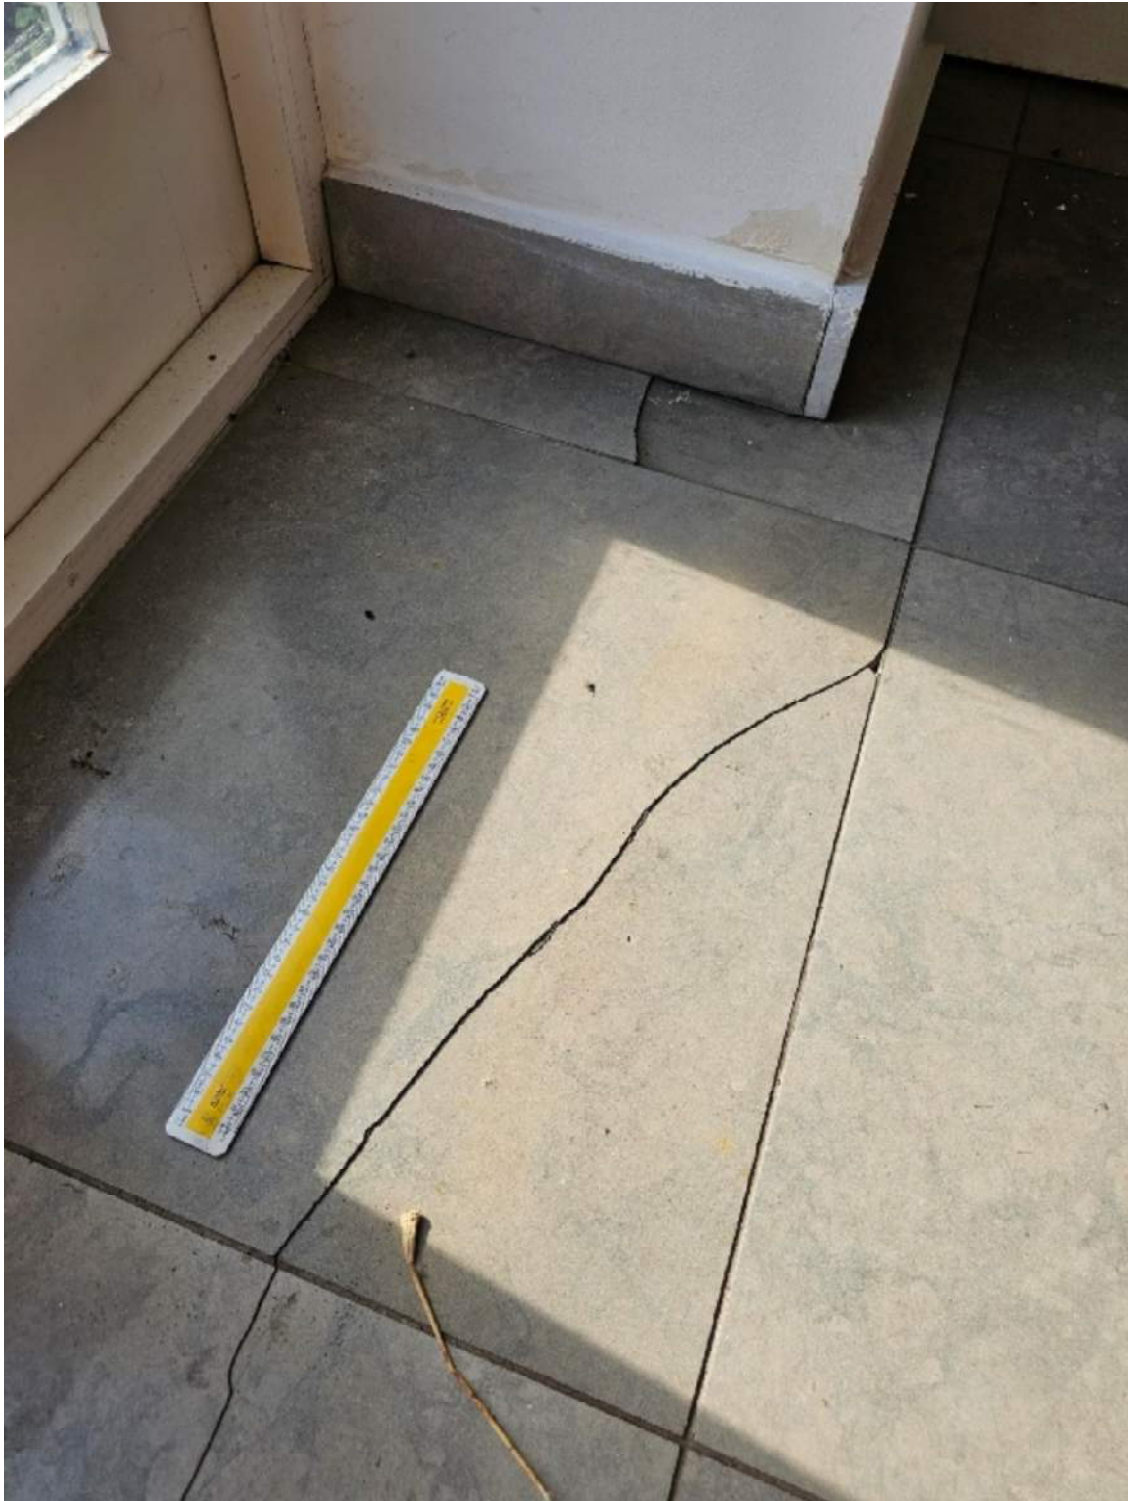
1 Photograph showing cracks in floor due to ongoing building movement

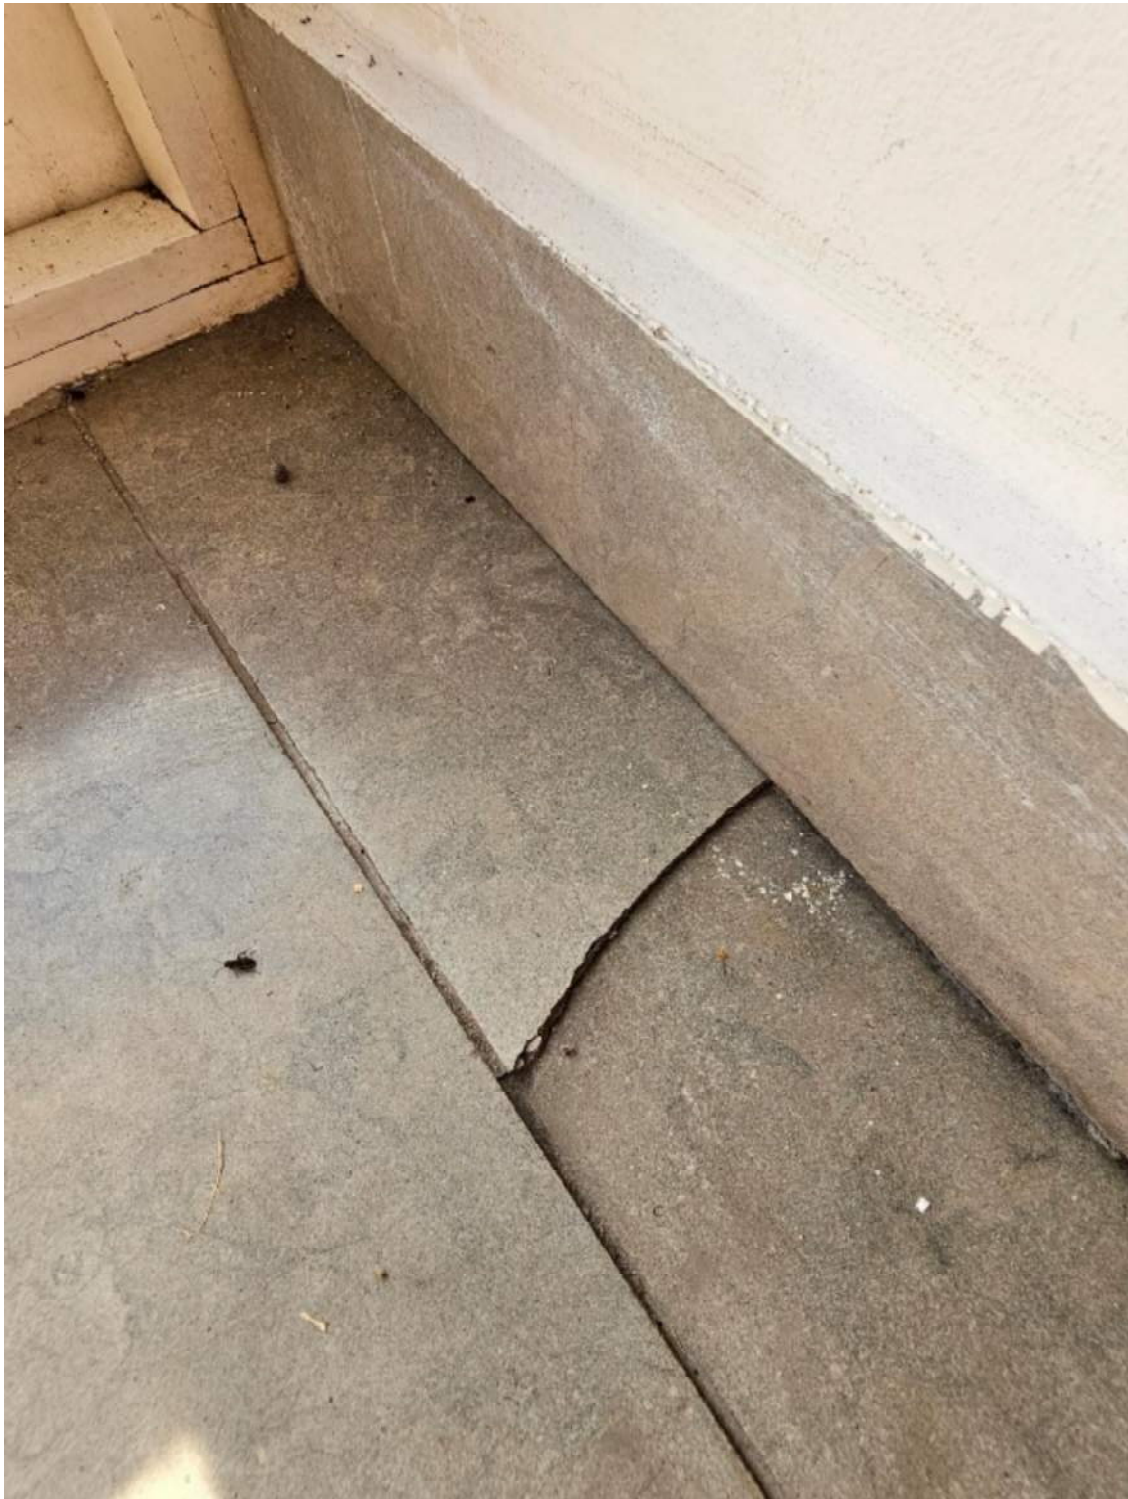
2 Photograph showing cracks in floor due to ongoing building movement

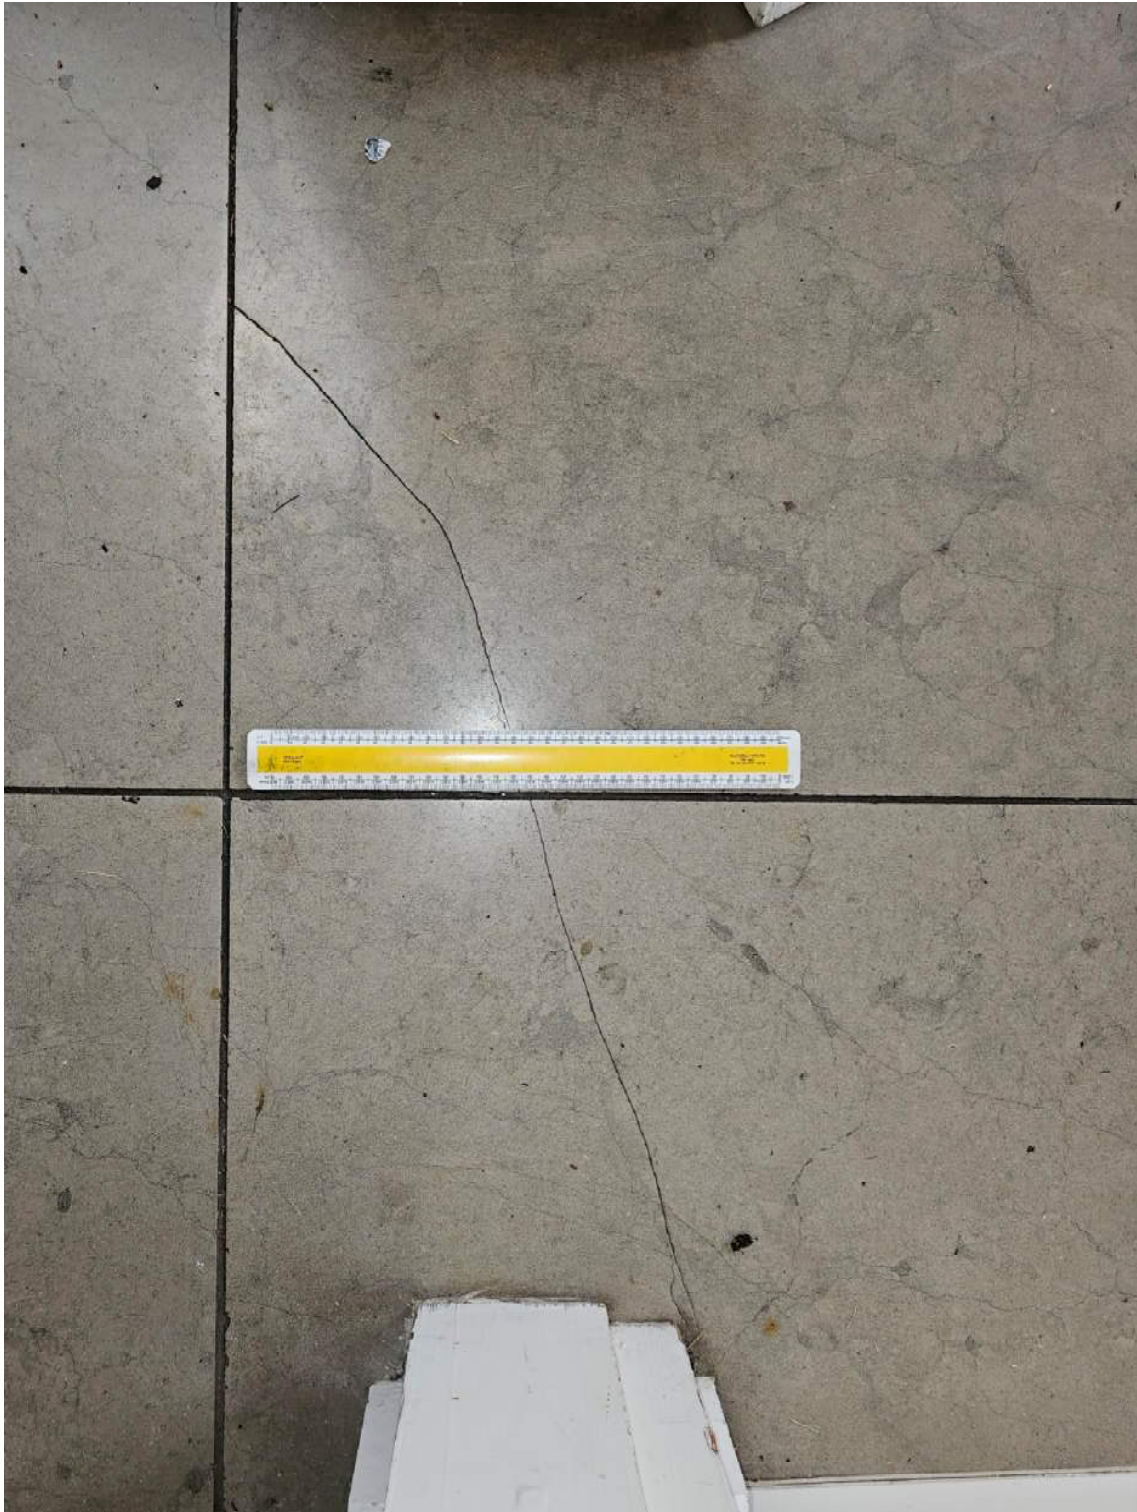
3 Photograph showing cracks in floor due to ongoing building movement

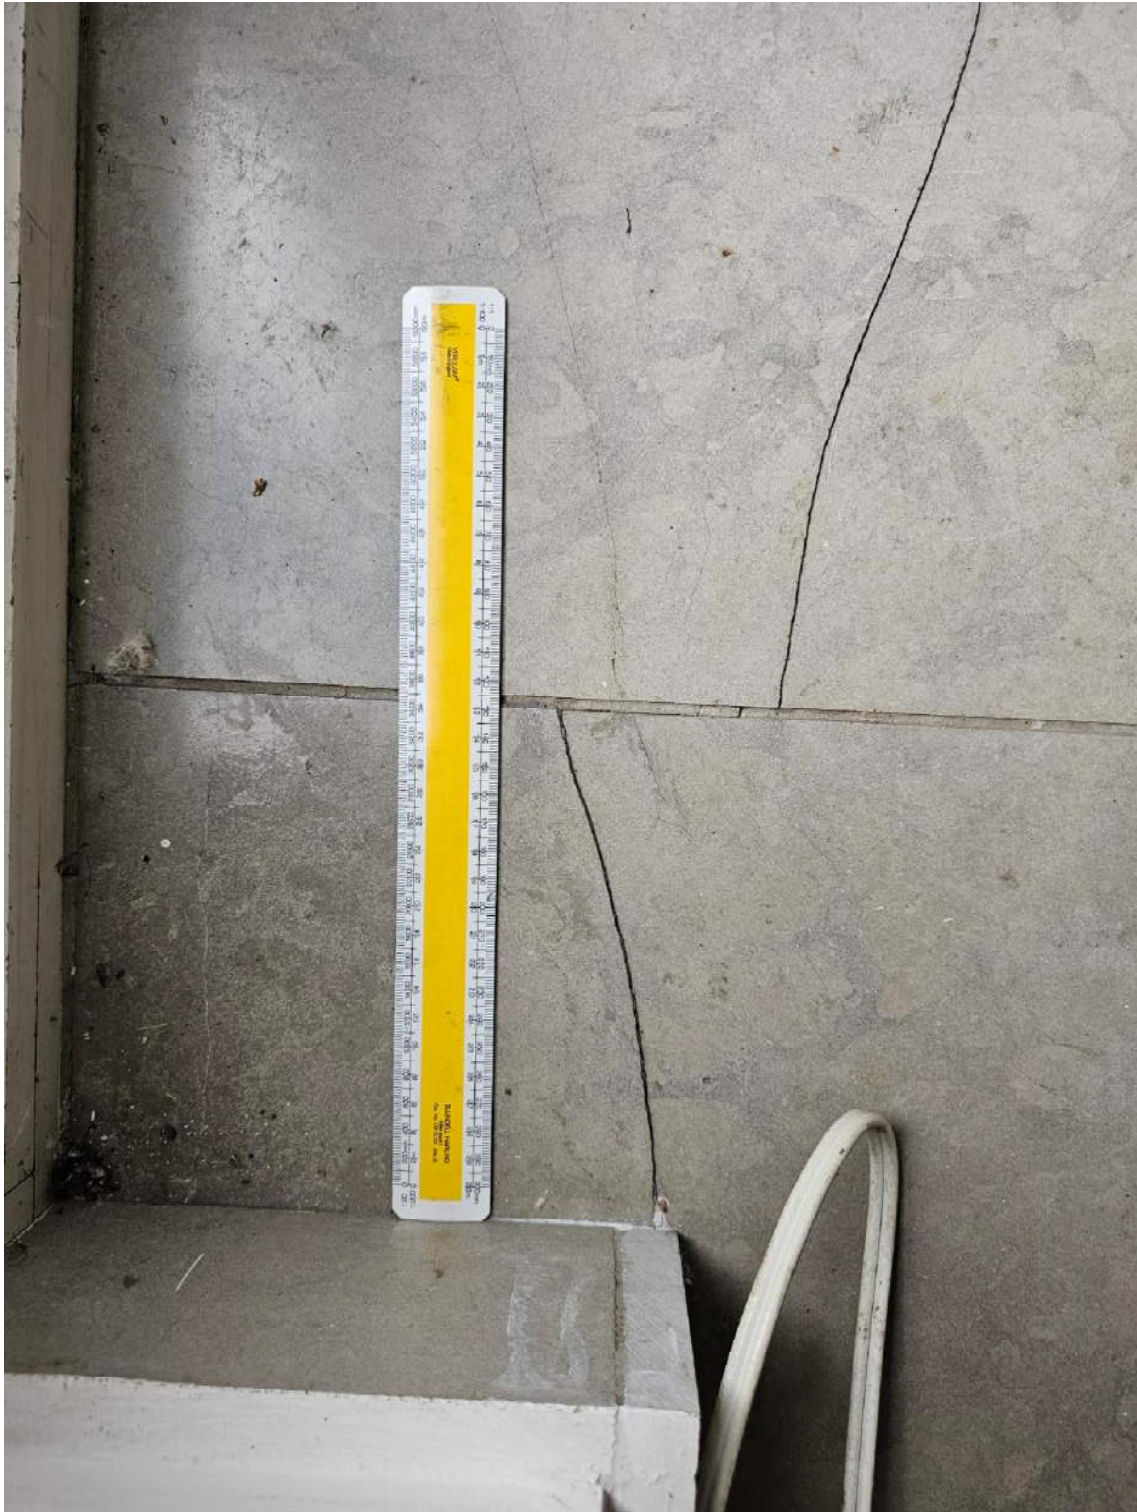
4 Photograph showing cracks in floor due to ongoing building movement

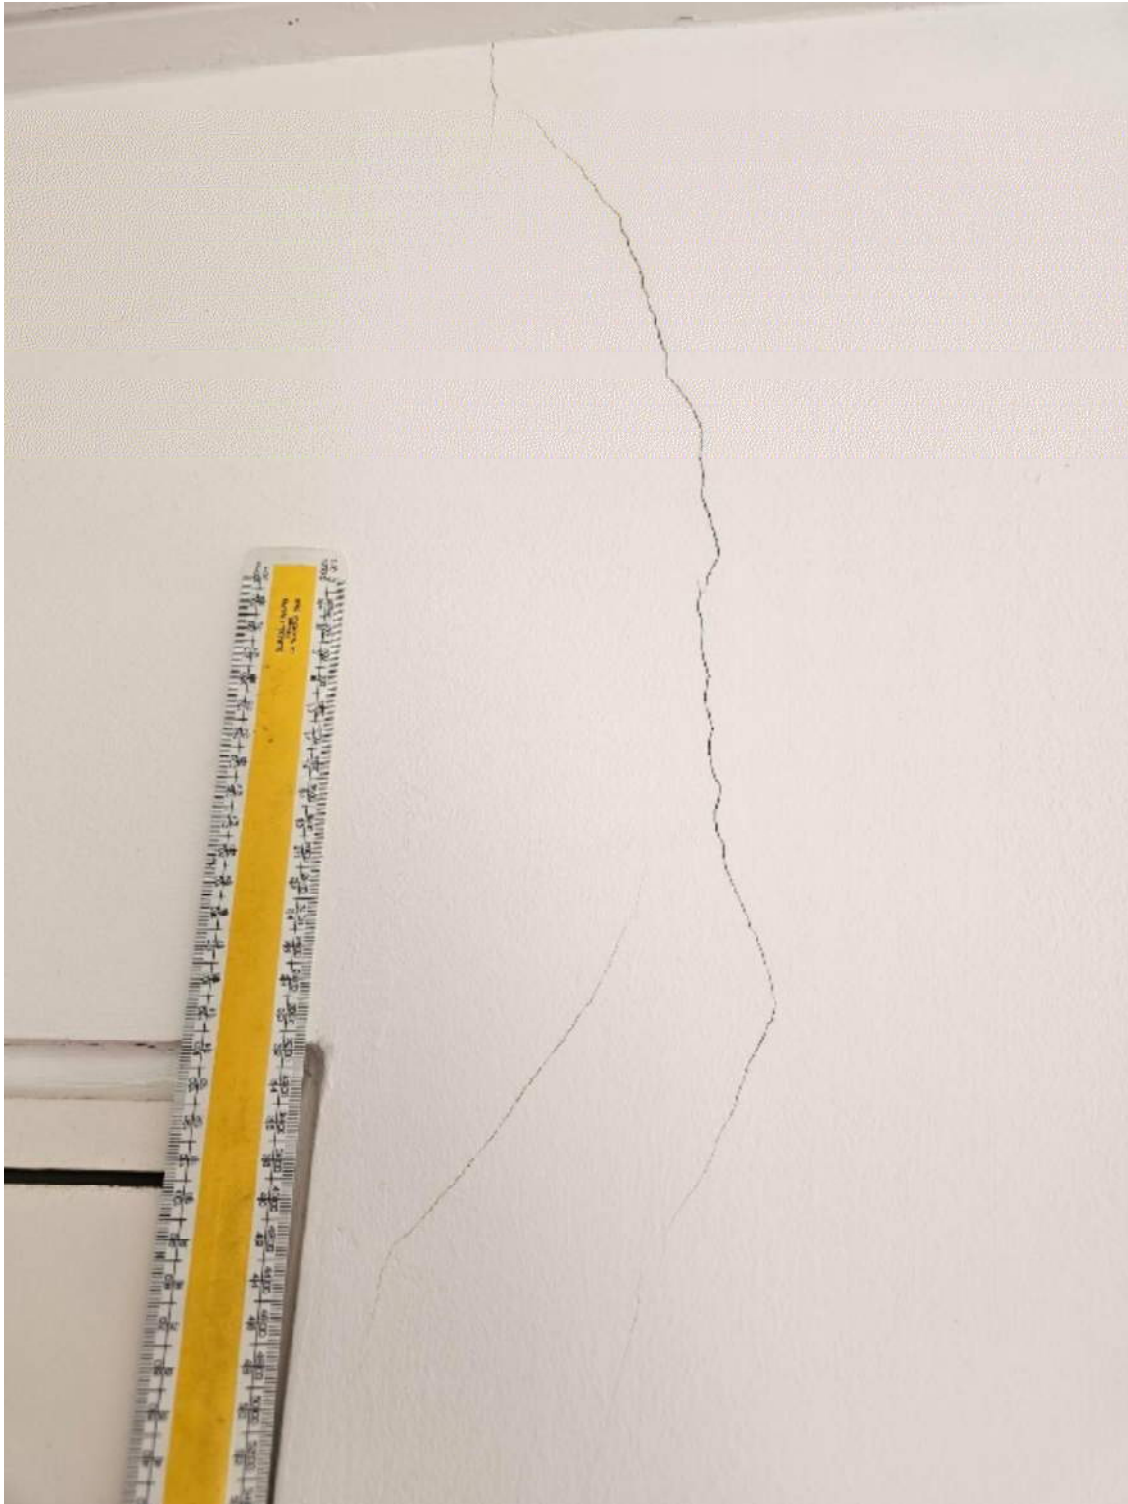
5 Photograph showing cracks in wall due to ongoing building movement

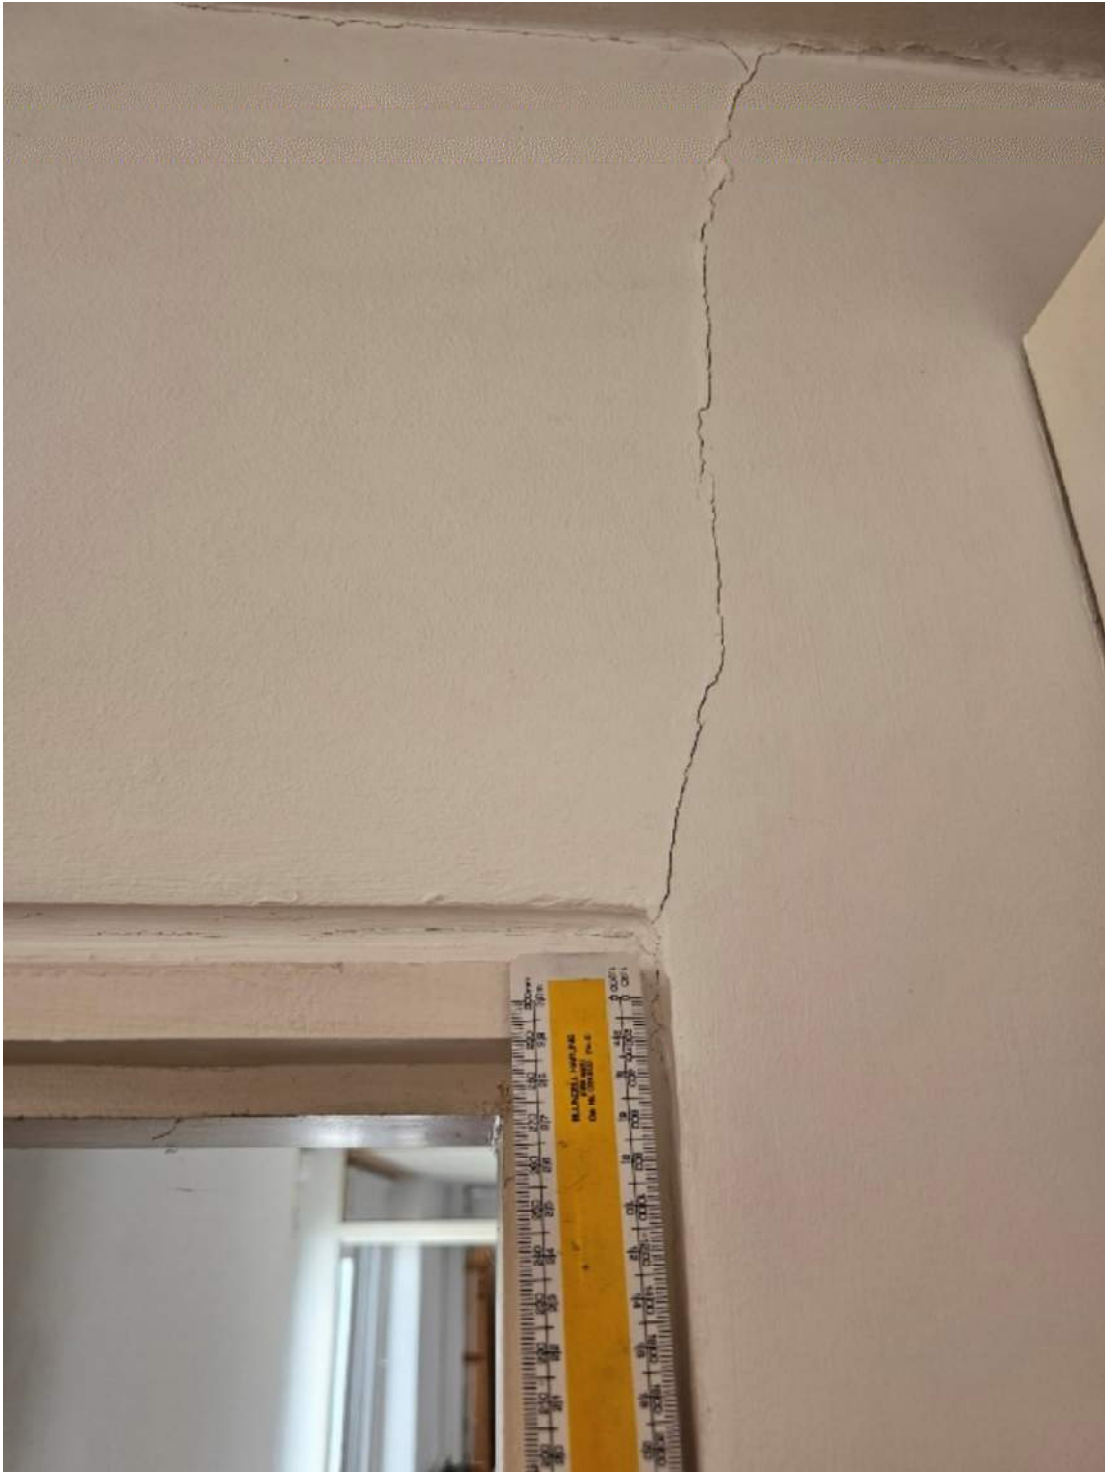
6 Photograph showing cracks in wall due to ongoing building movement

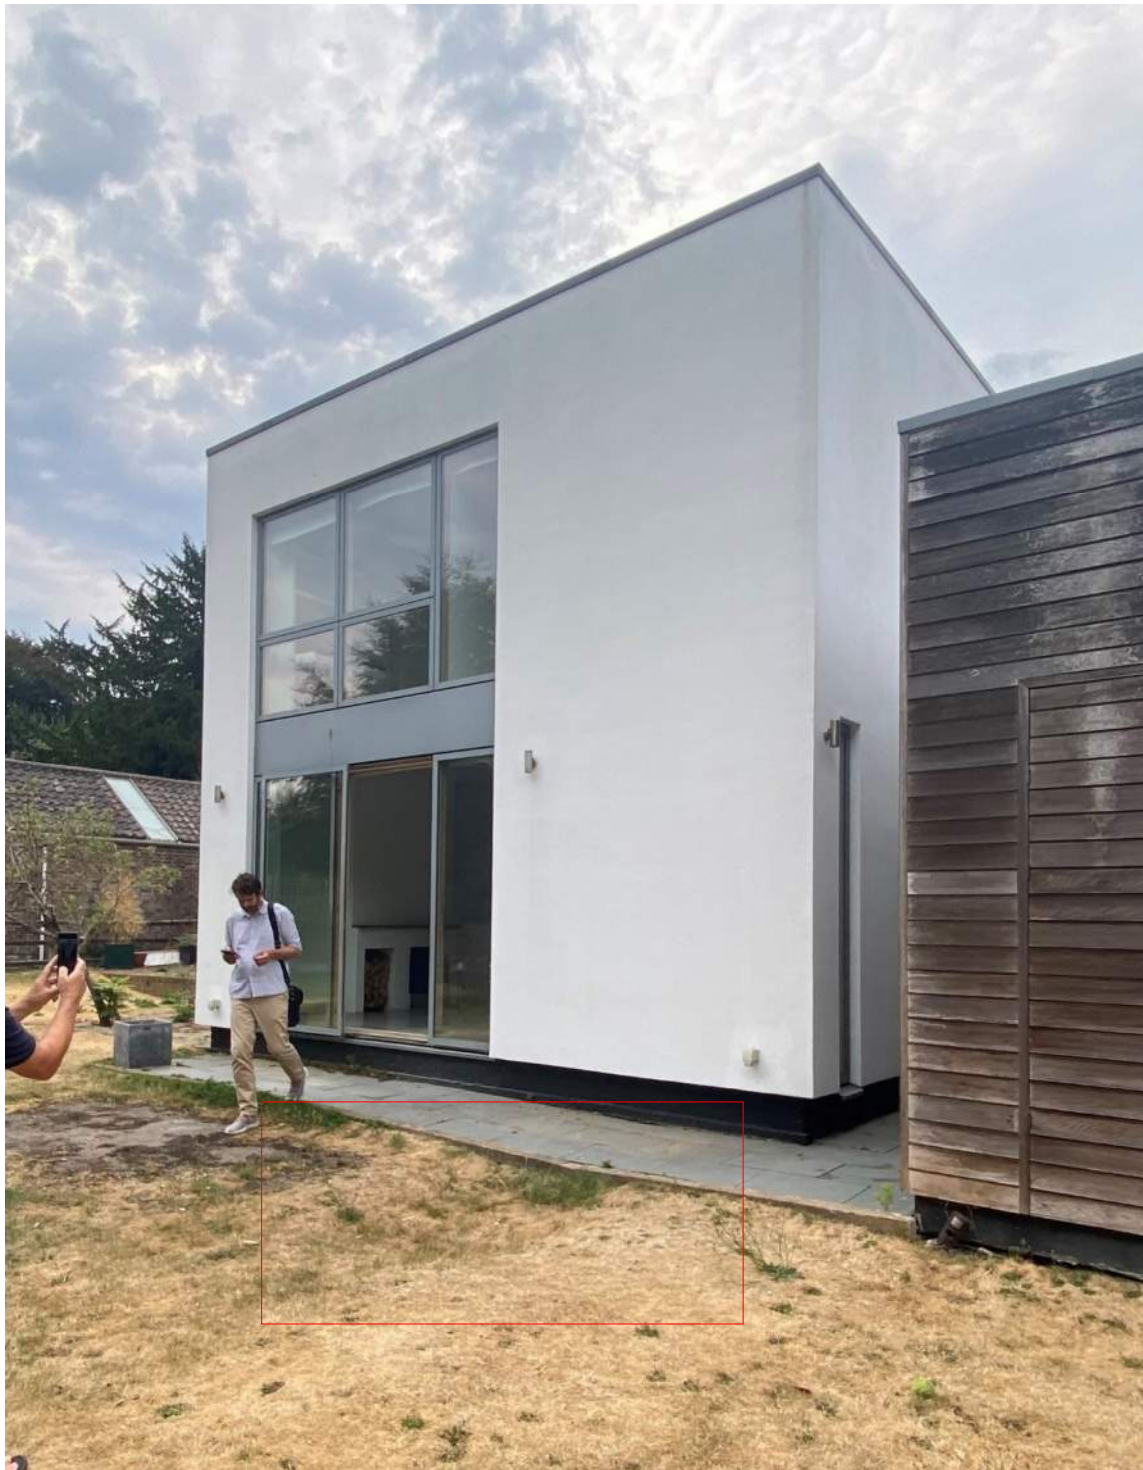
7 Photograph showing depression in the ground

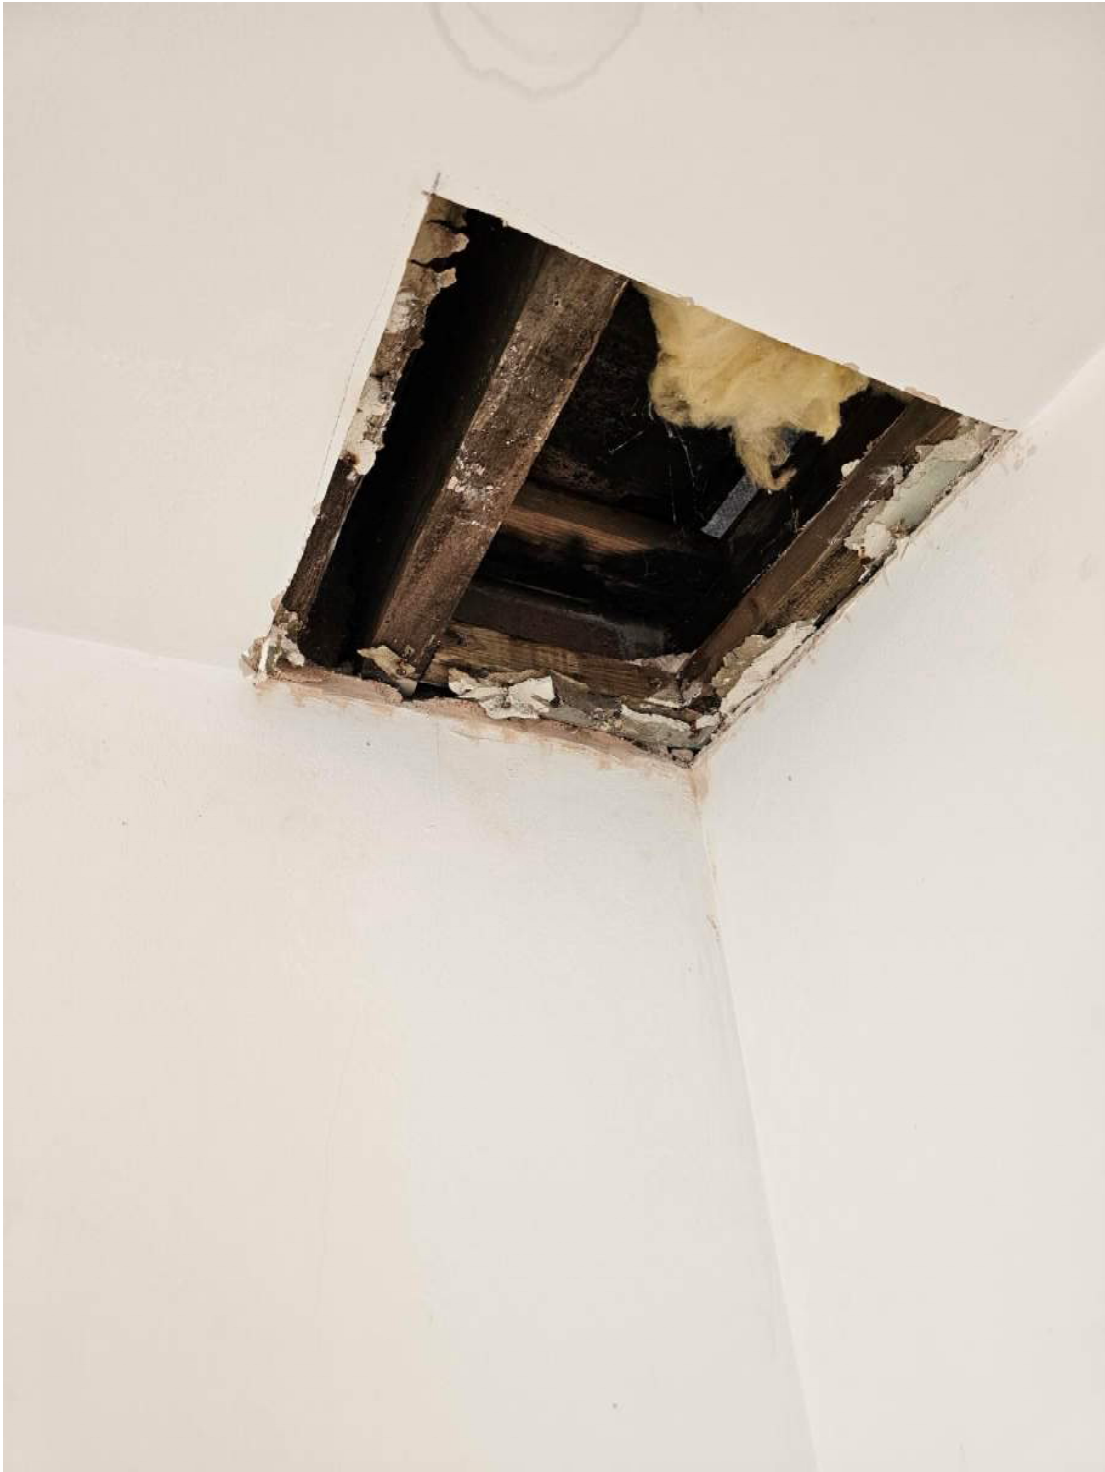
8

Photograph of inspection hole that shows water penetration to the first floor timber joists
