5, BACON'S LANE, HIGHGATE, N6 6BL.

Pre-Demolition Audit
October 2024

Document No.: 5BL-PP-9040 (Rev A)

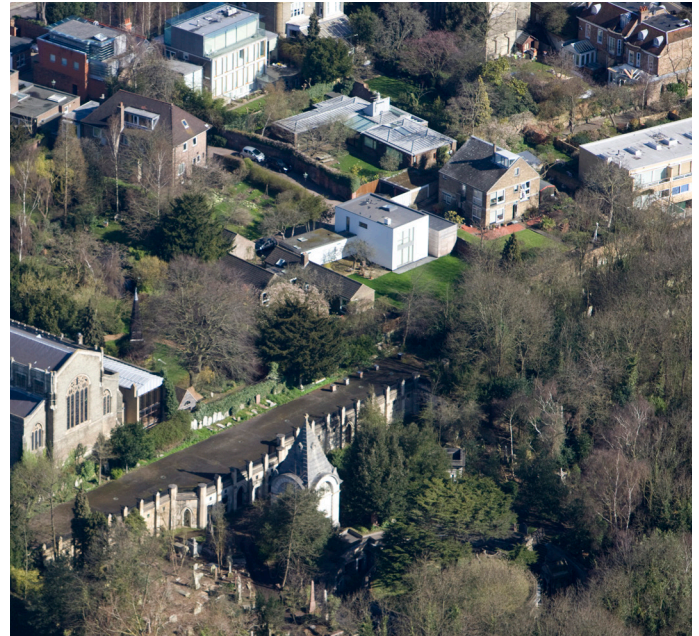
Extract from Aerial Photo 26615_029 (Historic England website) that shows Bacon's Lane, Highgate in 2010. The photo shows the remodelled No. 5 with white over-render.

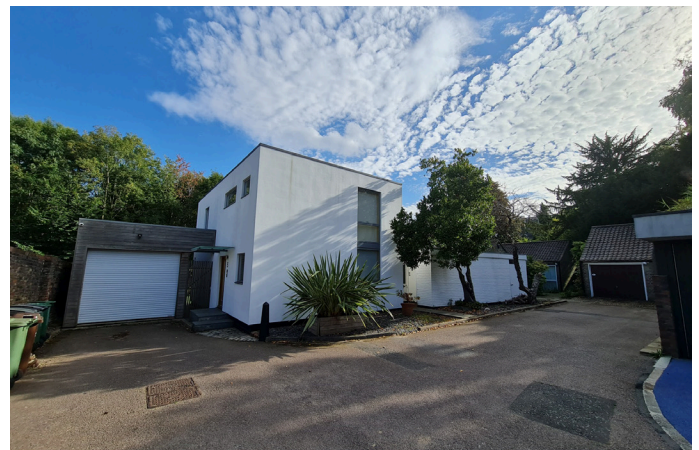
Photo showing the existing house from Bacon's Lane
