772: Leather Lane – Structural Inspection

We write following our visit with you and our mutual client to the upper apartment at 87 Leather Lane, Clerkenwell, EC1N 7TS on the 13<sup>th</sup> September this year to confirm our comments made during the visit.

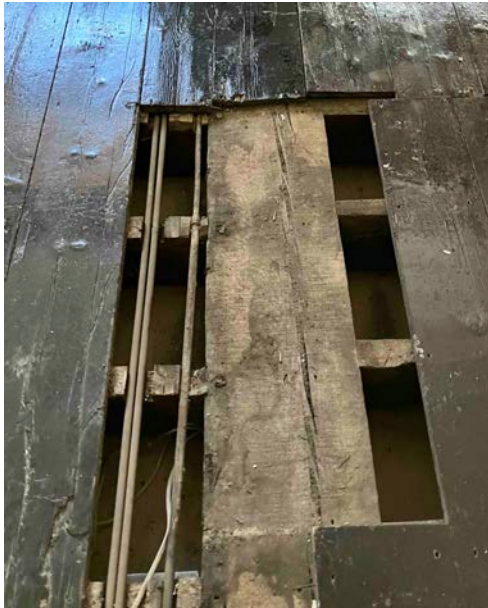
Fig. 1 : View of main floor beam / joists

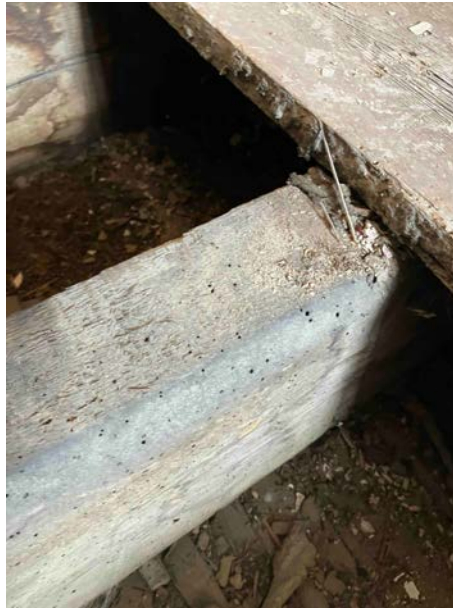
Fig. 2 : Woodworm to existing joists

A survey of the existing timber should be commissioned by a timber specialist to check for signs of wet / dry rot or insect attack and provide recommendations for appropriate treatment. There are clear signs of woodworm attack at various points in the building – but most significantly at loft level.

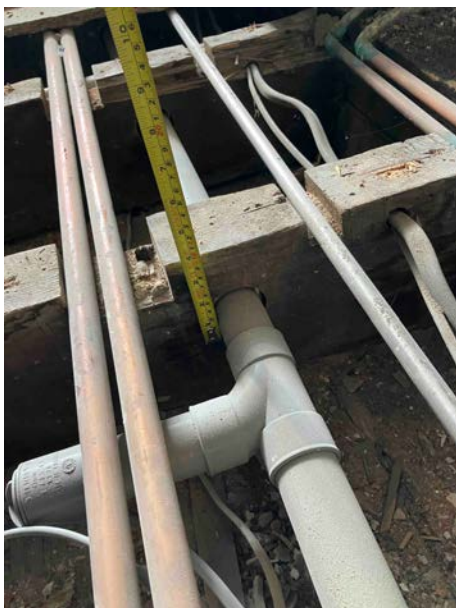
At the second floor level where the previous bathroom fit out had been removed there is evidence of notching to the existing floor joists (see fig. 3). Although the notching seen in this location is reasonably significant the span of the joists in this part of the building is reasonably small and the joists here were relatively substantial (measured in this location at 75 x 195mm at 360mm c/c.). The joists in this area did not show any significant signs of structural distress relating to this existing notching.

Fig. 3 : Notching to existing floor joists

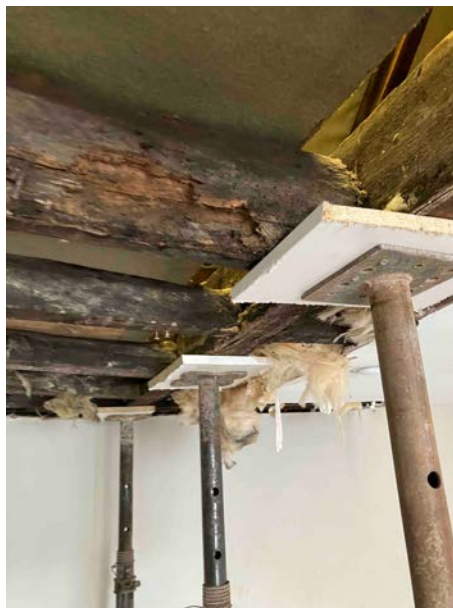
At loft level we were able to carry out an inspection of both the front and rear sections of lofts through the loft hatches. Part of the underside of the loft build-up to the rear section of the main house is currently propped (see fig. 4).

Fig. 4 : Propping to existing loft build-up

It is clear that there are areas where the existing loft level structure is in poor condition – with temporary propping to the underside of the loft floor build-up at the rear of the building and evidence of previous crude repairs in the front half of the loft. We recommend that the existing mineral wool insulation and ceiling finishes are removed to allow a full inspection of the existing loft level timberwork. As a minimum it is anticipated that the existing short span loft joists should be removed and replaced however some of the primary beams may also need to be replaced.

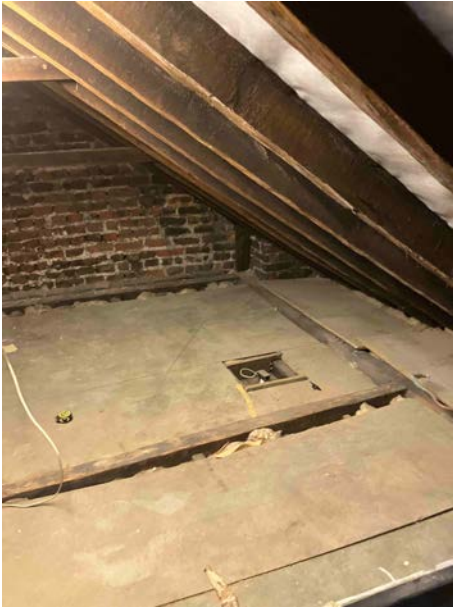
The loft floor structure appears to comprise a series of timber support beams (spaced approx. 1.3 - 1.6m apart) spanning from the head of the spine wall onto the side face of a timber beam set just inside the eaves spanning party wall to party wall (see fig. 5 for general view of rear section of loft). This eaves beam spanning party wall to party wall measured at approximately 140-170mm wide by 150-170mm deep. The short spanning loft floor joists (which span parallel to the front / rear elevations) comprised variable and irregularly sized timbers with approximate sizes of 70mm wide x 90 mm deep at approx. 360 - 400mm c/c. These timbers were in poor condition and showed significant woodworm. In the rear half of the loft (where the propping is currently installed to the underside of the loft) one of the front / back support beams appears to have split and in the front half of the loft space one of the front to back beams has been crudely re-strapped off the rafters where the end of the beam appears to be badly decayed at the junction with the valley beam running along the head of the spine wall (refer to fig. 6).

Fig. 5 : General view of rear loft space

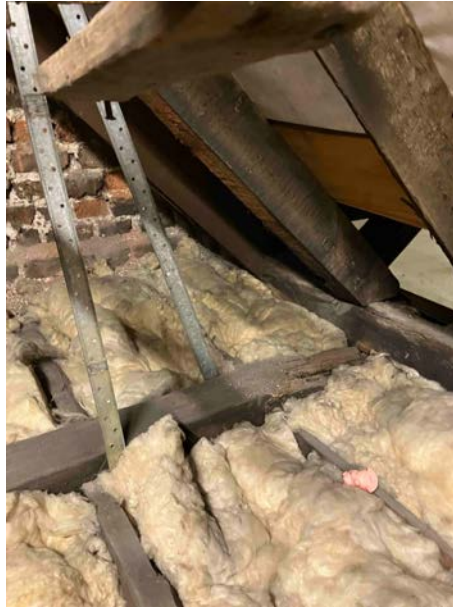
Fig. 6 : Strapped & re-supported loft beam

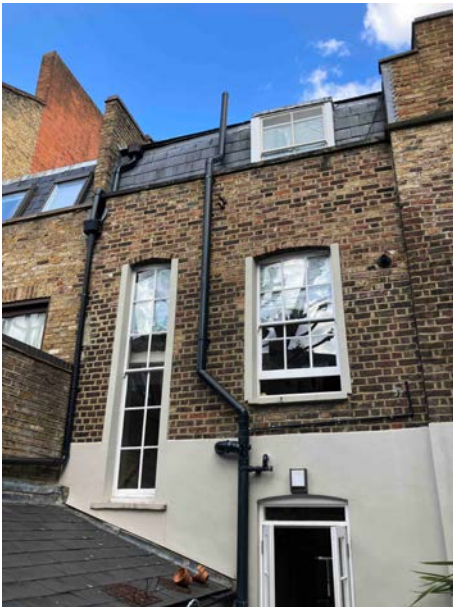
The rear elevation brickwork was viewed from the rear terrace at first floor level. The rear brickwork up to around second floor level is rendered with exposed brickwork above. There are clear signs of rebuilt brickwork across the face of the rear elevation from mid-way between 2<sup>nd</sup> and 3<sup>rd</sup> floor up to parapet level. This rebuilt brickwork extends across the face of the rear elevation. There are clear signs of historic rear elevation movement - most particularly in a noticeable bulge on the face of the projecting rear chimney which has partially been repaired with rebuilt brickwork. However there are no indications that there is currently any significant ongoing structural movement. The lintels over the two second floor windows are an unusual brick on flat arched lintel detail (which we understand will be replaced with new gauged brick arch lintels). The rear elevation of the high level timber framed mansard build-up seems to curved outwards towards the centre of the roof - but this is assumed to be historic.

Fig. 7 : General rear elevation view

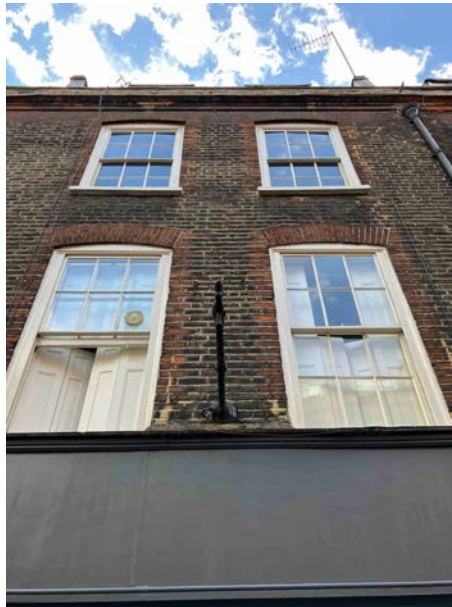
The front elevation brickwork was viewed from street level. The brickwork over the first and second floor windows is supported on traditional brick arch lintels which appear to be in relatively good condition given the age of the property with no significant signs of distortion or movement. There is some indication of some outward bowing of the brickwork at the upper level but this is considered to likely be historic and not a significant structural issue. At various points across the façade there are areas of mortar patching which may be in locations where there has been historic cracking, however this appears limited and not a significant structural concern. To the right hand side of the first floor front elevation window (when viewed from the front elevation) there are some locations of vertical brickwork cracking. Some of this cracking may relate to locations where previous signs have been fixed back into the brickwork. Again this cracking is not a significant structural issue but if works are being carried out to the front elevation then it may be sensible to carry out helibar remedials across these cracks.

Fig. 8 : General front elevation view

There are areas of minor cracking to the existing front elevation brickwork. These are not sufficiently significant to merit remedial works on their own – but if other works were being completed to the front elevation it would be worth considering carrying out local helibar remedial repairs in these areas.
