## SITE INVESTIGATION FACTUAL REPORT

Site: 102-104, Albert Street  
Camden

Home Emergency Response - Subsidence Investigation - Drainage Services – Crack & Level Monitoring – Property Video Surveys

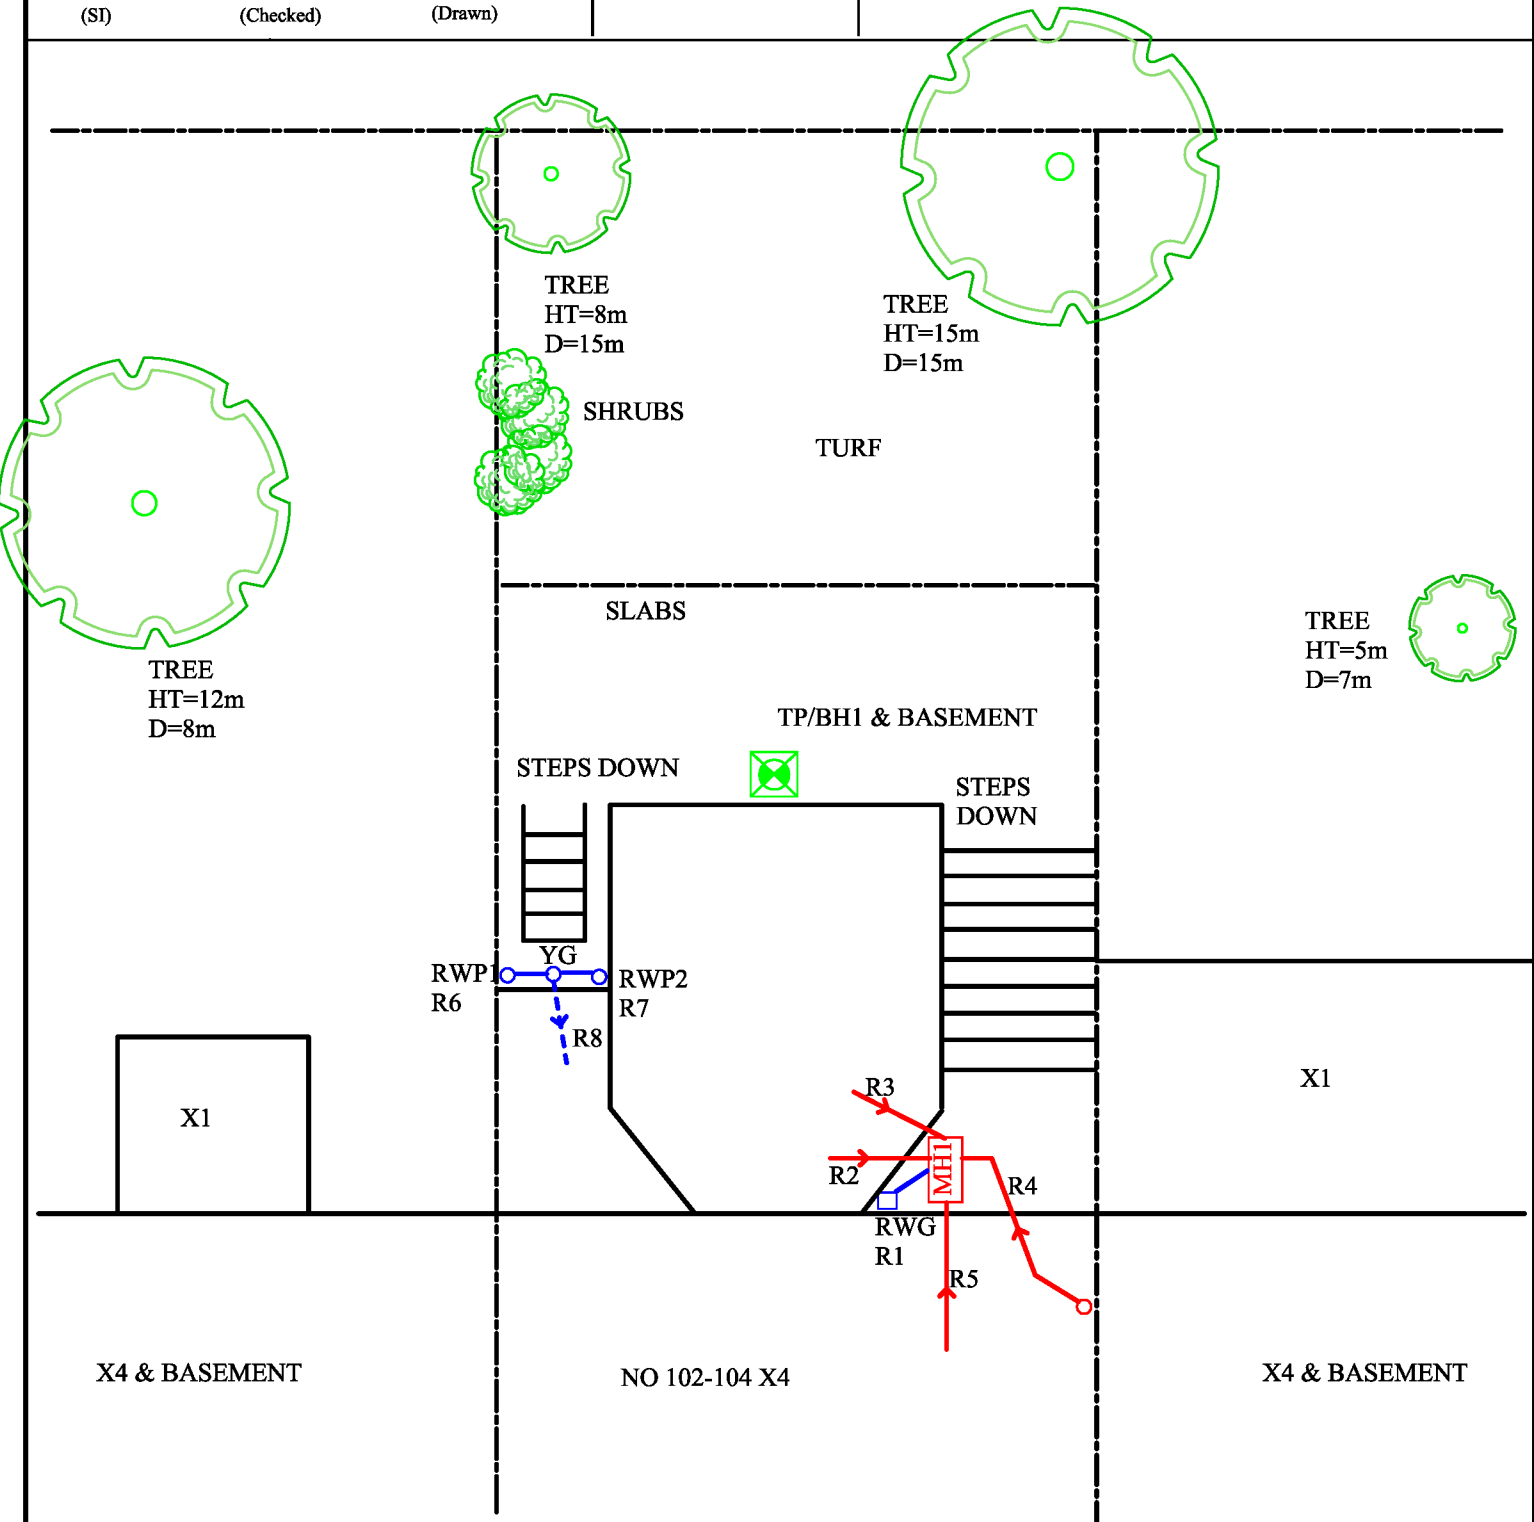
# Investigation Layout Plan

ON SITE TREE IDENTIFICATION FOR GUIDANCE ONLY. NOT AUTHENTICATED.

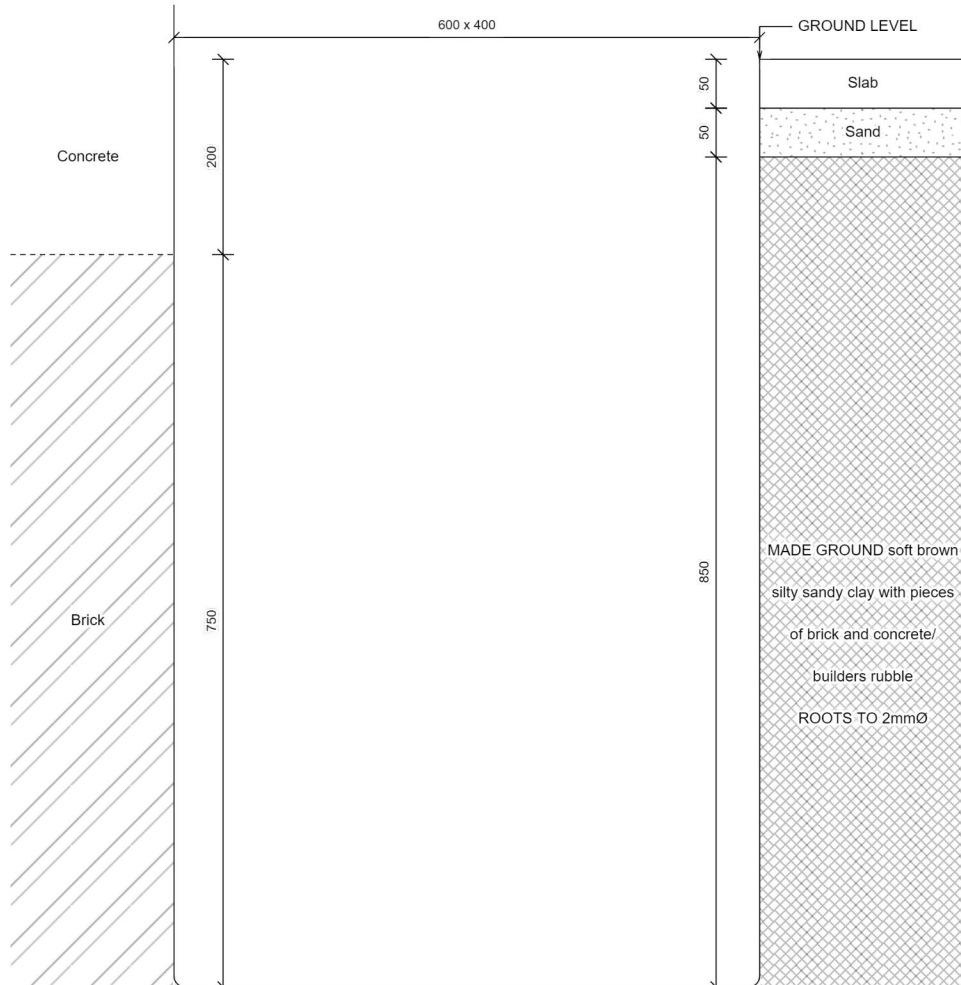
**TRIAL PIT REF:** TP1

For Strata below 950mm see Bore Hole log

U/S not found No samples taken tp abandoned at 950mm due to collapsing made ground. BH done to rear of tp to avoid made ground.
