# Arboricultural Appraisal Report

## Subsidence Damage Investigation at:

218 Finchley Road  
London  
NW3 6DH

CLIENT: Crawford & Company  
CLIENT REF: [REDACTED]  
MWA REF: [REDACTED]  
MWA CONSULTANT: Andy Clark  
REPORT DATE: 21/11/2023

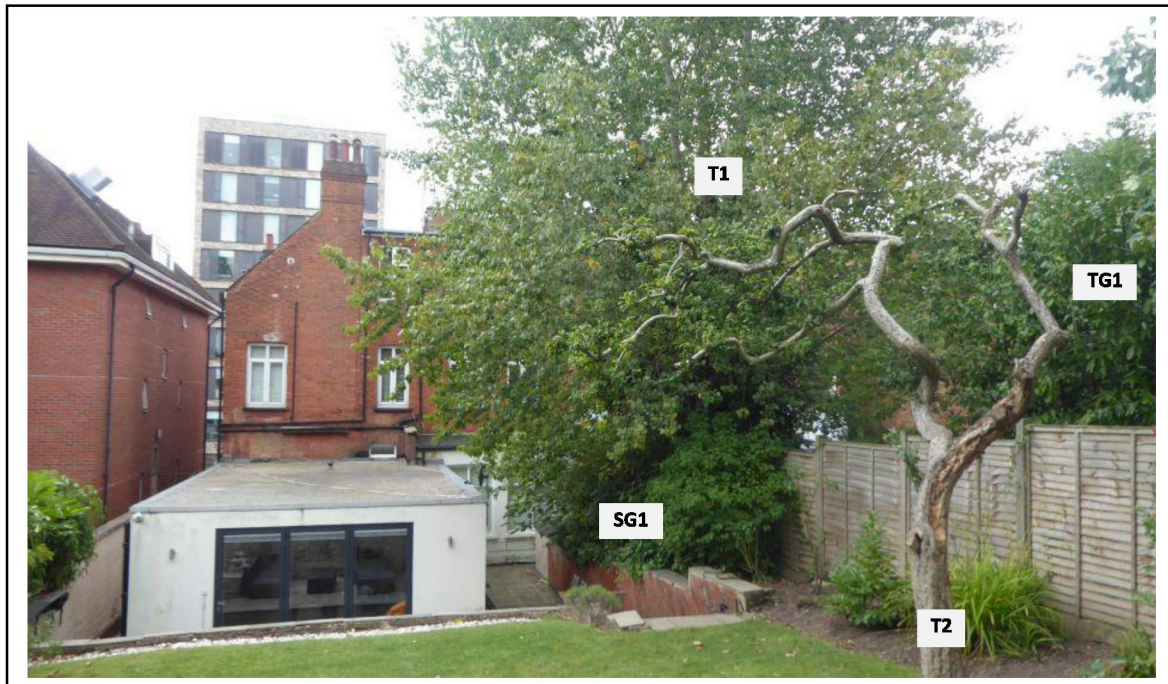
Roots were observed to a depth of 1.1m bgl in TP/BH1, and recovered samples have been positively identified (using anatomical analysis) as Salicaceae spp.; the origin of which will be T1 Poplar confirming its influence on the soils below the foundations at the rear of the building.

View of T1 Poplar with SG1 shrub group understorey and T2 Apple and TG1 group to foreground

Tree No.	Species	Ht (m)	Dia (mm)	Crown Spread (m)	Dist. to building (m)	Age Classification	Ownership
T1	Poplar	19.0	900 *	11.0	3.6	Older than extension(s)	Third Party 220 Finchley Road NW3 6DH
Management history		Subject to past management/pruning - previously heavily crown reduced/pollarded.					
Recommendation		Remove (fell) to near ground level and treat stump to inhibit regrowth.

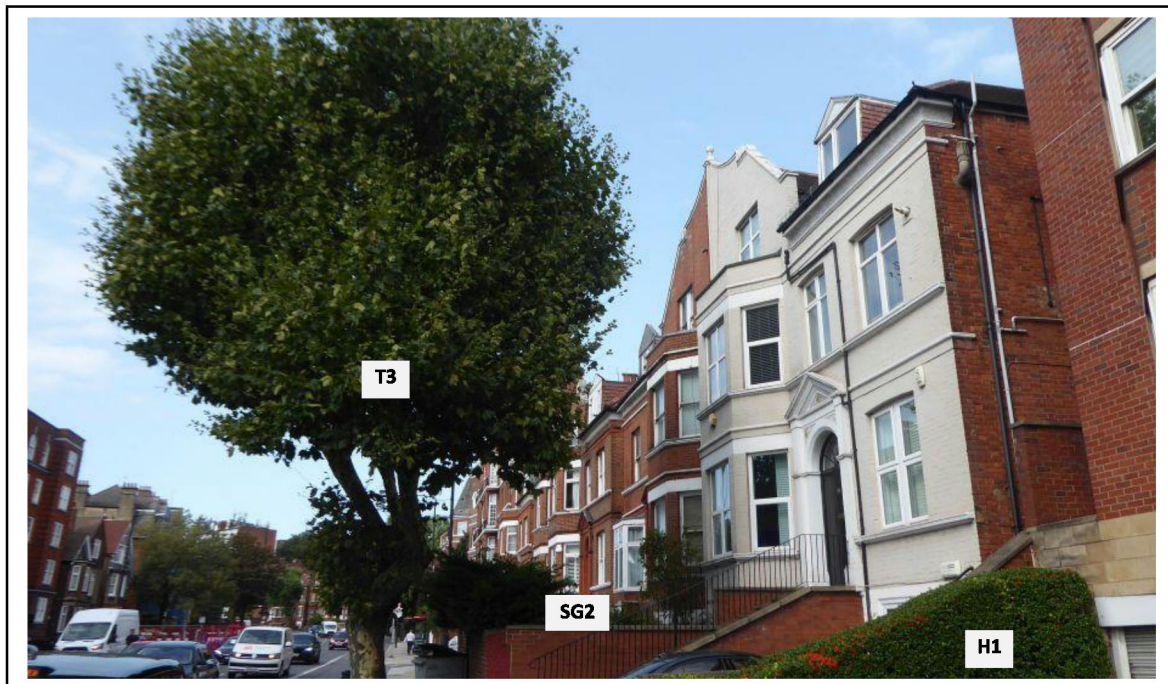
Level monitoring is in progress, with initial readings also showing movement to the front of the building. We are not aware of any damage affecting the property frontage, however readings suggest that T3 London Plane may be responsible.

View of T3 London Plane with SG2 shrub group

If an arboricultural solution is to be implemented to mitigate the influence of the implicated trees/vegetation we recommend that T1 Poplar is removed in the first instance. If movement persists, or if further evidence comes to light which confirms the involvement of T3 London Plane the management of this tree may need to be reviewed.
