# Site Investigation Report

Auger were commissioned by Allianz to undertake a site investigation and CCTV inspection of the underground drainage within the area of concern (AOC) at the property.

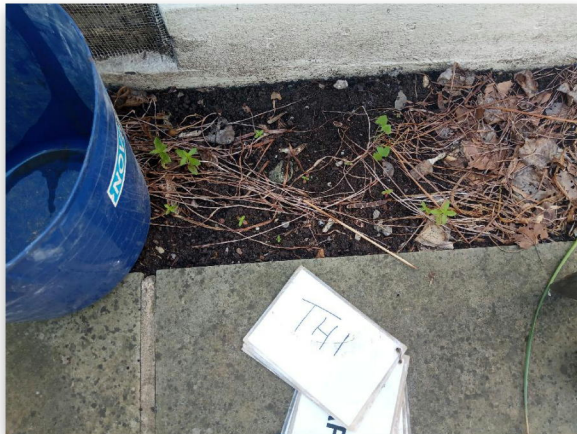
Fig 1.1: Trial Hole 1 Location

Within TH1 we revealed the footing but we were unable to reach the required because we hit refusal at 2.1m. The Trial Hole was excavated in the proposed location. We took soil and root samples. These measurements are shown in Trial Hole Log 1 below.

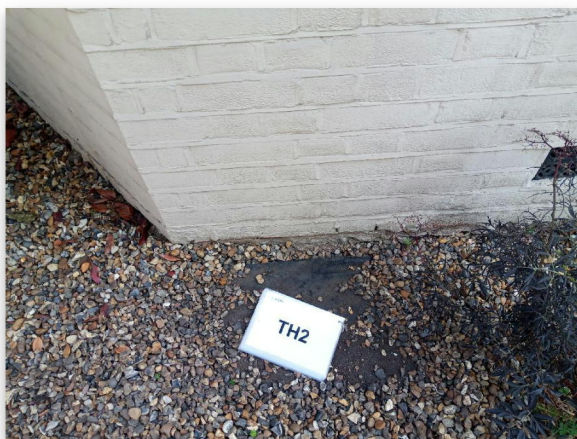
Fig 2.1: Trial Hole 2 Location

Within TH2 we revealed the footing and augered to the required depth (3m) in the proposed location. We took soil samples. We were unable to collect root samples from TH2 because no roots were present during the trial hole, hence no samples were retrieved. These measurements are shown in Trial Hole Log 2 below.

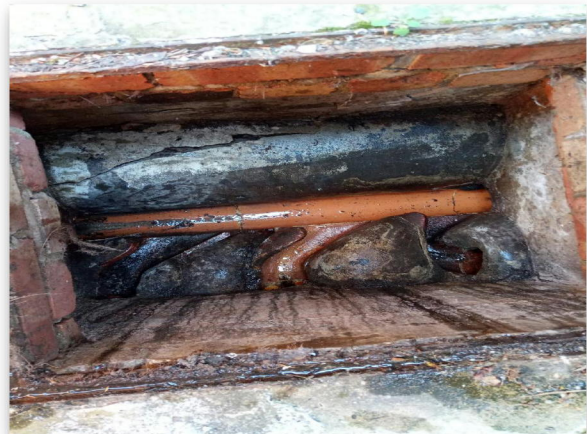
Fig 4.4: MH1

Our survey of line 3 revealed a minor crack at 1.42m.

The above mentioned defects to the below ground drainage system have been caused by ground movement.

Install a 100mm patch liner approximately 1.42m upstream of MH1.

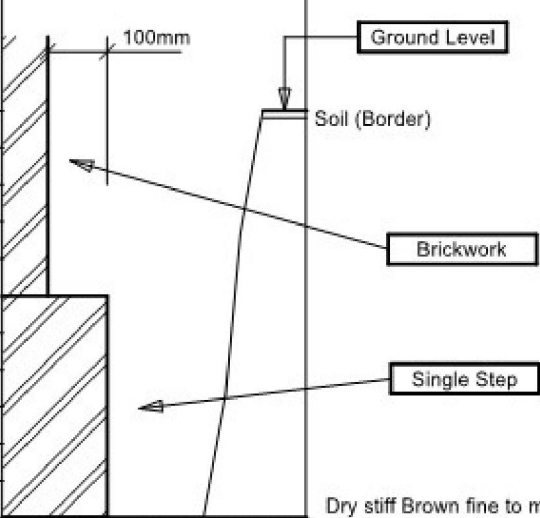
# Trial Hole Log No.1

Location: Rear single story

Ground Level				
0.5		Soil (Border)				
1.0		Brickwork				
1.5		Single Step				
2.0		Dry stiff Brown fine to medium gravelly silty CLAY	70kpa		Soil @ 1.1m	Root @ 1.1m
2.5			74kpa		Soil @ 1.6m	
3.0		TRIAL HOLE TERMINATED

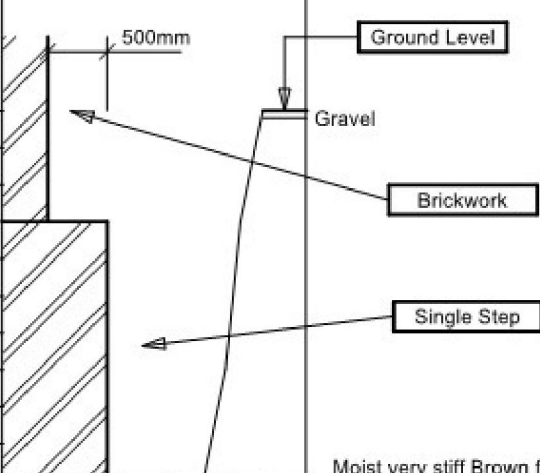
## Trial Hole Log No.2

Location: Front bay window

Ground Level				
		Gravel				
		Brickwork				
0.5		Single Step				
1.0		Moist very stiff Brown fine to medium gravelly silty CLAY	76kpa		Soil @ 1m	
1.5			80kpa		Soil @ 1.5m	
2.0			80kpa		Soil @ 2m	
2.5			84kpa		Soil @ 2.5m	
3.0		TRIAL HOLE TERMINATED	84kpa
