**26 Rosslyn Hill
London – NW3**

Partial Visual Survey
Boundary Wall Foundations

| Reference: | 1031-rep-002 | Checked by: | |

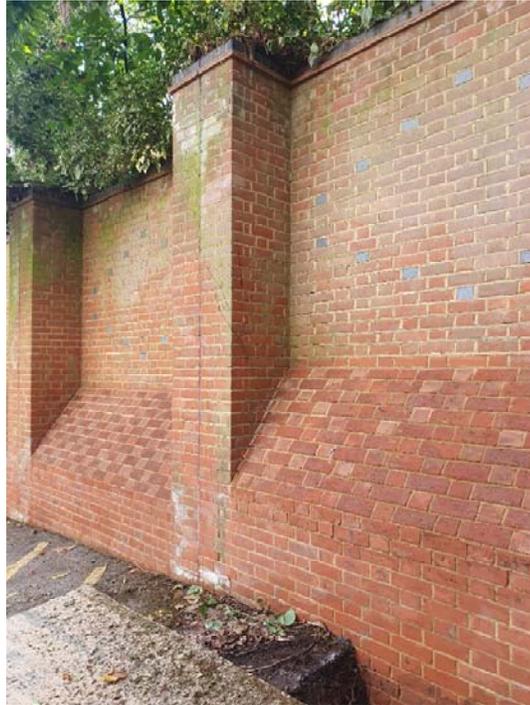
- The wall is a substantial brick construction given the required purposes.
- The wall appears to be in good condition with no sign of distress or structural damage.

Photo 1: Brick Garden Wall

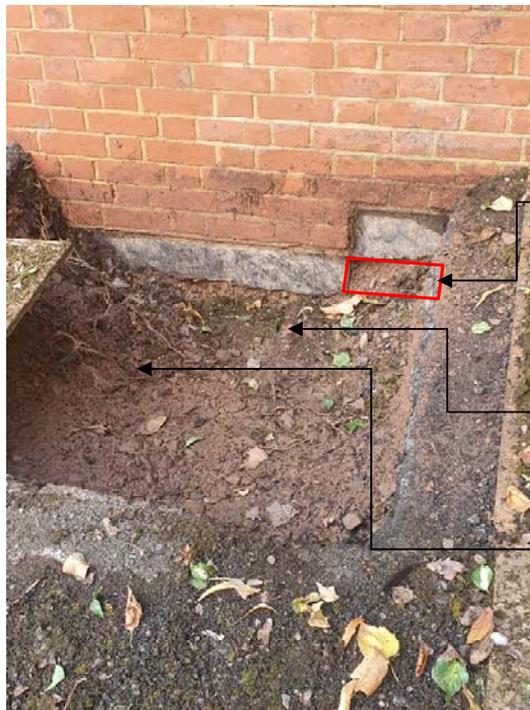
- No overlap has been installed at the step between the higher and lower level concrete footing (see Photo 2).
- Roots, including a large approximately 60 mm diameter root, below the foundations were noted in the trial pit. These roots appear to be from the plane tree on the other side of the wall on No 24 garden.

- The stepped foundations have been installed with no overlap at the change in level of the footing (see Photo 2). Consequently, there is a weak point at the step location and should ground movement occur, cracks could develop from this point.

No footing overlap
At step

60 mm diameter root
under footing

roots
under footing

Photo 2: Trial Pit - Wall Foundations

- A preventive measure to make the wall futureproof would be to increase the depth of the foundations and underpin the wall to such depths so that the bases of the underpins are outside the tree roots influence zone.

- In the view of high risk of potential structural damages, which could occur in the near future, we recommend that the wall is underpinned as described above at the earliest opportunity.

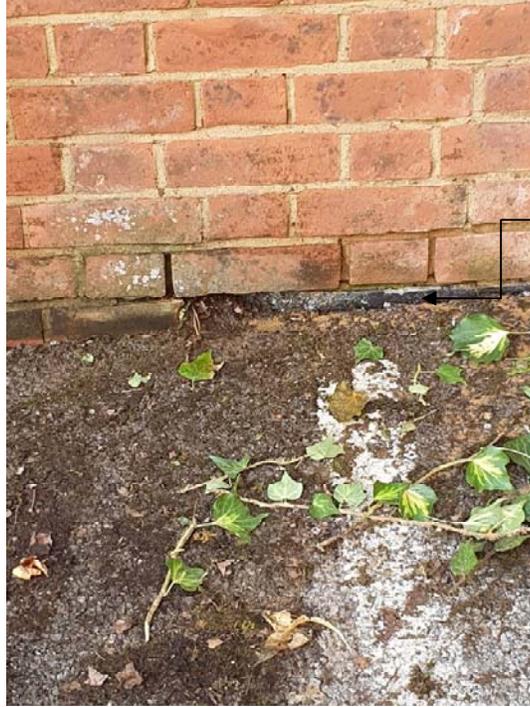
- At one location the step has been installed slightly above ground level (see Photo 3) and consequently the foundations formation level at this location is only 150 mm below ground level.

Concrete footing
above ground

Photo 3: Wall Foundations at or Above Ground Level

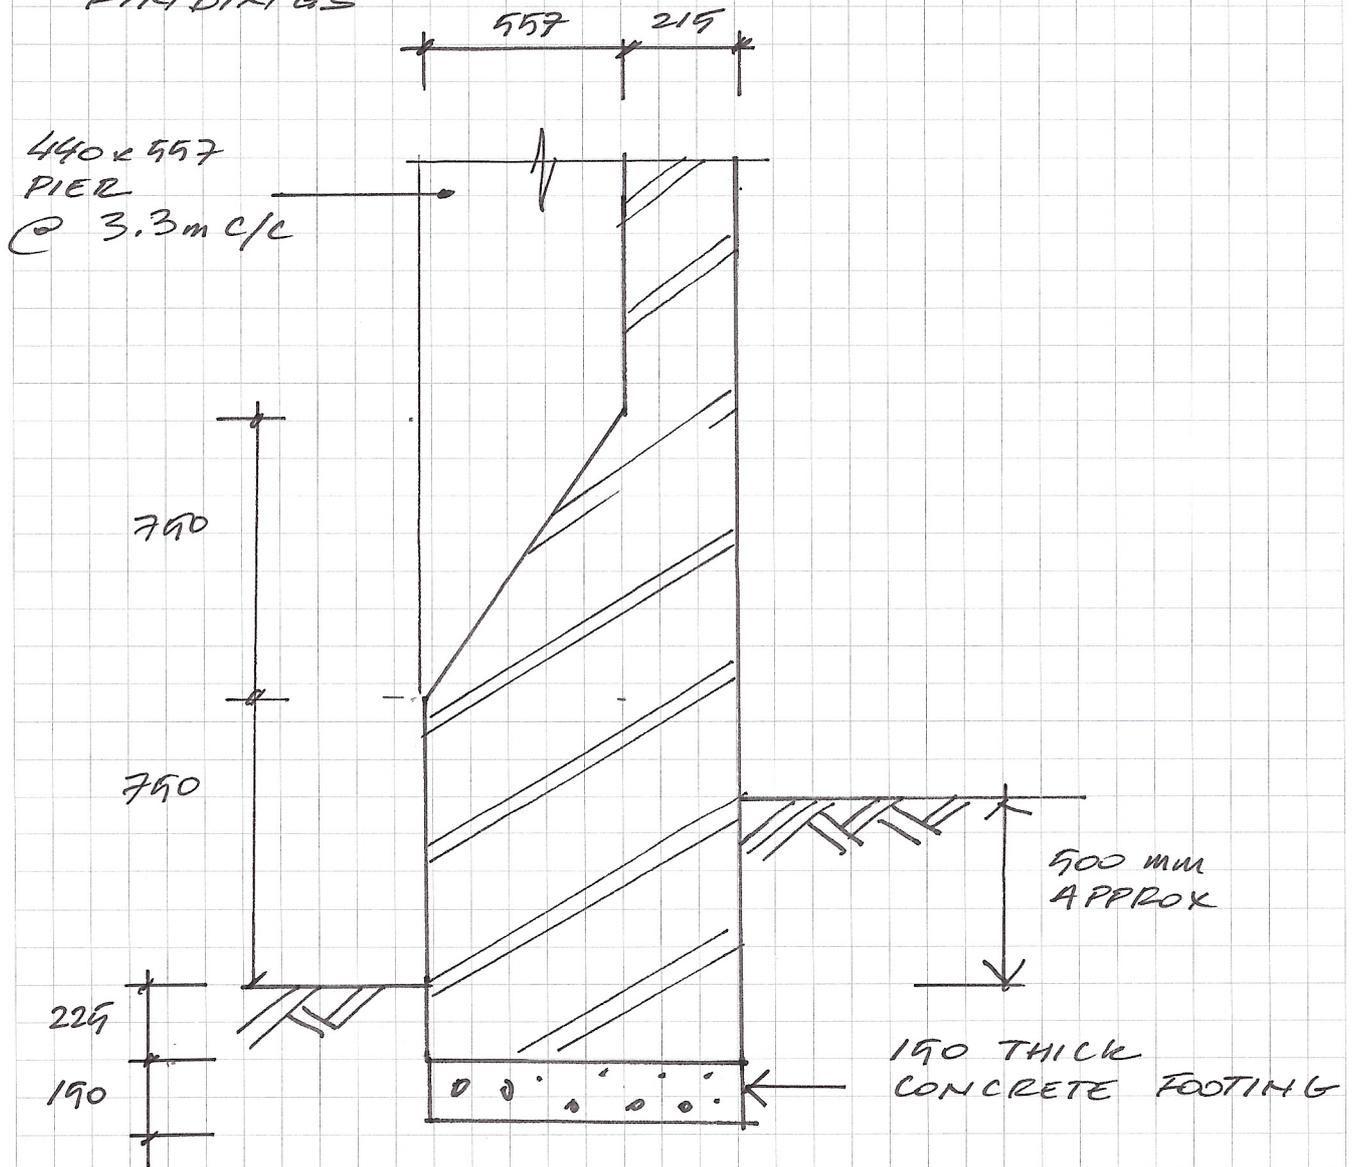
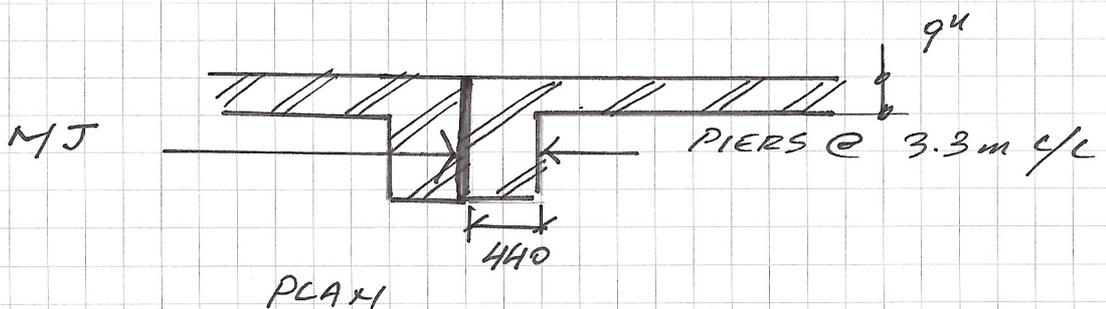
| Ref: | 1031-SK-230822-001 | Page: | |

- The boundary wall is a solid brick wall 1 brick thick (9") at the top and 675 mm thick at its base (see sketch 1031-SK-230822-001).
- 440 x 557 mm brick piers at 3.30 m c/c provide lateral stability to the wall.

- The wall foundations consist of a stepped concrete footing 150 mm thick only and typically 225 mm below ground level on No 26 sides.
- The substrata at foundations formation level consists of Clay soil.

FOUNDATION PROFILE
FROM TRIAL PIT
FINDINGS
