Writtle Forest Consultancy

Report	Further Investigation Report
Descriptor	A Further Investigation Report - including using Impulse Tomography testing and an aerial inspection to establish the structural condition of 1no. London Plane tree (<i>Platanus × hispanica</i>).
Address	British Museum Great Russell Street, London WC1B 3DG
Reference Number	240130
Client	British Museum Great Russell Street
Instructed	William Horton Capital Planning & Programme Management
Documents referenced	1. Tree Survey and Tree Constraints Plan Ref. 231005 2. Arboricultural Implication Assessment Ref. 231005 3. Arboricultural Method Statement Ref. 231005
Visited by	D. Riley & B. Yarwood
Date of Visit	12 th June 2024
Prepared	D. Riley
Reviewed	O. Booth
Date completed	June 2025

3.1 T8 – London Plane (*Platanus × hispanica*)

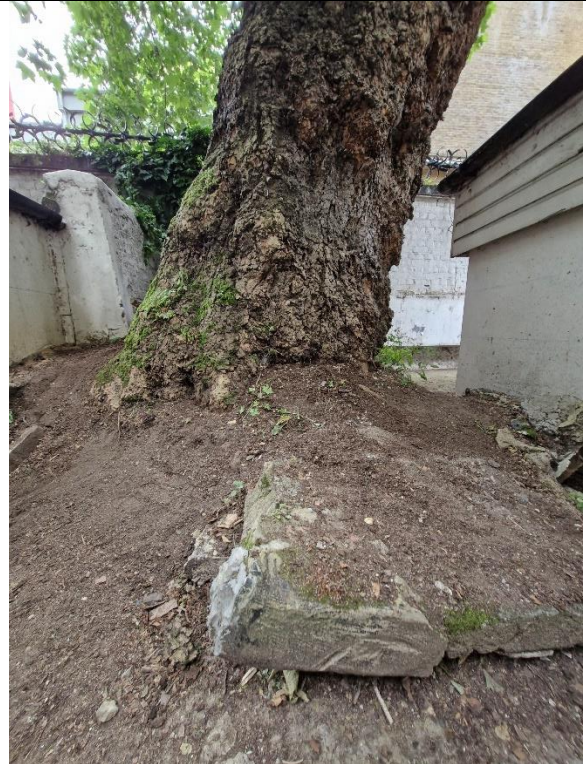
Photo 3: Showing limited exposed soils around the base of the main stem significant disruption to the concrete edging.

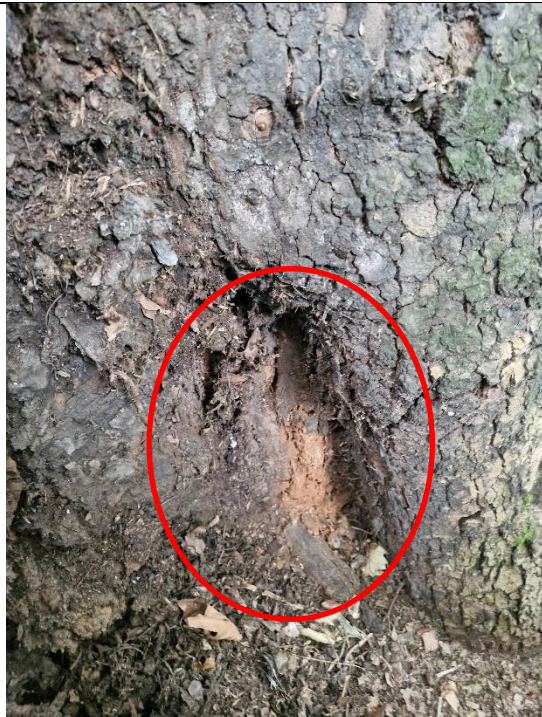
Photo 4: Showing area of decay observed at the base of the main stem to the north-east, highlighted in red.

The Visual Tree Inspection (VTA) revealed an area of decay at the base of the main stem to the north-east. As such, an Impulse Tomography test was conducted at 10cm above ground level. The results showed an small area of decay to the north-east which corresponds to the findings of the VTA, there also was a small central area of decay. (Figure 2). The associated strength loss of the cross section at 10cm above ground level is up to 7% (Figure 3).

Aspect of Management	Recommended Management	Timeframe
Works related to bio-mechanical structure:	Remove large diameter deadwood and dead Ivy. Reduce crown to a high pollard at a finishing height of approximately 12m and maintain on re-pollarding cycle of 5 to 7 years (dependent on rate of re-growth)	6 months all works
Further monitoring:	Carry out comparative Impulse Tomography and Resistance drills to ascertain if the decay is progressing or has stabilised within the base of the tree.	24 – 36 months

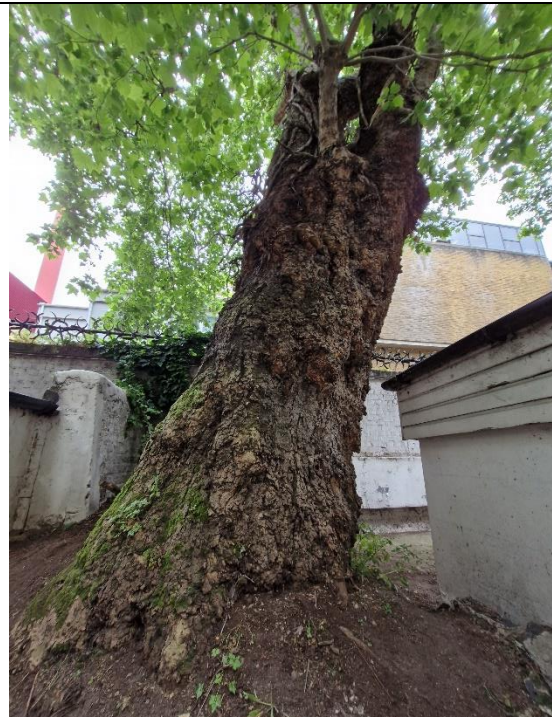
Photo 5: Showing the main stem with a moderate lean to the south.

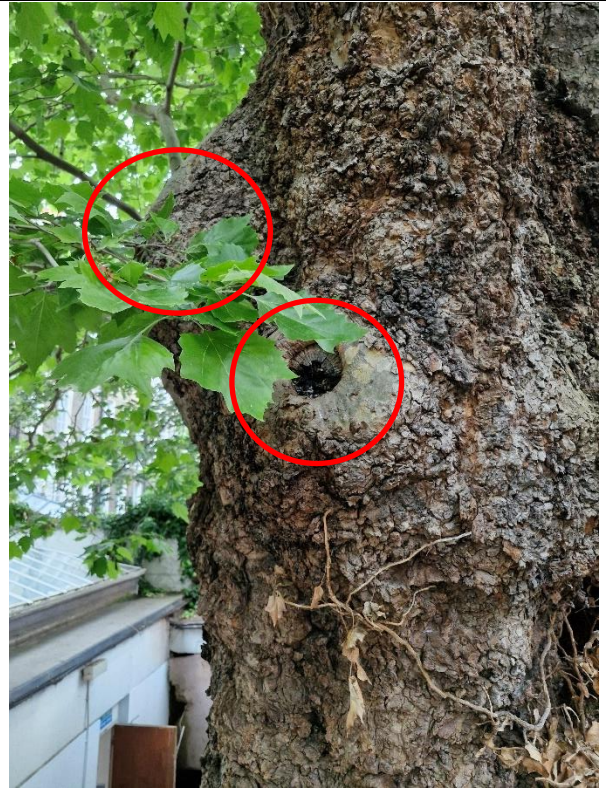
Photo 7: Showing location of 2no cavities formed from historical pruning wounds at 4 to 4.5m to the south and south-west, highlighted in red.

Further observation during the VTA were 2no. historical pruning wounds on the main stem at approximately 4m to the south and south-west. An aerial inspection was carried out which revealed cavities had formed in an area of an pruning wounds, adjacent to a main stem unions. 2no. resistance drills (Figure 4 and 5) were carried out to assess the extent of decay associated with the wounds.

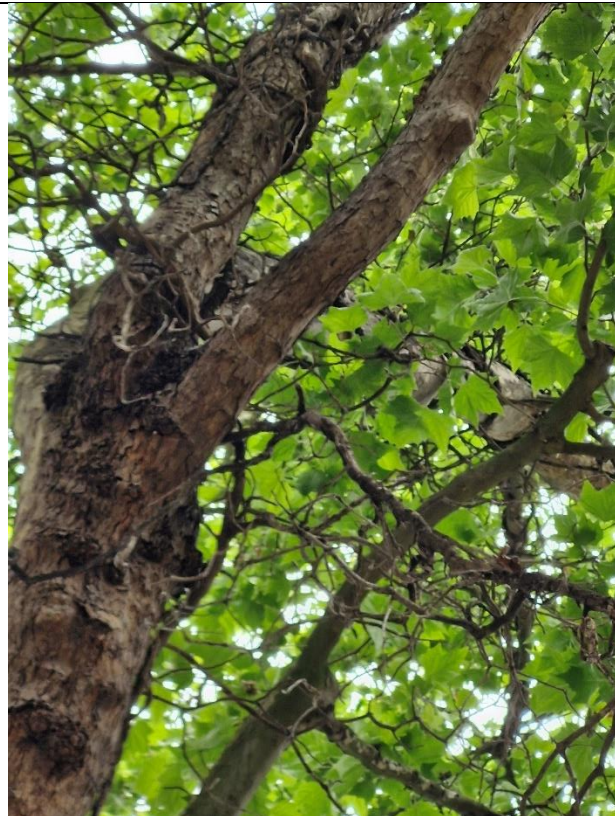
Photo 8: Showing dense inner foliage and dead Ivy encroaching within crown structure.

The aerial inspection of the crown structure carried out revealed no significant structural defects. This inspection was restricted due dense inner foliage and significant amount of dead lvy throughout the entire structure, the dead lvy will eventually fall out of the crown. This will presenting a potential risk to people below.

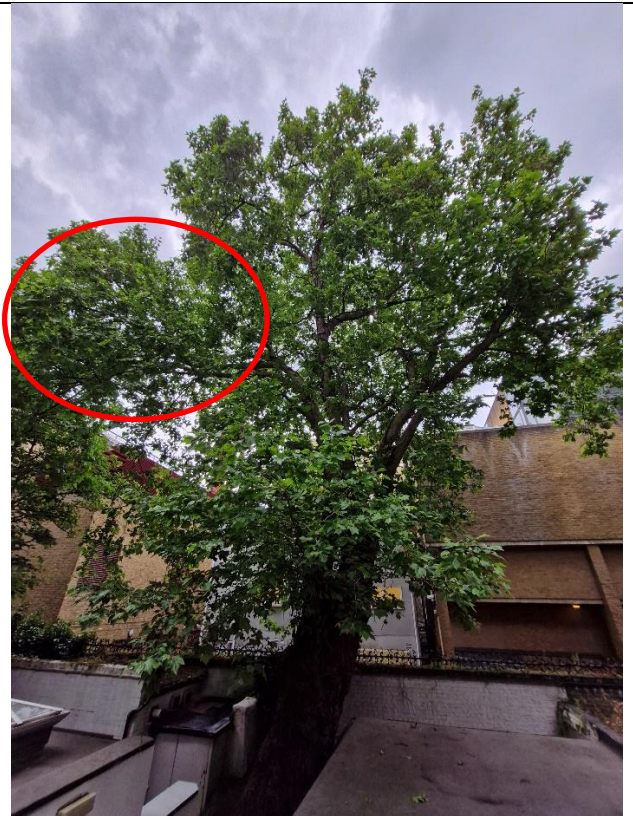
Photo 9: Showing over-extension of lateral growth to the north, highlighted in red.

One observation of the crown structure from a ground level inspection is that it is significantly over-extended to the north due to historical pruning to the east and south.

To this end it is considered prudent to manage the tree with a reduced size and stature. This may be achieved by managing the tree as of a high pollard on a cyclical pruning regime of 5 to 7 years. This is outlined below within the recommendations.

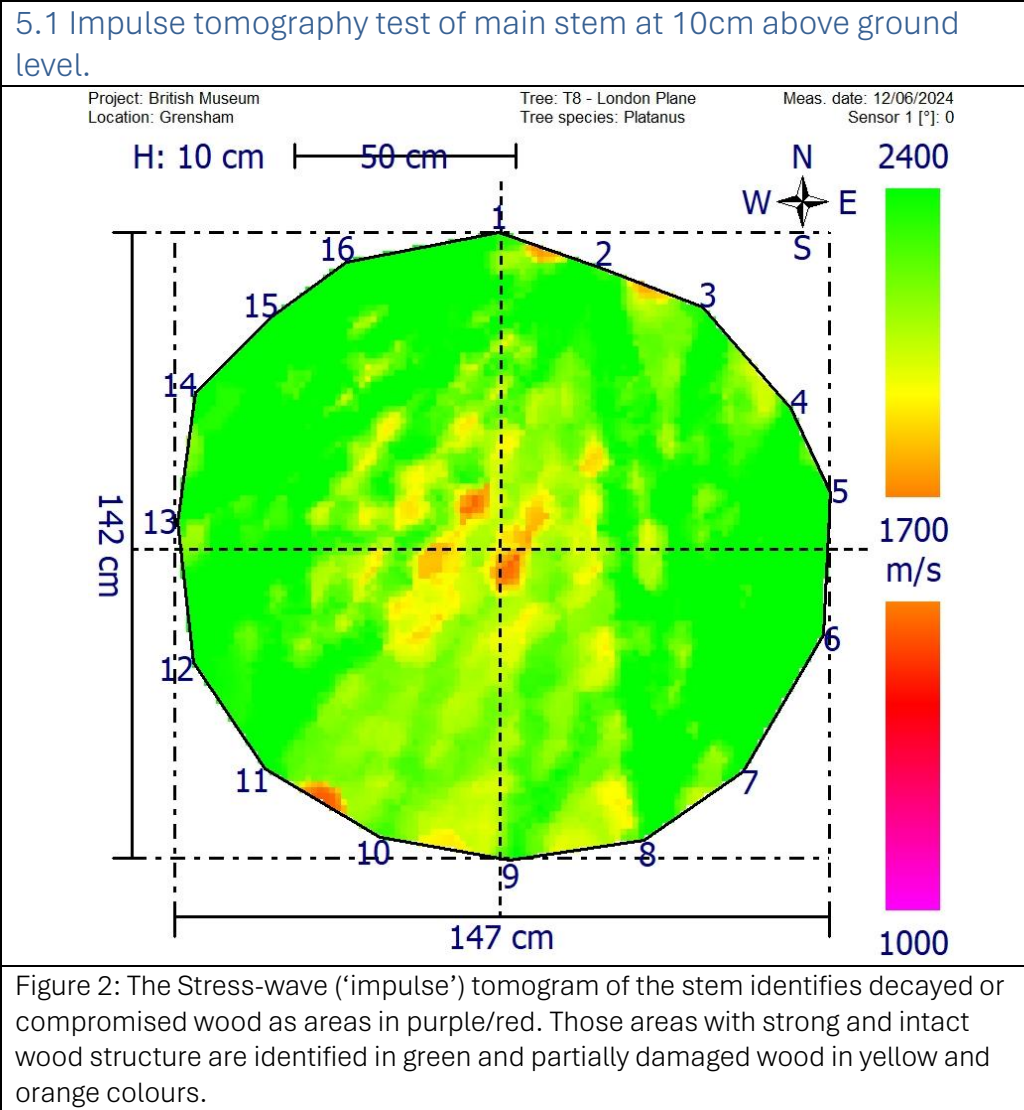
Figure 2: The Stress-wave ('impulse') tomogram of the stem identifies decayed or compromised wood as areas in purple/red. Those areas with strong and intact wood structure are identified in green and partially damaged wood in yellow and orange colours.

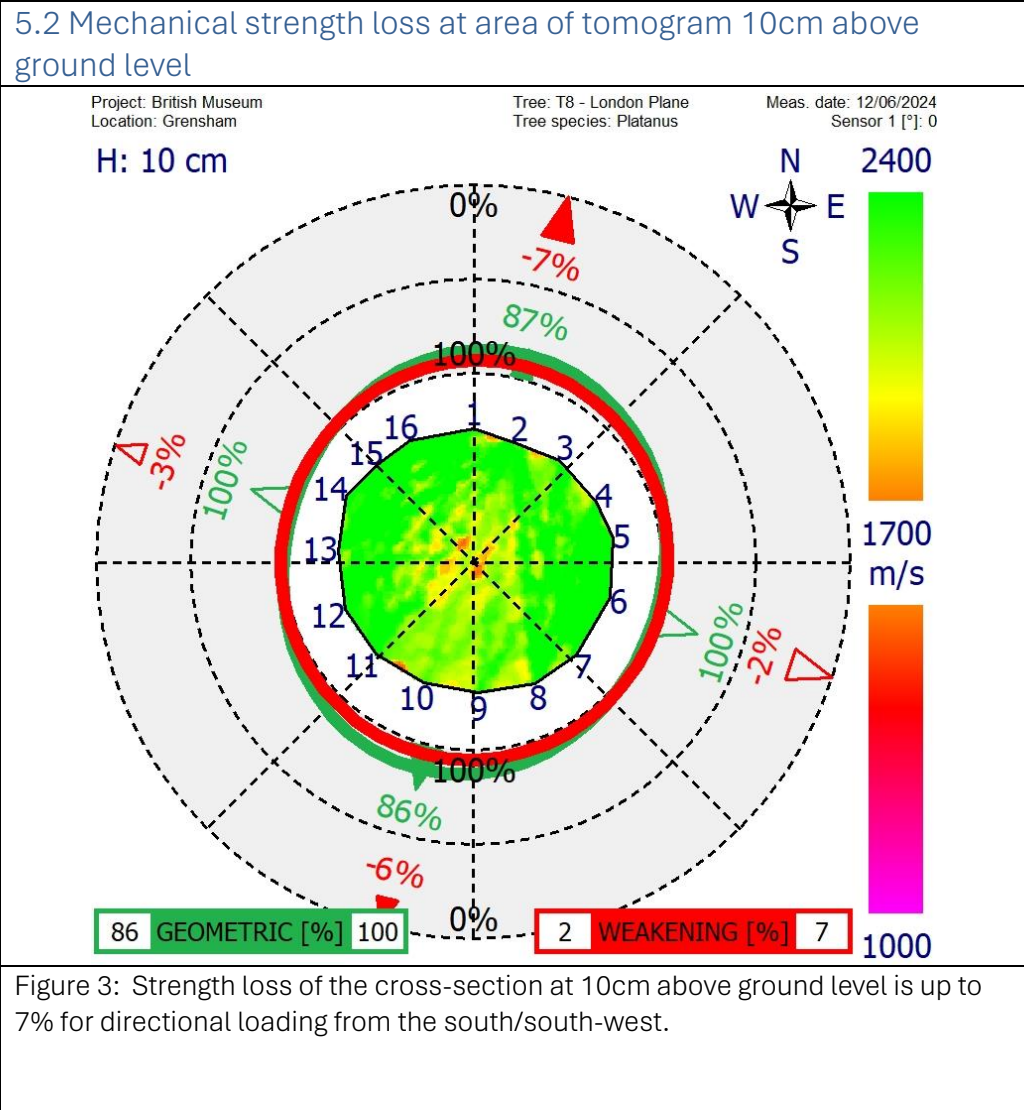
Figure 3: Strength loss of the cross-section at 10cm above ground level is up to 7% for directional loading from the south/south-west.

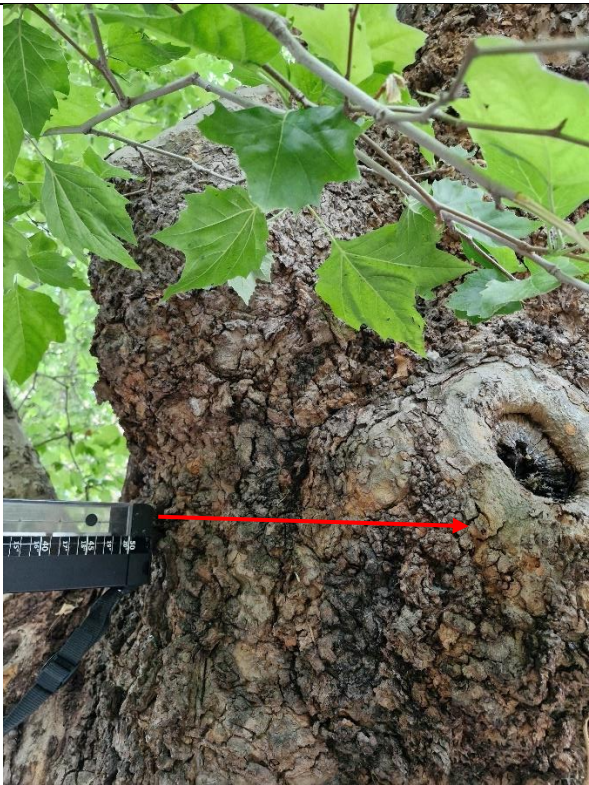
Photo 10: Showing location of resistance drill profile 1 carried out at 4m to the south-west, below the historical wound towards the centre of the stem. Approximate projection of drill shown by a red arrow.

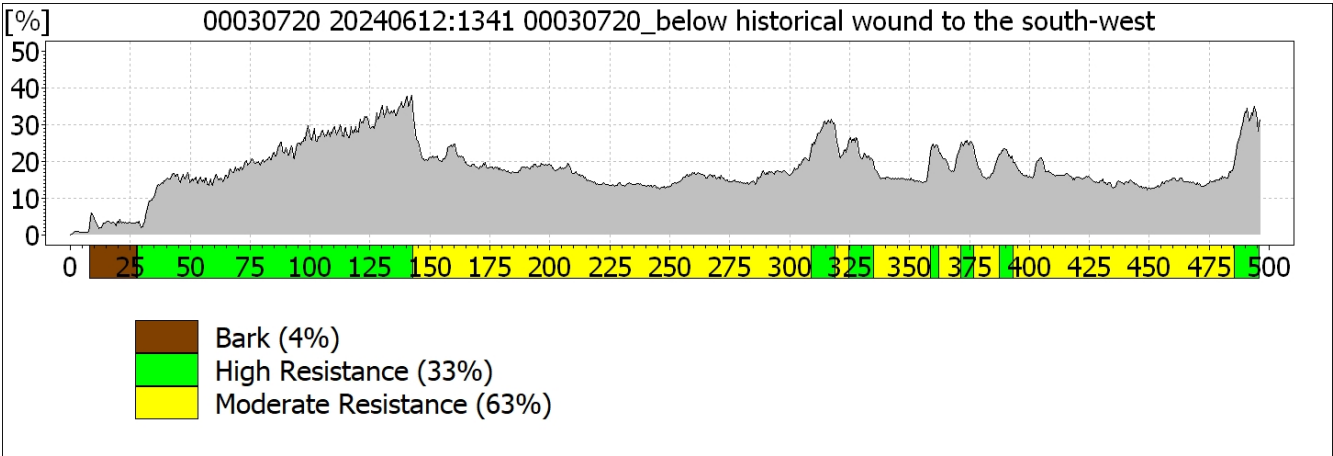
Figure 4: Resistance drill profile 1 records high resistance up to 14.5cm then an area of moderate resistance up to 48cm, several pockets of high resistance was recorded between 31cm to 39cm.

The resistance drills 1 (Figure 4) shows an area of moderate resistance from 14.5cm to approximately 31cm this is deemed to be the column of decay extending down from the historical pruning wound to the south-west. The drill then records a further area of decay extending from 33cm to 39cm this is considered to be the column of decay extending from the historical wound to the south. A further resistance drill 2 (Figure 5) was carried below the historical pruning wound to the south. The readings recorded high resistance for the majority of the test, with 2no. small areas of low resistance at 36cm and 41cm. Therefore, it is considered the decay from the 2no. wounds to be confined to the south-west of the stem, between the 2no. wounds and not currently progressed further into the stem to the south.

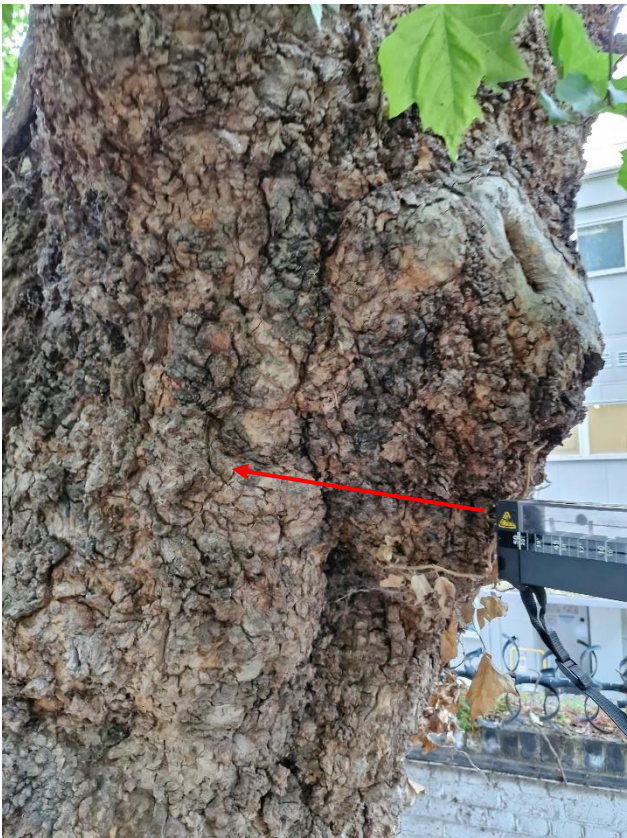
Photo 11: Showing location of resistance drill profile 2 carried out at 4m to the south, below the historical wound towards the centre of the stem. Approximate projection of drill shown by a red arrow.

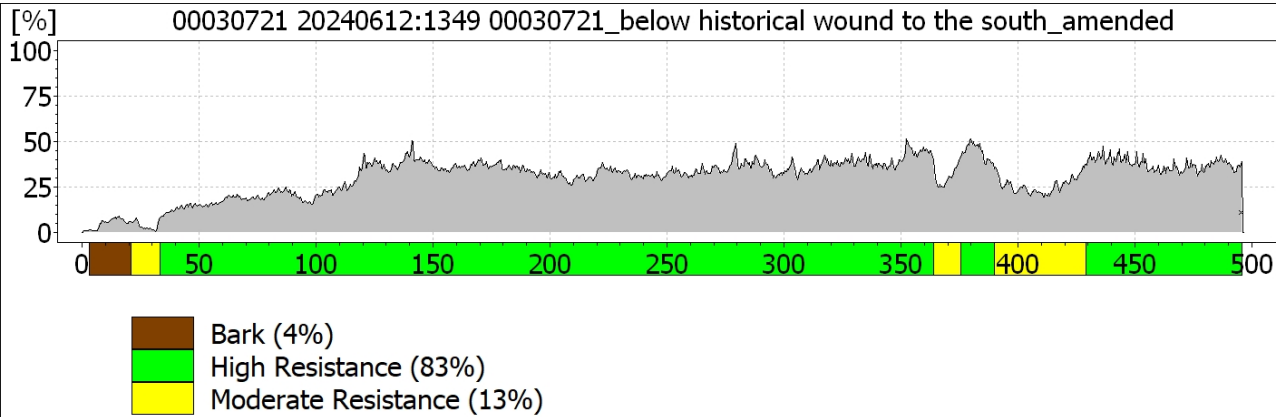
Figure 5: Resistance drill profile 2 recorded high resistance for the majority of the test, with 2no. small areas of low resistance at 36cm and 41cm.
