**Project 2185
21-23 Bedford Place**

Technical Note on Roof Structure

project manager	Jo Smith	26th September 2024
engineers	Jo Smith

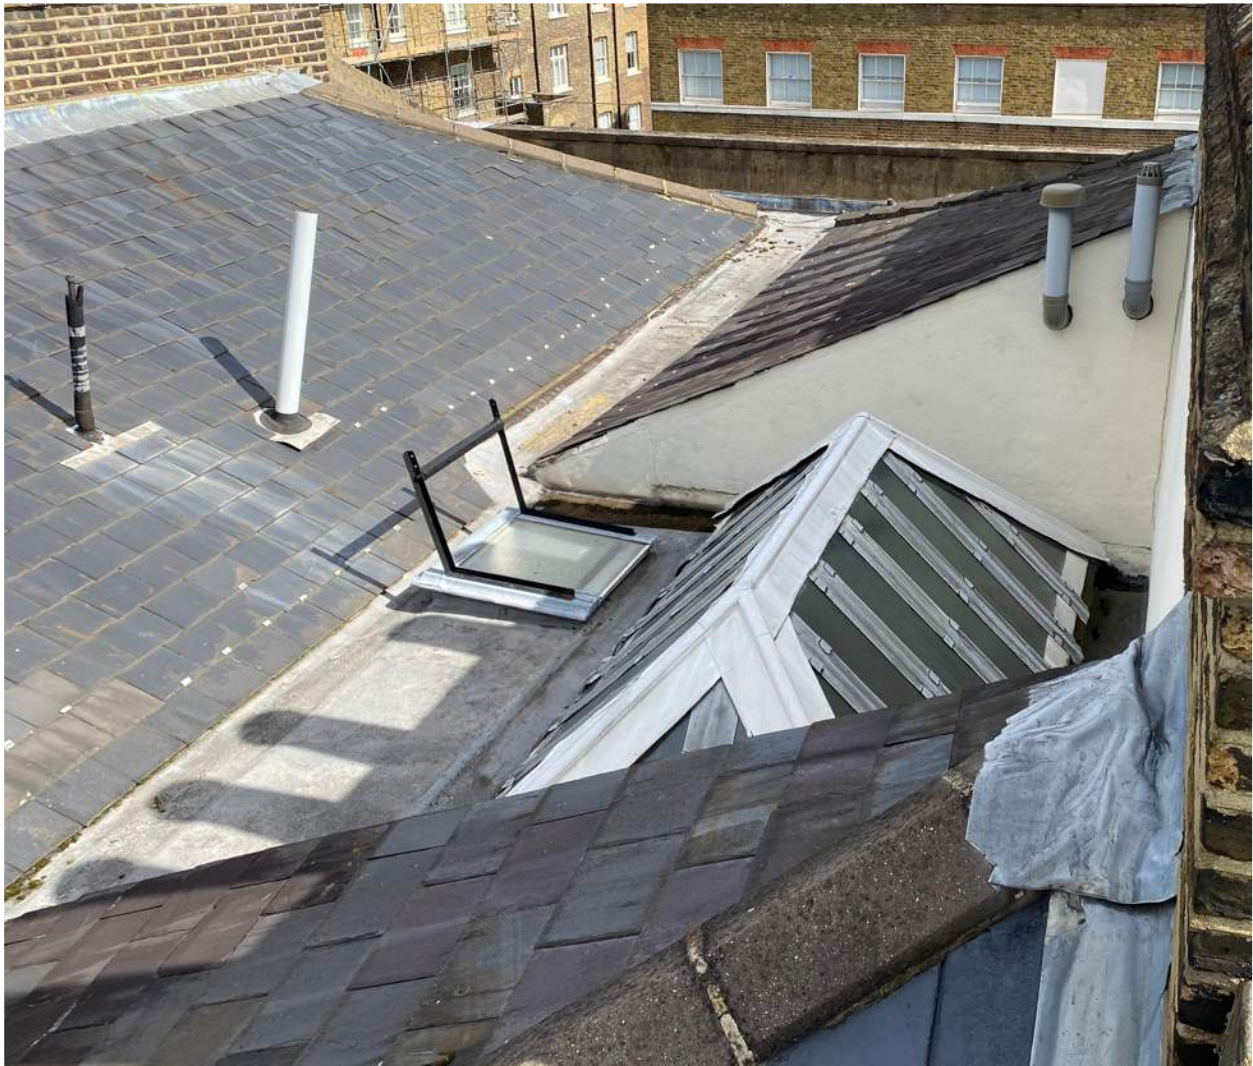
Fig 1: Typical Roof Arrangement (External)

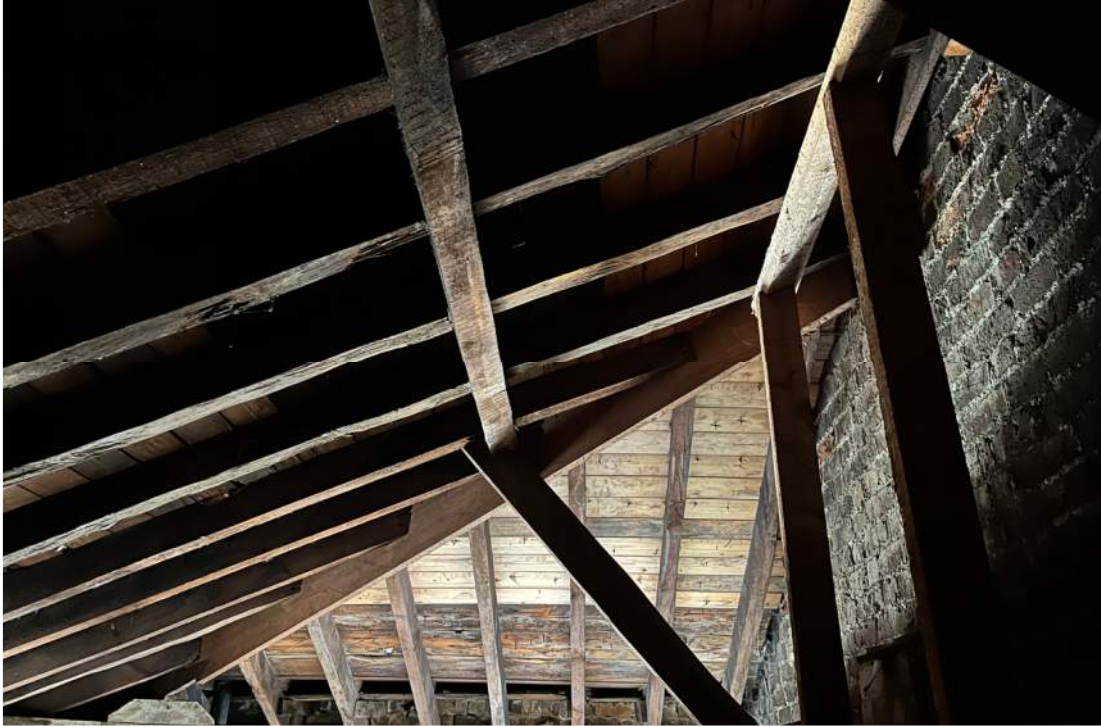
- 100mm deep rafters at approximately 360mm spacing spanning from the party walls to the central valley beam.
- 200mm deep hip members to form the front and rear roof lines.
- Timber purlins supporting the rafters were observed in some areas but not all.

Fig 2: Internal Roof Space showing Rafters, Hip Beam and Purlins

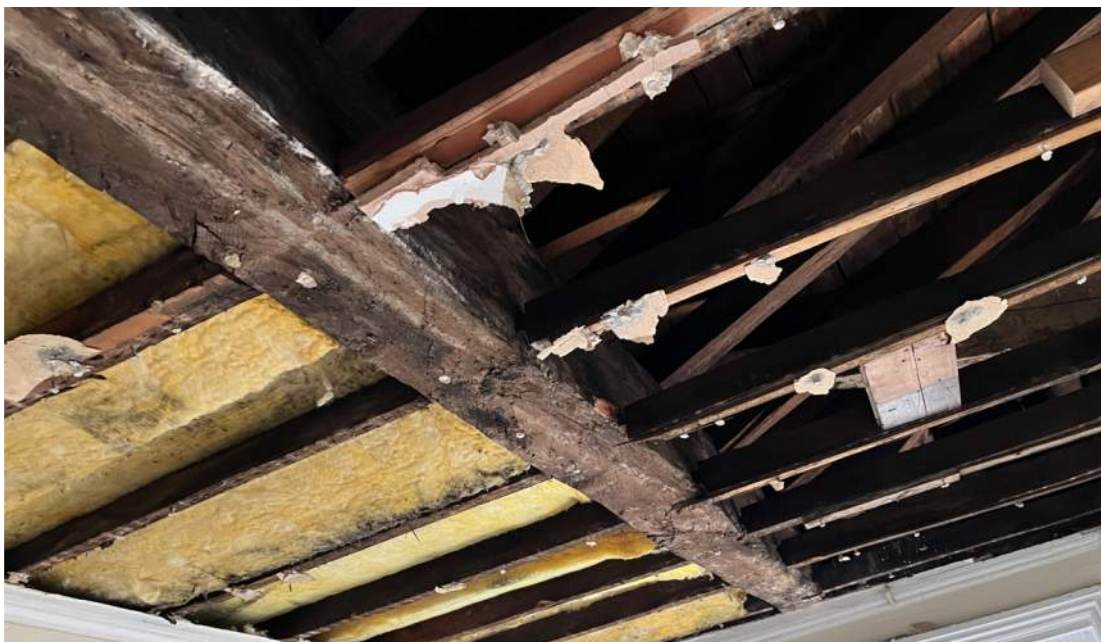
- 160mm wide x 250mm deep valley beams located on the centreline of the buildings.

Fig 3: Valley Beam showing Rafters and Ceiling Joists

- There is some indication of rot close to the ends of the valley beam in some locations where it is supported on the external wall.
- We have considered all timber to be of equivalent to C24 timber softwood grade. It is likely that the beams themselves are either Oak or Scots Pine given the age of the building. The C24 assumption is conservative.

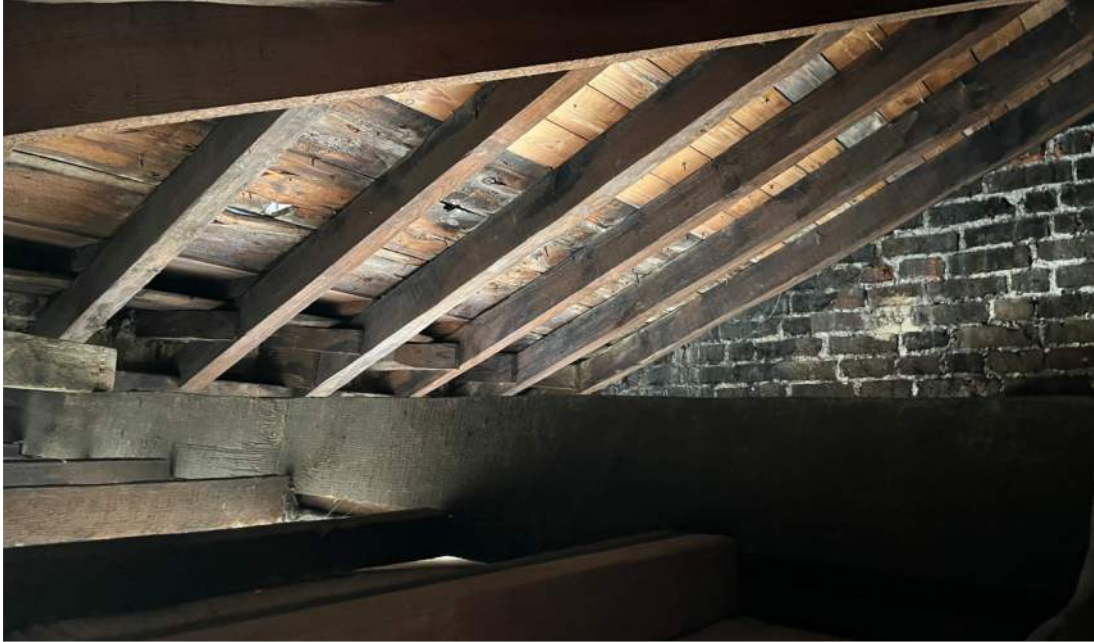
- 32mm wide x 70mm deep ceiling joists span between the party walls and the valley beams with an additional intermediate beam spanning front to back. This is picked up on the stair walls on that side of the valley beam but has no clear line of support on the opposite side of the valley beam.

Fig 4: Inside of Roof showing Rafters, Hip Beam and Intermediate Ceiling Support Beam

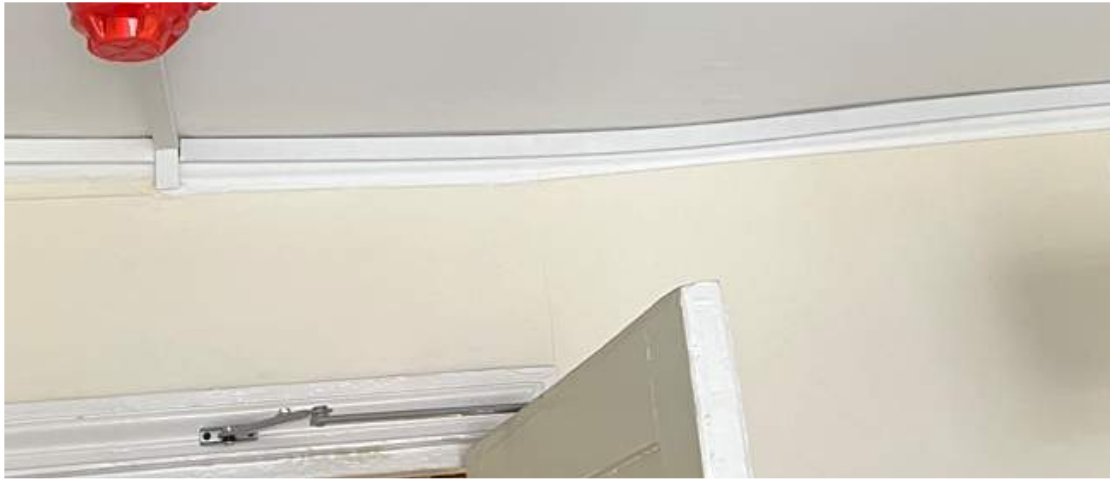
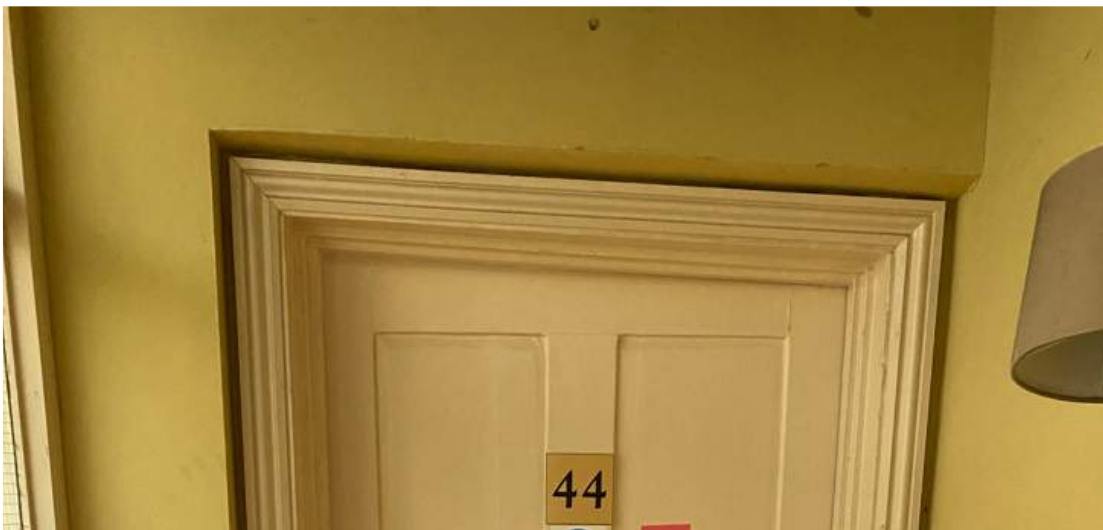
- There are signs that the valley beam has settled over time to be supported on the cross partitions within the third floor creating unintended load paths further down the building. It is clear that this was not the original intent as the partitions are showing signs of deformation.

Fig 5: Examples of Deformed Partitions below Valley Beams

- The valley beams are undersized for the larger spans for both the original and current condition. This presents itself as both visible deflection and deformation of both original and more contemporary partitions below creating unintended load paths down the building.
- When considered as a single span front to back, the valley beam exceeds the capacity for bending stress, shear stress, compressive stress and deflection. The bending stress is around 8 times its capacity.

- Based on the above, additional supports will be required to pick up the valley beam at intermediate points. The best option for this will be at the stair walls by inserting cross beams to span between the stair wall and the party walls. These beams have been sized as 203UC sections – refer to appendix B for proposed arrangement.

- Prop the valley beam to enable the strengthening works.
- Expose the full length of the valley beams from below to allow inspection of the full extent for any areas of decay or rot.
- Remove rafters to allow for strengthening
- Repair any decayed sections using a Rotafix detail in line with the manufacturers recommendations.
- Cut the existing valley beam to allow the insertion of the new trimming beams. The intermediate ceiling joist support beam will also need to be cut to suit.
- Install strengthening channels either side of the valley beams as shown on enclosed details
- Remove temporary propping.
- Replace existing rafters and ceiling joists alongside new timber members if/where required.

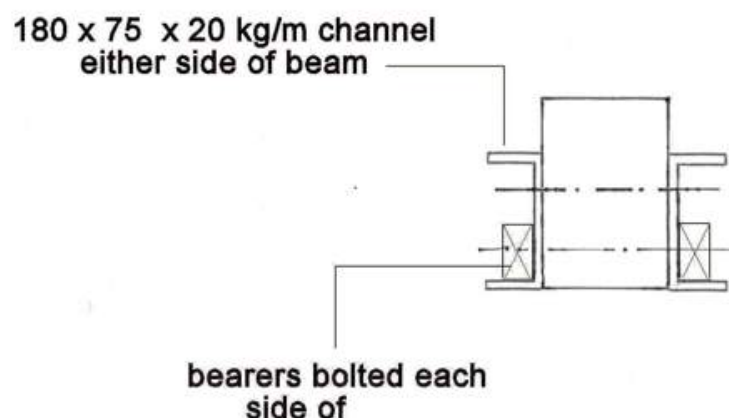
- When considering the 3 separate spans, the valley beam would still exceed capacity for bending stress, shear stress, compressive stress and deflection on span 3 but to a much lesser degree. The bending stress is now 2.6 times the capacity for this span. Span 2 exceeds the deflection requirements but is within stress limits.

- As such, the valley beam will also need to be strengthened as well. We consider it prudent, given the age of the valley beam to strengthen all three spans to future proof the beam rather than just the two spans which exceed capacity.

Fig 7: Proposed Strengthening of Valley Beam

- A timber specialist has been contacted and they have advised that the below arrangement would be appropriate in the circumstances and that this could be installed in a safe and heritage appropriate manner.

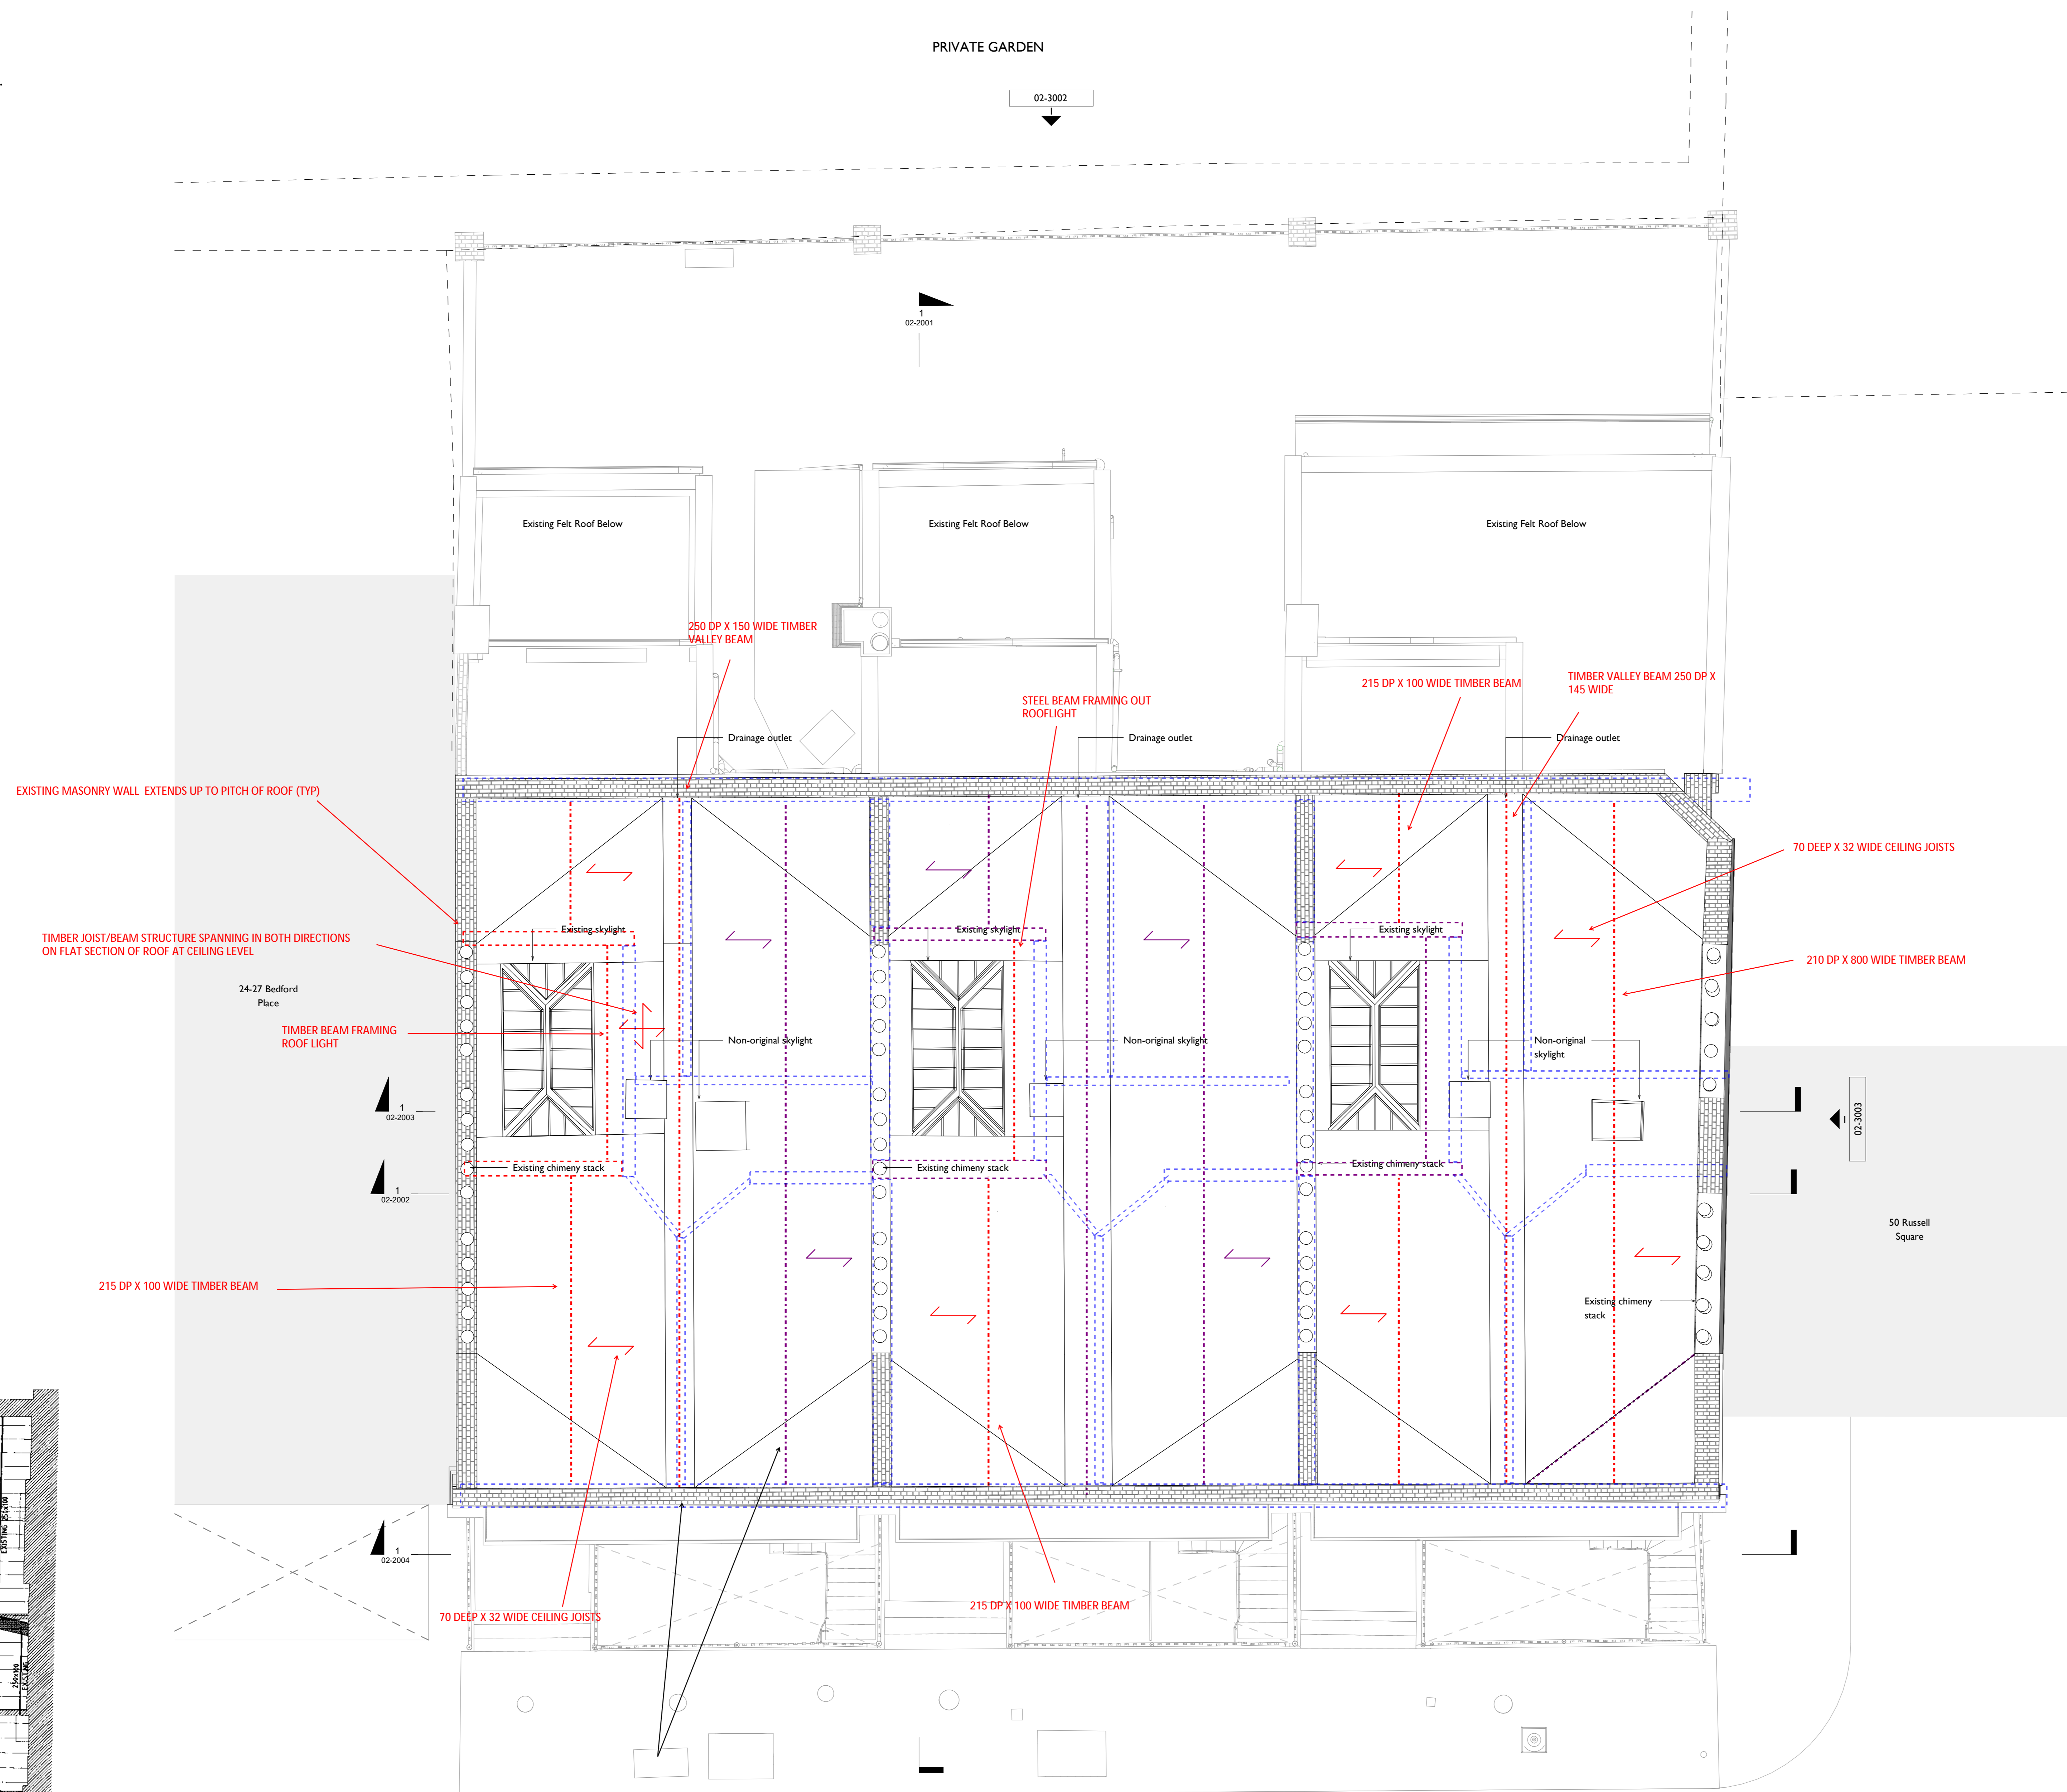
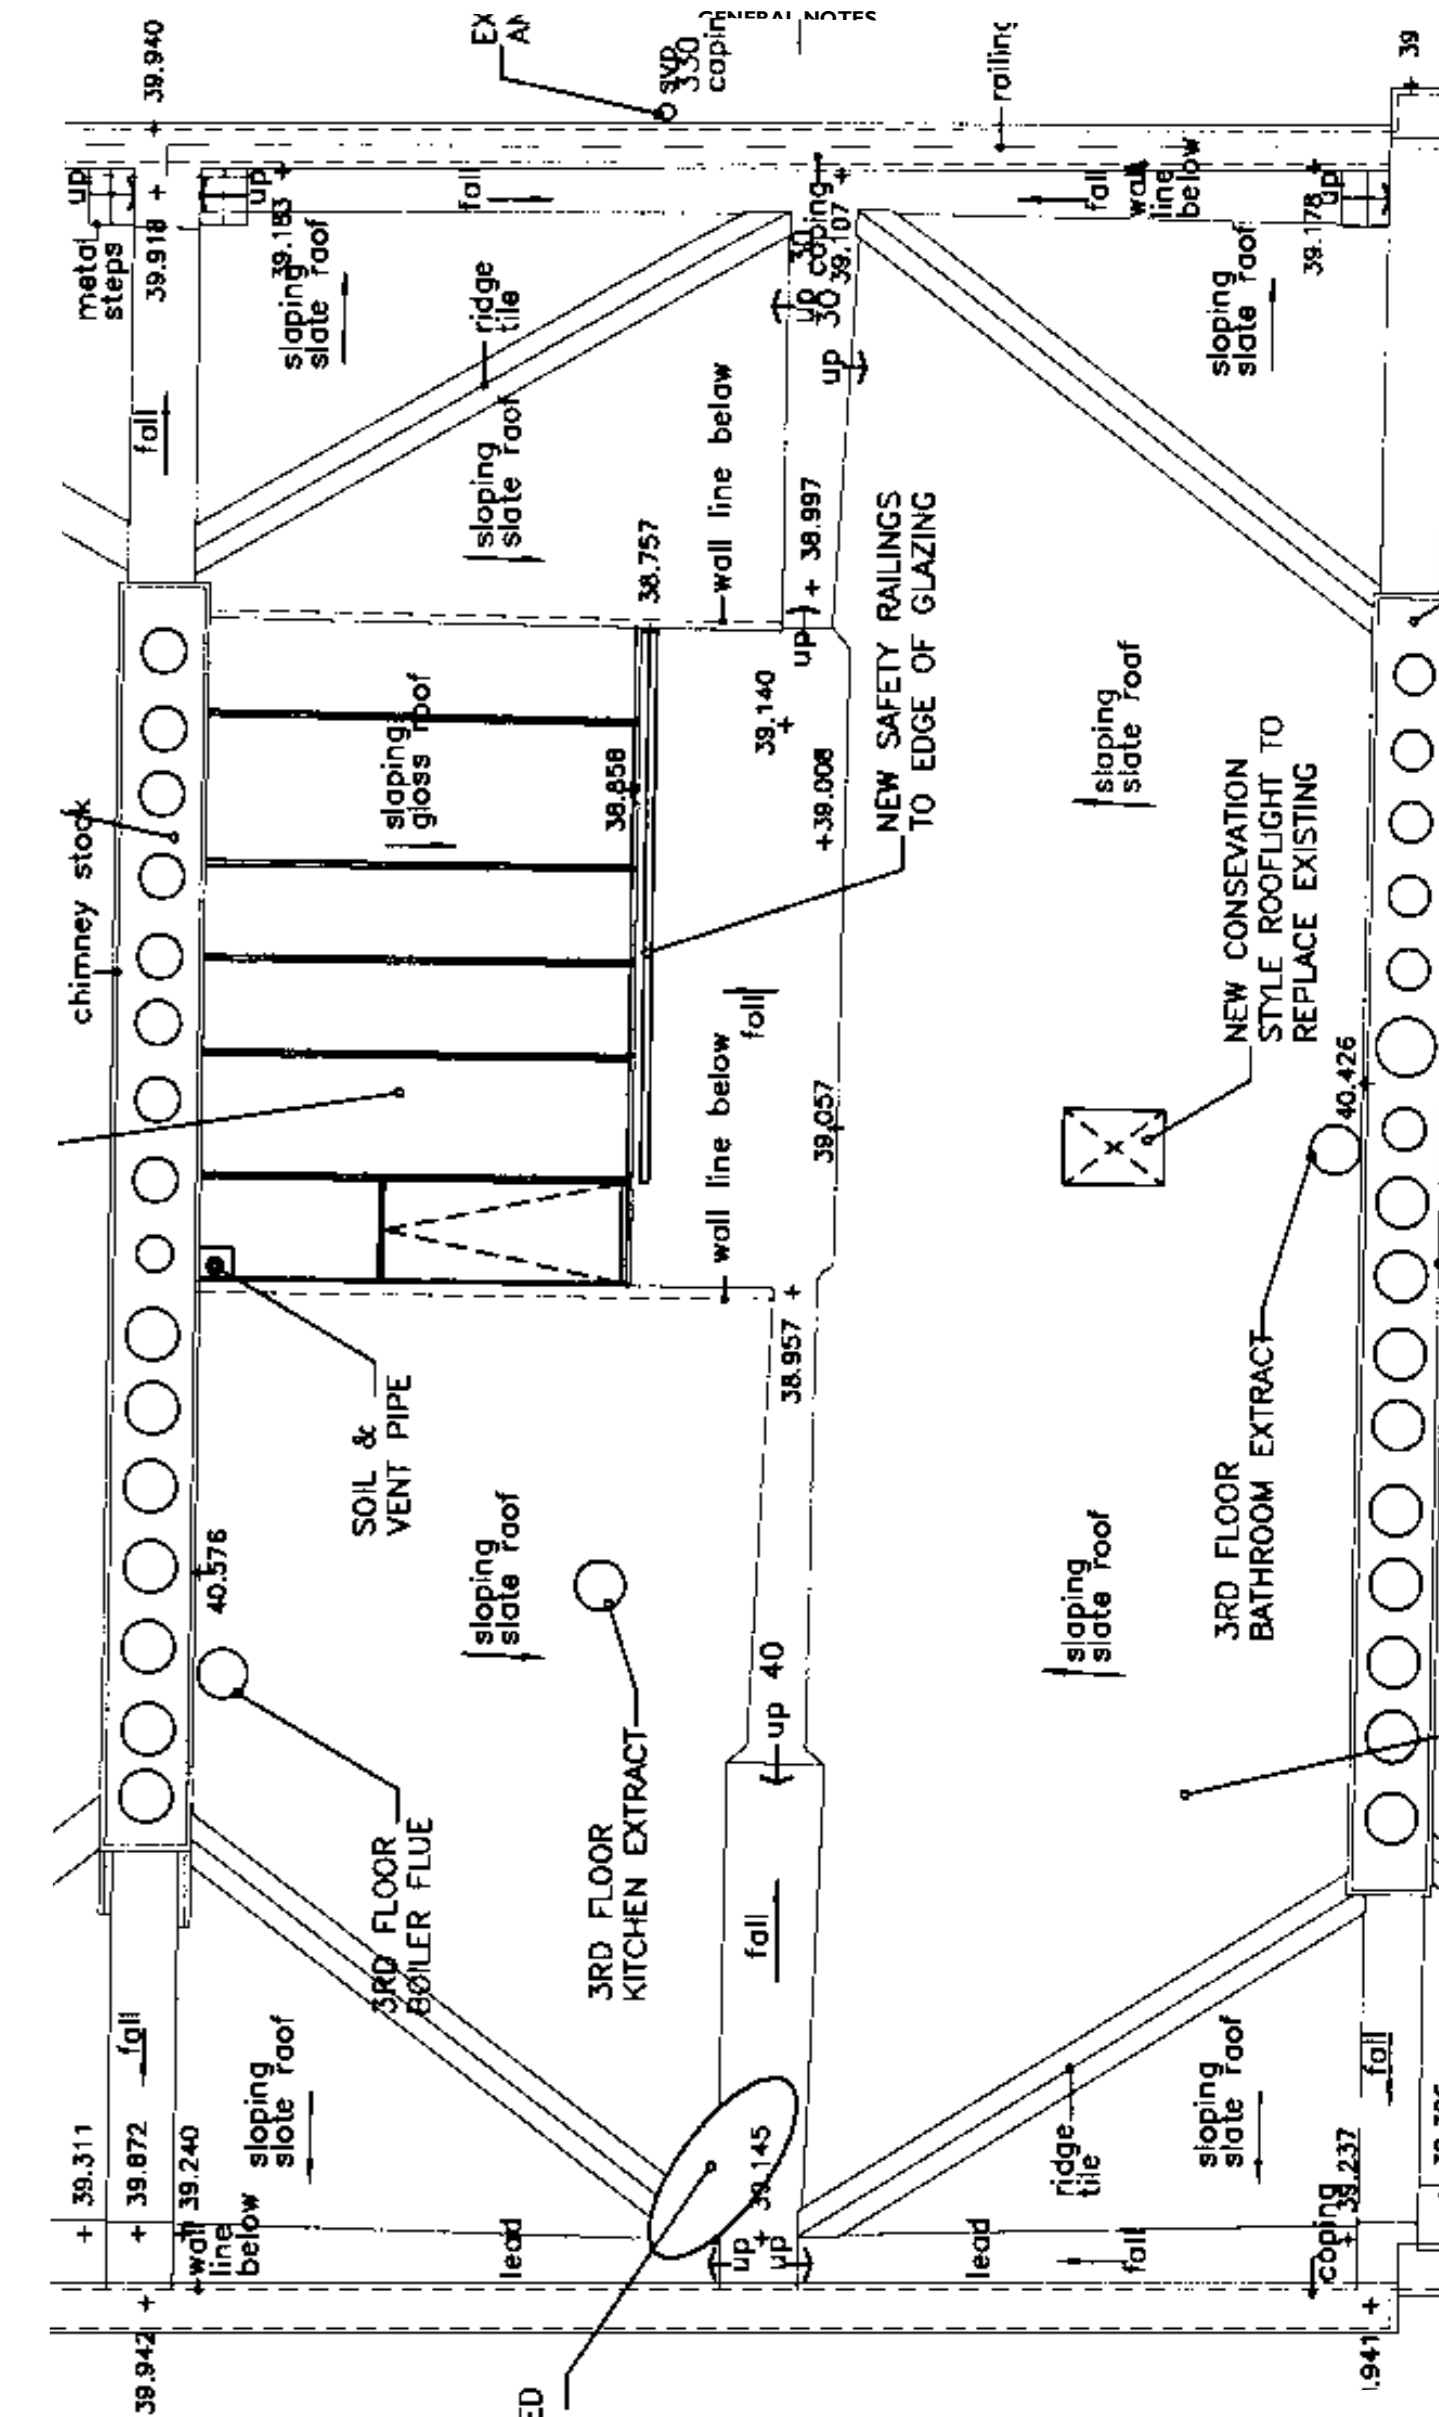
ORIGINAL STRUCTURAL LAYOUT AT 38 BEDFORD PLACE

- EXISTING MASONRY WALL EXTENDS UP TO PITCH OF ROOF (TYP)
- TIMBER JOIST/BEAM STRUCTURE SPANNING IN BOTH DIRECTIONS ON FLAT SECTION OF ROOF AT CEILING LEVEL
- TIMBER BEAM FRAMING ROOF LIGHT
- 250 DP X 150 WIDE TIMBER VALLEY BEAM
- STEEL BEAM FRAMING OUT ROOFLIGHT
- 215 DP X 100 WIDE TIMBER BEAM
- TIMBER VALLEY BEAM 250 DP X 145 WIDE
- 70 DEEP X 32 WIDE CEILING JOISTS
- 210 DP X 800 WIDE TIMBER BEAM

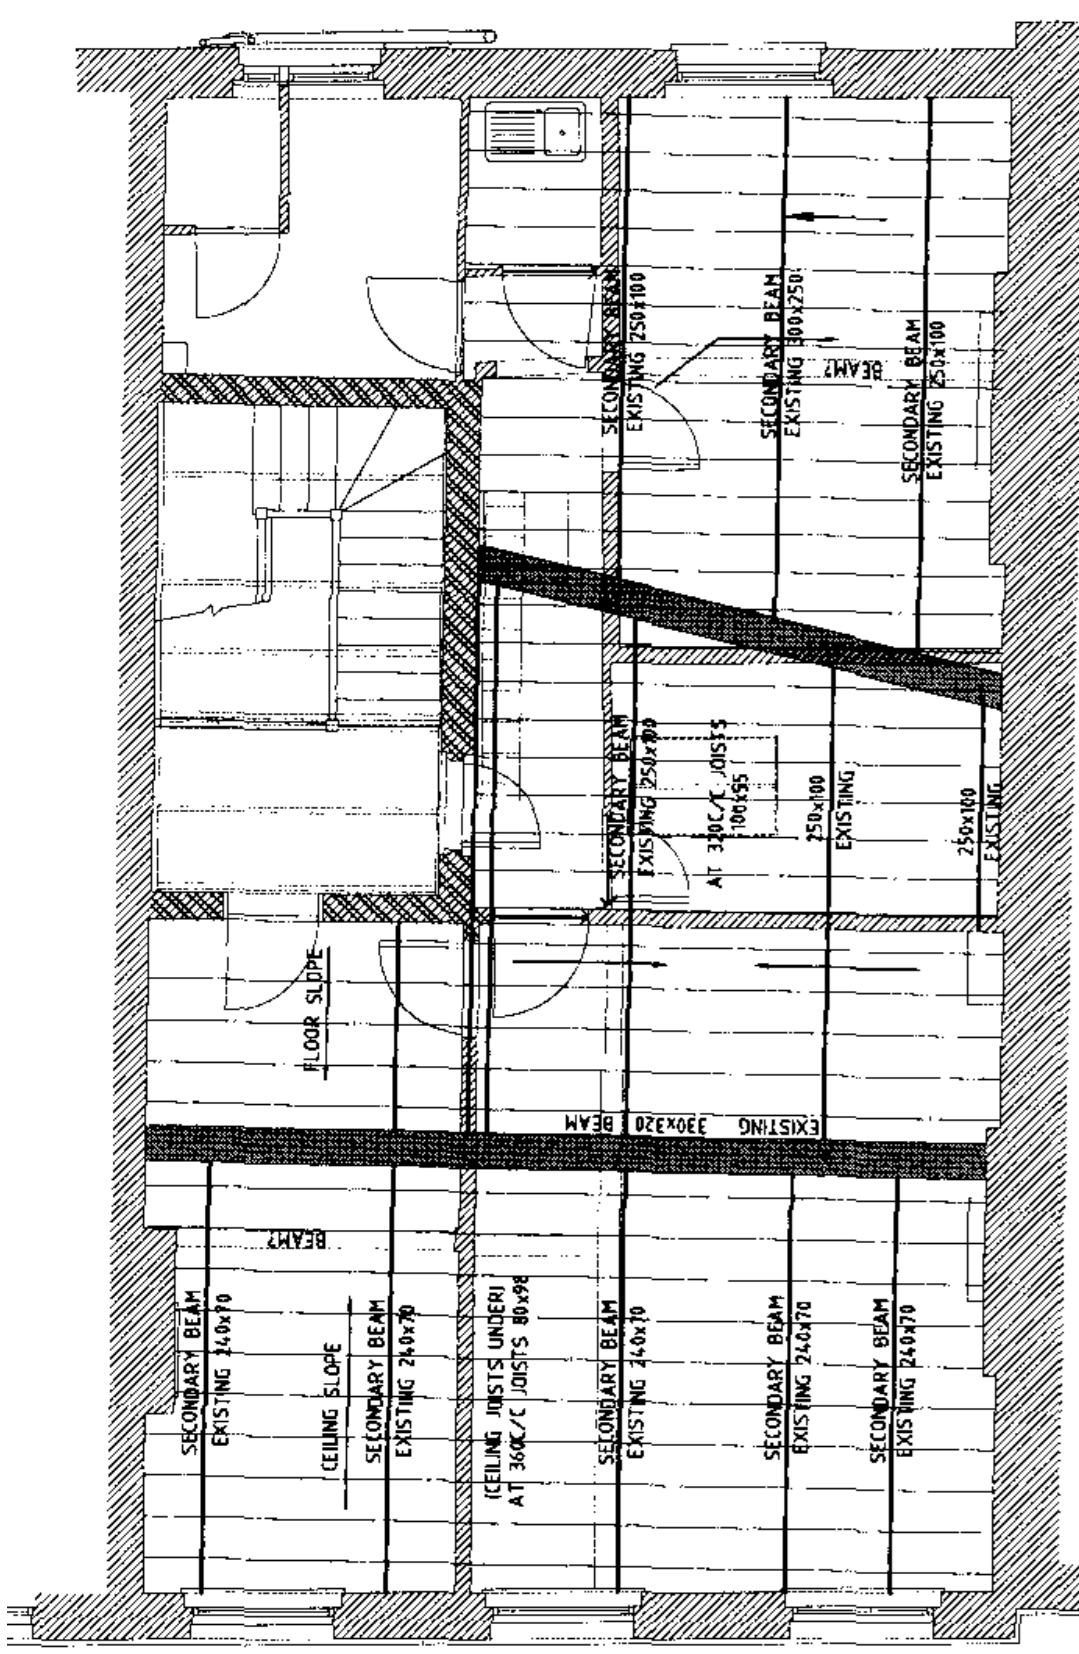
ORIGINAL STRUCTURAL LAYOUT AT 38 BEDFORD PLACE: FLOOR BELOW

NOTE: FURTHER OPENING UP WORKS SUGGEST THAT THE VALLEY BEAM AND CEILING JOIST SUPPORT BEAM TO THE RIGHT OF THE STAIRWELL ARE SUPPORTED ON THE PARTITION WALLS.

BASED ON THE SIZE OF THE MEMBERS, IT LOOKS AS IF THERE WILL HAVE BEEN SOME SUPPORT HERE IN THE ORIGINAL BUILDING BUT THE CURRENT PARTITIONS DO NOT LOOK TO HAVE BEEN DESIGNED FOR THIS AND DO NOT GO ALL THE WAY TO THE BASEMENT/FOUNDATIONS. THIS MAY BE WHY SOME OF THE DOOR OPENINGS LOCAL TO THE VALLEY BEAMS ARE NOT STRAIGHT.

AS PART OF THE WORKS TO SUPPORT THE PLANT AND REPLACEMENT LANTERN, WE WILL LOOK TO REINSTATE A LINE OF SUPPORT HERE; LIKELY WITH STEEL FRAMING
