14 RED LION SQUARE LONDON WC1R 4QH

ROOM BY ROOM
SCHEDULE

19 SEPTEMBER 2024

DOCUMENT NAME	14 RED LION SQUARE LONDON WC1R 4QH ROOM BY ROOM SURVEY
VERSION	1.0
ISSUE DATE	19 SEPTEMBER 2024
AUTHOR	CM
CLIENTS	13-17 RED LION SQUARE LLP
COPYRIGHT	HWO ARCHITECTS

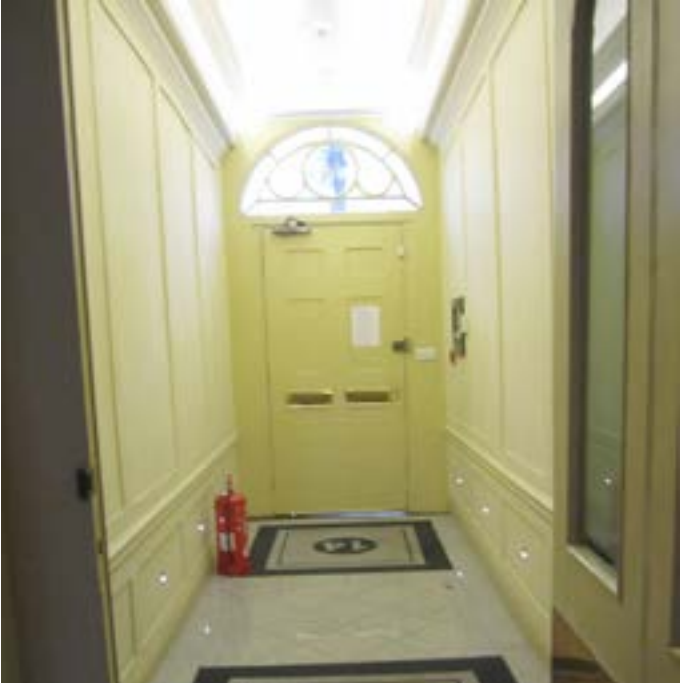
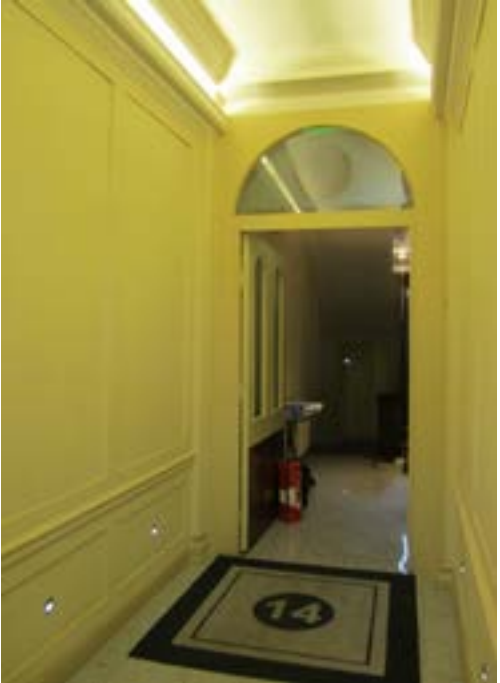
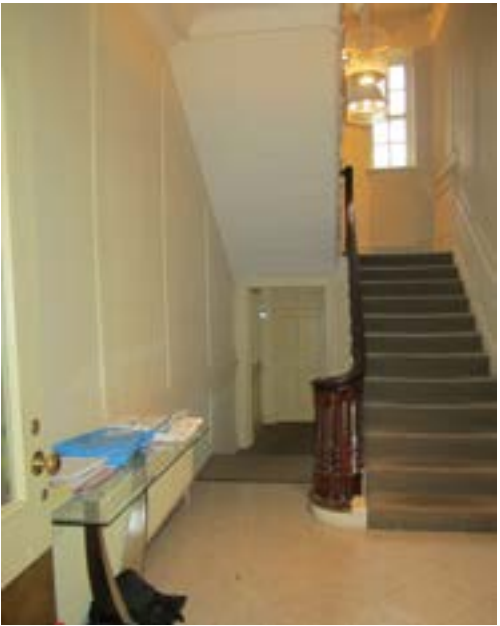
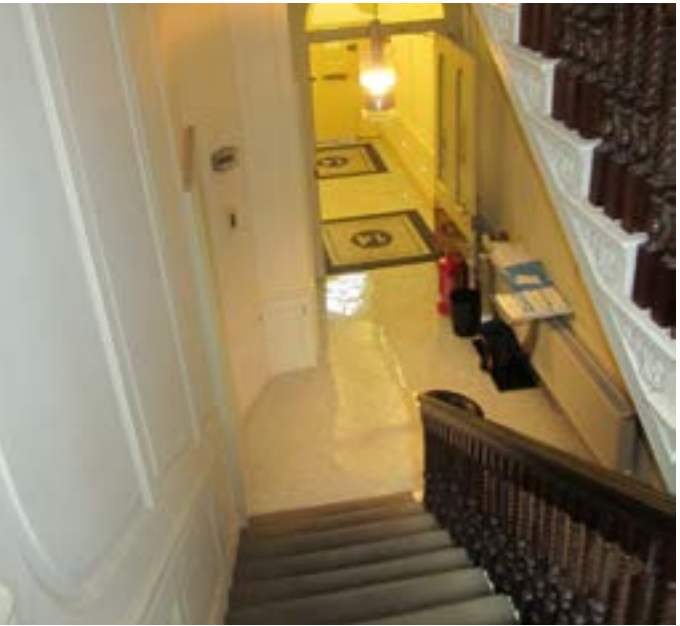
2
ROOM PHOTOGRAPHS

14-HALLWAY & STAIRS

Existing Use: Entrance
Proposed Use: Entrance
Significance: High

Walls
Original decorative timber panelling on walls to be retained and restored.

Doors/Doorways
Original entrance door to be retained. Georgian style fanlight above front door. Original lobby door to be retained. Original door to basement to be retained.

Ceiling
Carefully repair and nail back any original lath & plaster ceiling with Ring shank plastering lath nails or similar. Modern coving and lighting to be removed in entrance hallway and to be replaced with sympathetic upgrades.

Floors
Modern tile/stone flooring in lobby to be removed. Modern carpet on stair to be removed, carefully repair or fix back any original creaking steps. The proposal will include a carpet runner with metal rods to replace the wide carpet on the stairs.

Services
Electrical light fitting, intercoms, pendant unit with integrated lights, fire exit sign, fire detector to be removed. Fire systems and lighting to be replaced with sympathetic upgrades.

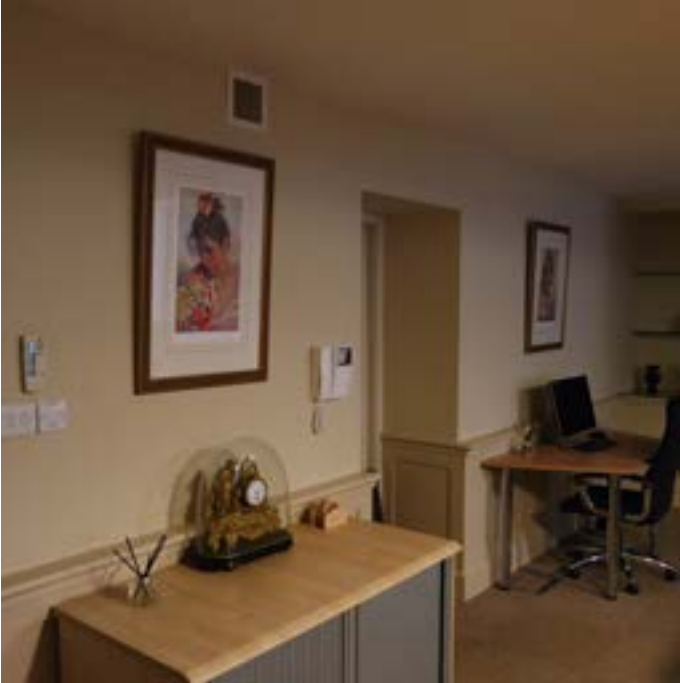
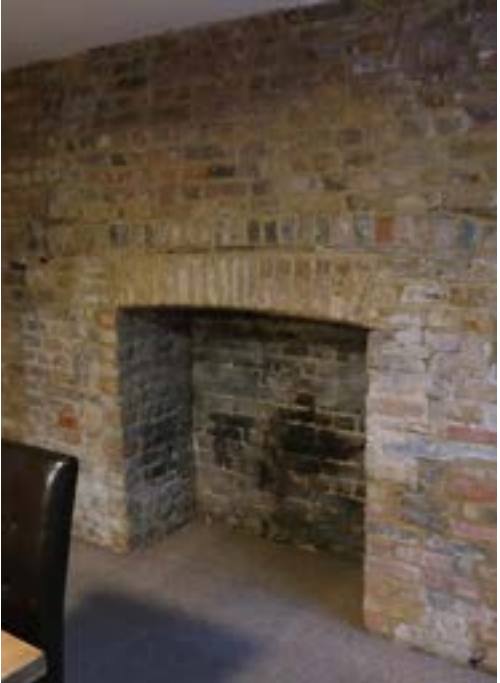
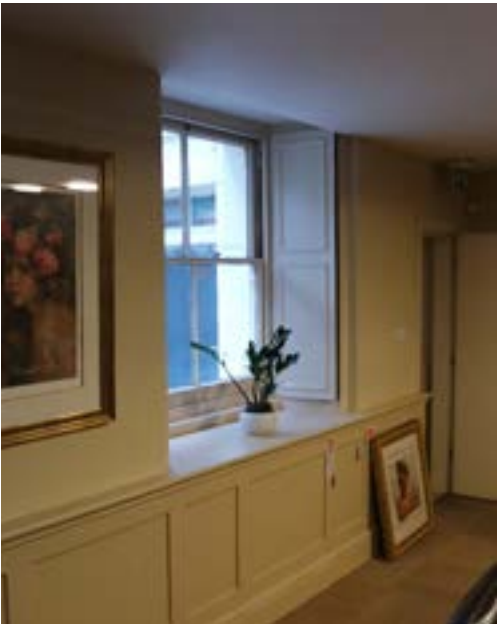
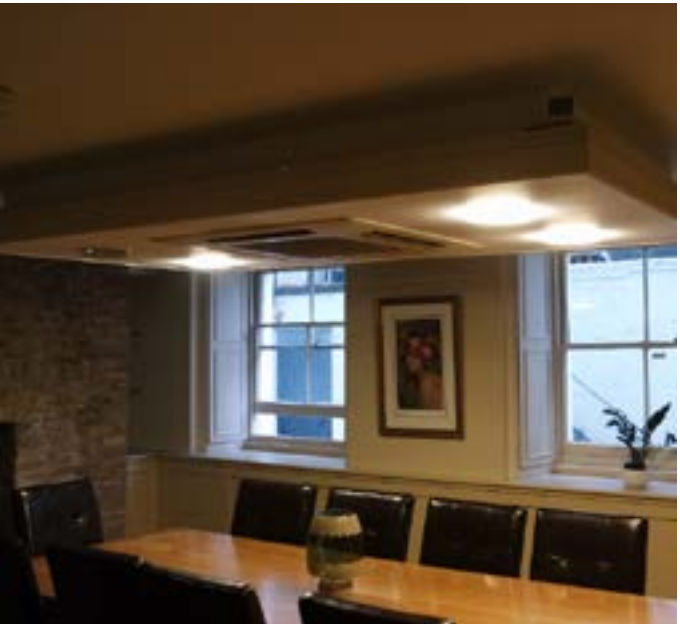
2
ROOM PHOTOGRAPHS

14-0B-01

Existing Use: Office
Proposed Use: Living Area
Significance: Low

Windows
Period sashes (Late 18th Century) 2x painted timber, single glazed sash window 4 panels, 115/115 opening, applied moulding shutters. All sash windows are to be checked for soundness and carefully repaired as required with like for like timber sections. Any rotten section of cills are to be carefully repaired piecing in matching timber.

Decorative Features
Exposed brick fireplace wall asymmetric built-in shelving units both sides of the fireplace. Modern units to be removed.

Ceiling
Painted modern plasterboard to be removed.
Modern suspended ceiling feature with concealed lighting to be removed.

Walls
Modern decorative timber panelling from half way down the wall to be removed

Skirting and cornice
Modern skirting and corning to be removed and replaced with a sensitive upgrade.

Doors/Doorways
Access Door – leading to the main staircase: steel door to be retained. 2 x Room Door – leading to 14-0B-02, 04: painted timber door to be removed.

Floors
Modern carpet on cement floor to be removed and replaced with engineered timber flooring or similar.

Services
Electrical light fitting, intercoms, pendant unit with integrated lights and built-in fan coil unit, fire exit sign, fire detector to be removed. Fire systems and lighting to be replaced with sympathetic upgrades.

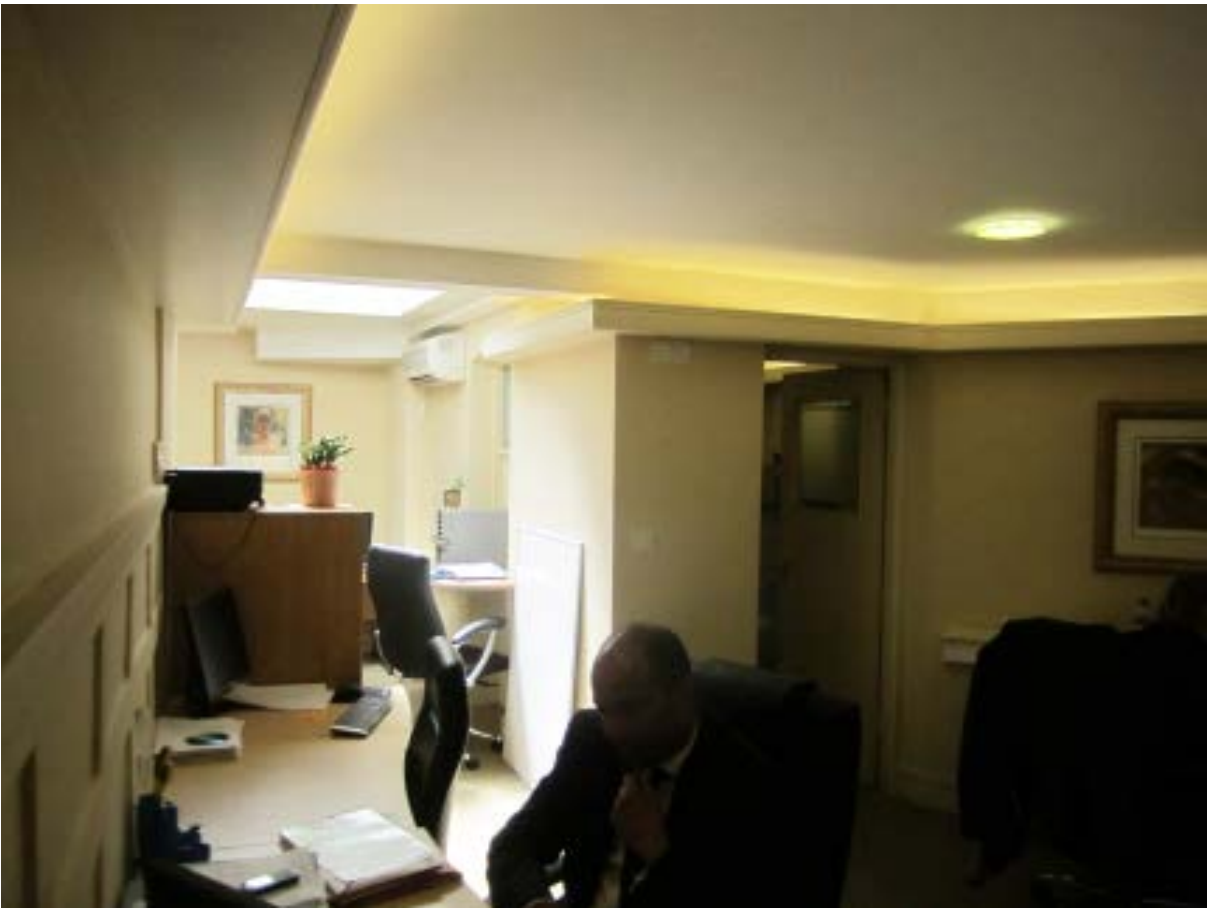
2
ROOM PHOTOGRAPHS

14-0B-02

Existing Use: Office
Proposed Use: Guest Bedroom / Outside
Significance: Low

Ceiling
Painted modern plasterboard to be removed.

Walls
Modern decorative timber panelling from half way down the wall to be removed

Skirting and cornice
Modern skirting and corning to be removed and replaced with a sensitive upgrade.

Floors
Modern carpet on cement floor to be removed and replaced with engineered timber flooring or similar.

Decorative Features
Modern up-lighting boxing and fittings to be removed from outer perimeter of room.

Services
Electrical light fitting, intercoms, pendant unit with integrated lights and built-in fan coil unit, fire exit sign, fire detector to be removed. Fire systems and lighting to be replaced with sympathetic upgrades.

Other
Modern extension to rear to be carefully removed and reverted to external courtyard.

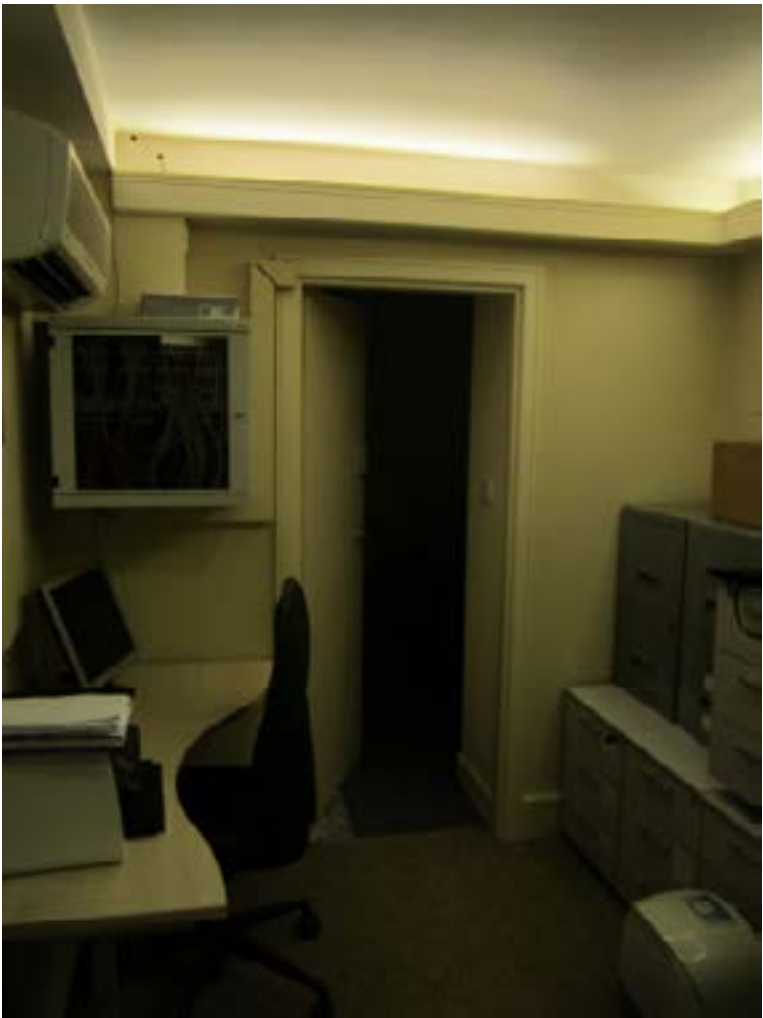
2
ROOM PHOTOGRAPHS

14-0B-03

Existing Use: Office
Proposed Use: Bathroom
Significance: Low

Ceiling
Painted modern plasterboard to be removed.

Walls
Modern plasterboard to be removed and replaced.

Skirting and cornice
Modern skirting and cornicing to be removed and replaced with a sensitive upgrade.

Doors/Doorways
Modern access door – leading from office to be replaced.

Floors
Modern carpet on cement floor to be removed and replaced with engineered timber flooring.

Decorative Features
Modern up-lighting boxing and fittings to be removed from outer perimeter of room.

Services
Electrical light fitting, intercoms, pendant unit with integrated lights and built-in fan coil unit, fire exit sign, fire detector to be removed. Fire systems and lighting to be replaced with sympathetic upgrades.

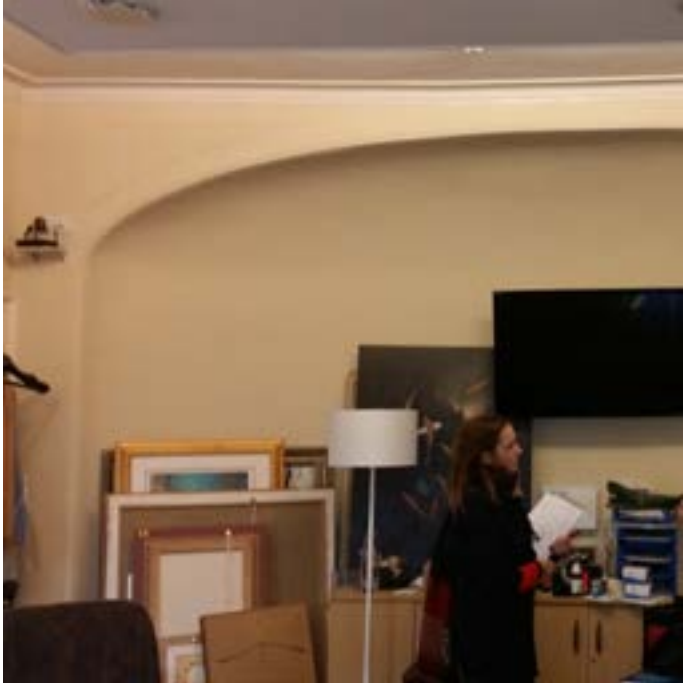
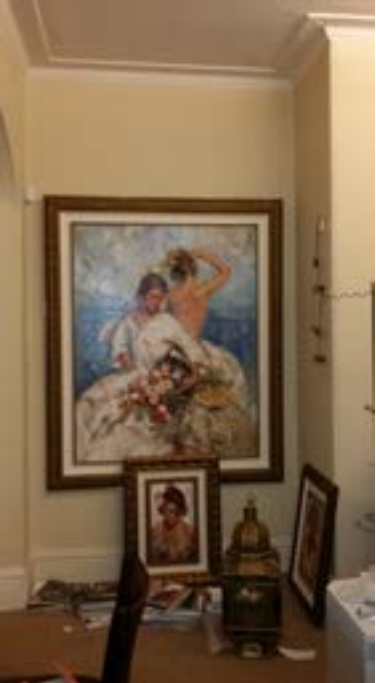
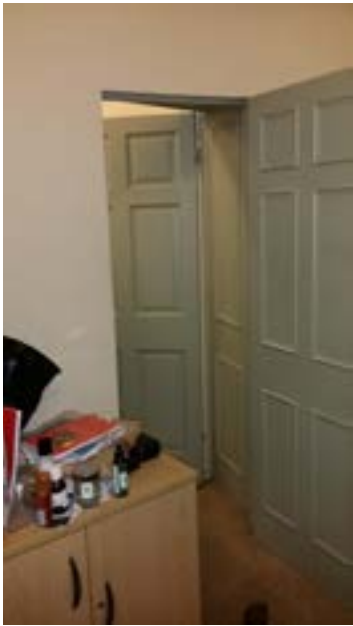
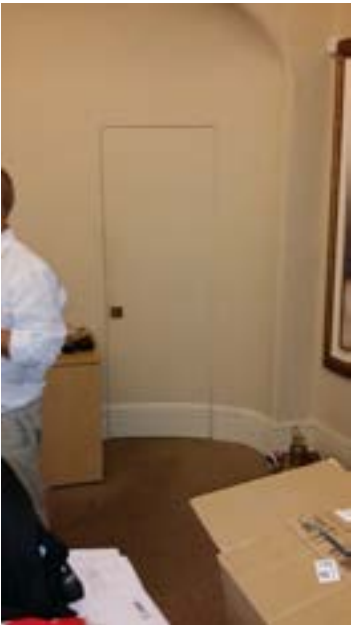
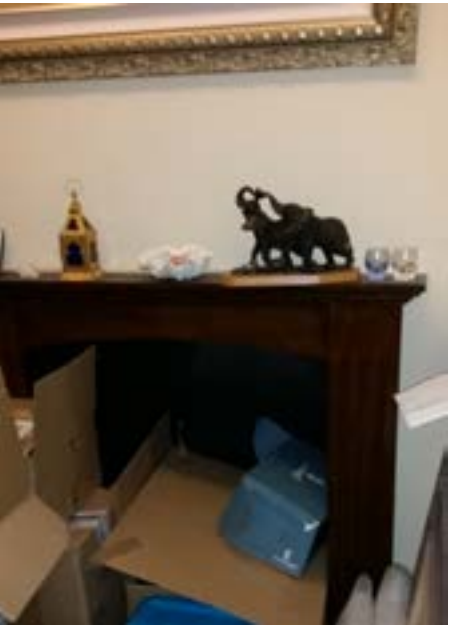
2
ROOM PHOTOGRAPHS

14-00-01

Existing Use: Office
Proposed Use: Formal Reception Room
Significance: Medium

Skirting and cornice
Cornicing might be original or 18th Century. Further investigations are required once the building is vacant. If original or historic skirting and cornicing to be retained and restored.

Ceiling
Modern Plasterboard ceiling to be replaced. Modern suspended ceiling feature with concealed lighting to be removed.

Walls
Original decorative lath & plaster walls to be repaired. Modern plasterboard to be removed.

Doors/Doorways
Non-original main access door leading to the main staircase to be replaced with new door. Hidden door into adjacent office to be retained.

Windows
Period sashes (Late 18th Century) painted timber, single glazed sash window 12 panels. All sash windows are to be checked for soundness and carefully repaired as required with like for like timber sections. Any rotten section of cills are to be carefully repaired piecing in matching timber.

Floors
Modern carpet on timber floorboards to be removed, carefully repair or fix back any original creaking floorboards, taking care not to remove large sections when access to joists is required.

Decorative Features
Non-original fireplace removed and replaced with a more in keeping fire place.

Services
Electrical light fitting, intercoms, pendant unit with integrated lights and built-in fan coil unit, fire exit sign, fire detector to be removed. Fire systems and lighting to be replaced with sympathetic upgrades.

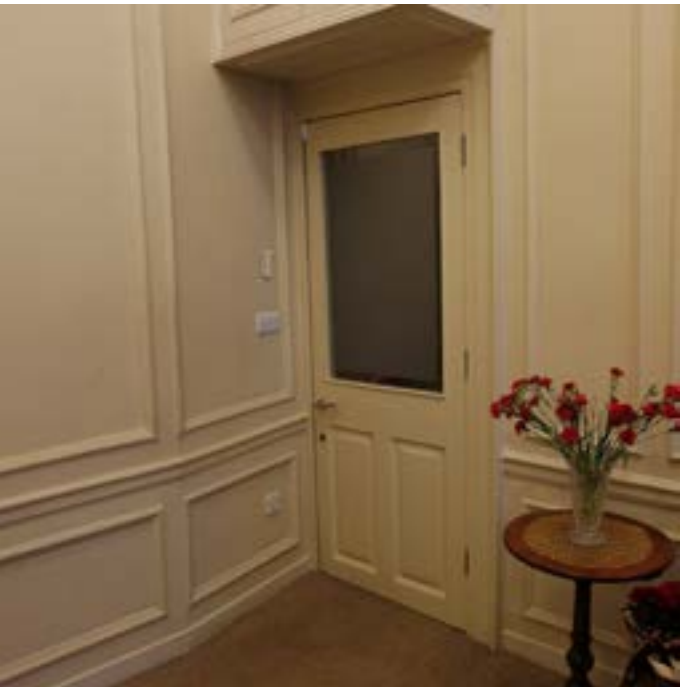
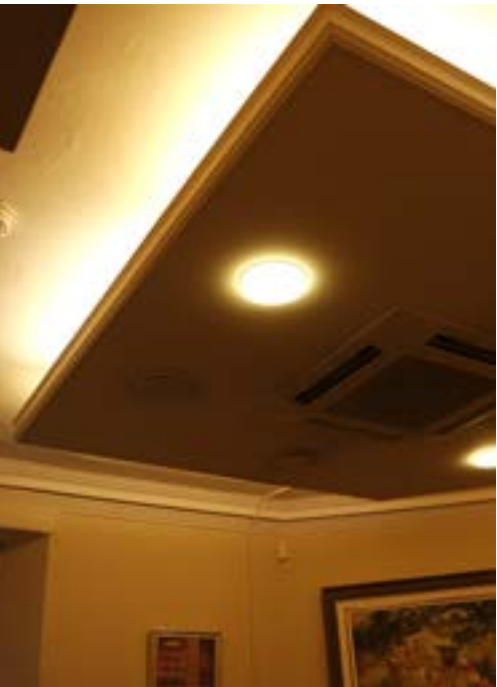
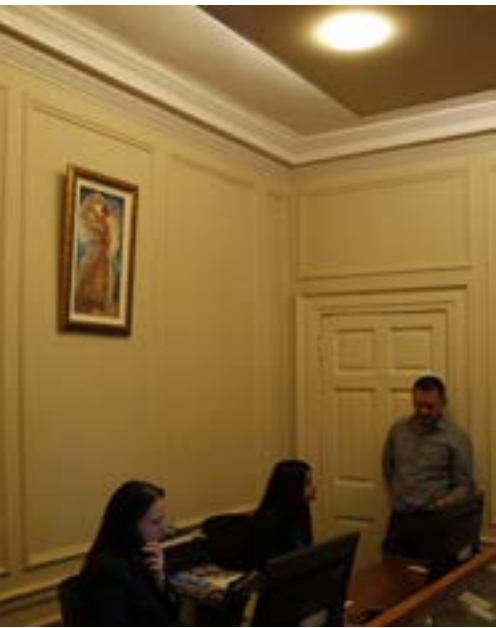
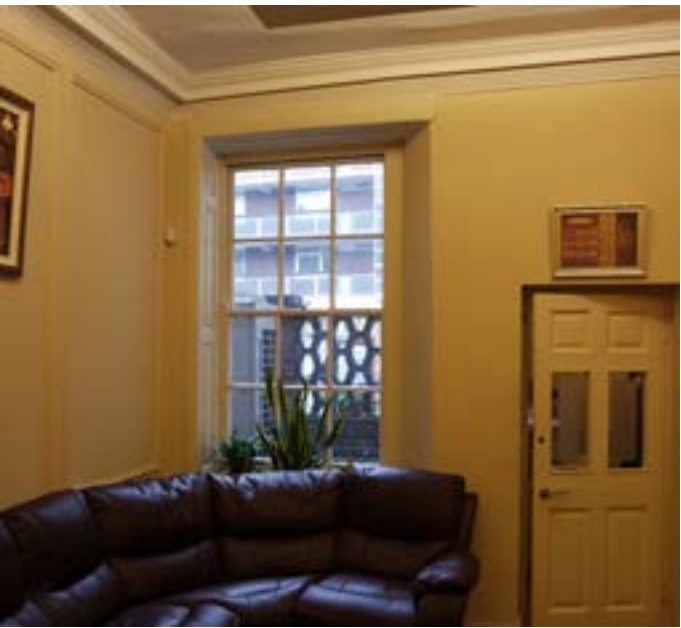
2
ROOM PHOTOGRAPHS

14-00-02

Existing Use: Office
Proposed Use: Reception Room
Significance: Medium

Ceiling
Carefully repair and nail back any original lath & plaster ceiling. Remove fan coil unit and central false ceiling.

Walls
Modern panelling to be removed. Remove electrical box over door and re-install panelling.

Skirting and cornice
Modern cornicing to be removed and replaced with a sympathetic upgrade.

Doors/Doorways
Modern access Door with glass panel leading to the main staircase to be replaced. Internal room doors with mouldings to office (2 doors back to back) be replaced with new doors.

Windows
Period sashes (Late 18th Century) painted timber, single glazed sash window 12 panels. All sash windows are to be checked for soundness and carefully repaired as required with like for like timber sections. Any rotten section of cills are to be carefully repaired piecing in matching timber.

Floors
Modern carpet on timber floorboards to be removed, carefully repair or fix back any creaking floorboards, taking care not to remove large sections when access to joists is required

Services
Electrical light fitting, intercoms, pendant unit with integrated lights and built-in fan coil unit, fire exit sign, fire detector to be removed. Fire systems and lighting to be replaced with sympathetic upgrades without further damage to panelling.

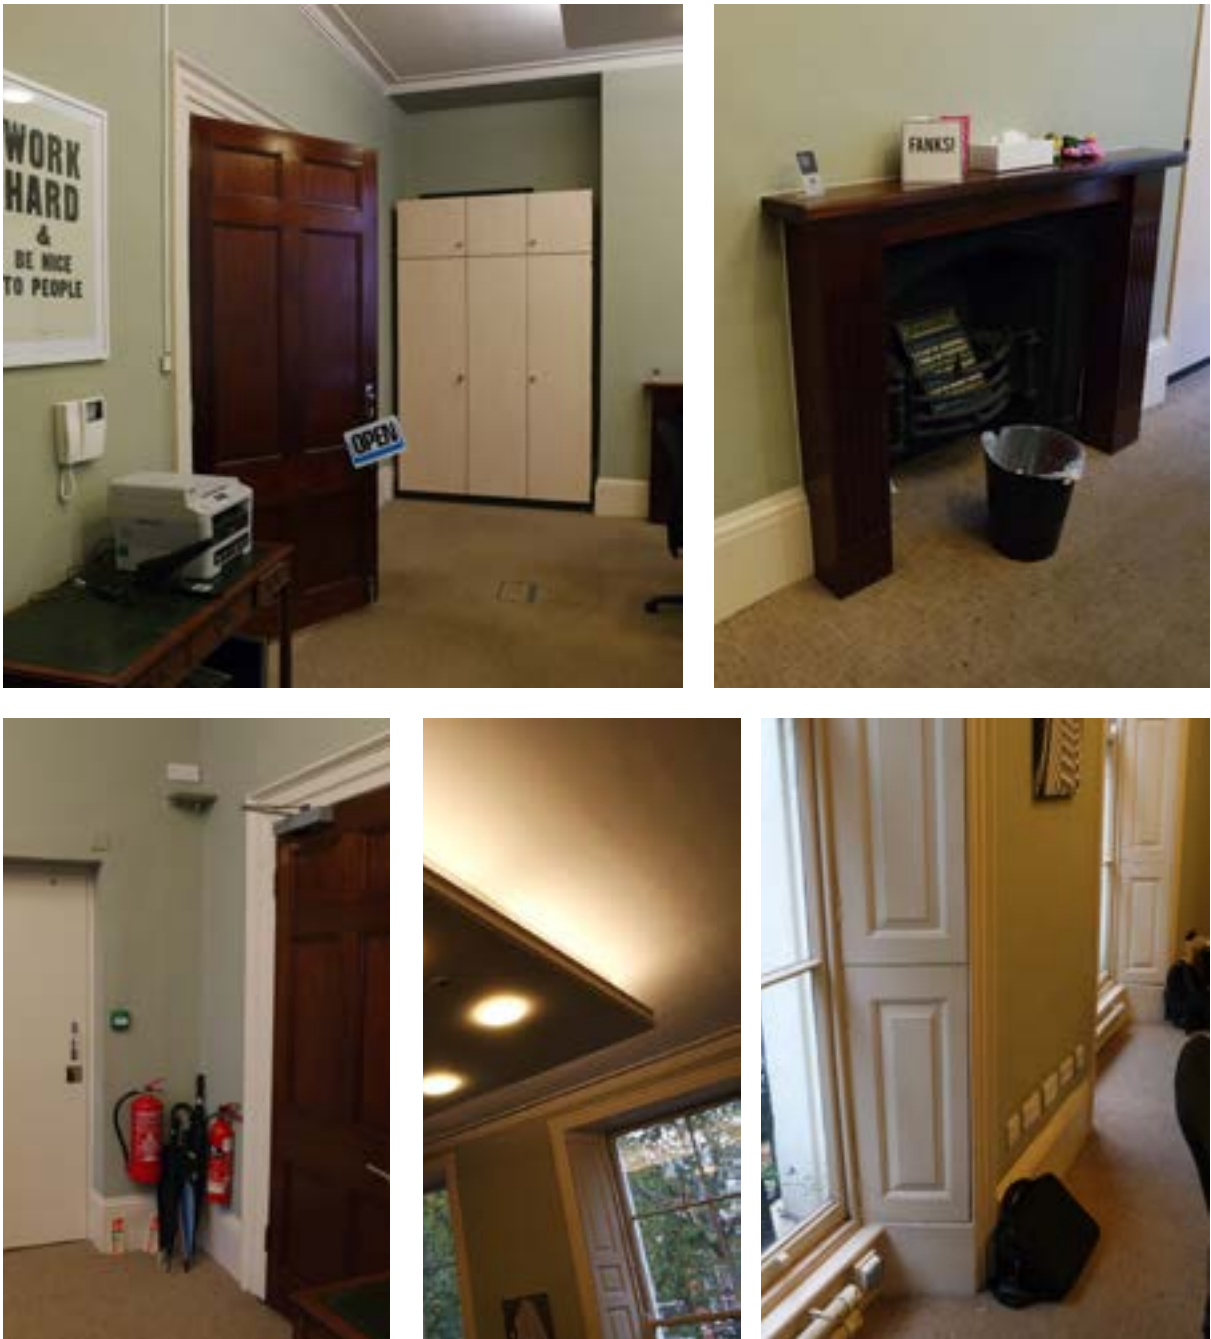
2
ROOM PHOTOGRAPHS

14-01-01

Existing Use: Office
Proposed Use: Family Living / Dining
Significance: Medium

Skirting and cornice
Retain skirting which appears to be original (TBC).

Ceiling
Retain original cornicing and lath & plaster ceilings. Modern suspended ceiling feature with concealed lighting to be removed. Carefully repair and nail back any original lath & plaster ceiling.

Walls
Original lath & plaster walls to be repaired. Any modern plasterboard to be removed.

Doors/Doorways
2 x Non original room entrances and double panelled doors and architraves to be replaced. 1 x Modern door that connects townhouses to be removed and filled in. Original architraves to be retained.

Windows
Period sashes (Late 18th Century) 2 x painted timber, single glazed sash window 8 panels, moulding shutters. All sash windows are to be checked for soundness and carefully repaired as required with like for like timber sections. Any rotten section of cills are to be carefully repaired piecing in matching timber.

Floors
Modern carpet on timber floor boards to be removed, carefully repair or fix back any original creaking floorboards, taking care not to remove large sections when access to joists is required

Decorative Features
Non original fireplace with wooden surround to be removed and replaced with a more in keeping fire place.

Services
Electrical light fitting, intercoms, pendant unit with integrated lights and built-in fan coil unit, fire exit sign, fire detector to be removed. Fire systems and lighting to be replaced with sympathetic upgrades.

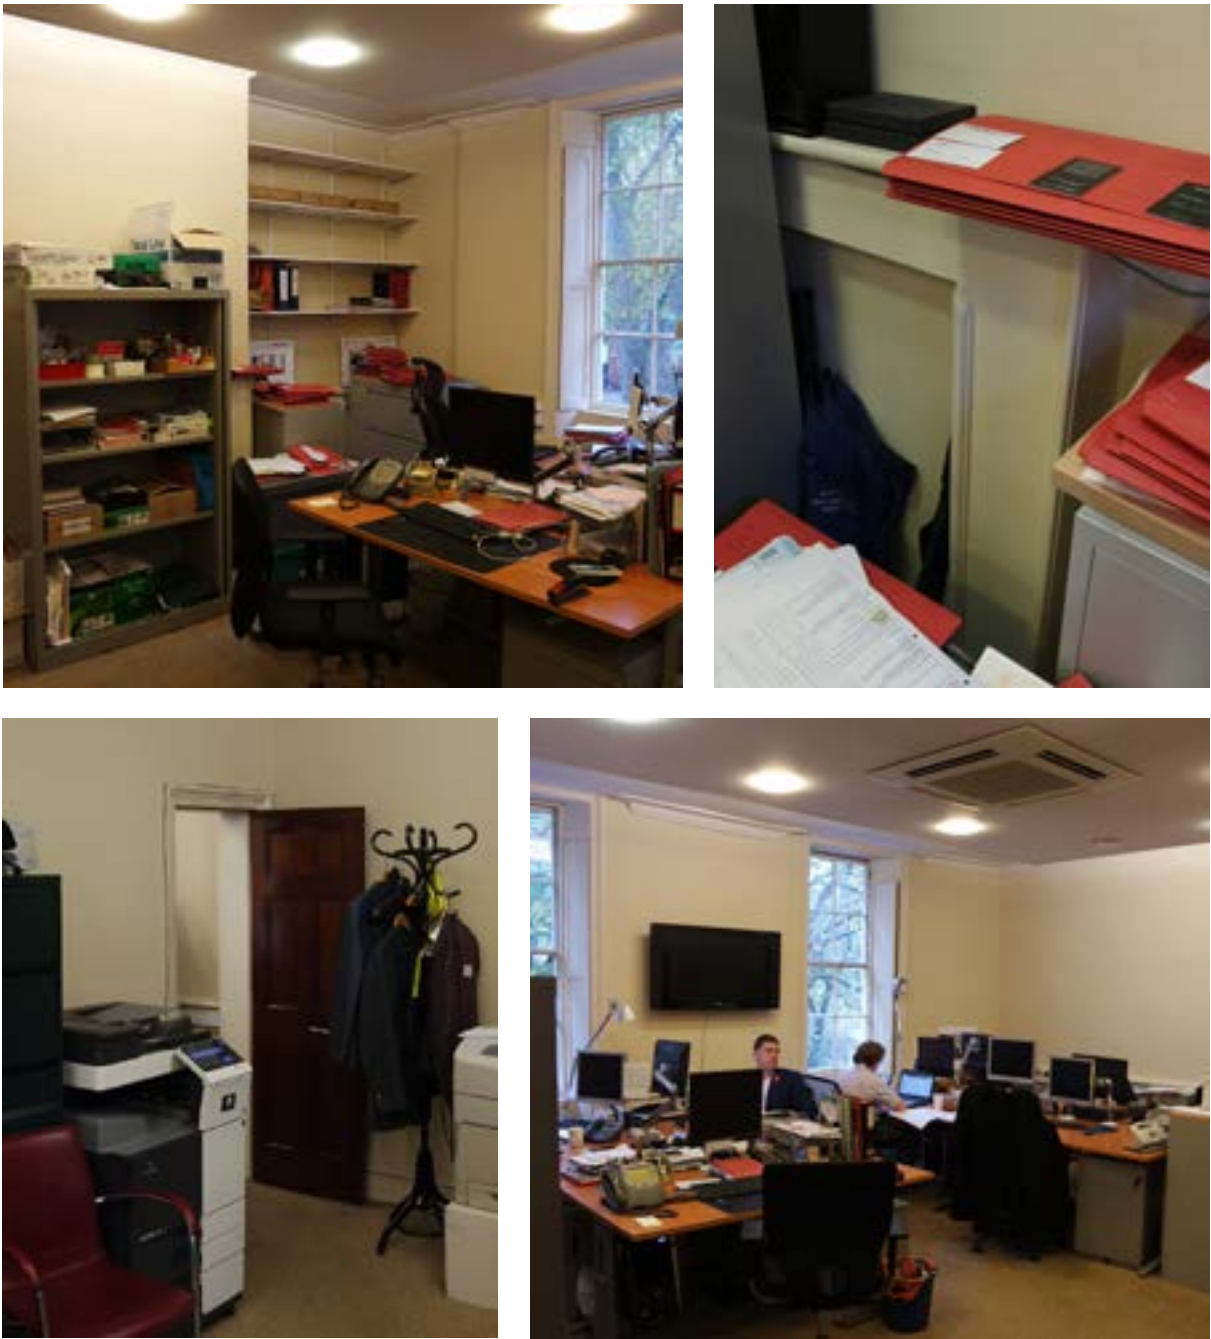
2
ROOM PHOTOGRAPHS

14-02-01

Existing Use: Office
Proposed Use: Master Suite
Significance: Medium

Skirting and cornice
Cornice appears to be modern but is to be retained until further investigation. Original skirting to be retained and restored.

Doors/Doorways
Generally modern doors to be replaced. Architraves seem to be original (TBC).

Ceiling
Modern plasterboard recessed light fittings and fan coil units to be removed

Walls
Original decorative original lath & plaster walls to be repaired. Modern plasterboard to be removed.

Windows
Period sashes (Late 18th century) 2 x painted timber, single glazed sash window 8 panels, moulding shutters. All sash windows are to be checked for soundness and carefully repaired as required with like for like timber sections. Any rotten sections of cills are to be carefully repaired piecing in matching timber.

Floors
Modern carpet on timber floorboards to be removed, carefully repair or fix back any creaking floorboards, taking care not to remove large sections when access to joists is required

Decorative Features
Potentially period fireplace with painted wooden surround to be repaired.

Services
Electrical light fitting, intercoms, pendant unit with integrated lights and built-in fan coil unit, fire exit sign, fire detector to be removed. Fire systems and lighting to be replaced with sympathetic upgrades.

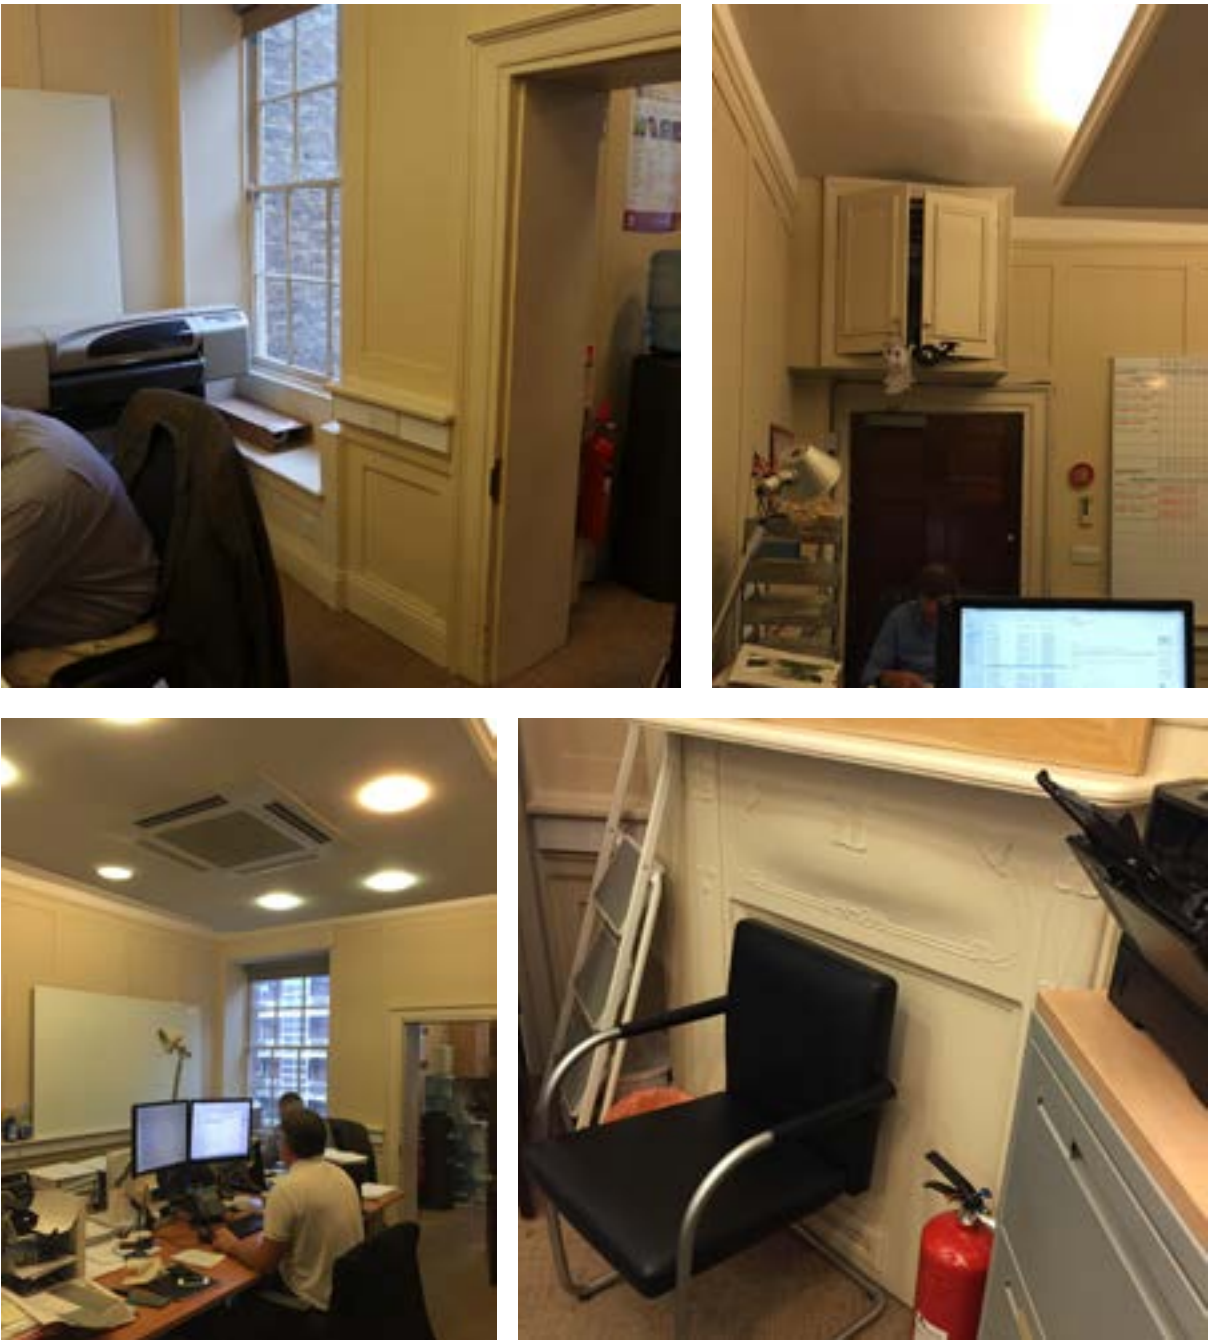
2
ROOM PHOTOGRAPHS

14-02-02

Existing Use: Office
Proposed Use: Wardrobe
Significance: Medium

Decorative Features
Period fireplace, possibly 19th century, to be retained.

Ceiling
Painted modern plasterboard, false ceiling in centre, recessed lights and fan coil unit to be removed.

Walls
Original decorative timber panelling to be retained.

Doors/Doorways
Modern access door to be replaced with new door.

Windows
Period sashes (Late 18th century) 2 x painted timber, single glazed sash window 12. All sash windows are to be checked for soundness and carefully repaired as required with like for like timber sections. Any rotten sections of cills are to be carefully repaired piecing in matching timber.

Floors
Modern carpet on timber floor boards to be removed, carefully repair or fix back any creaking floorboards, taking care not to remove large sections when access to joists is required.

Services
Electrical light fitting, intercoms, pendant unit with integrated lights and built-in fan coil unit, fire exit sign, fire detector to be removed. Fire systems and lighting to be replaced with sympathetic upgrades.

Other
Electrical cupboard to be removed. Electrical dado rail to be removed and wall made good behind.

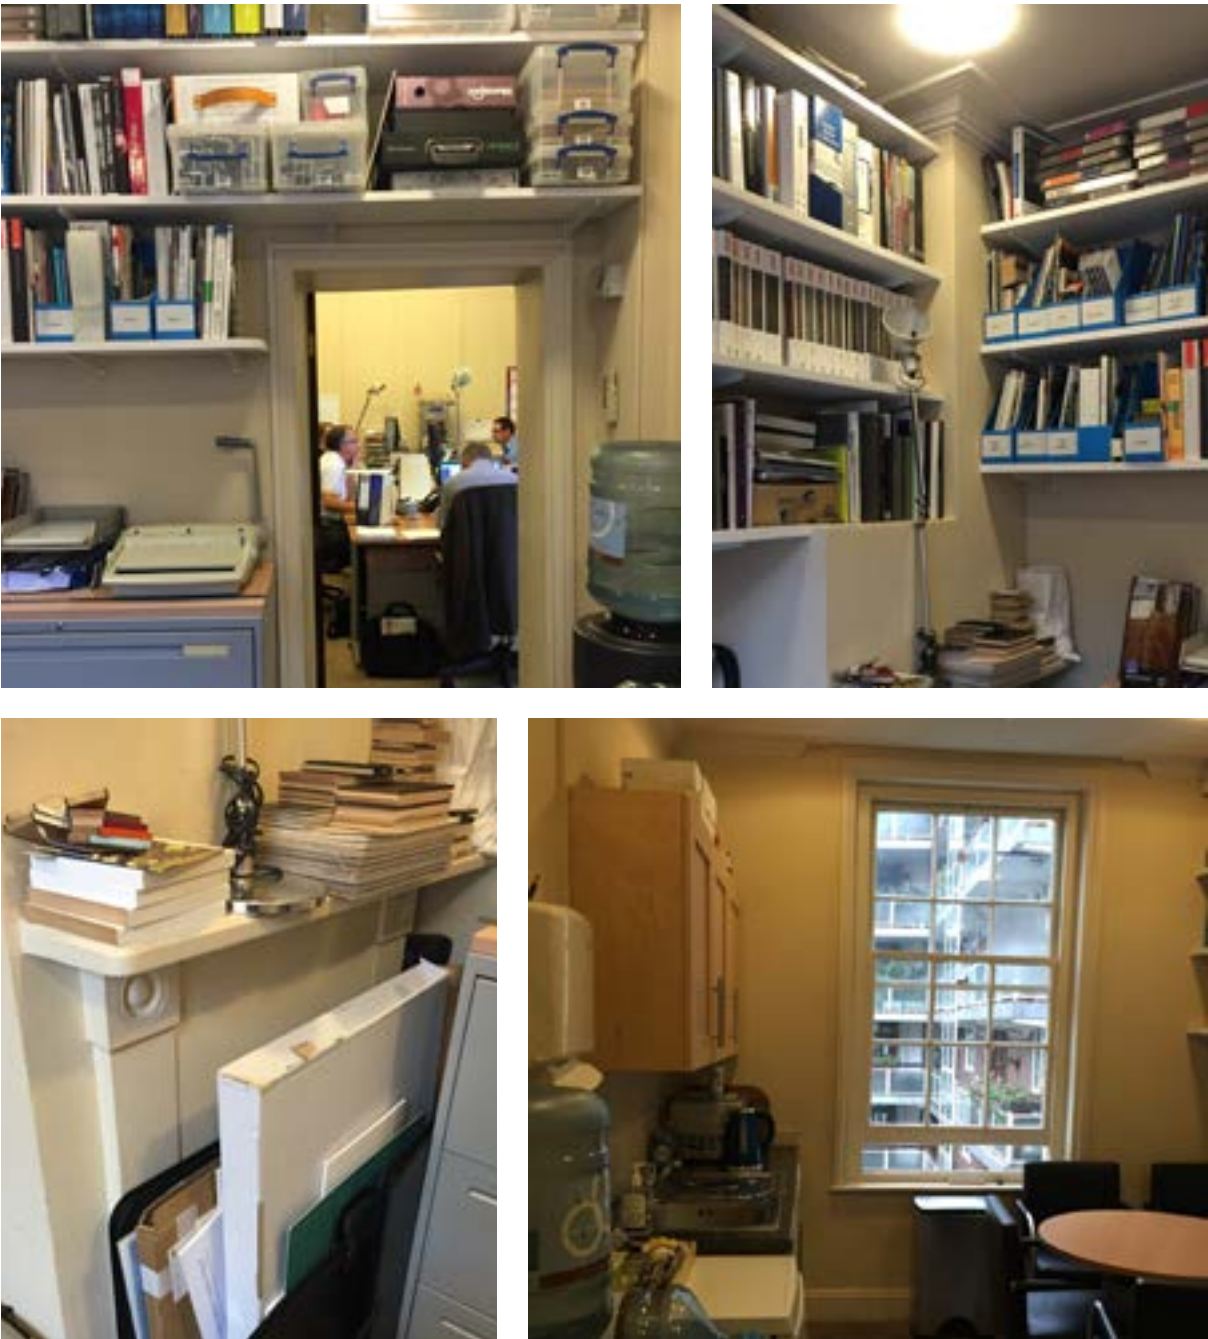
2
ROOM PHOTOGRAPHS

14-02-03

Existing Use: Tea Point
Proposed Use: Ensuite
Significance: Medium

Skirting and cornice
Period skirting and cornicing to be retained and restored.

Ceiling
Modern ceiling to be replaced a new ceiling.

Walls
Modern plasterboard to be removed and replaced with a sympathetic upgrade.

Doors/Doorways
Access door to be retained.

Windows
Period sashes (Late 18th Century) 1 x painted timber, single glazed sash window 12 panels. All sash windows are to be checked for soundness and carefully repaired as required with like for like timber sections. Any rotten sections of cills are to be carefully repaired piecing in matching timber.

Floors
Modern carpet on timber floor boards to be removed, carefully repair or fix back any creaking floorboards, taking care not to remove large sections where access to joists is required

Decorative Features
Period fireplace to be retained and restored.

Services
Electrical light fitting, intercoms, pendant unit with integrated lights and built-in fan coil unit, fire exit sign, fire detector to be removed. Fire systems and lighting to be replaced with sympathetic upgrades.

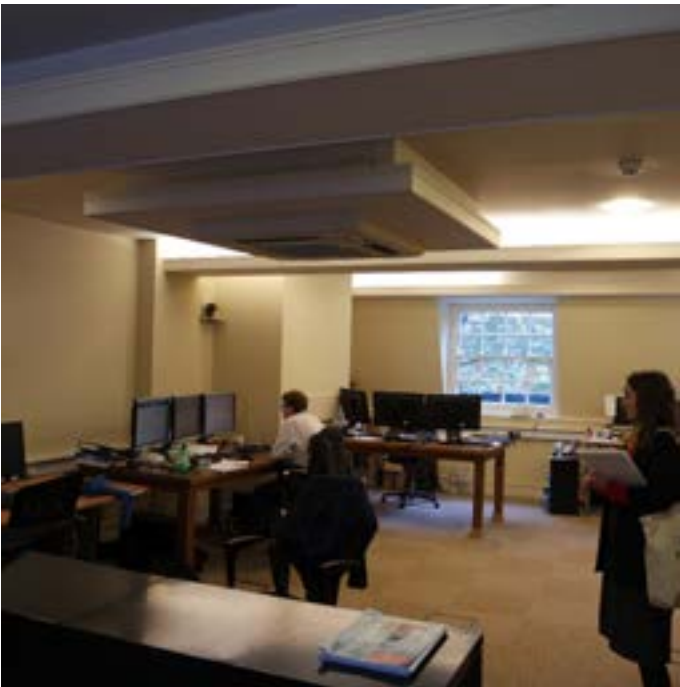
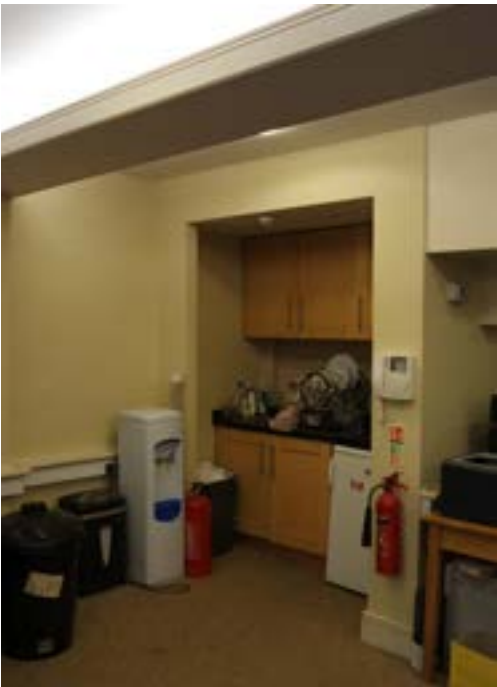
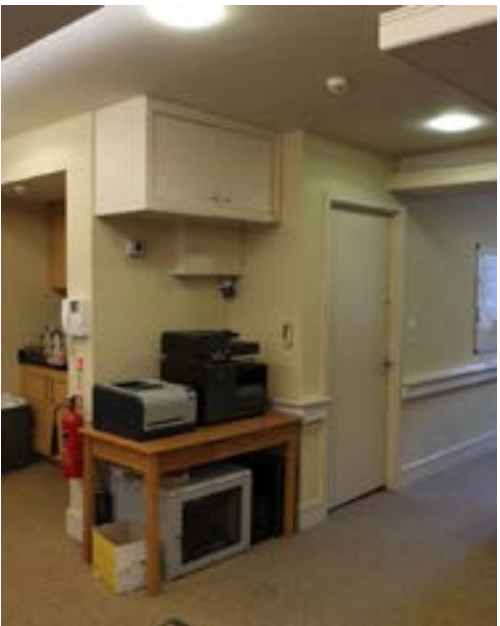
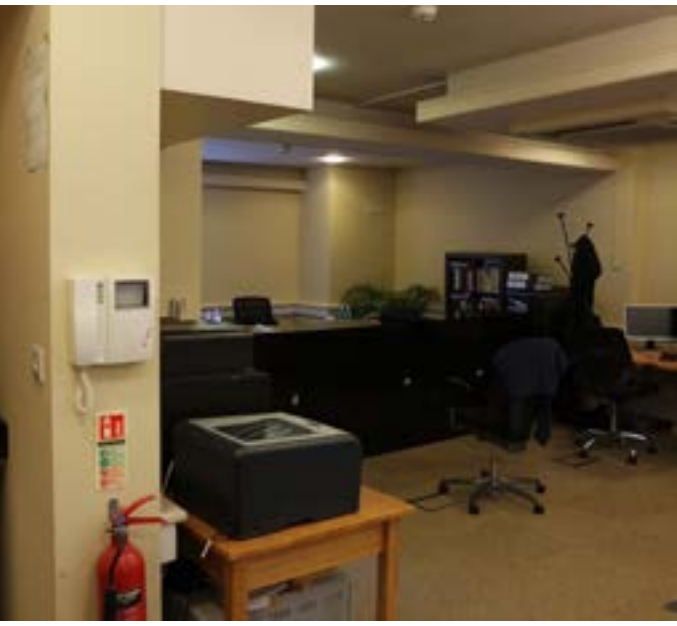
2
ROOM PHOTOGRAPHS

14-03-01

Existing Use: Tea Point / Office (Modern roof extension)

Significance: Low

Painted modern plasterboard to be removed.

Modern plasterboard to be removed

Modern skirting and cornicing to be removed and replaced with a sympathetic upgrade.

Access Door – leading to the main staircase: door to be retained.

Modern painted timber, single glazed sash window 16 panels. All sash windows are to be checked for soundness and carefully repaired as required with like for like timber sections. Any rotten sections of cills are to be carefully repaired piecing in matching timber.

Modern carpet on timber floor boards to be removed, carefully repair or fix back any creaking floorboards, taking care not to remove large sections when access to joists is required

Modern up-lighting boxing and fittings to be removed from outer perimeter of room.

Electrical light fitting, intercoms, pendant unit with integrated lights and built-in fan coil unit, fire exit sign, fire detector to be removed. Fire systems and lighting to be replaced with sympathetic upgrades.

Modern tea point fixtures and plumbing to be removed and made good.
