Project No: P4200	
Refurbishment Survey (with MA only)	Survey Date: 22 Oct 2024
	NO ASBESTOS DETECTED
	Issue Date: 28 Oct 2024

Specified Areas of 87 Arlington Road London NW1 7ES

87 Arlington Road  
London  
NW1 7ES

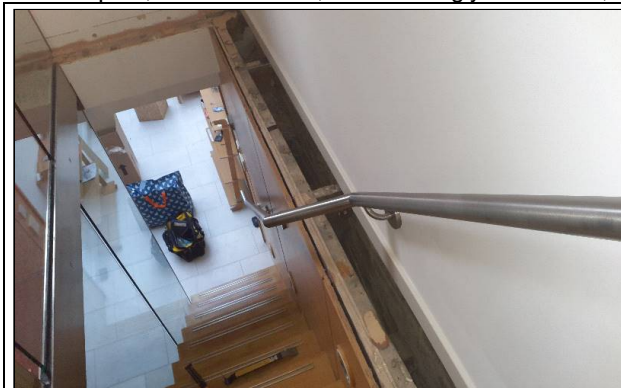
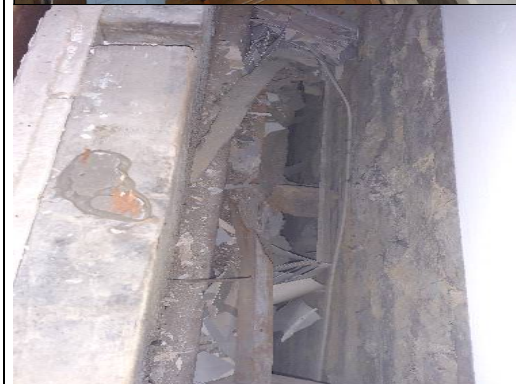
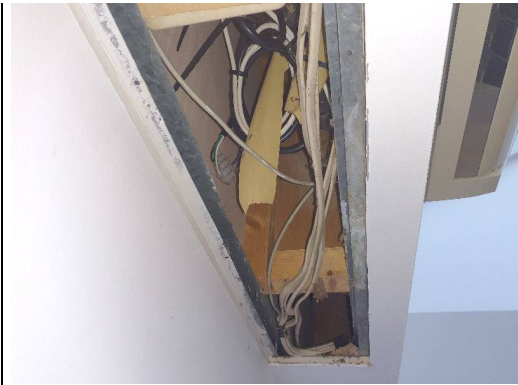
Survey Date:	Lead Surveyor	Survey Type	Floor	Analysis
22 Oct 2024	Alastair Kirby	Refurbishment Survey (with MA only)	Ground Floor	N/A
Building	Room	Item	Quantity	
No. 87	Office G02	Representative photographs	N/A	
Sample No (S,SP,P,As)	Product Type	Surface Treatment	Condition	Accessibility

Visual (P)	N/A	N/A	N/A	N/A
Material Risk Score	Next Reinspection			
N/A	N/A			
No further action required				
N/A

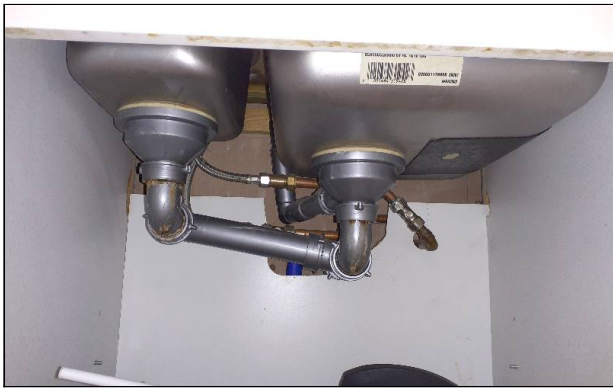
Survey Date:	Lead Surveyor	Survey Type	Floor	Analysis
22 Oct 2024	Alastair Kirby	Refurbishment Survey (with MA only)	Z-Sub Level 1	No Asbestos Detected
Building	Room	Item	Quantity	
No. 87	Kitchen Z101	Bitumen sink pad	1no.	
Sample No (S,SP,P,As)	Product Type	Surface Treatment	Condition	Accessibility
CT000729 (S)	N/A	N/A	N/A	N/A
Material Risk Score	Next Reinspection			
N/A	N/A			
Recommended action		No further action required		
Surveyor comments		N/A
