## 2.1 Introduction & Purpose

This document sets out the findings of the Condition & Feasibility Study for the existing building at The Courtyard Building, to respond to the requirements set out in the London Borough of Camden (LBC) Energy Efficiency & Adaptability Camden Planning Guidance (EEA CPG) Chapter 9. This document is provided in response to a request from LBC’s sustainability officer at the sustainability pre-app to provide further evidence of our workflows and analysis of the existing building ahead of the application for the new proposal for the site. Much of this work had taken place ahead of any decision to alter the existing building on site.

**Existing Facades – Thermal Analysis, Condensation Risk Analysis,  
Corrosion Risk & Vented Cavity Study**

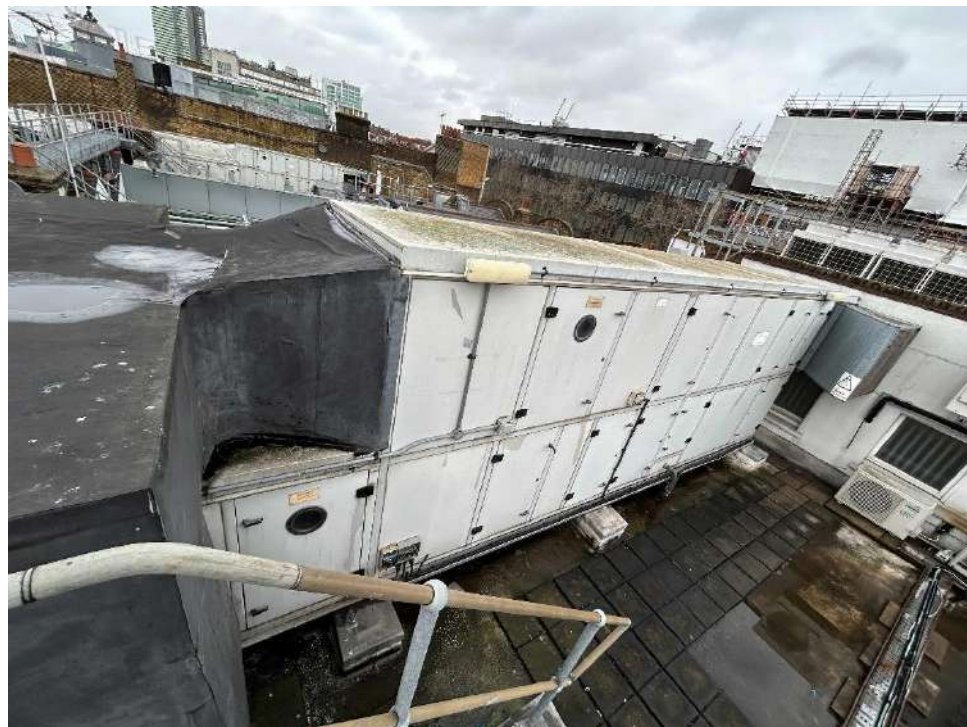
**Figure 4.1.1:** AHUs at roof level (via project team site visit).

The EPC for 1 Alfred Place (ref: 0240-5084-0331-0741-7044) was issued on 30<sup>th</sup> April 2009, and includes allowance for the electric heating systems, most likely in reference to the VRF condenser units that can be observed in Section 4.1. This suggests that they were installed prior to this EPC being issued, which means that the systems are at least 15 years old. Site review would also suggest that the AHUs are roughly the same age. As both of these systems typically have a service life of 15 years, these systems are deemed to be at the end of their service life and would require replacement.

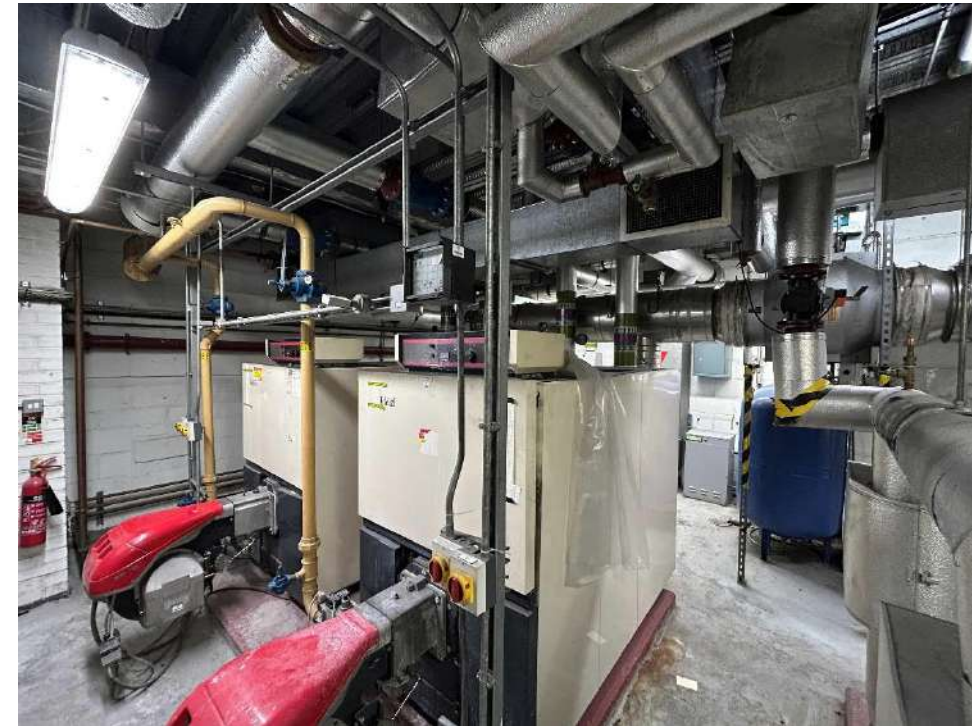
**Figure 4.1.2:** existing natural gas boilers at basement (via project team site visit).

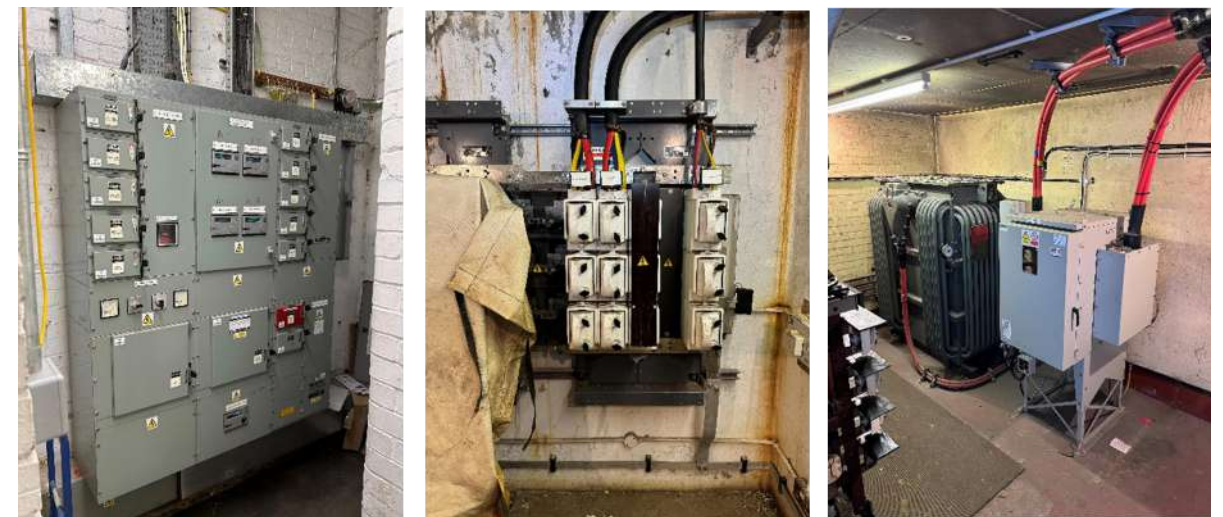
**Figure 4.1.3:** typical images of age, state and condition of existing electrical equipment including switchgear and transformers (via project team site visit).

Some of the basement systems, particularly the electrical systems such as the transformer and the switchgear, appear considerably older than this, with some of the equipment typical of kit installed in the 1970s and 1980s. The condition of these systems is poor, and they are deemed unlikely to meet more recent stringent regulations and testing requirements by the MEP consultant.

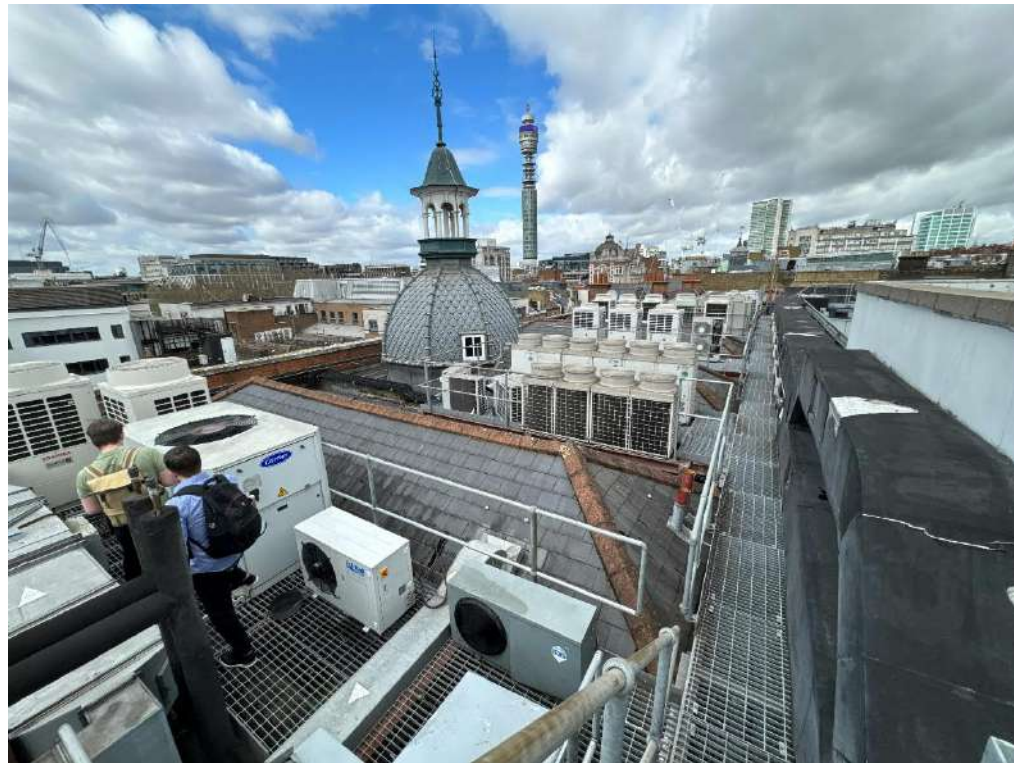
**Figure 4.1.4:** image showing condensers at roof level (via project team site visit).

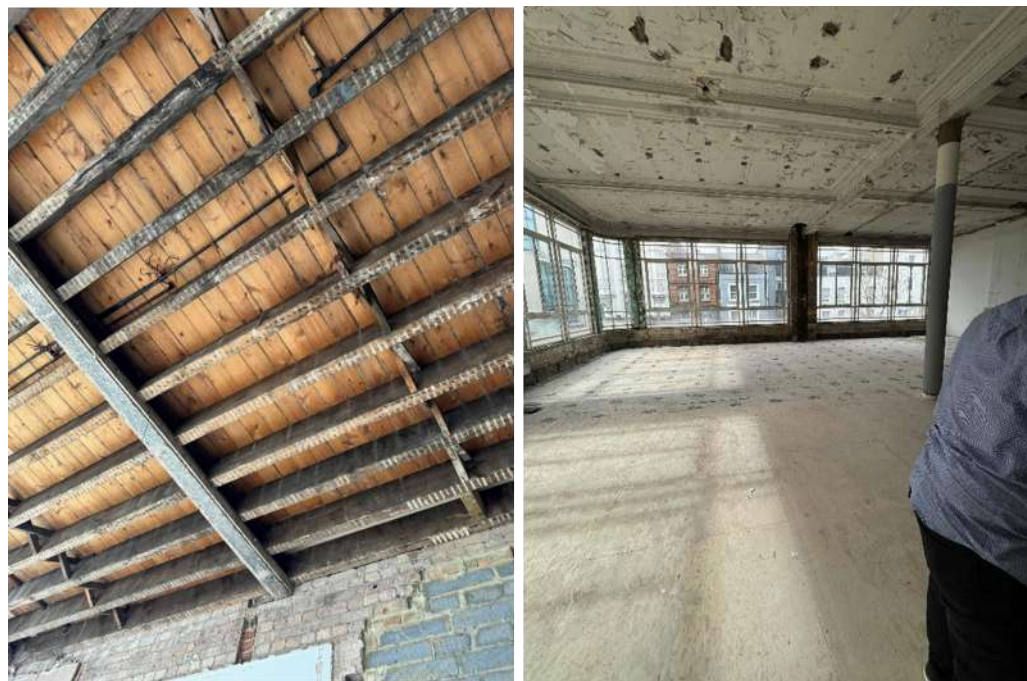
**Figure 4.1.5:** images demonstrating typical extents of services on floorplates i.e. minimal remaining services and systems on-floor (via project team site visit).

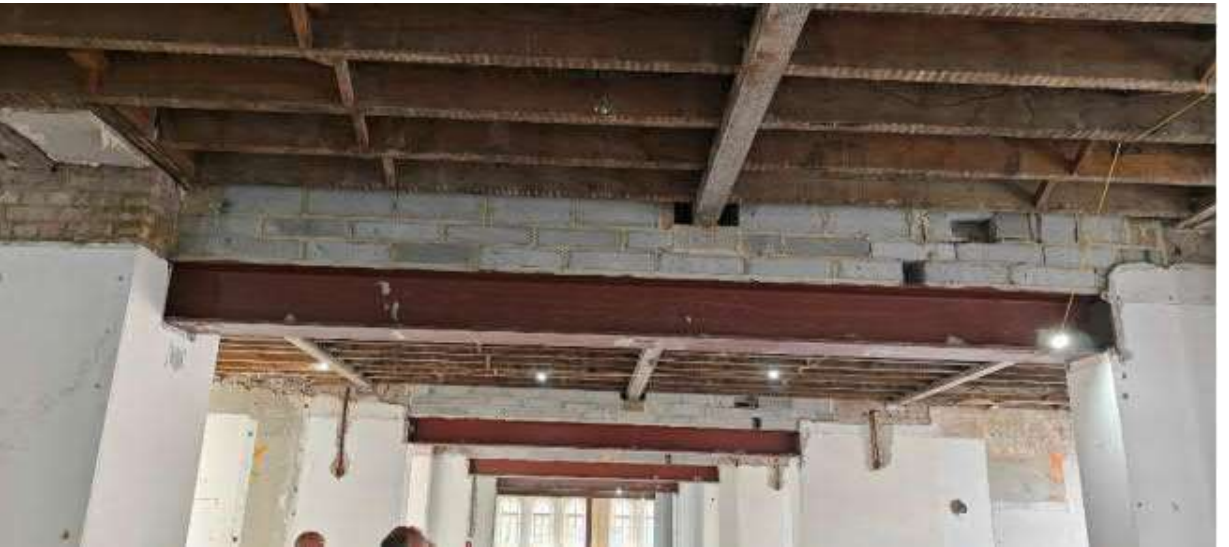
**Figure 5.3.1:** opening & load-bearing walls in 220-226 Tottenham Court Road.

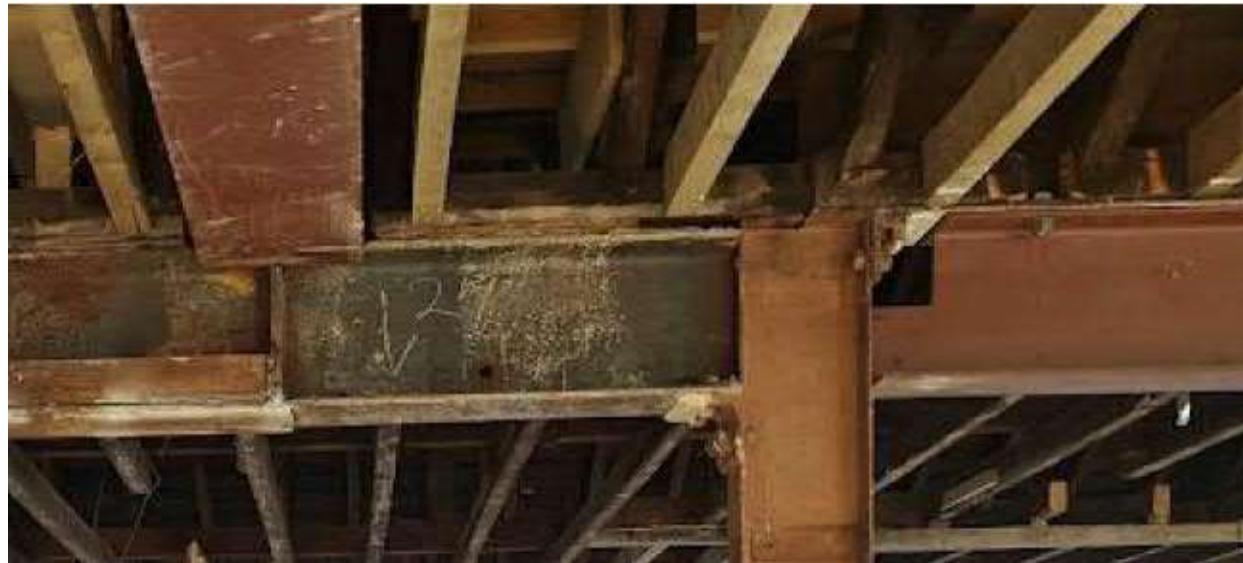
- **South block:** The steel grillage and ceiling installed during the refurbishment works has a number of unorthodox details and will require further investigation if it is to be salvaged, it has been recommended by EWP structures that this is to be replaced to allow it to continue to support the roof, plant deck, and/or be adapted to become a terrace.

**Figure 5.3.2:** Unorthodox steel detailing in steel grillage in 220-226 Tottenham Court Road. Key issues include lack of appropriate stiffeners and end plates to beams & top plate to columns.

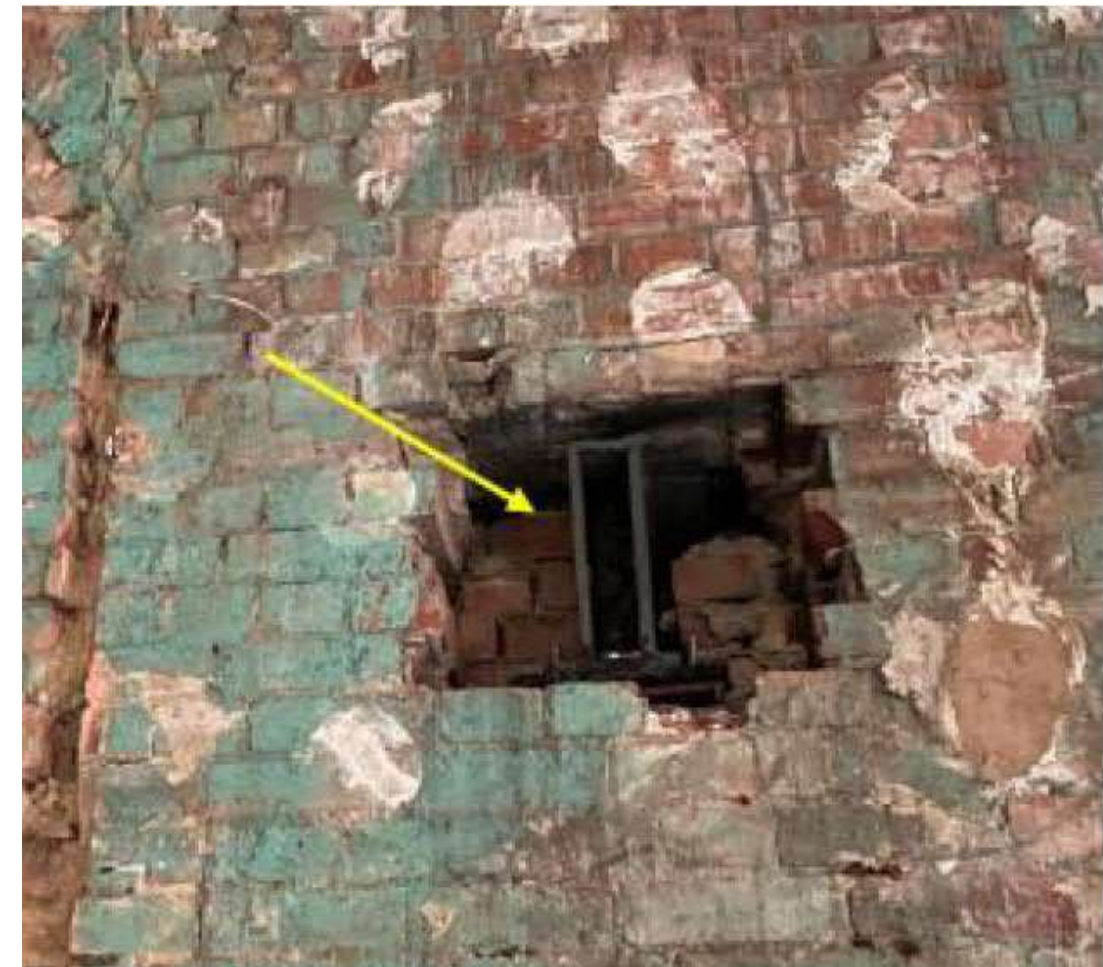
**Figure 5.3.3:** penetration through external wall of 22 Store Street.

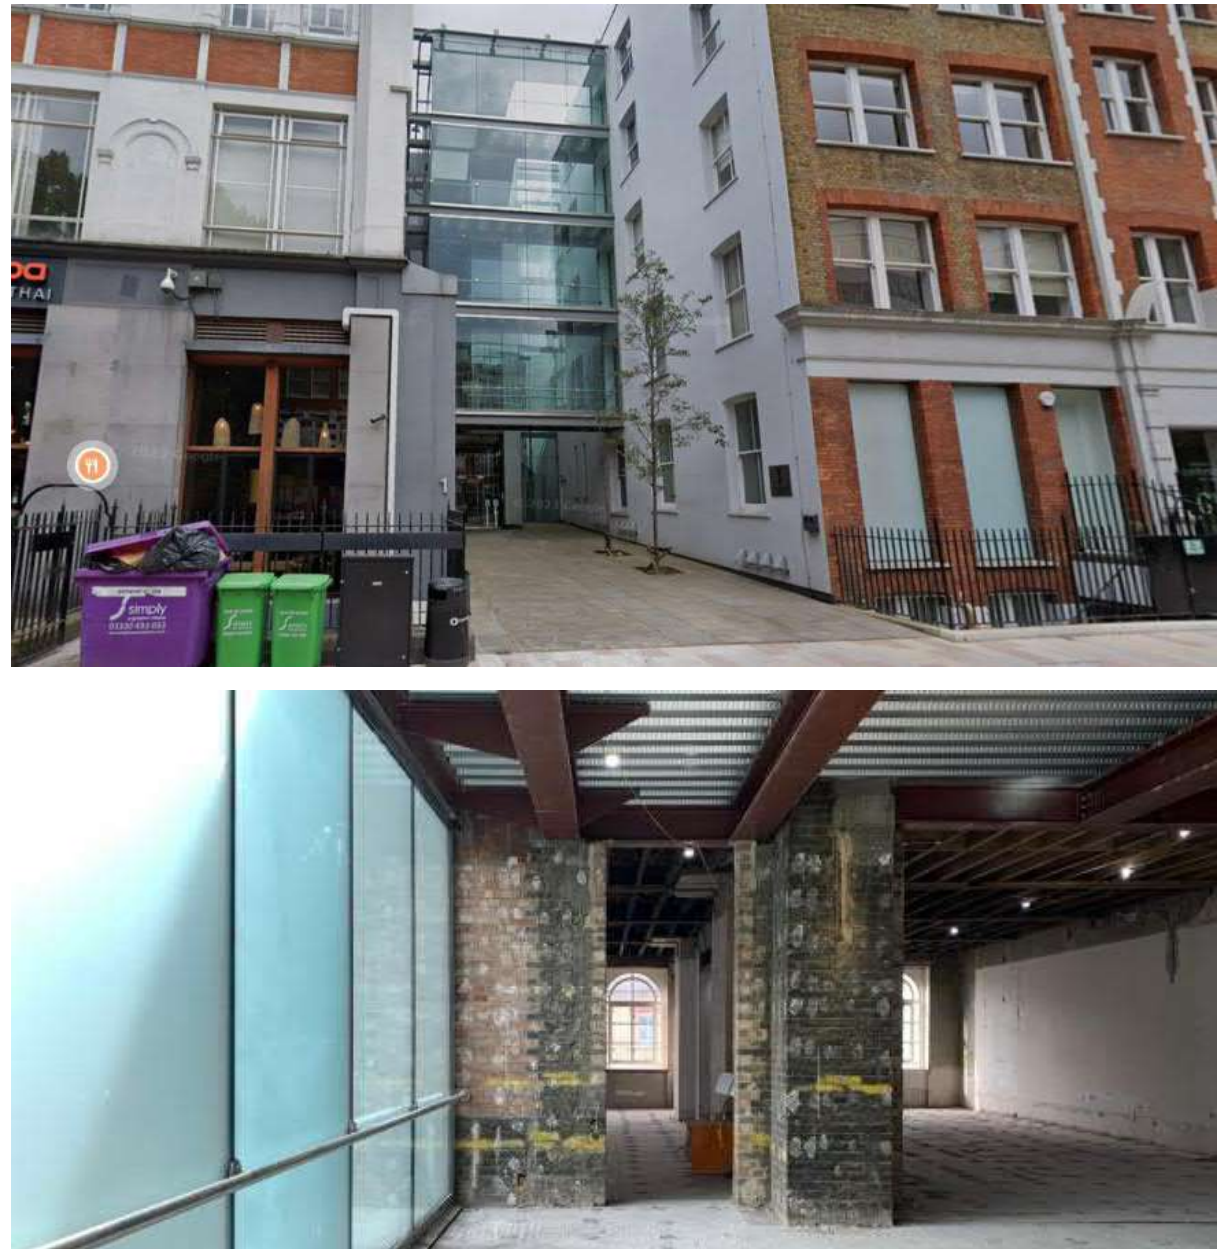
- Infill to the courtyard linking 220-226 Tottenham Court Road and 3-5 Alfred Place. It is constructed as a steel grillage with metal deck floors supported off existing walls to the other buildings.
- The party wall with 7 Alfred Place appears to have been an infill in blockwork with metal deck floors on steel beams. The floors have been built into the adjoining properties in each location, this is assumed to be a result of partially infilling the original courtyards in each property.
- The office entrance structure to link these buildings above ground floor is via a series of stair bridge links. The structure is steel and metal deck with glass facades.
- A number of the support details of the link are poorly executed and will need to be adapted or strengthened as part of the works.

**Figure 5.3.4:** Steel structure of the link building (first image) and internal image of steel and metal deck system (second image).

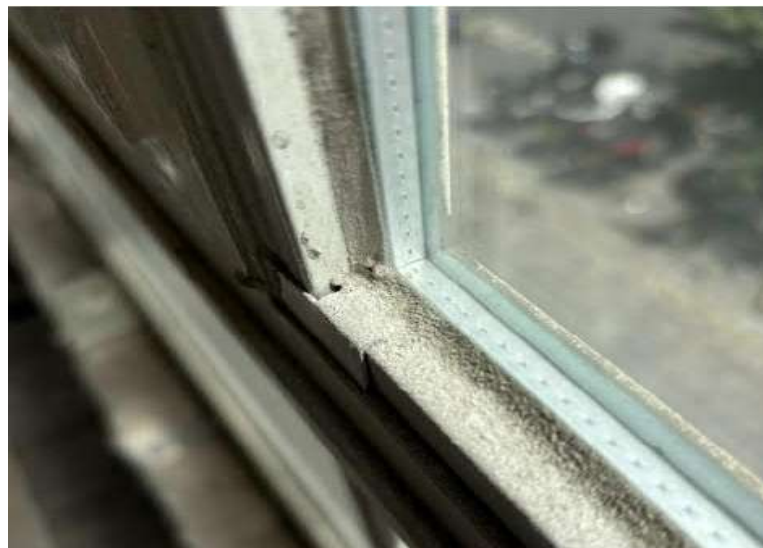
- The windows to Tottenham Court Road and Store Street are double glazed and potentially need replacing (See further comments/clarifications below). However, the windows to the Alfred Place are single glazed (Timber framed sash windows).

**Figure 5.4.1:** DGU glazing to Tottenham Court Road and Store Street elevations.

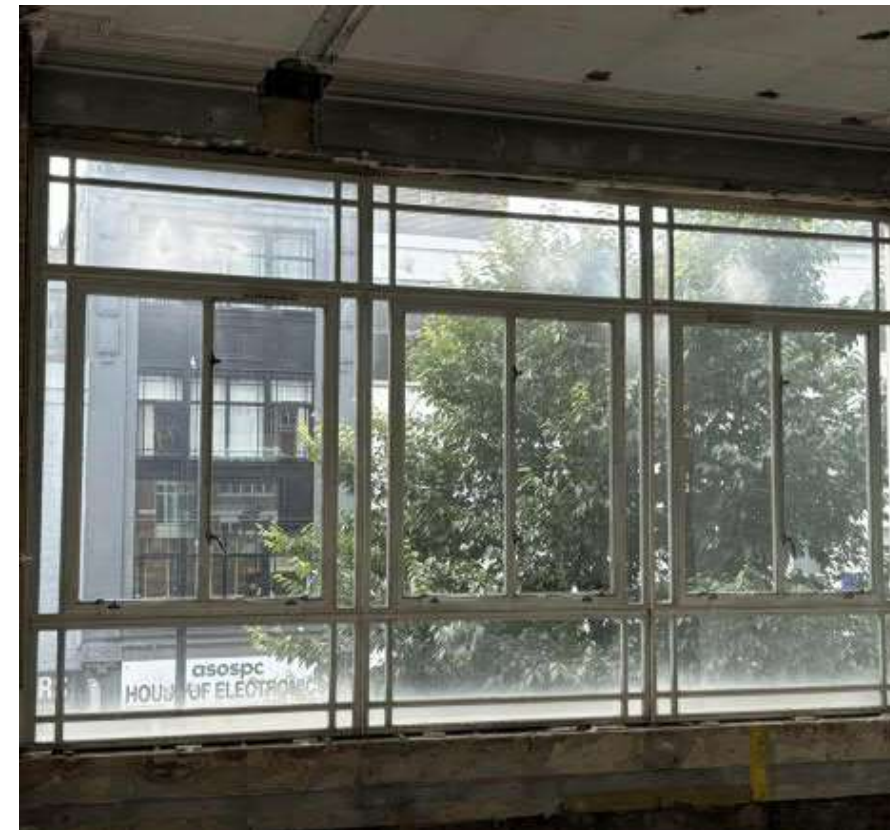
- There were several locations where interstitial condensation was evident in the existing DGUs.
- Typically, steel framed windows to Tottenham Court Road and Store Street.

**Figure 5.4.2:** steel frame windows to Tottenham Court Road and Store Street.

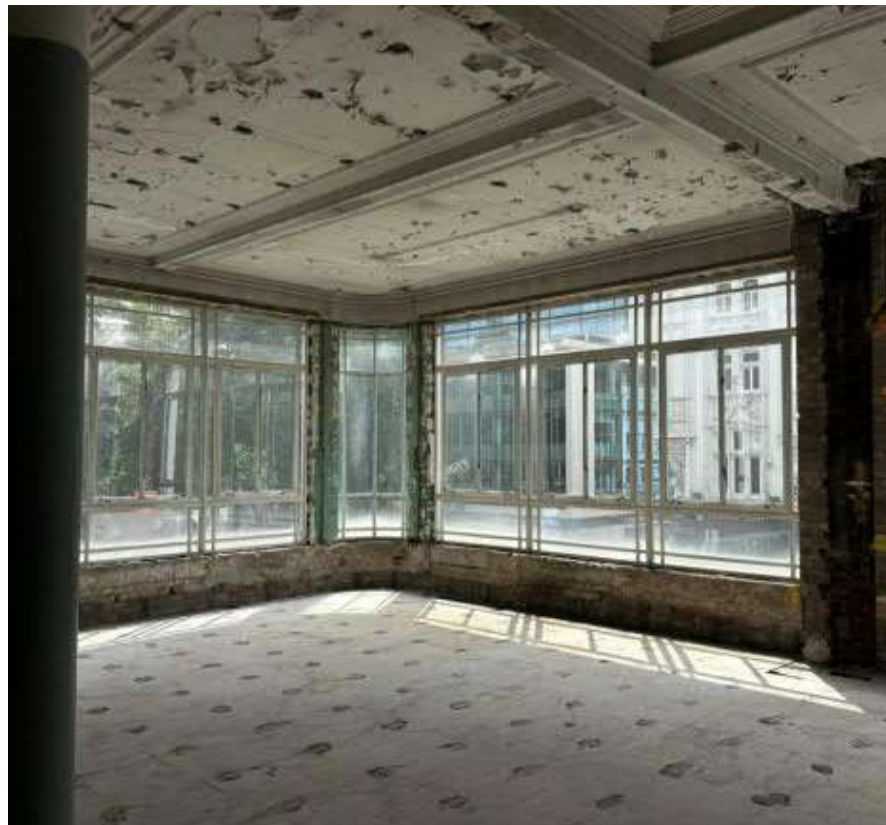
- The primary Tottenham Court Road and Store Street elevations are characterised at first floor level by large, South and West facing windows.

**Figure 5.4.3:** large south and west-facing windows on Tottenham Court Road and Store Street elevations.

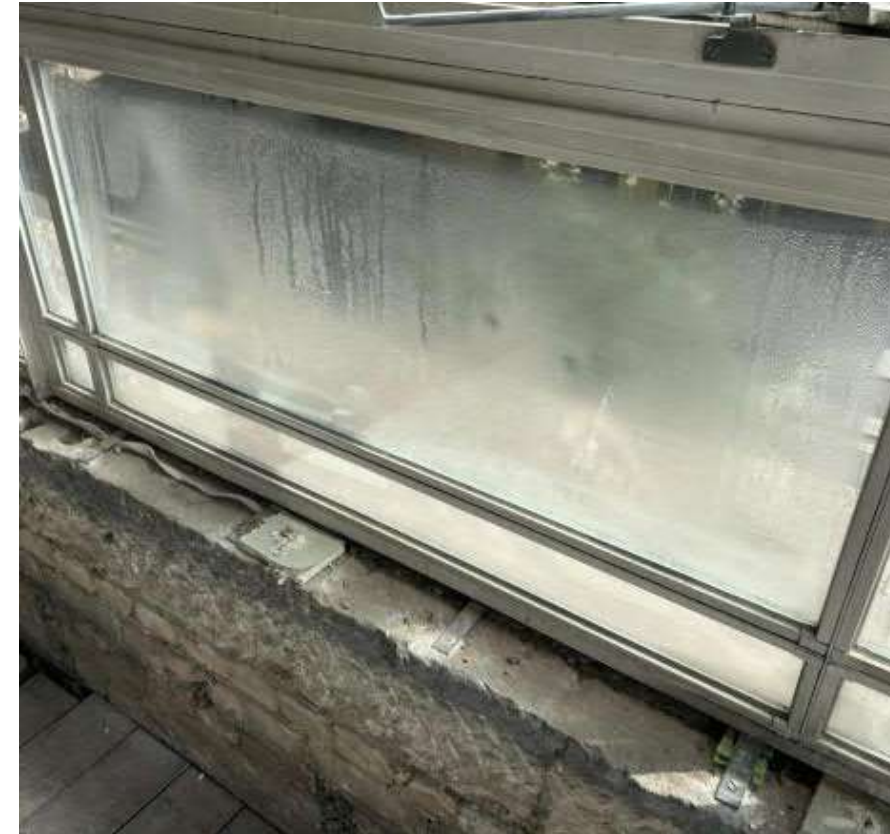
A number of the double-glazed units (DGU) have failed, whereby the edge seal no longer provides a fully sealed unit and interstitial condensation is evident within the cavity. These units will need to be replaced to meet the required u-value/thermal performance.

This is likely to be a result of the age of the unit and/or the condition of the window frame, or a problem with the manufacture of the unit. It could also be due to how the window was originally installed or a chemical cleaning material used on the window that over time has damaged the seal.

**Figure 5.4.4:** evidence of failure of DGUs.

Given the units were produced by Darbytuf, who ceased trading in approximately 2009, it is anticipated that the glazing units are circa 15-25 years old (a DGU would typically have a service life of 25-30-years).

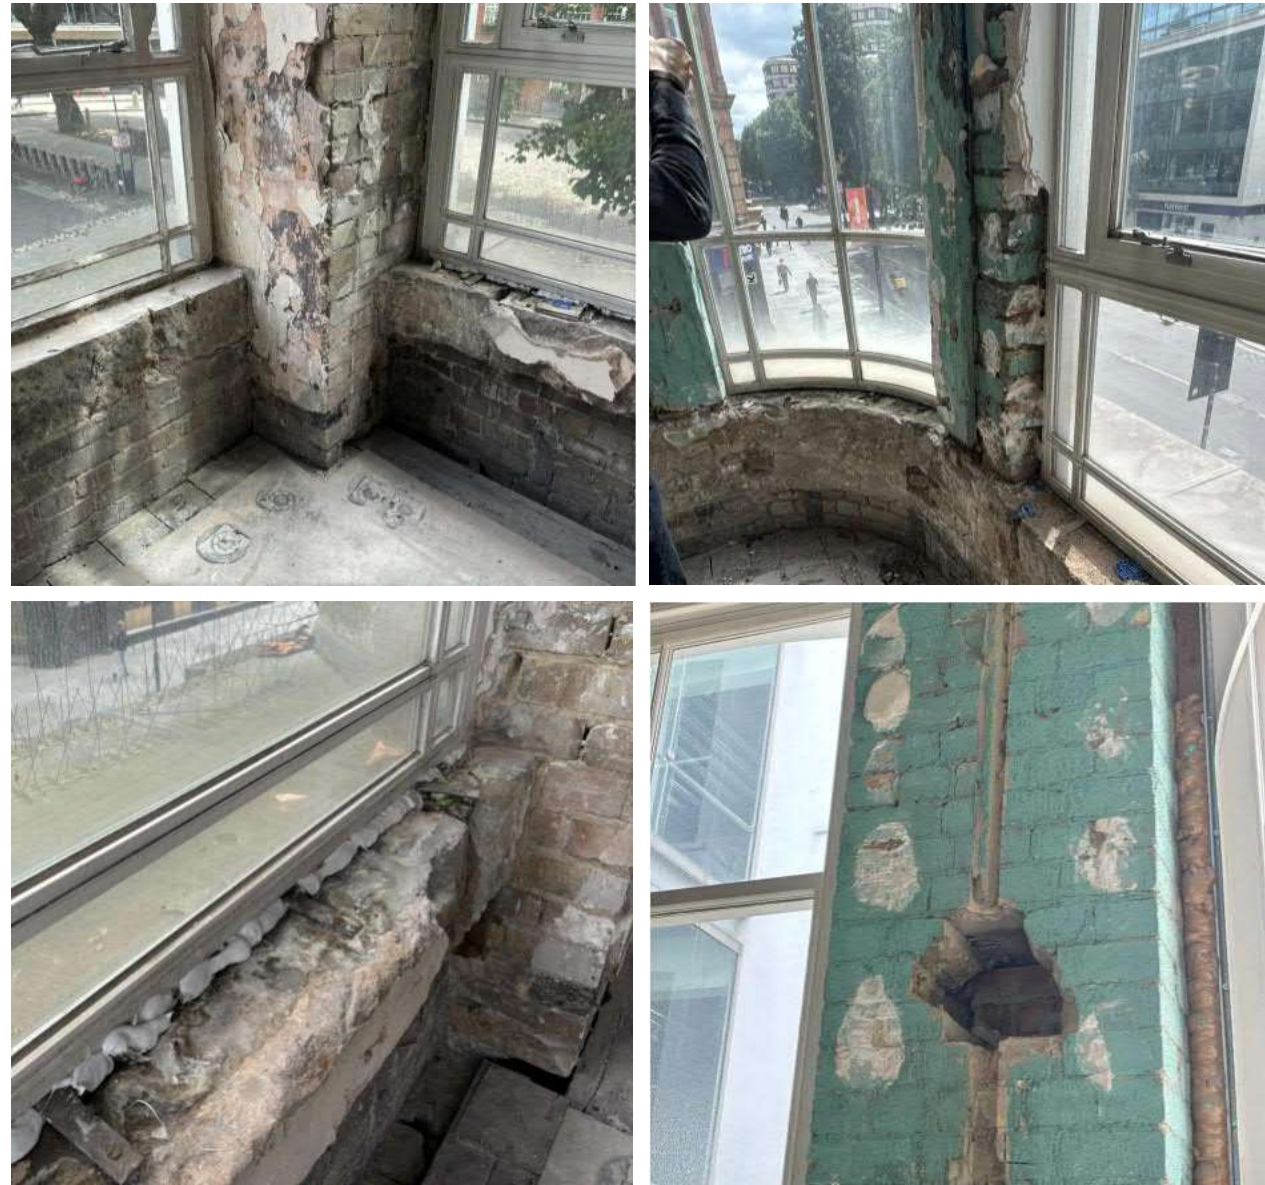
The quality of the masonry brick piers and walls is poor and in some locations sections of brickwork are missing, have been chased out or are loose and can be removed by hand. Further assessment of the brick piers may be required depending on the approach taken to the repair and thermal performance strategy for the refurbished building. If the approach is to insulate internally, further analysis of the wall construction will be required to determine the moisture content of the wall, to carry out thermal and condensation risk analysis.

As illustrated below, the quality of the interface between the glazing and the structural opening is very inconsistent and is likely a source of air infiltration/exfiltration through the facade. Any repairs/making-good should review the perimeter seals to the masonry piers. Ad hoc sealant work has been carried out in some locations, presumably to address water ingress issues.

**Figure 5.4.5:** condition of brick piers and façade/glazing interfaces.

Based on the evidence shown in Figures 5.4.5 and 5.4.6, it is also likely that thermal bridging is extensive across the existing facades and this is contributing to poor performance.

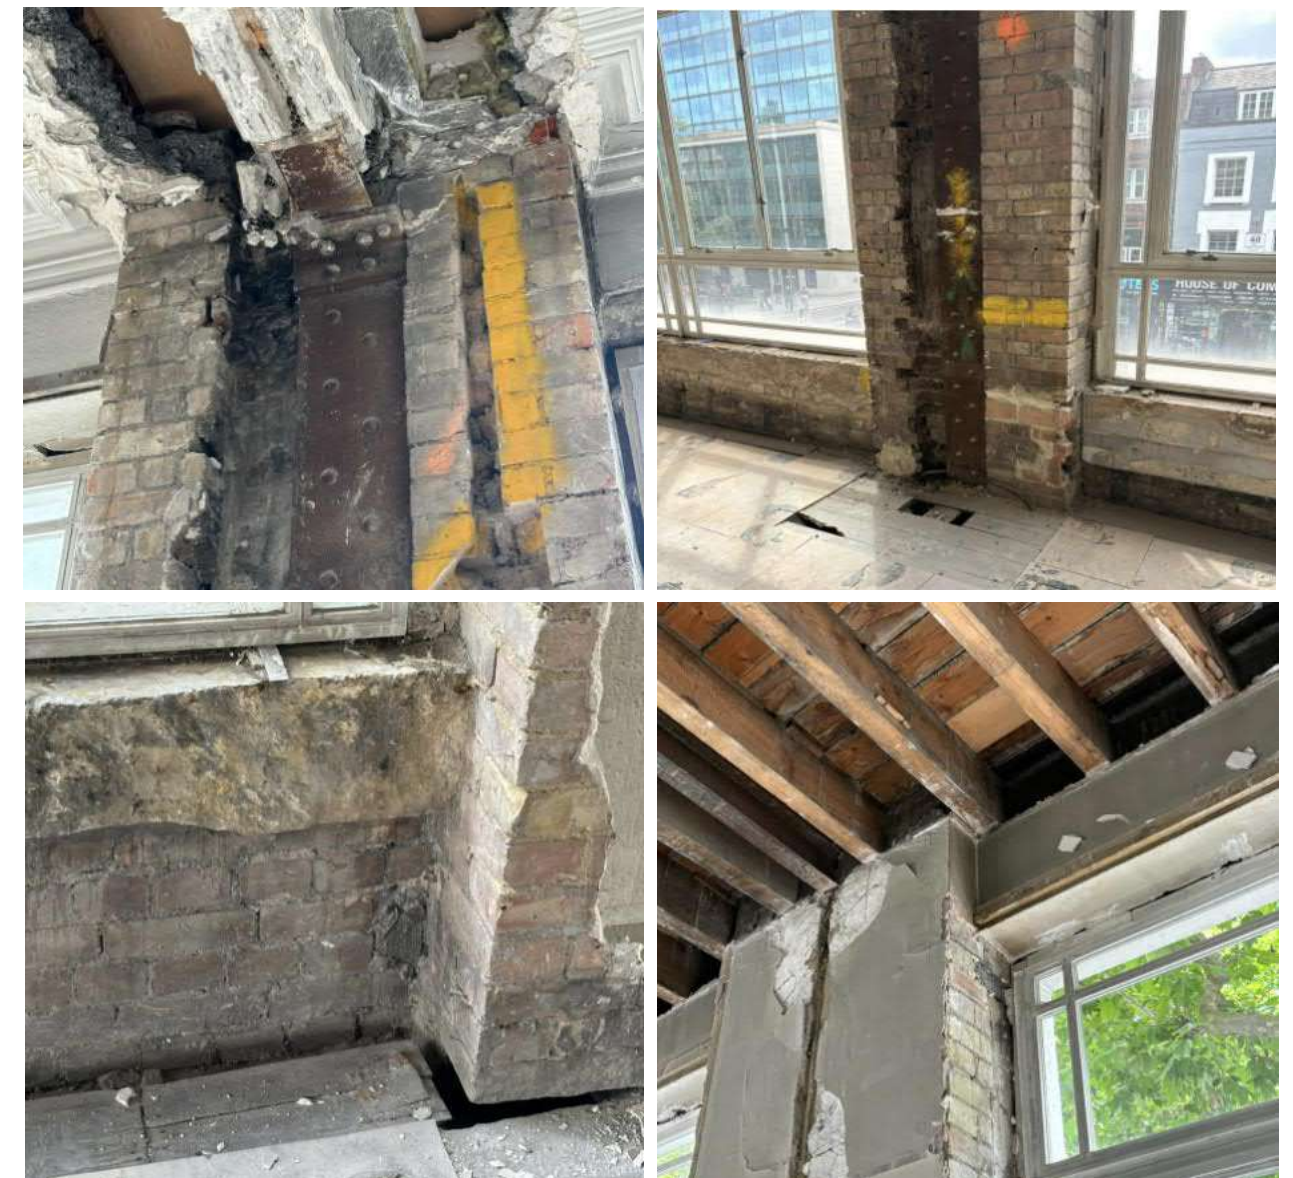
Given the condition of the external wall, missing/chased brickwork and pointing, and the primary frame steelwork being embedded in the masonry wall, there is the potential risk that adding insulation in-board of the external wall may alter the dew-point location which would potentially increase the moisture content of the existing wall construction and could lead to potential corrosion of the existing steelwork embedded in the masonry.

**Figure 5.4.6:** interfaces of facades and structures generating condensation risk if/where walls are insulated internally in any future upgrade of building fabric.

In an embedded steel frame structure, such as TCB, the prospect of condensation forming on the steel elements and accelerating corrosion is one to be avoided. As a result, it is recommended that retained facades with embedded steelwork within the facade are not internally insulated. The embedded steelwork needs to remain warm to avoid moisture forming on its surface, which could accelerate its corrosion rate. In accordance with BS EN ISO 13788, monthly mean relative humidity on the surface of steelwork should remain below 60% to avoid corrosion. Internal insulation of any type will leave the embedded steelwork cold and move the dew point internally towards the insulation zone (see Appendix B), increasing the risk of moisture forming on the embedded steelwork, accelerating its corrosion rate. Other options, such as insulating with capillary active and vapour permeable insulation, may be alternative solutions that avoid this issue and move the solid wall elements towards a more reasonable U-value, but are still unlikely to achieve the thermal performance close to new Part L requirements. The analysis was carried out with boundary conditions of -5°C/+20°C and 40% RH.
