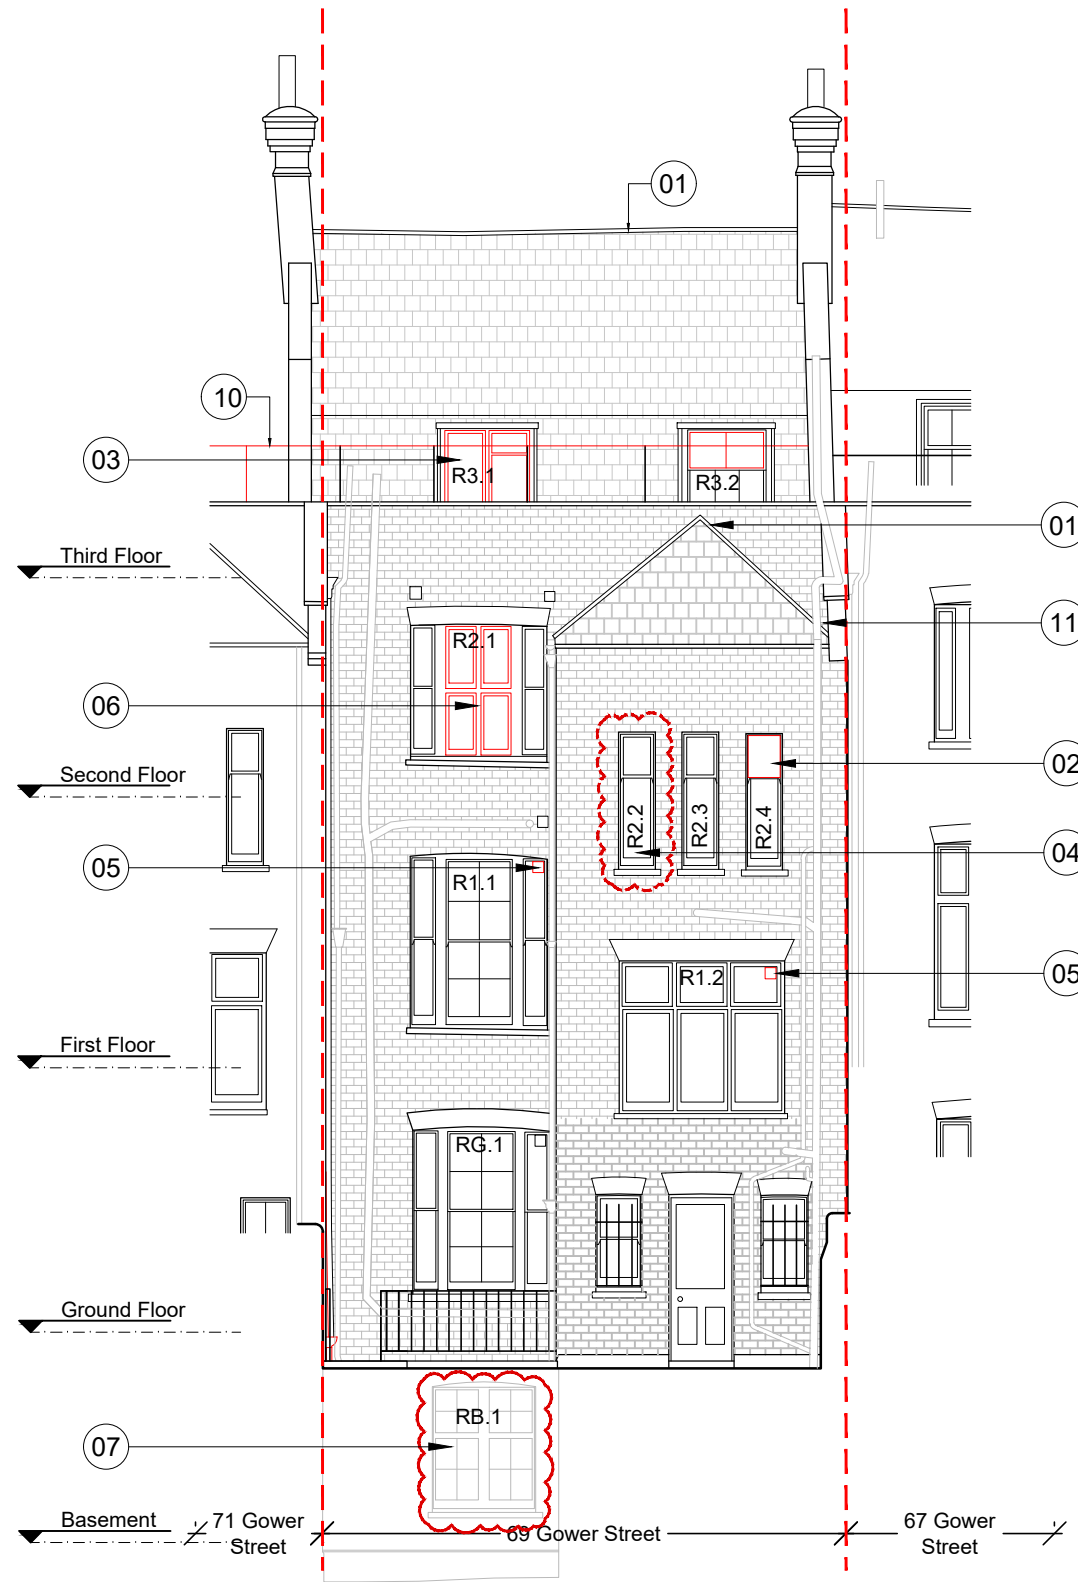
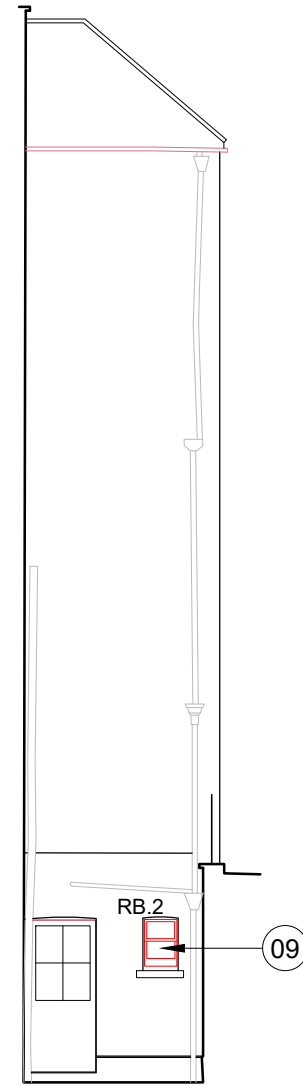
- 01 Evidence of rolled lead ridge and hips
- 02 Upper pane boarded over
- 03 Low quality 20th Century dormer casement. Very poor condition
- 04 Window has been boarded over internally.
- 05 Mechanical extract through glazing
- 06 20th Century casement windows mismatched to Victorian sash window on floor below (R1.1). Fair condition.
- 07 Replacement casement window assessed to be 1920s/1930s. Modern ironmongery.
- 08 Cill rotten
- 09 Upper sash mismatched glass
- 10 Steel balustrades provides inadequate protection
- 11 Existing parapet gutter to hip falling away from gutter, remedial work required.
- 12 Rotten ladder
- 13 Rotten timber balustrade
