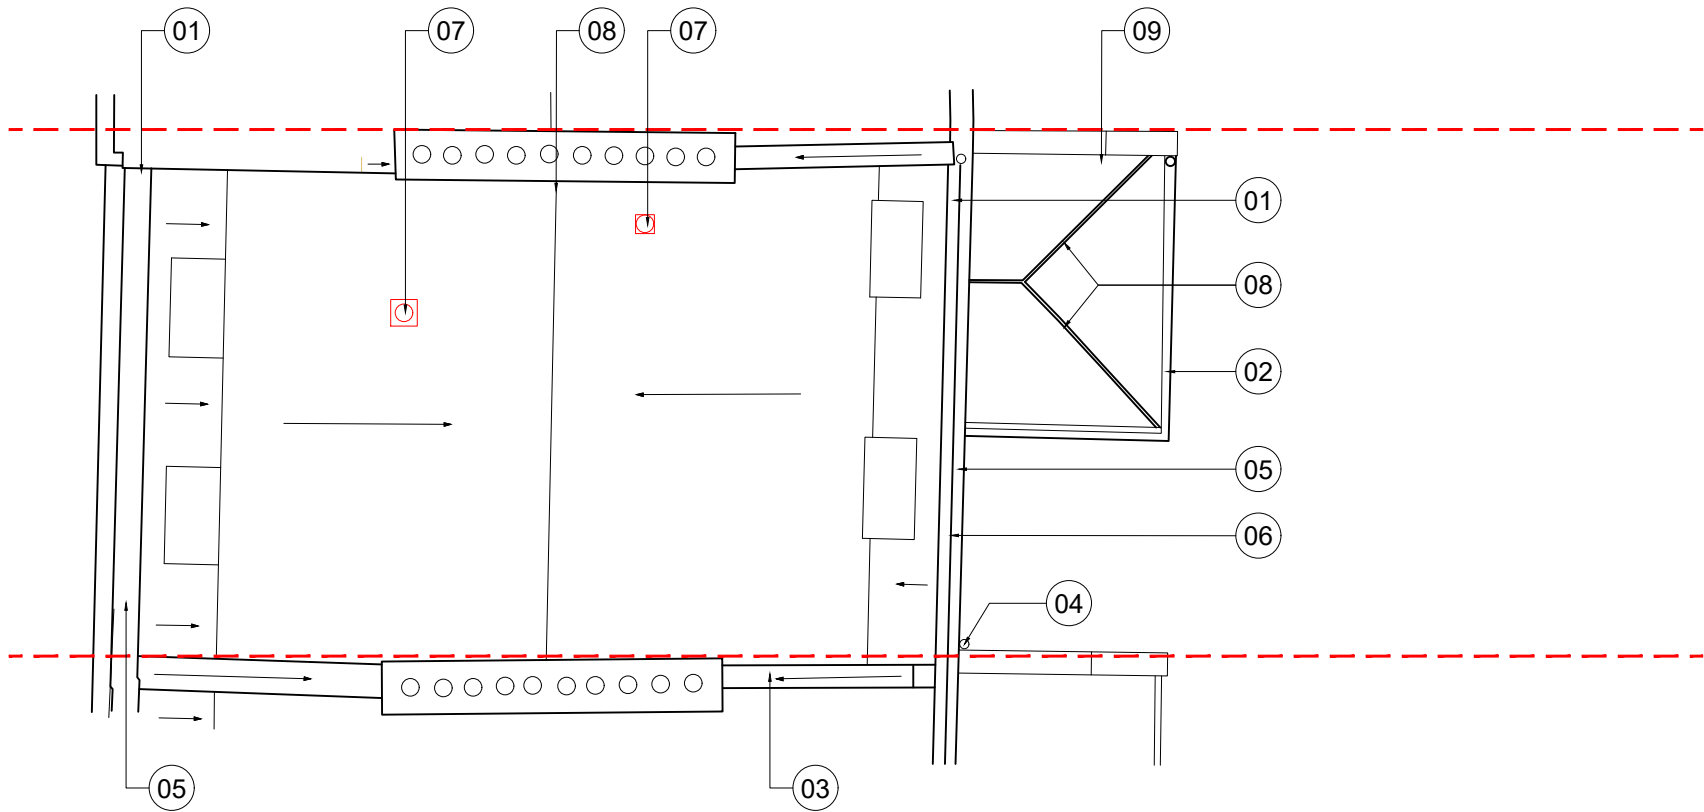
- Indicative Site Boundary
- Existing gutter waterproofing with liquid applied membrane in poor condition
- Existing gutter in poor condition
- Existing party wall in poor condition
- Existing Rainwater outlet
- Concrete parapet coping in poor condition
- Steel Balustrades provides inadequate protection
- Existing soil vent pipes penetrations through roof.
- Evidence of rolled lead ridge and hips
- Existing parapet gutter to hip falling away from gutter, remedial work required
