**Arboricultural Method Statement**

**9-11 Belsize Grove  
London  
NW3 4UU**

01 March 2024

Details of current site conditions and root damage uncovered during supervised excavation around garden pavilion posts holes can be seen in the Arboricultural Site Supervision Records (Arbtech ASSR 01, 02 & 03) in **Appendix 2**.

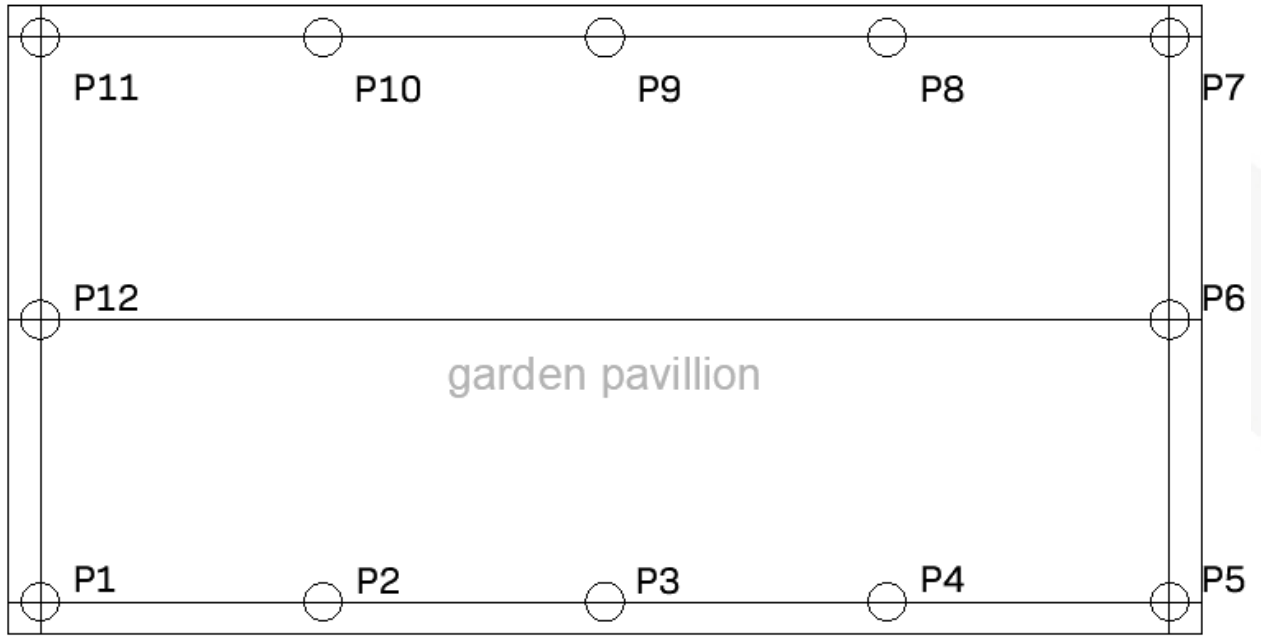
**Figure 1:** Post hole locations

Each of the posts have been numbered P1 – P12 (Fig. 1). During this visit, the areas surrounding two of the posts (P1 and P7) were excavated by hand under supervision to check for root damage. Due to a lack of access to the areas surrounding the remaining posts, it was agreed that the concrete and timber would be removed from these areas prior to the next visit taking place.

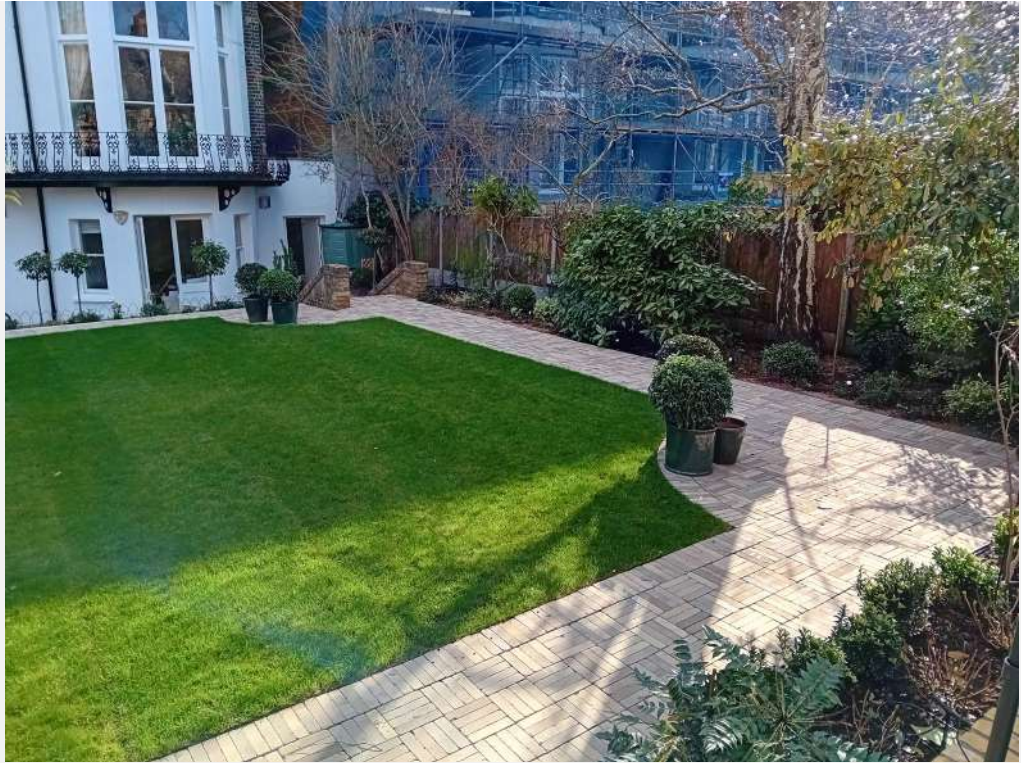
1 – New paving and lawn in the lower garden.

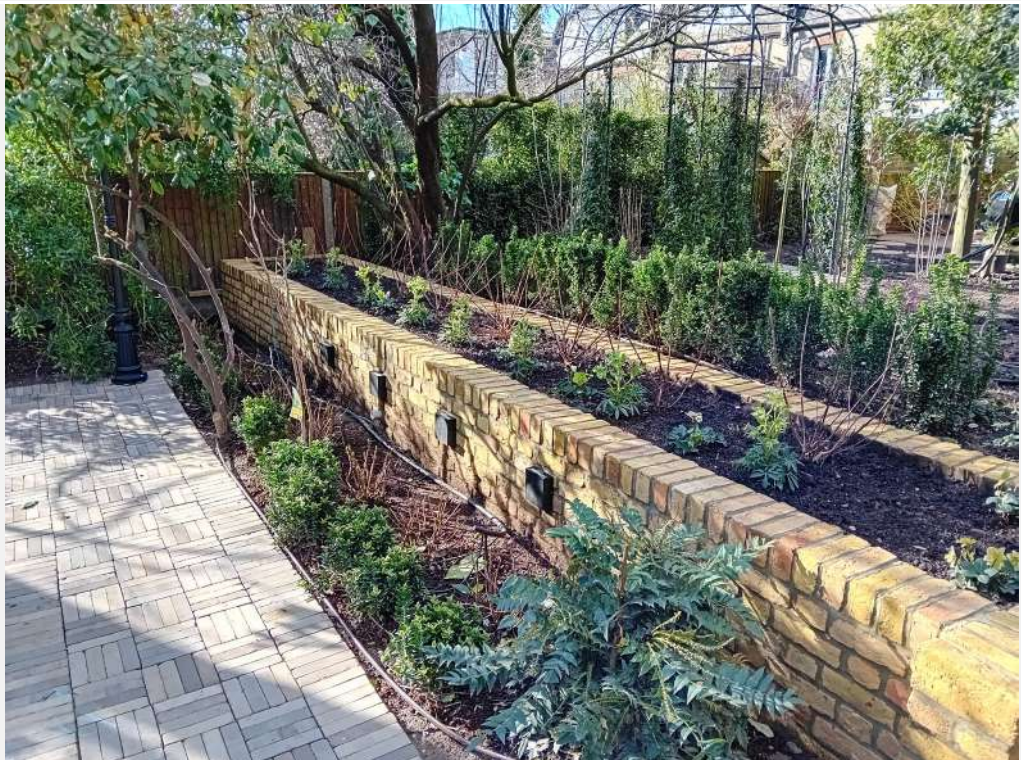
2 – Retaining wall constructed separating the upper and lower garden.

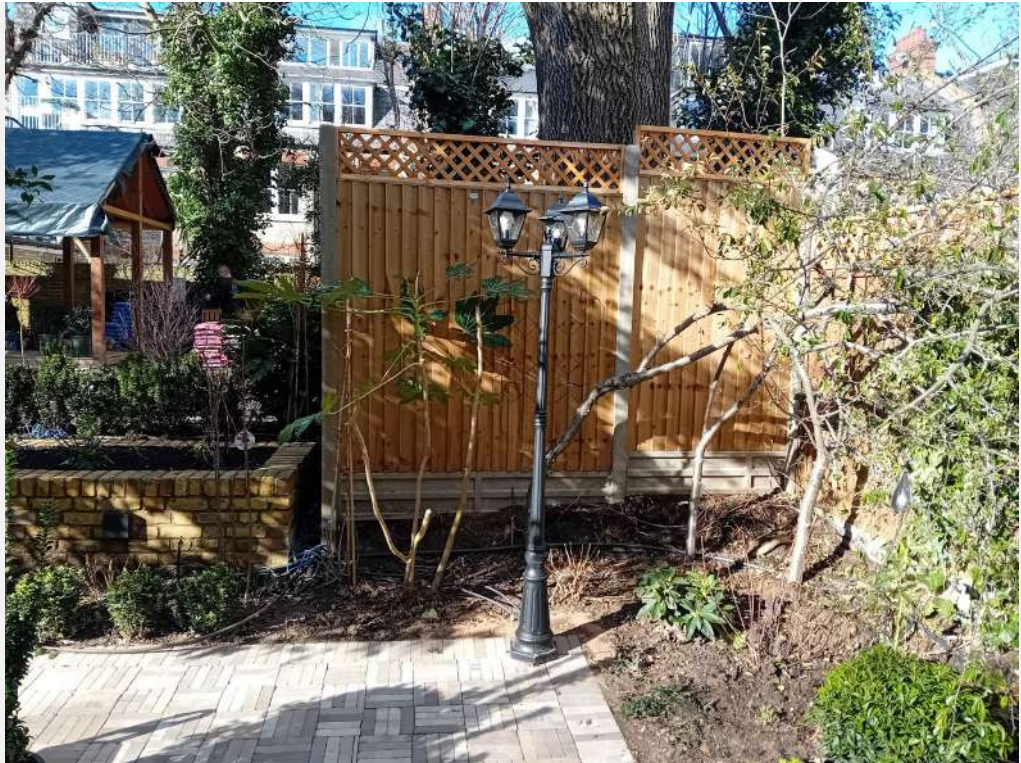
3 – Ground level lowered adjacent to the base of off-site tree T12.

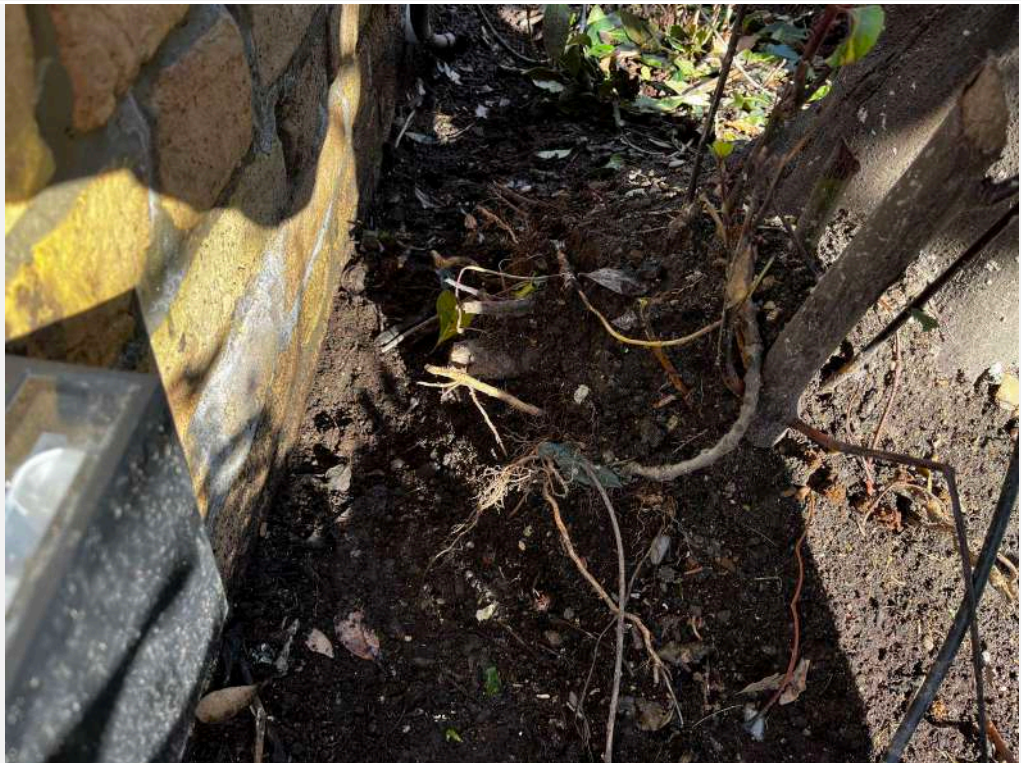
4 – 60mm root severed at the base of tree T16.

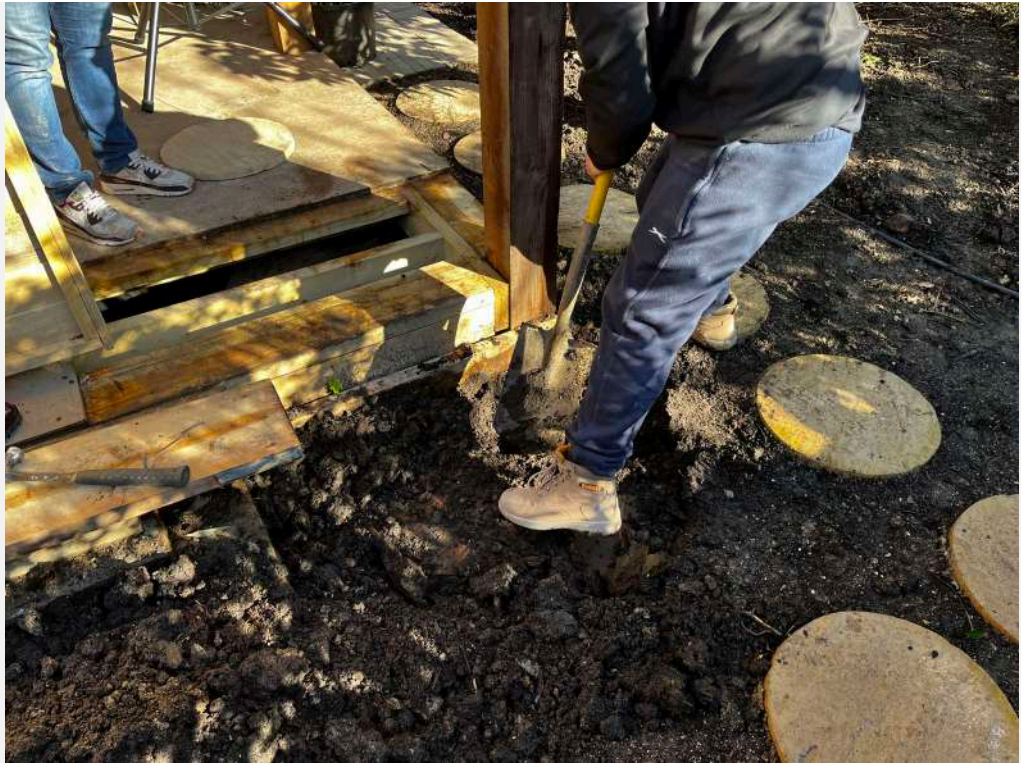
5 – Beginning of hand excavation around post P1.

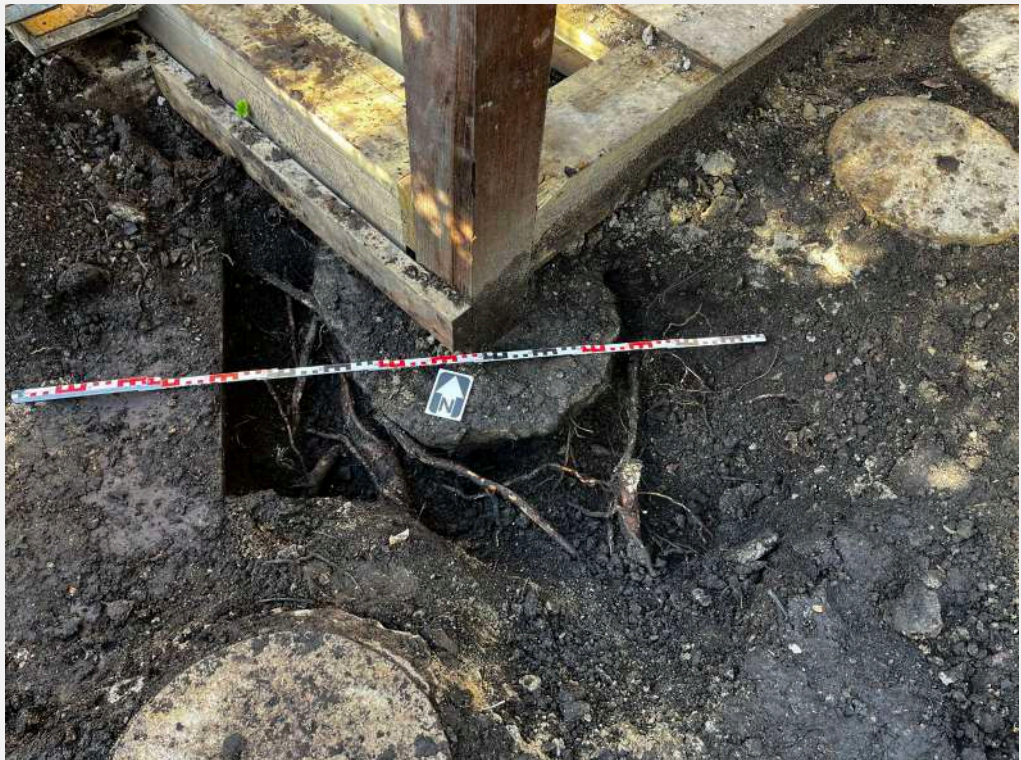
6 – Numerous roots surrounding concrete within post hole P1. Concrete is 600mm/700mm in diameter. 1x30mm, 1x50mm & 1x60mm roots severed. Roots likely to be from adjacent holm oak T05.

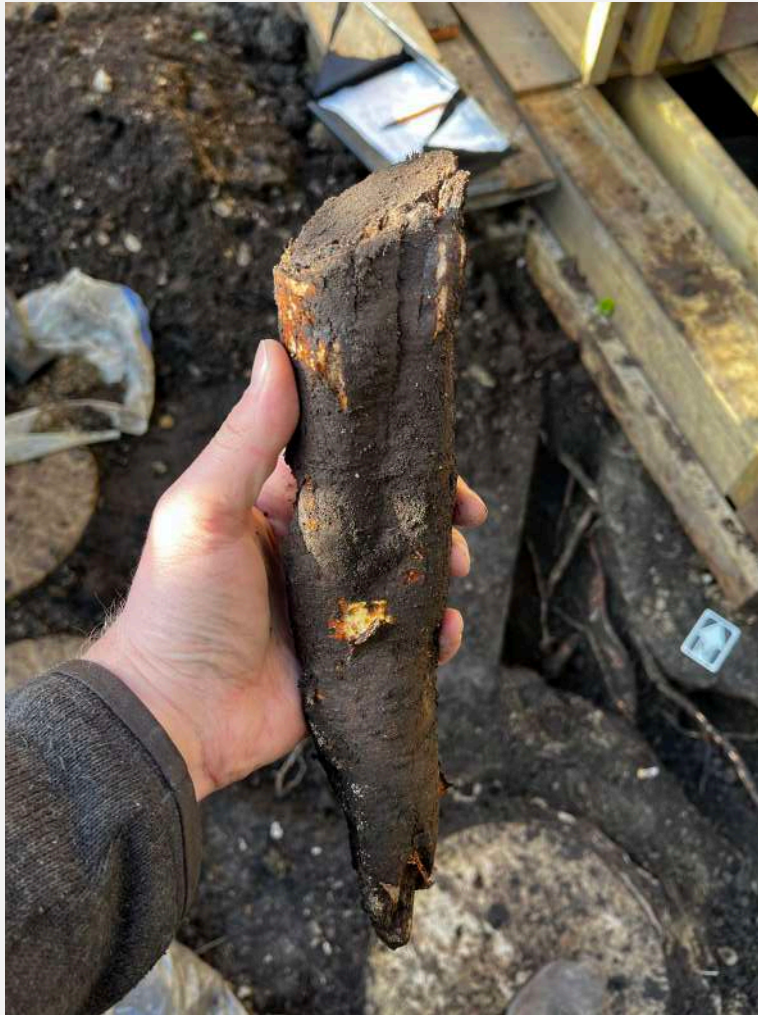
7 – Severed  
root removed  
from P1  
310mm x  
60mm.

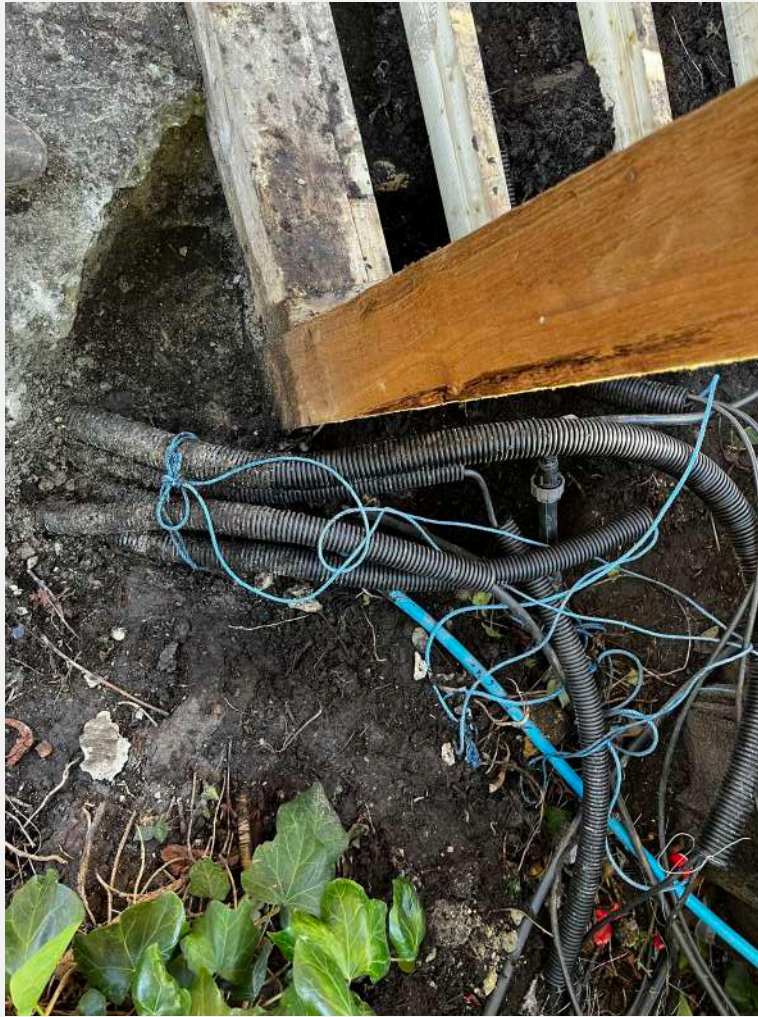
8 – Services  
within post  
hole P7.

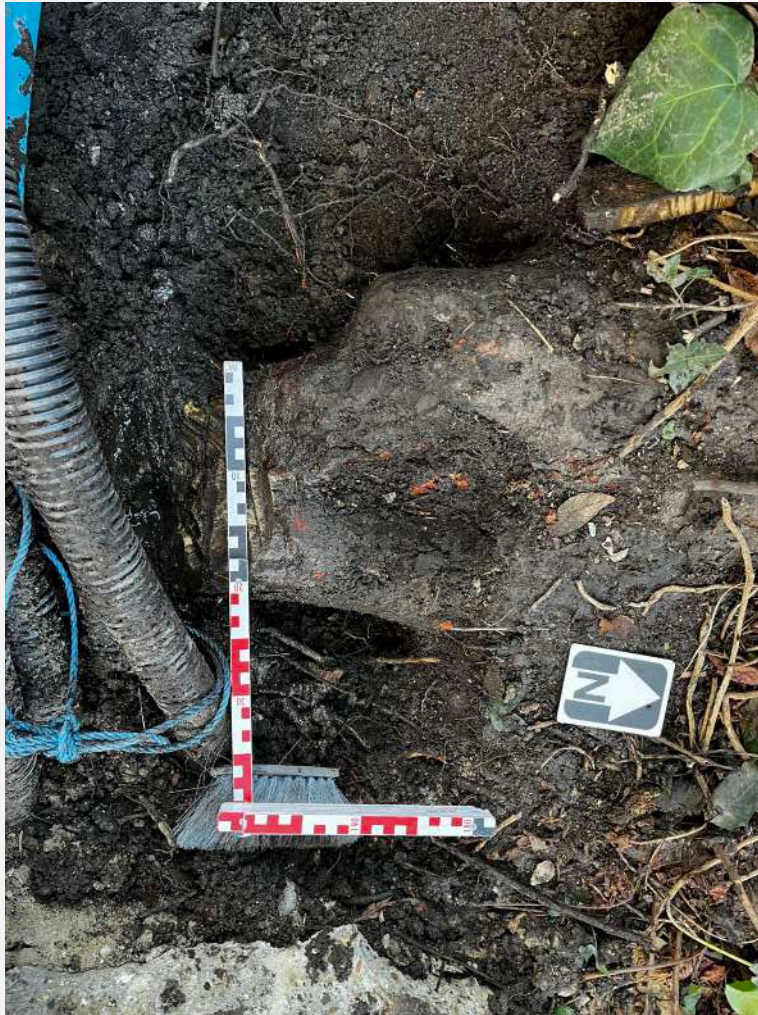
9 – 220mm diameter root from horse chestnut T08 severed within post hole P7. Structural integrity of tree T08 may be compromised.

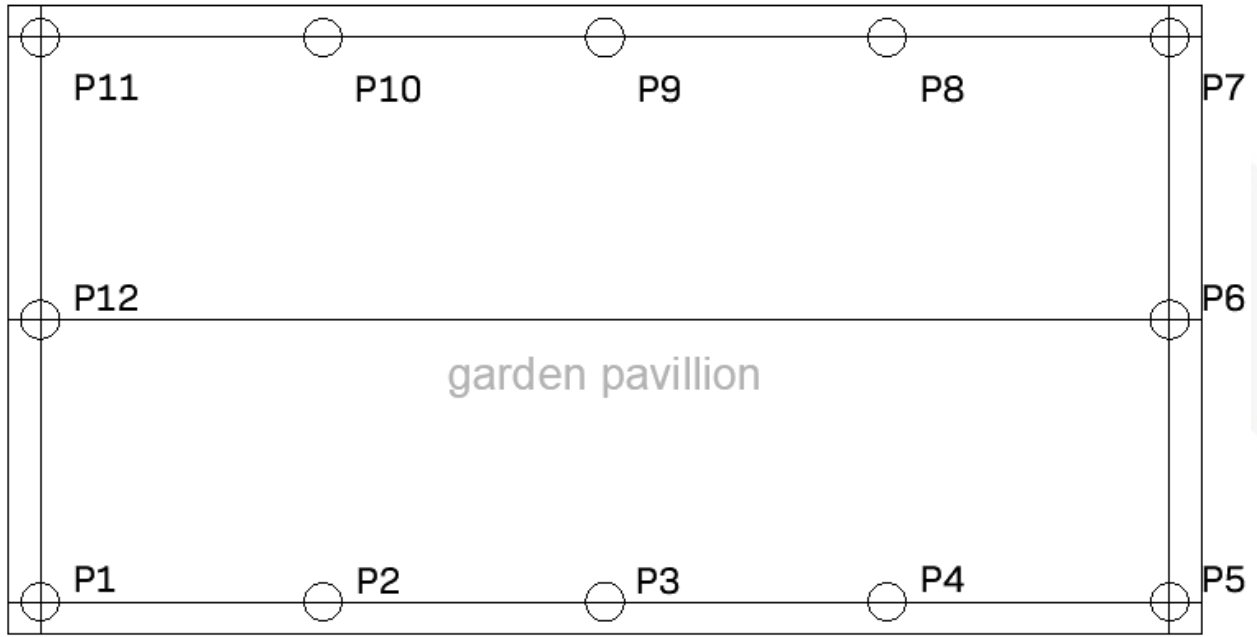
**Figure 1:** Post hole locations

During this visit, the area around post hole P9 was excavated as far as was possible. Excavation was limited due to the proximity of the summer house structure. Several severed and/or damaged roots were discovered as detailed below. It is recommended that the full area be cleared of the summer house structure to allow proper inspection.

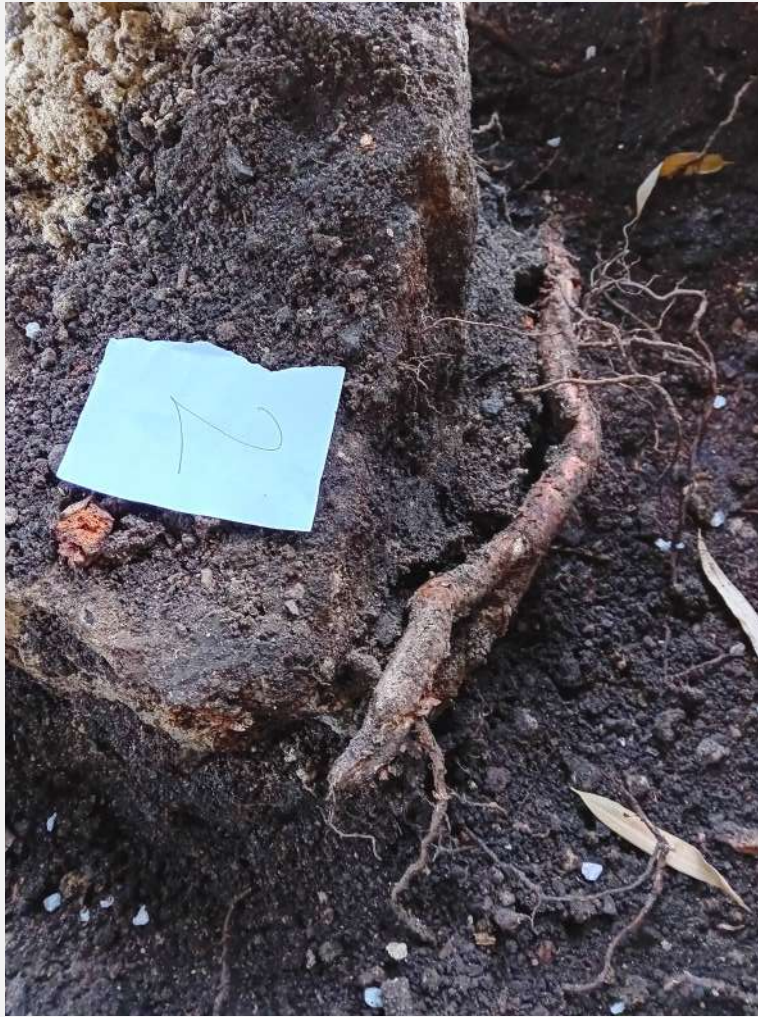
2 – 20mm  
horse  
chestnut root  
severed within  
P2.

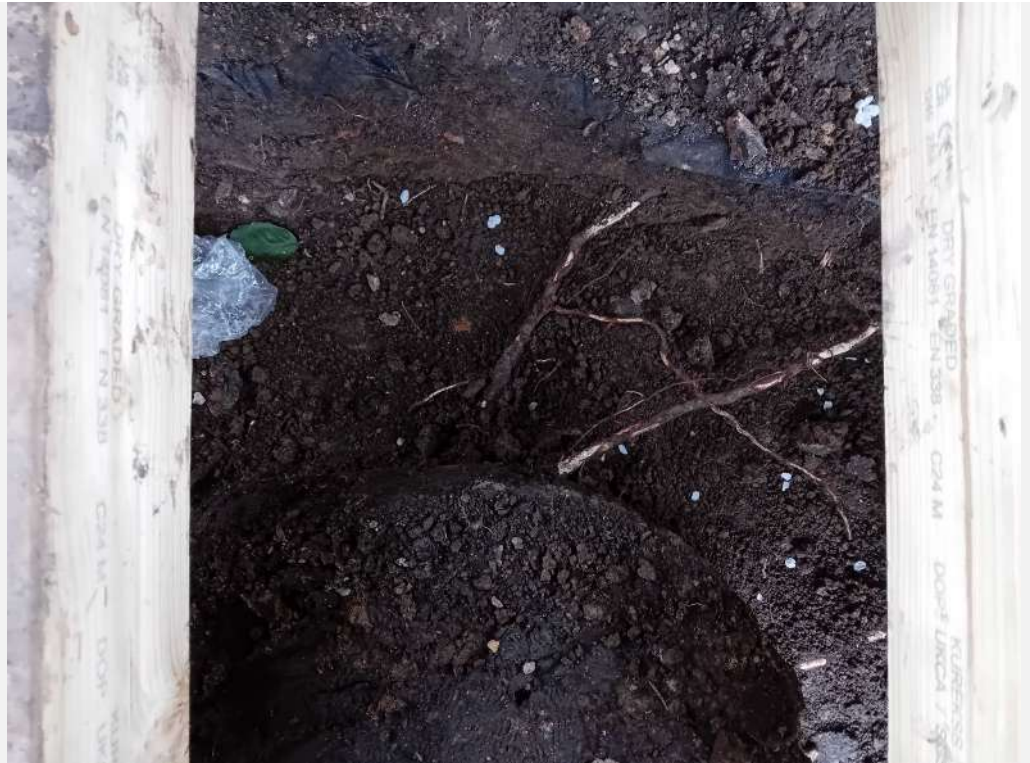
4 – 2x20mm  
horse  
chestnut roots  
severed within  
post hole P3.

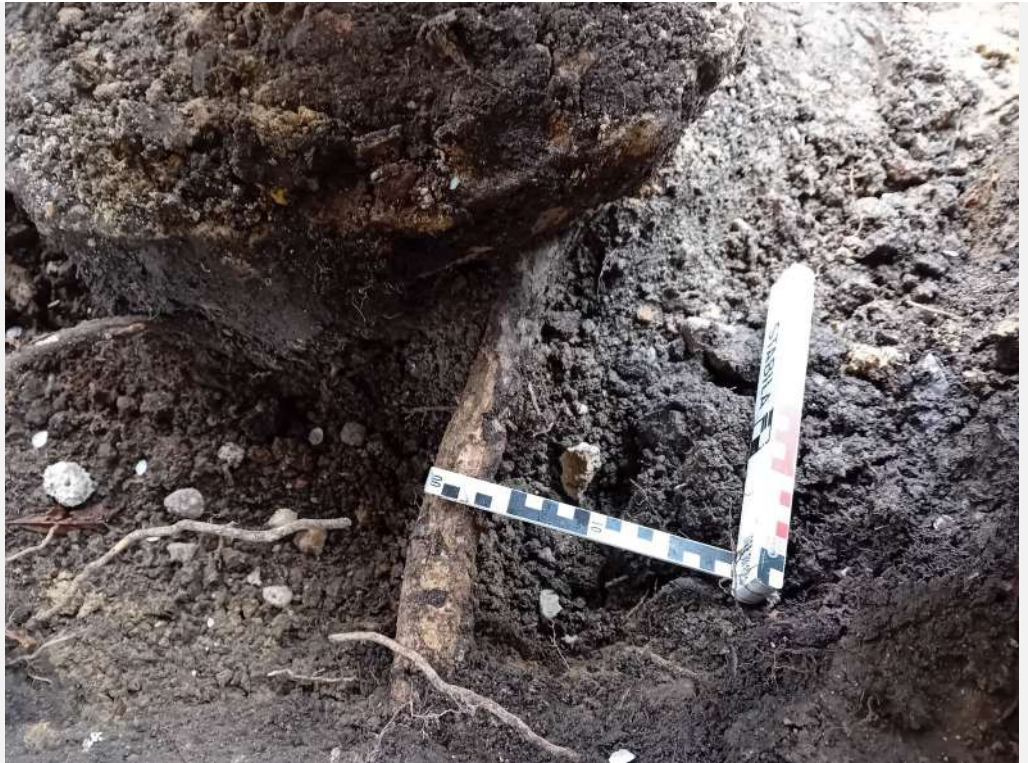
6 – 1x40mm  
ash root  
severed within  
post hole P4.

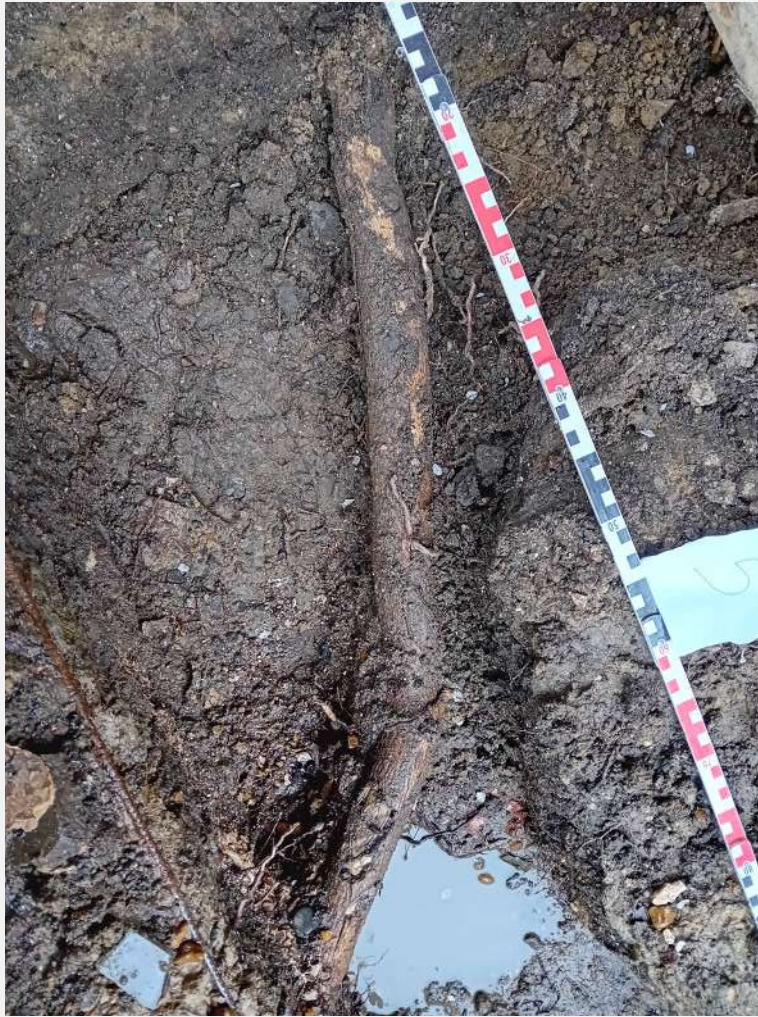
8 – 1x60mm  
and 1x25mm  
ash roots  
damaged  
within post  
hole P5.

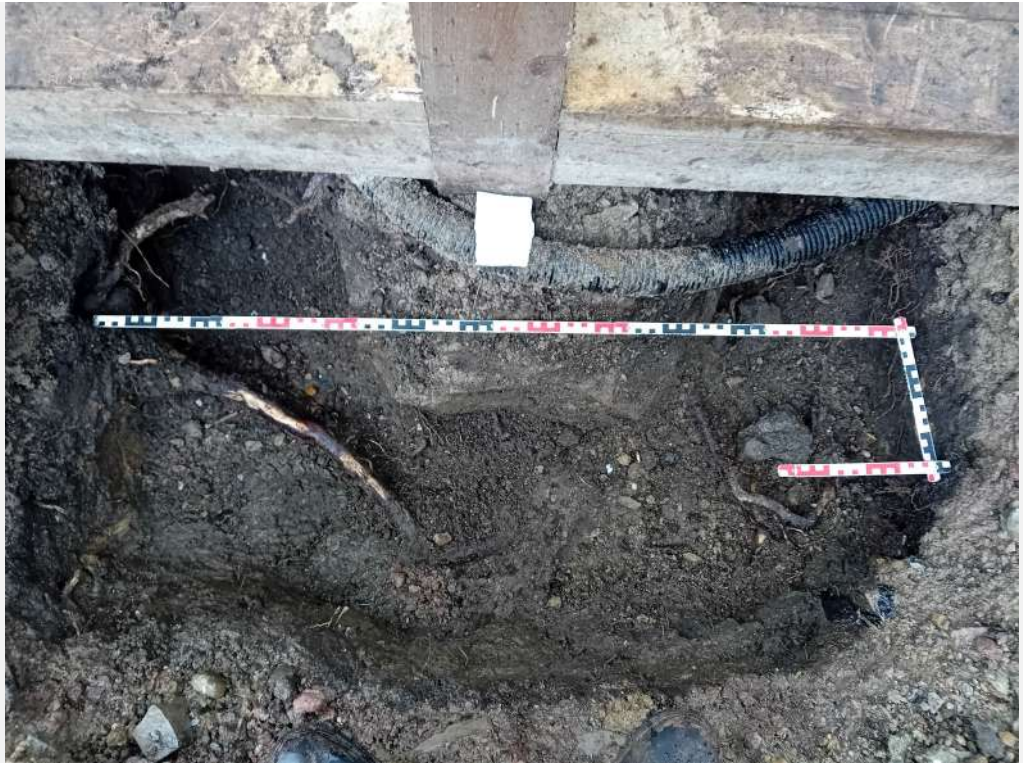
9 – Post hole  
P6. 1x35mm  
horse  
chestnut root  
damaged and  
1x20mm  
horse  
chestnut root  
severed.

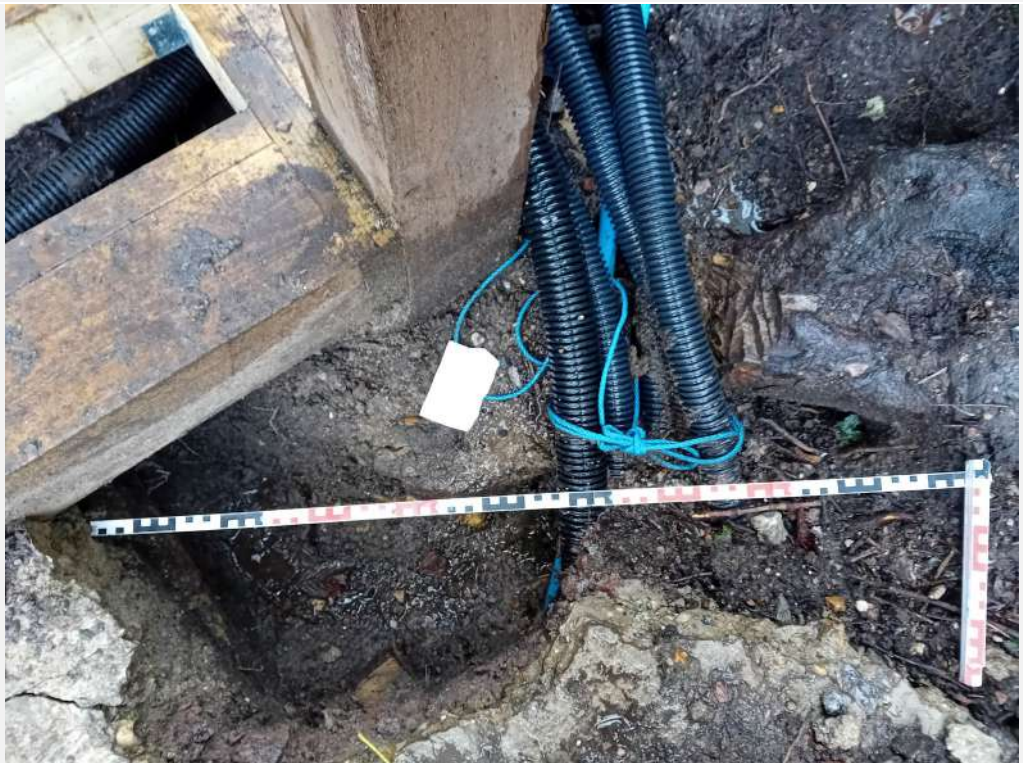
10 – Post hole  
P7 with  
220mm horse  
chestnut root  
severed  
directly at the  
base of tree  
T08.

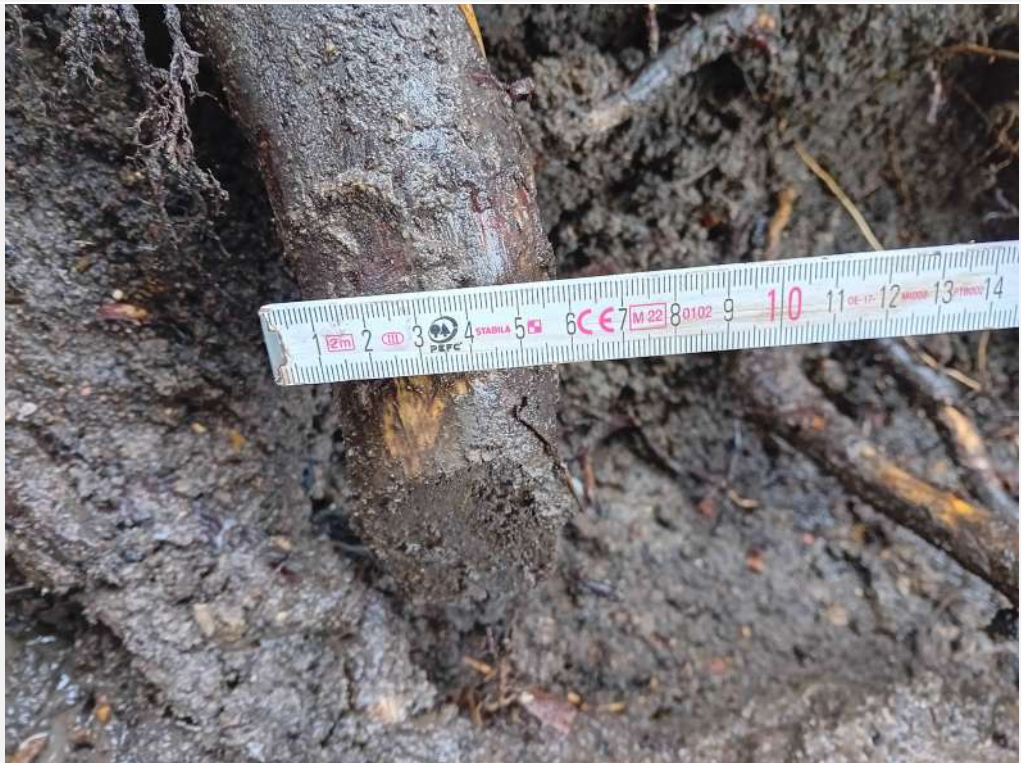
12 – 1x60mm  
and 2x20mm  
horse  
chestnut roots  
severed within  
post hole P8.

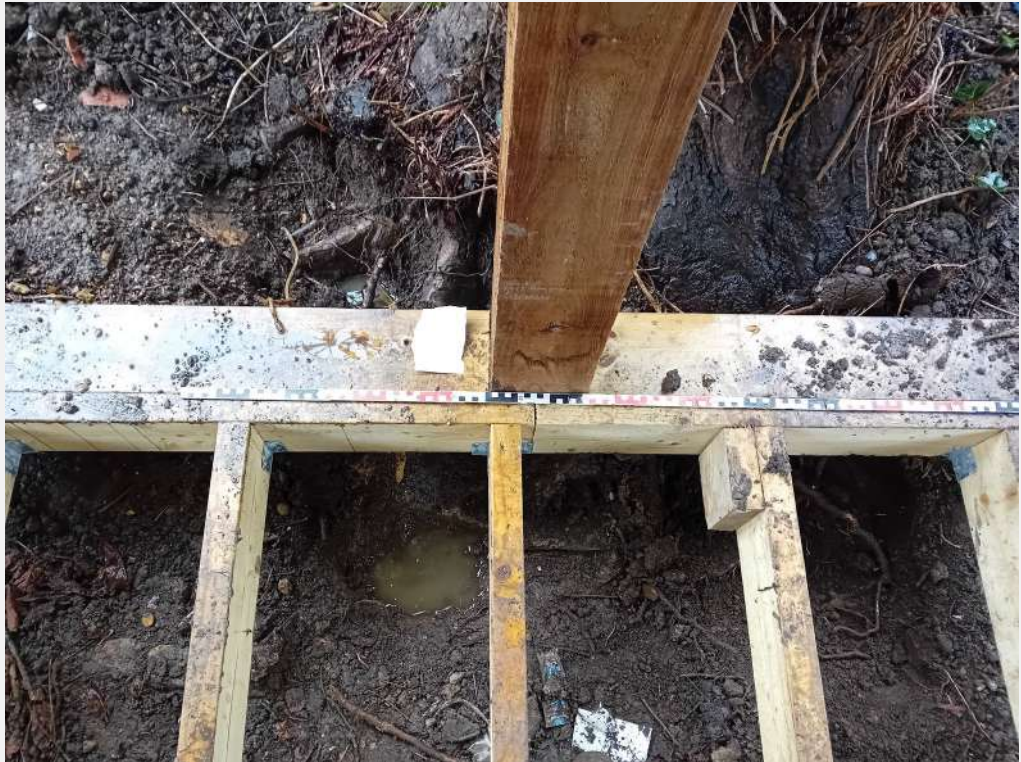
13 – Post hole P9. Full excavation was not possible due to proximity of summer house structure. Further investigation is considered essential to assess further root damage and structural integrity of the tree.

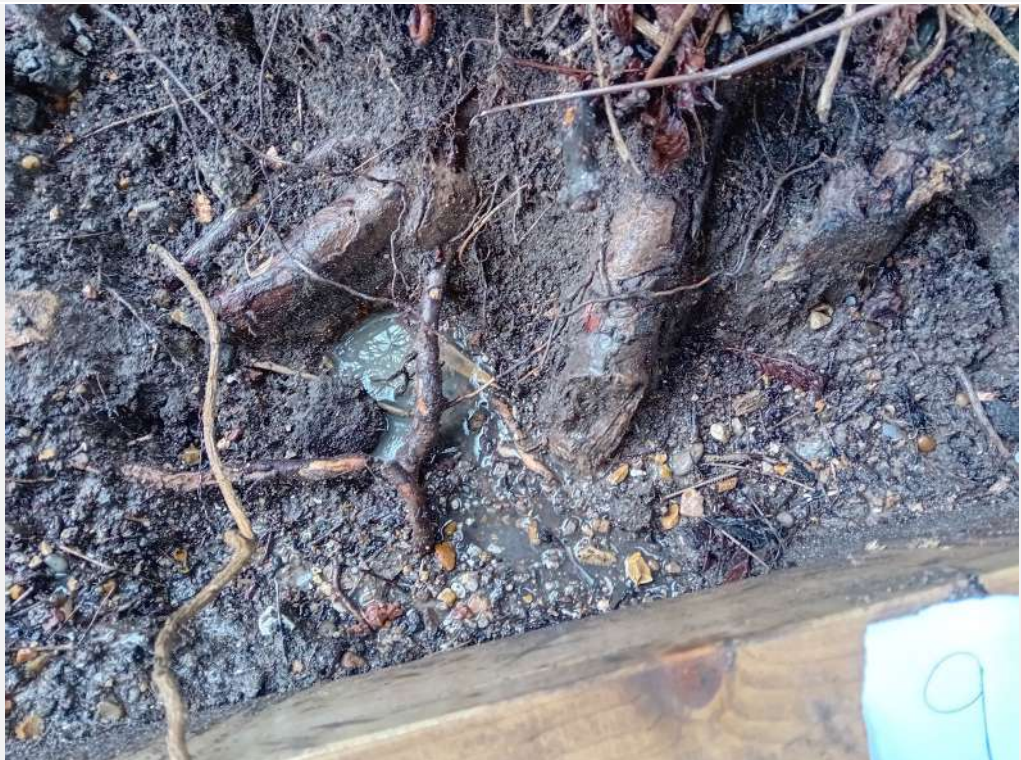
14 – 1x90mm, 1x70mm and 1x 45mm horse chestnut root severed within post hole P9 directly at the base of tree T06.

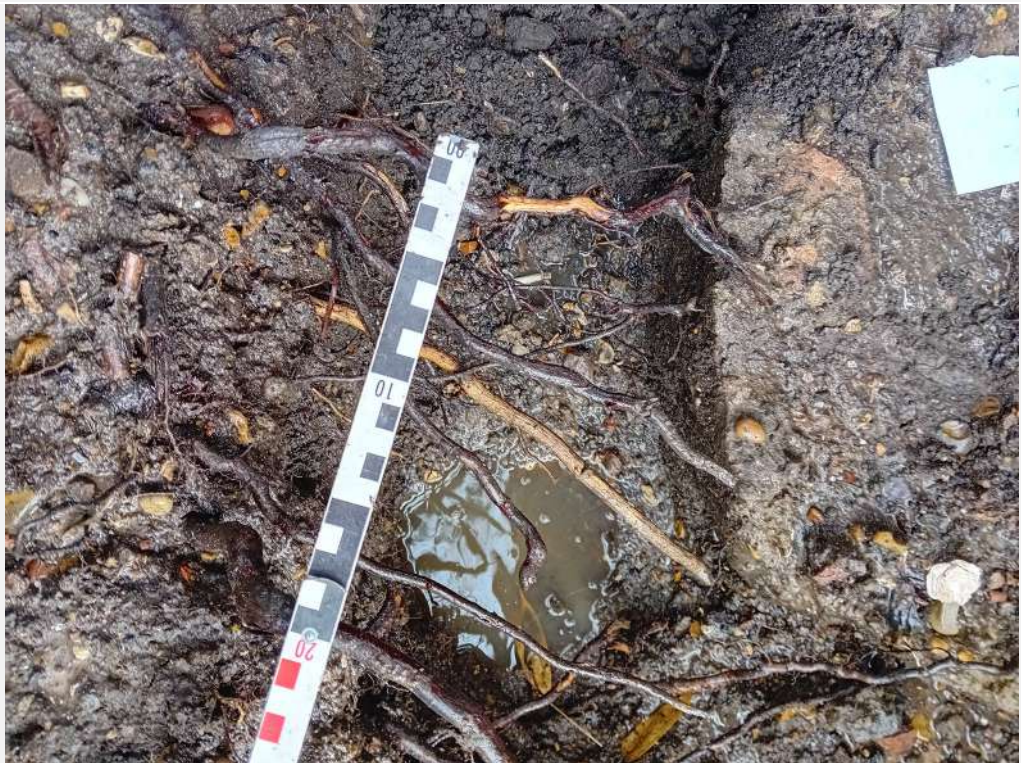
16 –  
Numerous  
10mm horse  
chestnut roots  
severed within  
post hole P10.

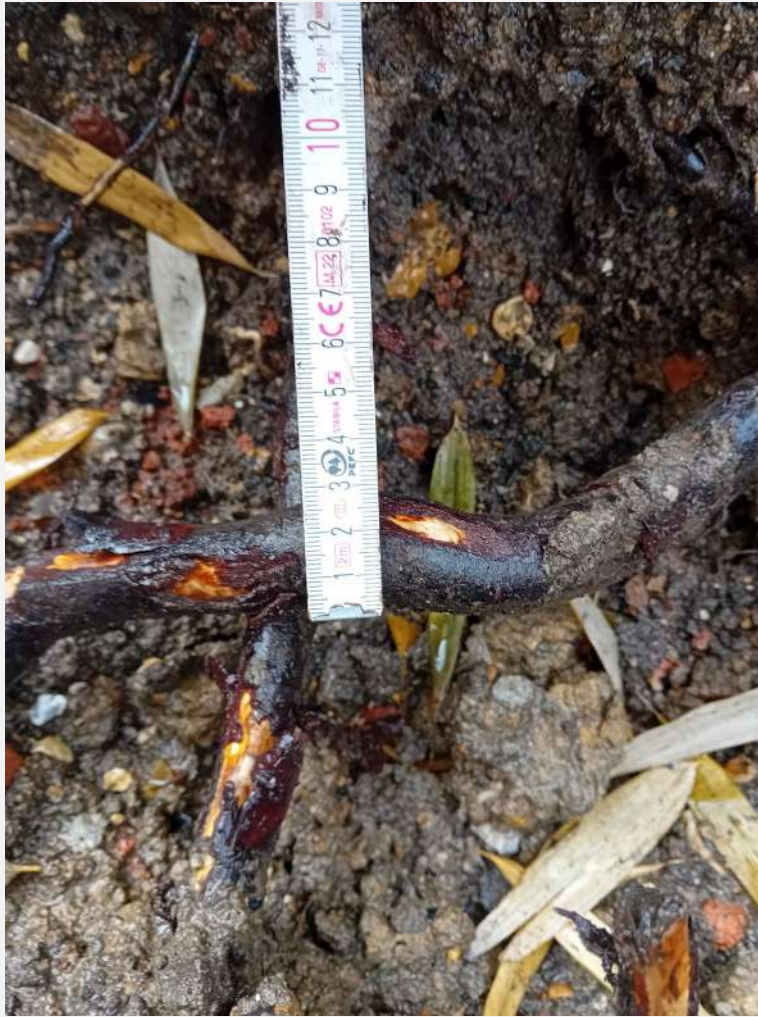
18 – 2 x  
20mm horse  
chestnut roots  
severed within  
post hole P11.

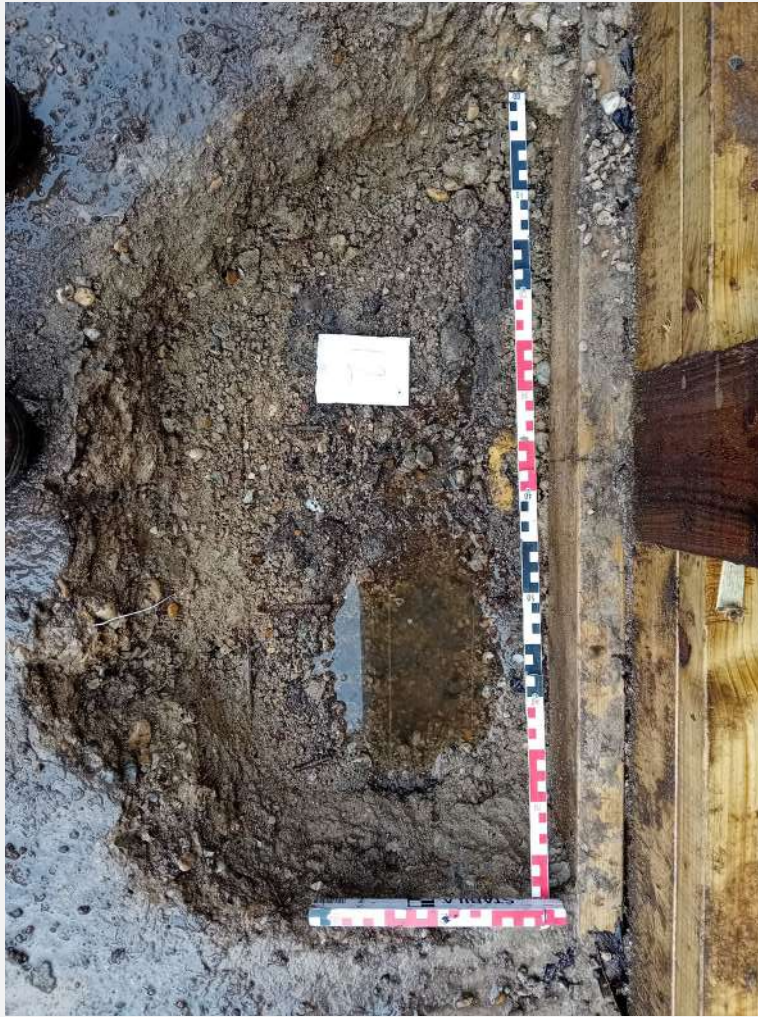
19 – Post hole  
P12 not fully  
excavated.

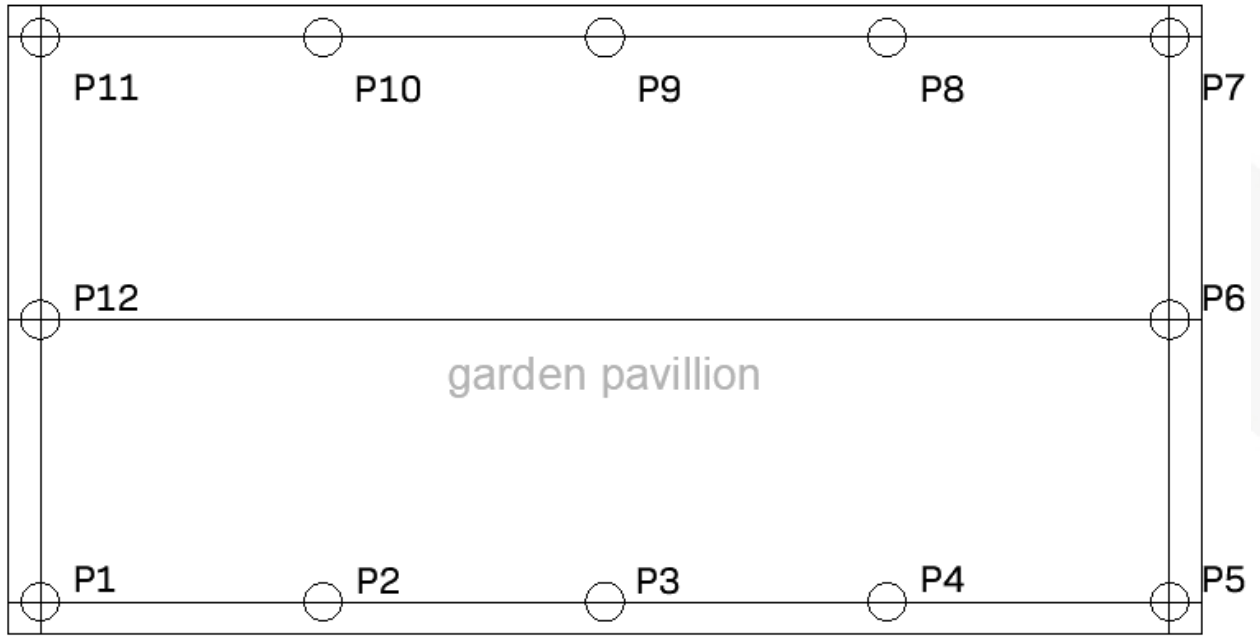
**Figure 1:** Post hole locations

During this visit, the area around post hole P9 was excavated to the full depth of the concrete surrounding the post. Several severed and/or damaged roots were discovered as documented below.

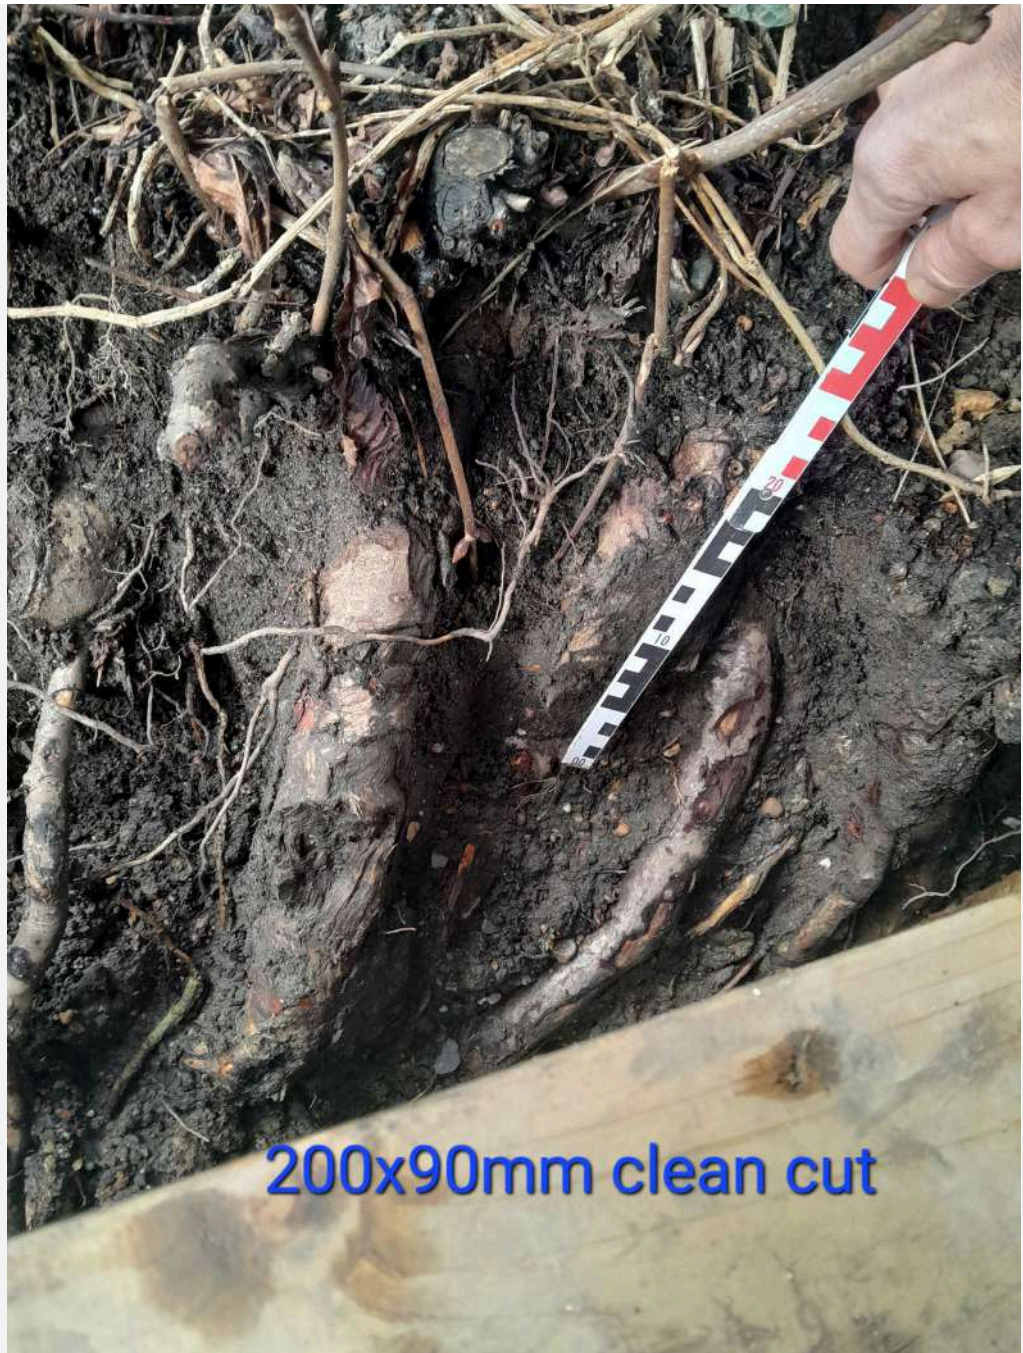
2 – 200mm x  
90mm clean  
cut.

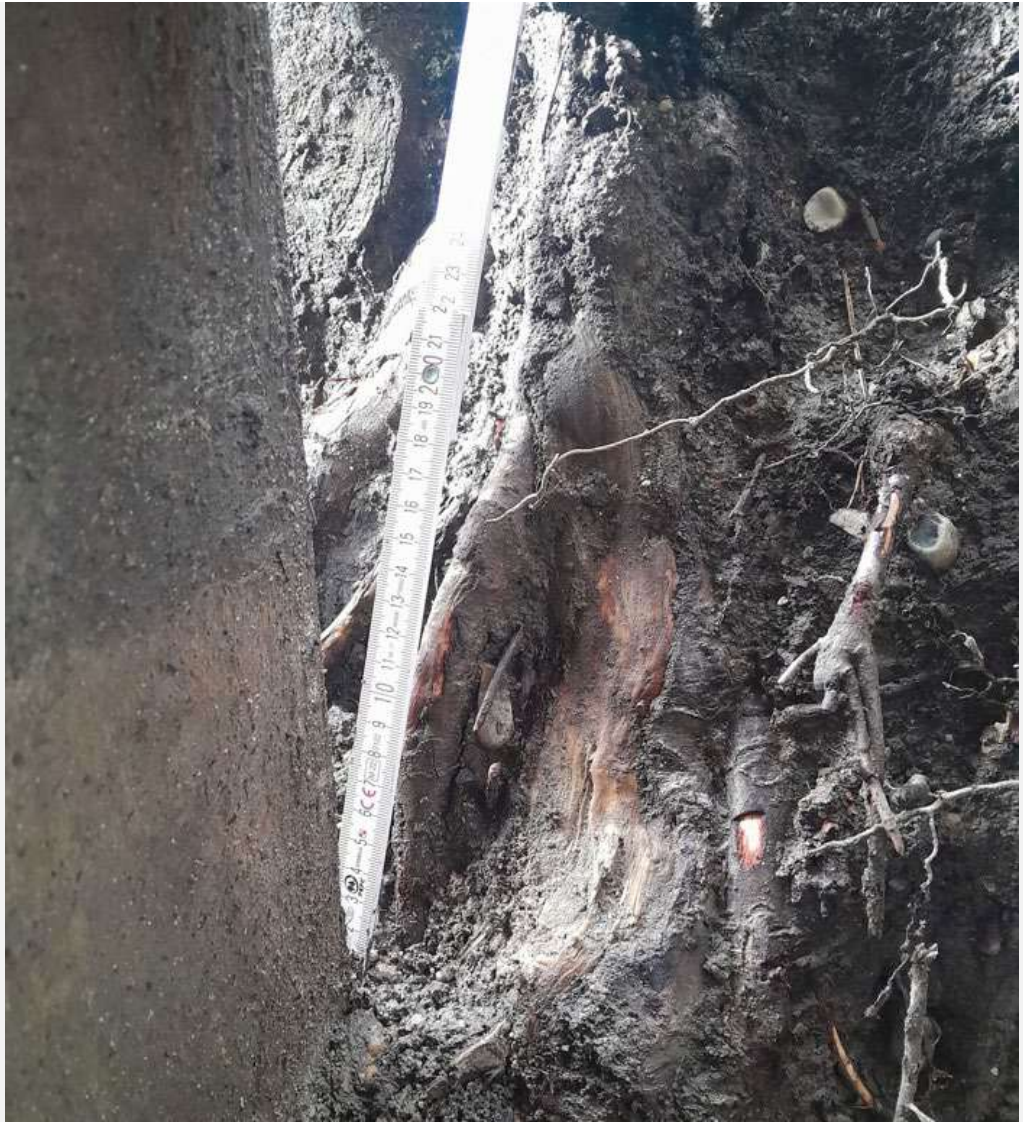
3 – 200mm x  
40mm wound.
