**Arboricultural Method Statement**

**9-11 Belsize Grove  
London  
NW3 4UU**

01 March 2024

Details of current site conditions and root damage uncovered during supervised excavation around garden pavilion posts holes can be seen in the Arboricultural Site Supervision Records (Arbtech ASSR 01, 02 & 03) in **Appendix 2**.

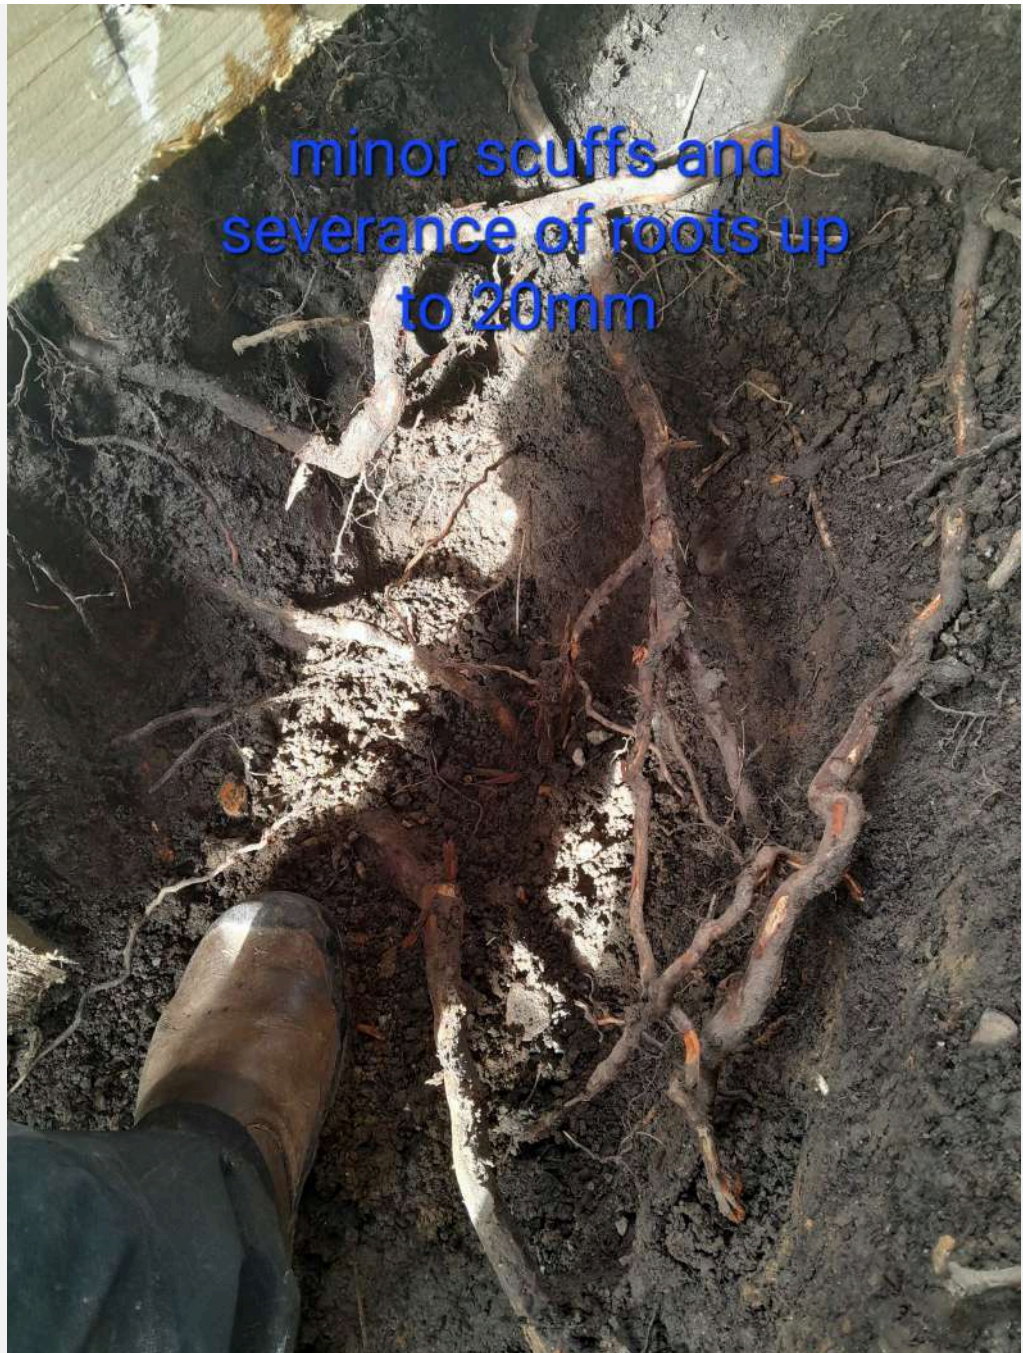
4 – Minor scuffs and severance of roots up to 20mm diameter.

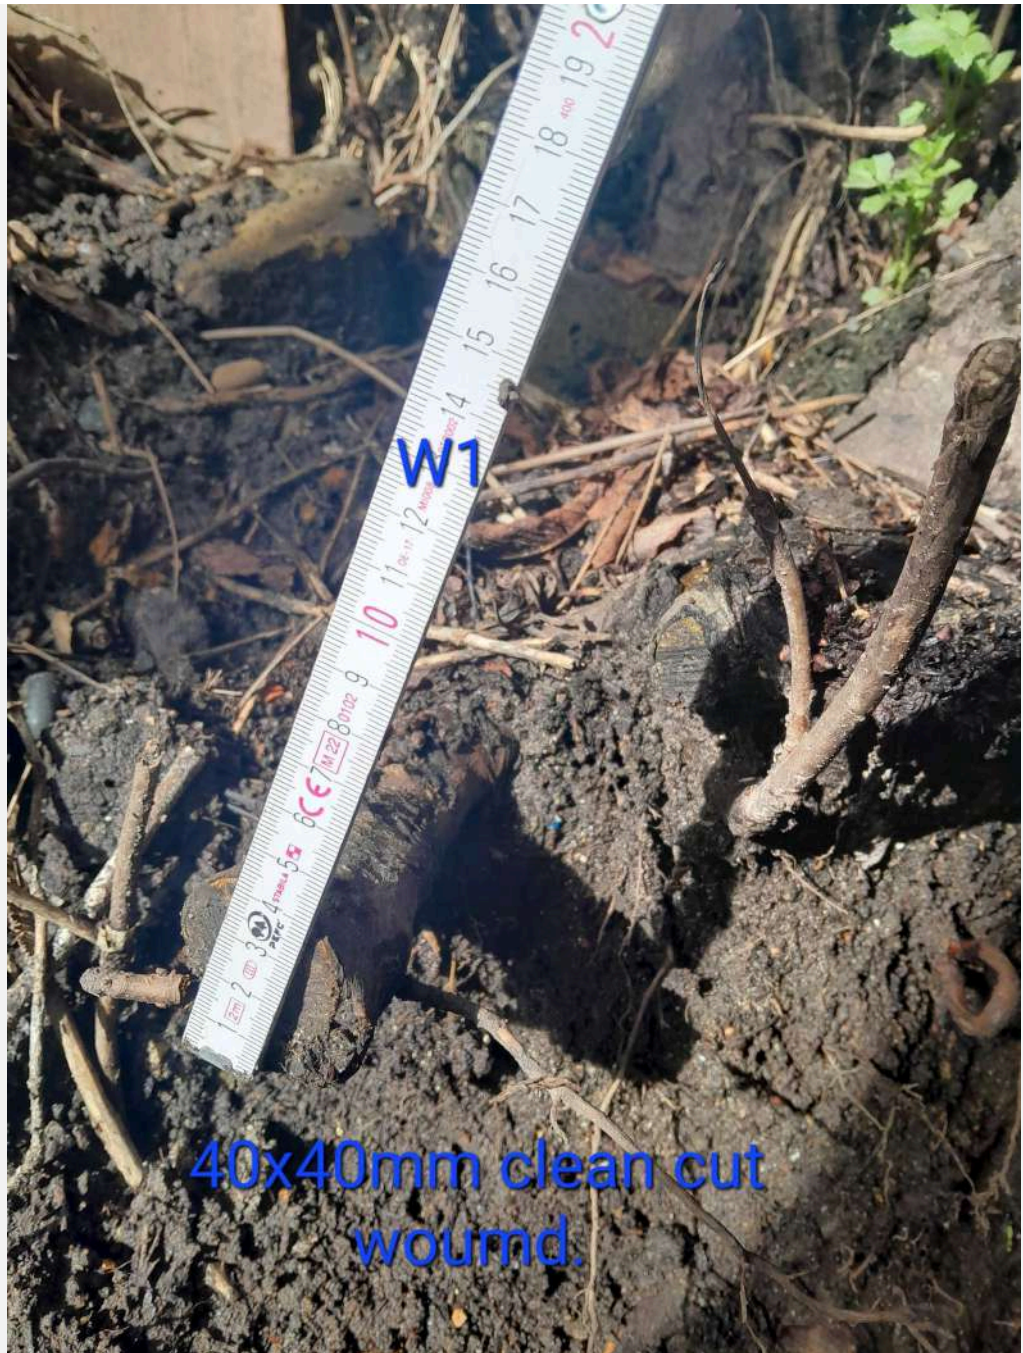
5 – 40mm x  
40mm clean  
cut wound.

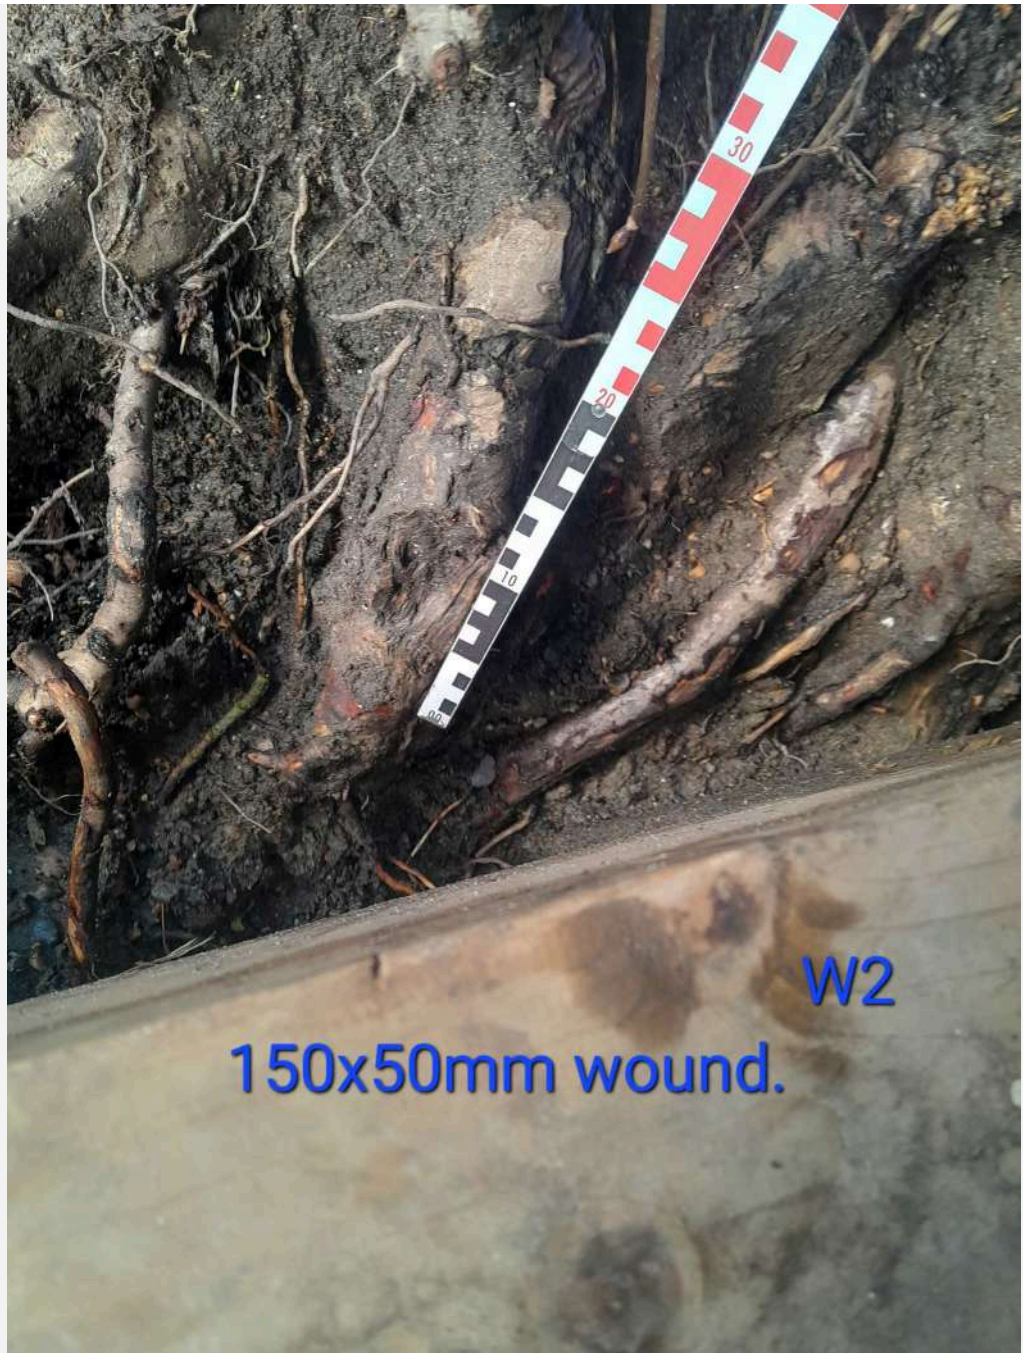
6 – 150mm x  
50mm wound.

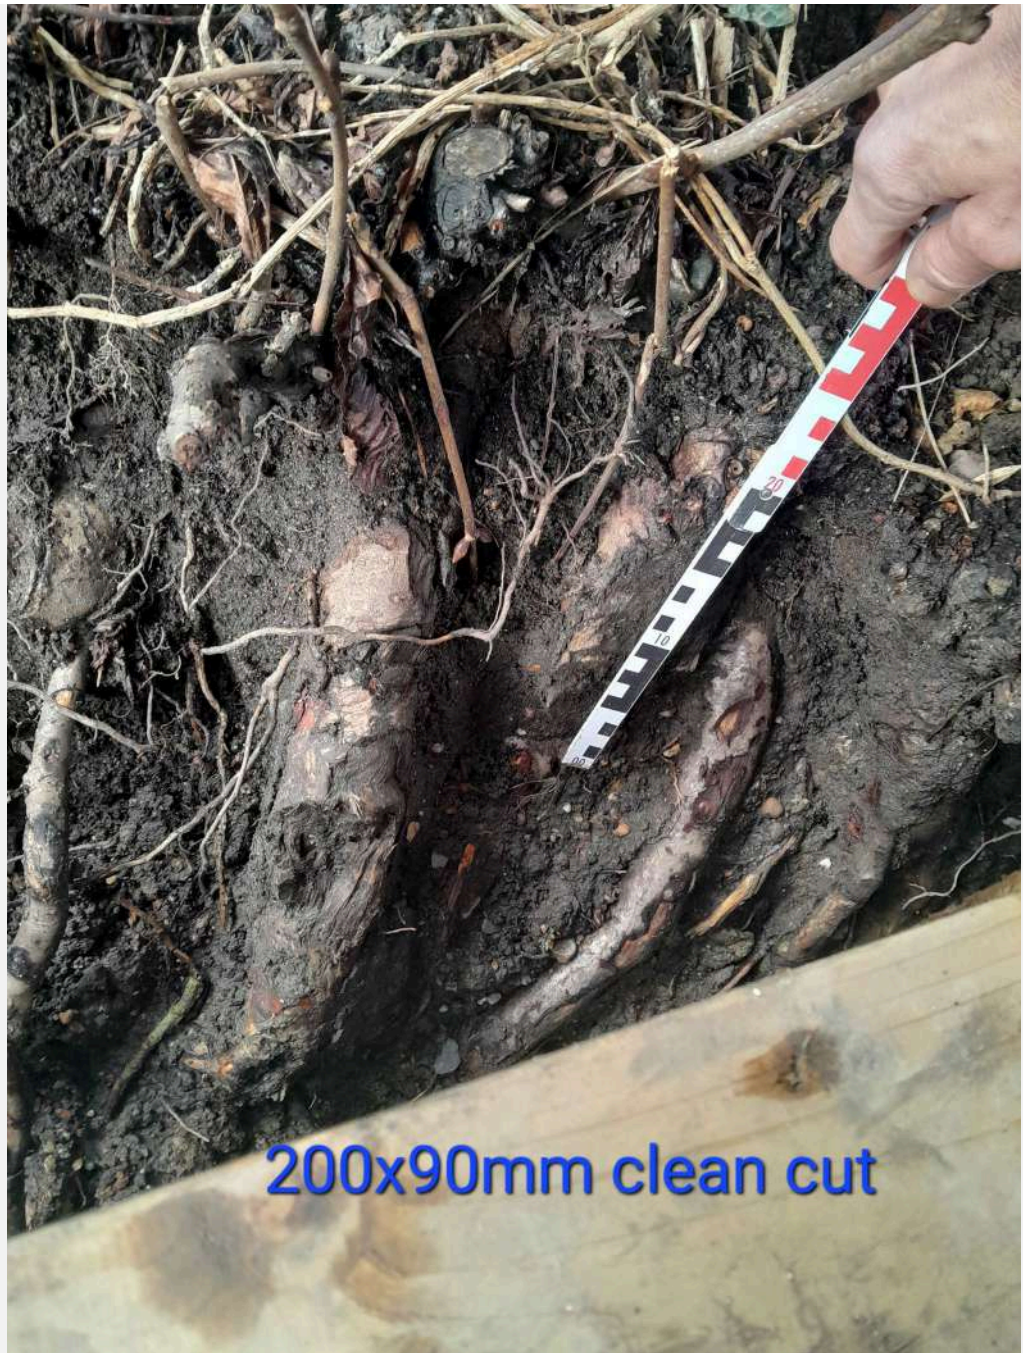
7 – 200mm x  
90mm clean  
cut.
