Revised Arboricultural Appraisal Report

Subsidence Damage Investigation at:

180 Camden Road
London
NW1 9HG

CLIENT:	Crawford & Company
CLIENT REF:	SU1904991
MWA REF:	SUB200225-6827Rev02
MWA CONSULTANT:	Steve Swinburne
REPORT DATE:	12/03/2020
REVISED REPORT REV01 DATE:	10/07/2020
REVISED REPORT REV02 DATE:	29/11/2021
REVISED REPORT REV03 DATE:	09/11/2023

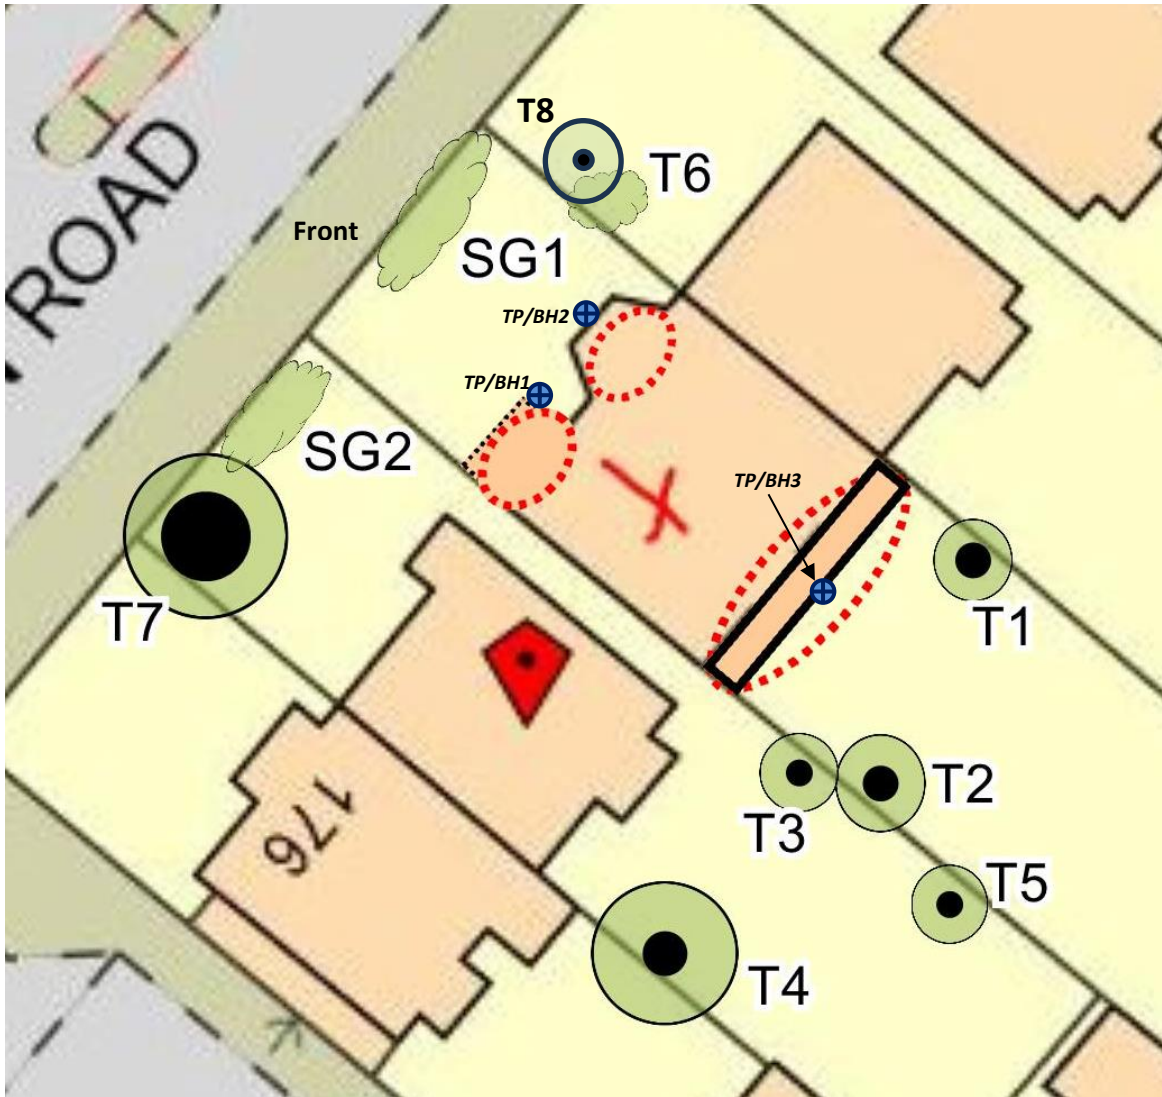
Site Plan

Approximate areas of damage

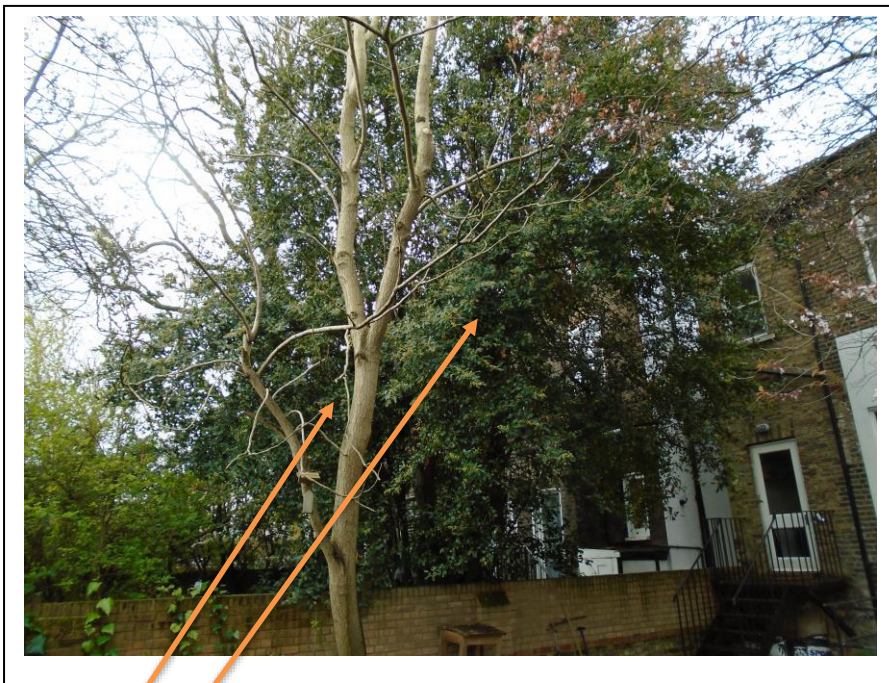
View of T2 & T3

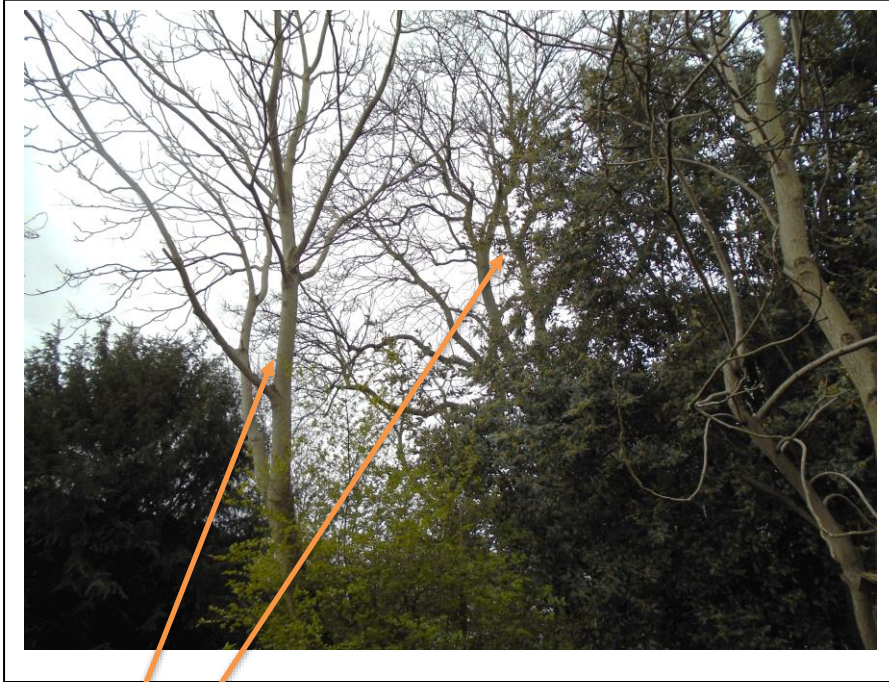
View of T5 and T4

Recommendation		Remove (fell) to near ground level and treat stump to inhibit regrowth.					
T4	Tree of Heaven	14 *	550 *	14 *	12 *	Younger than Property	Third Party 178 Camden Road NW1 9HG
Management history		No recent management noted. Tree located approximately 2m above ground level of basement flat. Unable to access the location to confirm species of tree.					
Recommendation		Reduce height by 2m and crown radius by 1m leaving balanced crown. Prune on a triennial cycle to maintain at broadly reduced dimensions.					
T6	Holly	6	Ms	5 *	5	Younger than Property	Third Party 182 Camden Road NW1 9HG
Management history		No recent management noted.					
Recommendation		Reduce height by 2m and crown radius by 1m leaving balanced crown. Prune on a biennial cycle to maintain at broadly reduced dimensions.

Tree No.	Species	Ht (m)	Dia (mm)	Crown Spread (m)	Dist. to building (m)	Age Classification	Ownership
T5	Tree of Heaven	9 *	250 *	7 *	11 *	Younger than Property	Third Party 178 Camden Road NW1 9HG
Management history		No recent management noted.					
Recommendation		Maintain broadly at no more than current dimensions by periodic pruning.					
SG1	Mixed species shrubs including Pyracantha & Laurel	4 *	Ms	3	6	Younger than Property	Policy Holder
Management history		No recent management noted.					
Recommendation		Maintain broadly at no more than current dimensions by periodic pruning.					
SG2	Laurel	3 *	Ms	3 *	9 *	Younger than Property	Third Party 178 Camden Road NW1 9HG
Management history		Subject to past management/pruning.					
Recommendation		Maintain broadly at no more than current dimensions by periodic pruning.

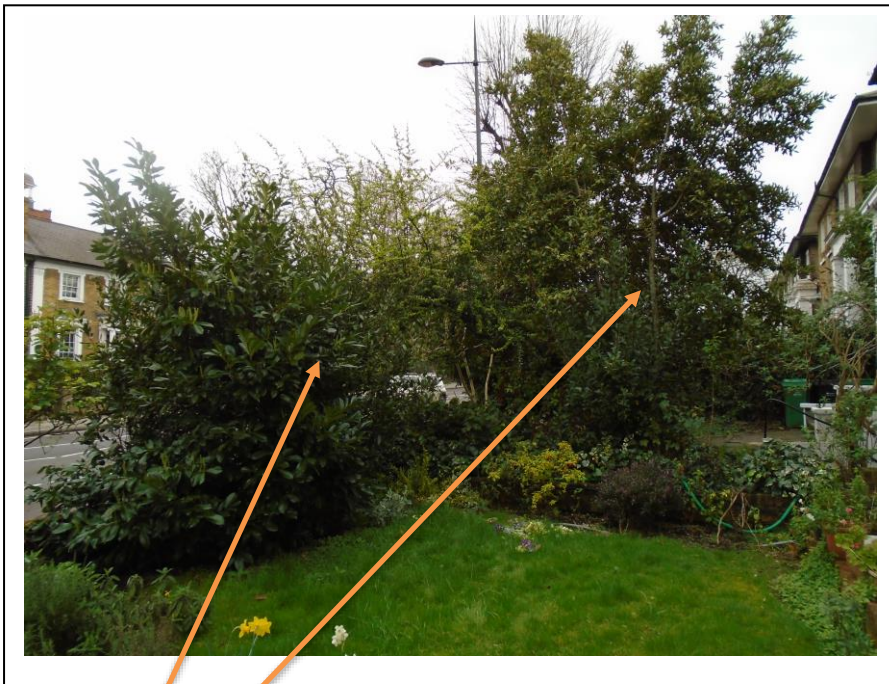
View of SG1 and T6

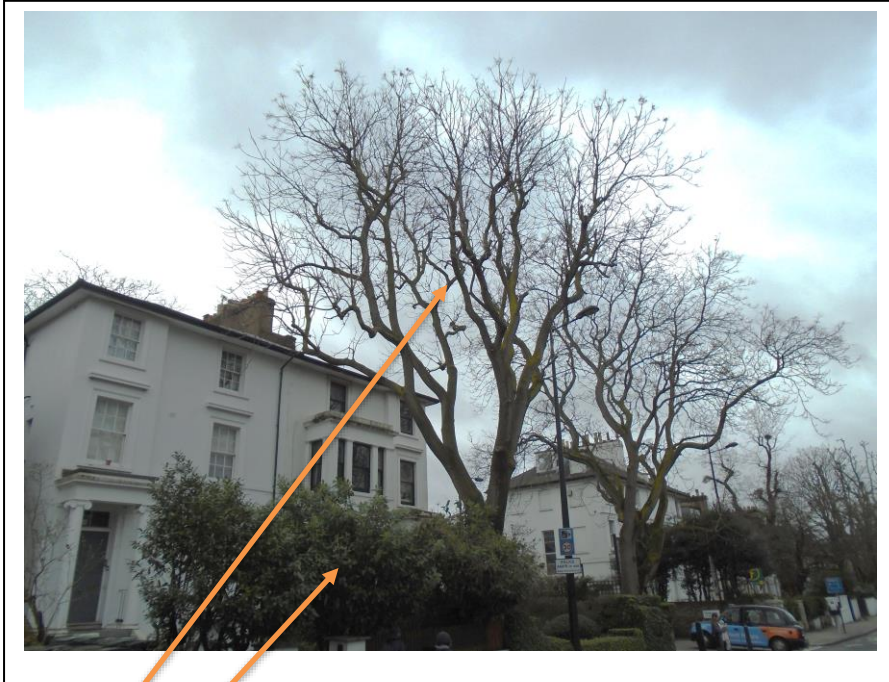
View of T7 and SG2

Tree No.	Species	Ht (m)	Dia (mm)	Crown Spread (m)	Dist. to building (m)	Age Classification	Ownership
T7	Tree of Heaven	17 *	650 *	13 *	12 *	Younger than Property	Third Party 178 Camden Road NW1 9HG
Management history		Subject to past management/pruning.					
Recommendation		Remove (fell) to near ground level and grind out stump to inhibit regrowth.					
T8	Cherry	9*	200 *	5*	6*	Younger than Property	Third Party 182 Camden Road NW1 9HG
Management history		Subject to past management/pruning.					
Recommendation		Remove (fell) to near ground level and grind out stump to inhibit regrowth.
