Site Investigation Report

101134.1.BSI

Job Information	
Client	Crawford & Co
Client ref	SU1904991
Visit date	02/01/2020
Report date	06/01/2020

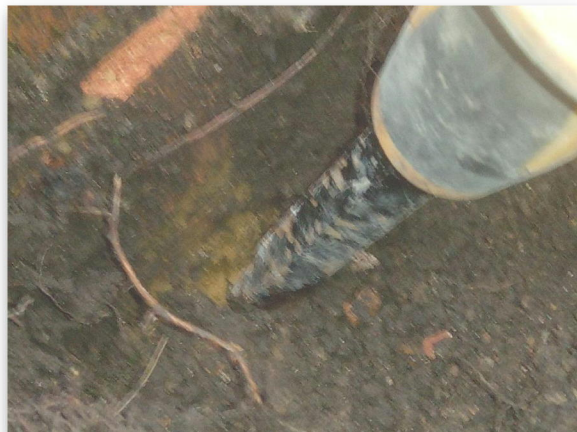
Fig 1.2: Trial Hole 1 Footing

Trial Hole Log No.1

Location: Front rhs

Depth (m)	Symbolic Log	Strata Description	Insitu Tests		Soil Sample	Root Sample
			SV(19)			
0.0	<p>Ground Level</p> <p>Concrete</p> <p>Brickwork</p> <p>Brick Footing (No Proj)</p>	<p>Dry stiff Brown sandy fine to medium gravelly silty CLAY</p>	54kpa		Soil @ 0.6m	
1.0			63kpa		Soil @ 1.1m	Root @ 1.1m
1.5			79kpa		Soil @ 1.6m	Root @ 1.6m
2.0			81kpa		Soil @ 2.1m	
2.5			90kpa		Soil @ 2.6m	
3.0		TRIAL HOLE TERMINATED	94kpa

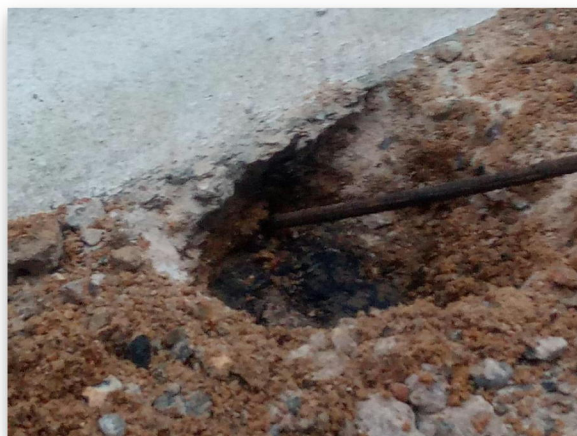
Fig 2.2: Trial Hole 2 Footing

Trial Hole Log No.2

Location: Front of bay

Depth (m)	Symbolic Log	Strata Description	Insitu Tests		Soil Sample	Root Sample	
			SV(19)				
0.0		Ground Level Concrete Brickwork Double Step Dry stiff Brown sandy fine to medium gravelly silty CLAY					
0.6			41kpa		Soil @ 0.6m		
1.1			56kpa		Soil @ 1.1m	Root @ 1.1m	
1.6			60kpa		Soil @ 1.6m		
2.1			61kpa		Soil @ 2.1m		
2.6			64kpa		Soil @ 2.6m		
3.0			71kpa	TRIAL HOLE TERMINATED

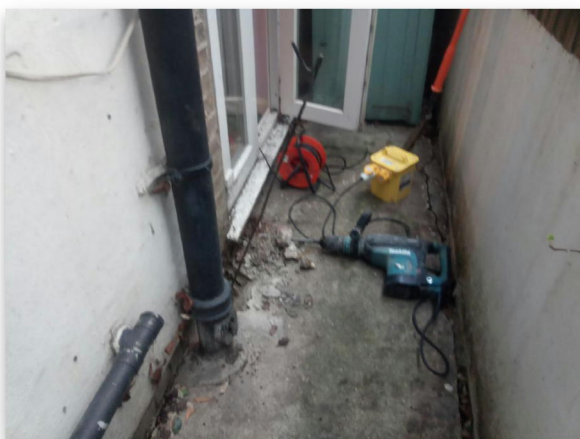
Fig 3.1: Trial Hole 3 Location

We were unable to collect root samples from TH3 because no roots were located within the trial hole.

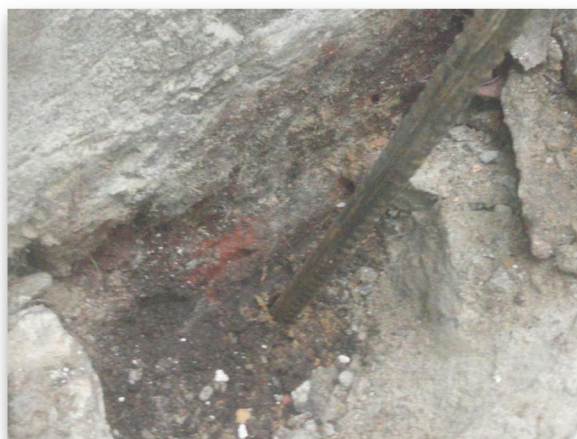
Fig 3.2: Trial Hole 3 Footing

Trial Hole Log No.3

Location: Rear centre

Depth (m)	Symbolic Log	Strata Description	Insitu Tests		Soil Sample	Root Sample
			SV(19)			
0.0	<p>100mm</p> <p>Ground Level</p> <p>Concrete</p> <p>Brickwork</p> <p>Double Step</p>					
1.0			31kpa		Soil @ 1m	
1.5			49kpa		Soil @ 1.5m	
2.0		Dry firm Brown sandy fine medium gravelly silty CLAY	61kpa		Soil @ 2m	
2.5			69kpa		Soil @ 2.5m	
3.0		TRIAL HOLE TERMINATED	70kpa

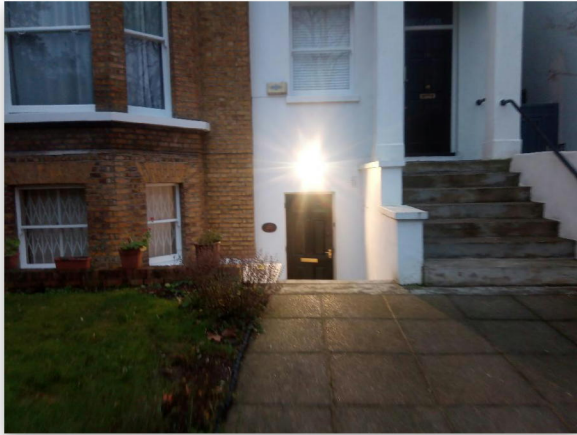
It should also be noted that there was a manhole located beneath the front set of stairs. This was over 2m deep and was a very tight manhole, due to this we could not survey any drainage lines entering it. If the LA wishes for this to be surveyed then 2 men will be required to attend site with confined space entry equipment which will come at a considerable cost. We believe that the drainage at the customers property is all accounted for and runs to the rear manhole.

Fig 7.1: Steps which MH is located beneath

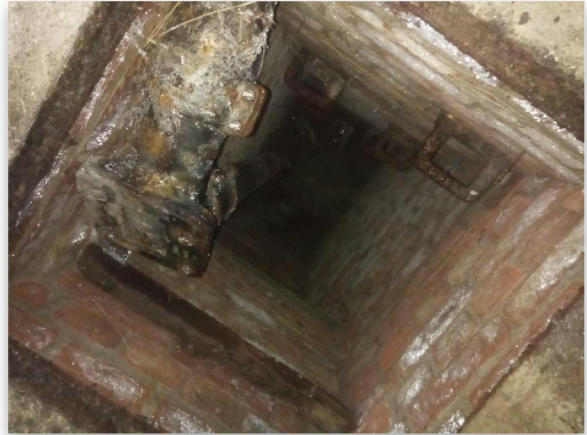
Fig 7.2: Deep MH
