**Clarifications and  
Responses on Demolition  
Justification including Pre-  
Redevelopment Audit and  
Retention options appraisal**

October 2023

This document relates to planning application 2023/2510/P and has been compiled in response to feedback from the GLA Stage 1, LB Camden officers and their 3rd Party technical reviewers. In particular the queries relate to how the proposals address the requirements of specific policies;

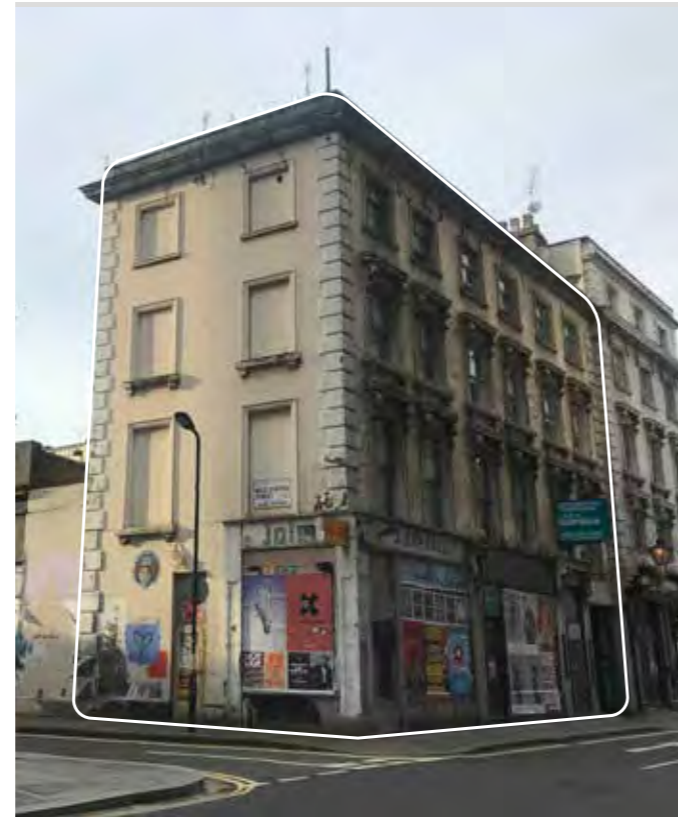
West Central Street and Museum Street Elevations

Alteration and replacement of the shop fronts alongside years of neglect have resulted in a building frontage of poor condition.

The existing windows incorporate poor quality secondary glazing which is detrimental to the appearance of the buildings. While the facade is in poor condition, many of the original decorative features appear intact.

The historic carriageway entrance to the internal yard is still legible however is currently closed off by an unsightly metal shutter.

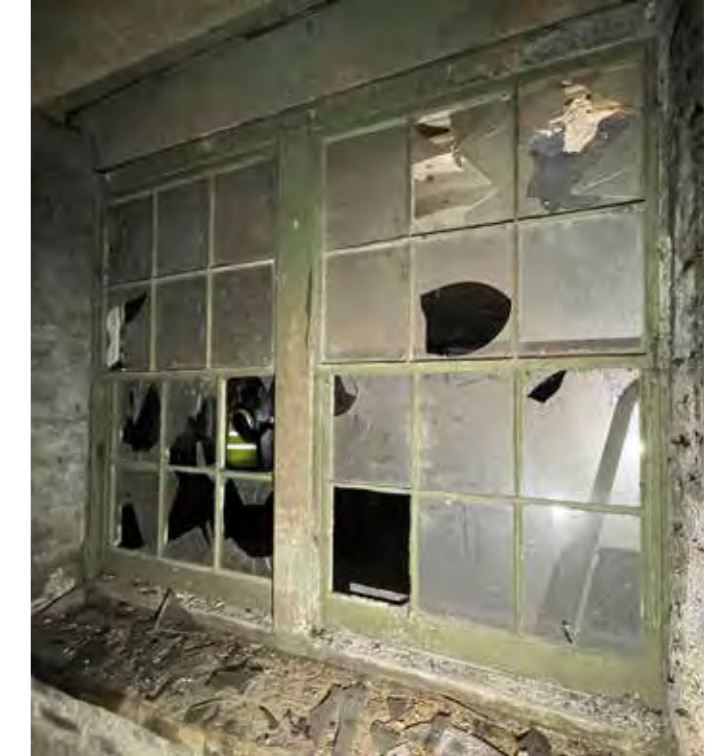
Historic sash window in need of repair

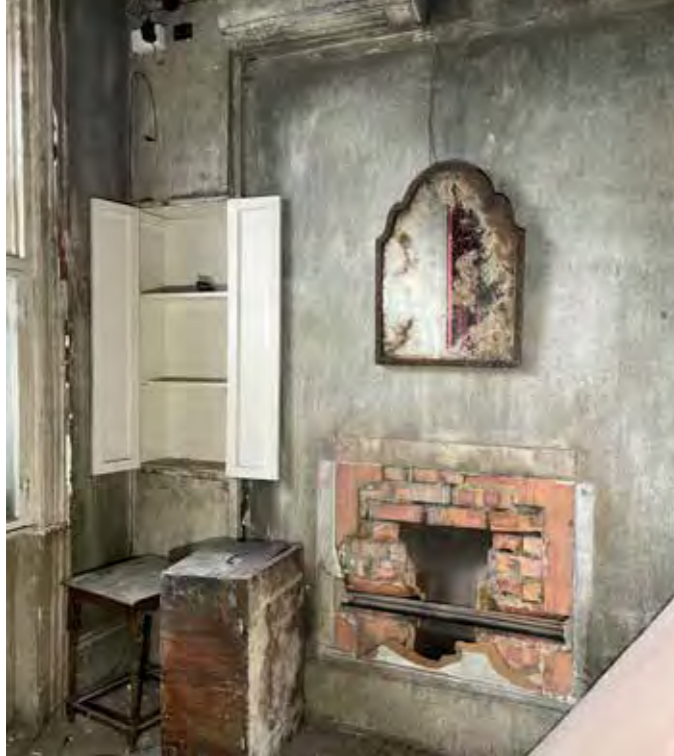
Infilled fireplace with pre-war common bricks - evidence of c1930s phase. Cupboard with modern joinery

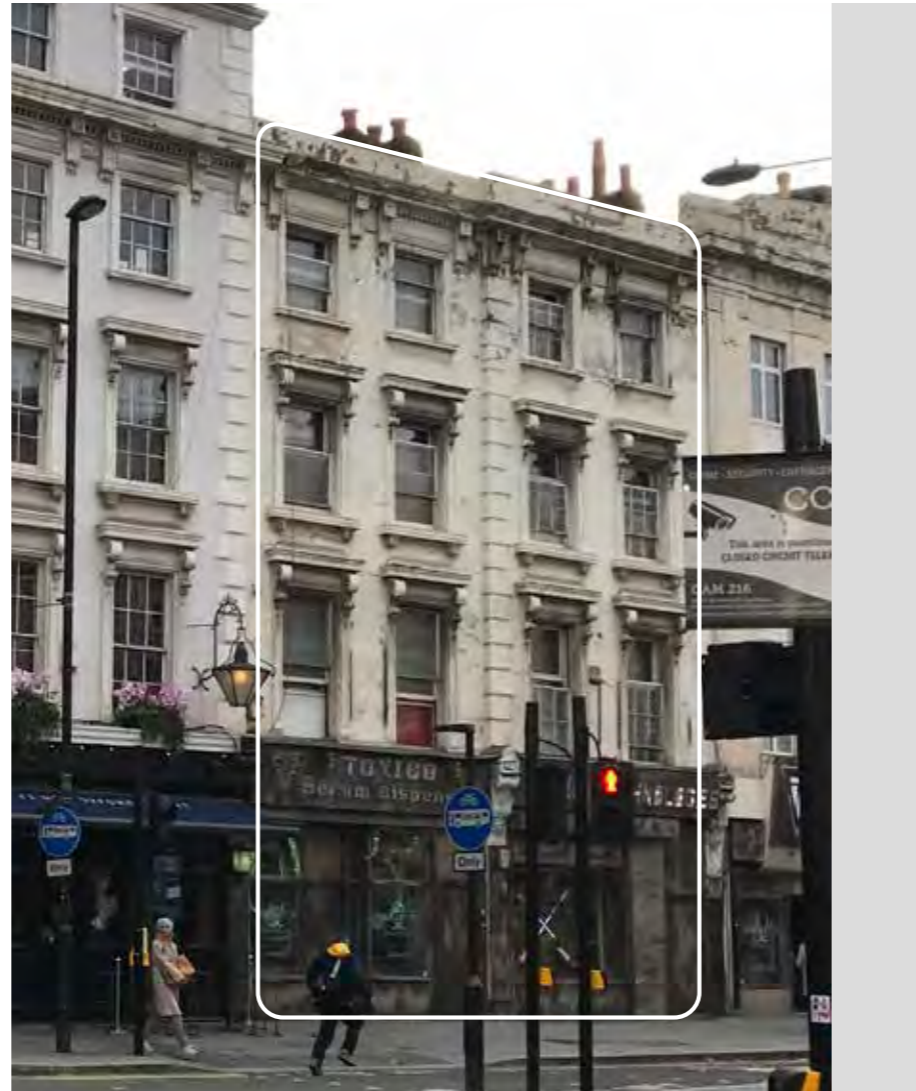
New Oxford Street Elevation

While the majority of the existing facade of 35-37 New Oxford Street is intact, it is in poor condition.

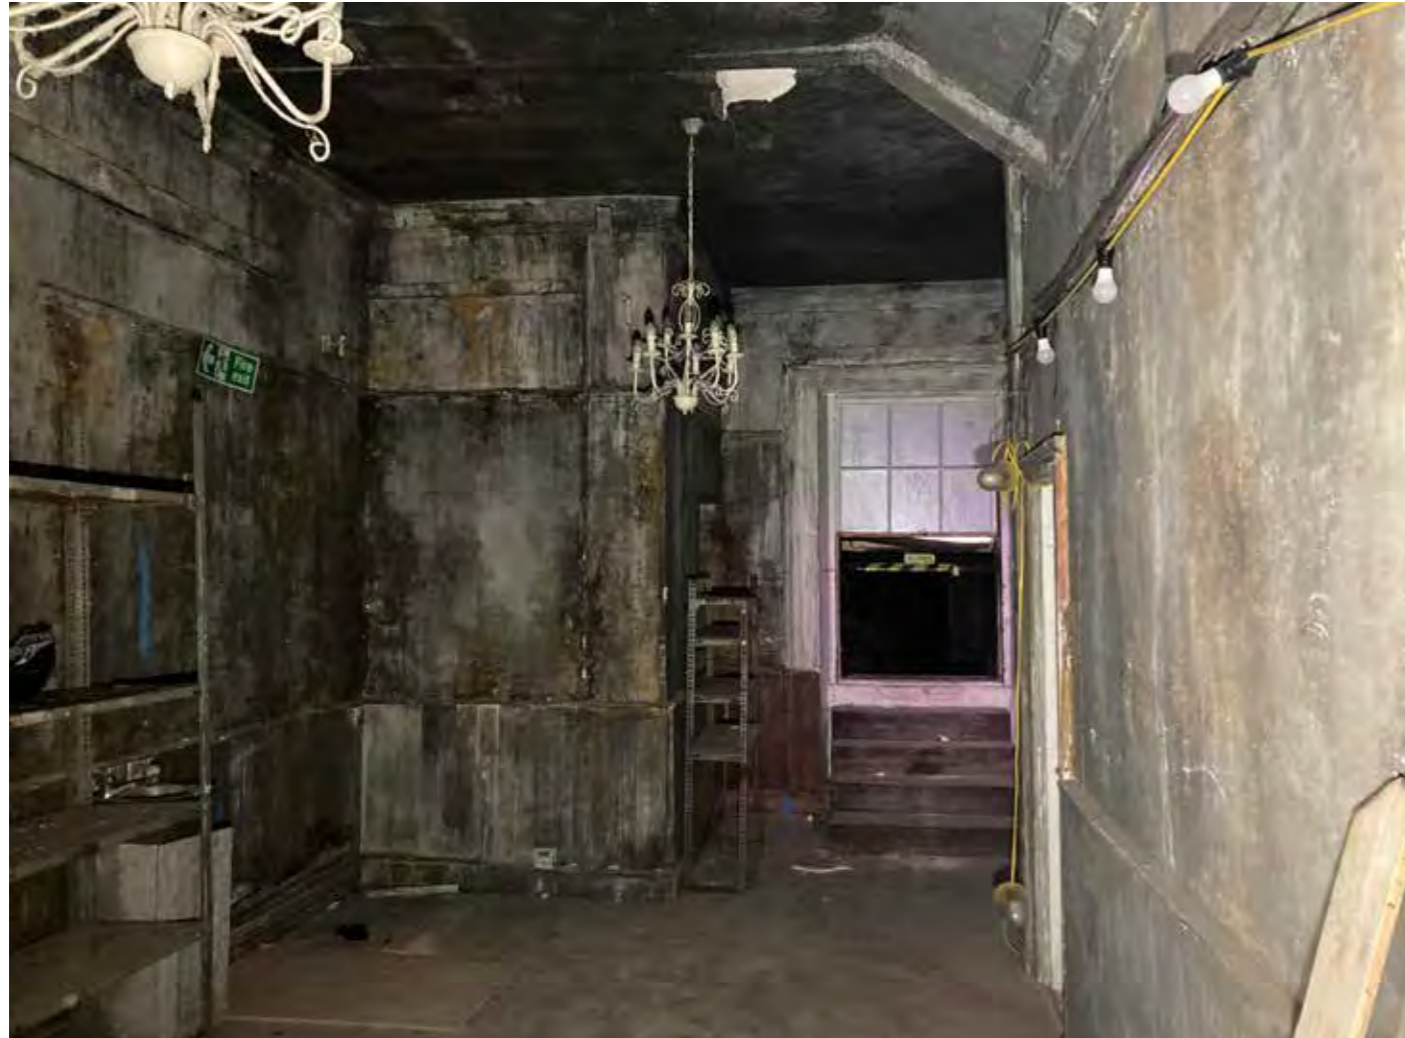
Mix of modern and historic joinery. Walls painted to appear abandoned. (35 NOST.)

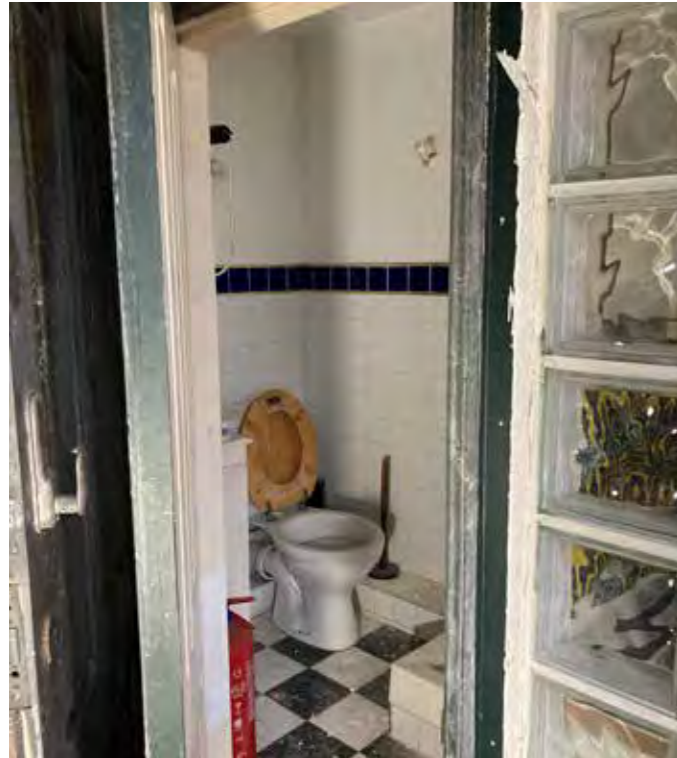
En-suite enclosure, changing historic plan. (35 NOST.)

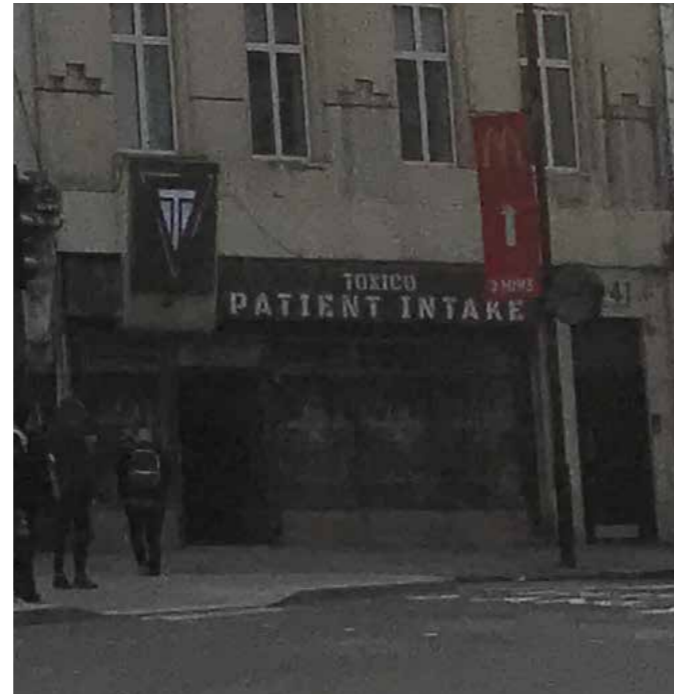
Existing Shopfront

On upper floors while the main body of the facade and ornament is in good condition, it requires repainting. The current windows however are poor quality PVC windows in poor condition and their appearance do not resemble the more filligree multi-paned aluminium style window which would be expected of this period of architecture. The aperture sizes and locations relative to finished floor levels are well suited to create a good level of daylight/sunlight and aspect expected for residential accommodation. The building is topped by the characterful pitched pediment which is in a state of disrepair.

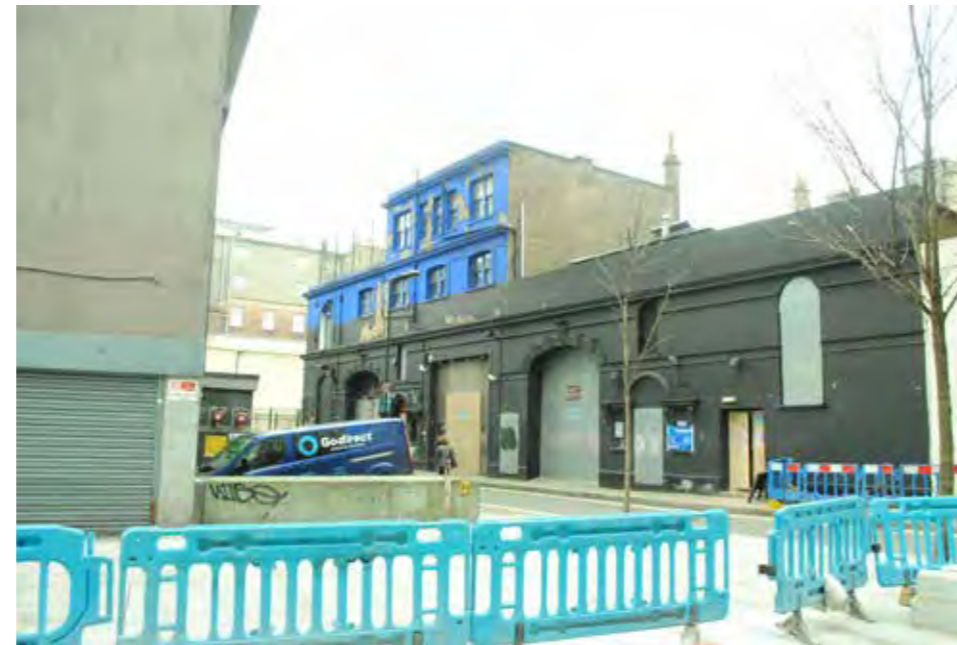
Existing Facade Condition as seen from Museum Street

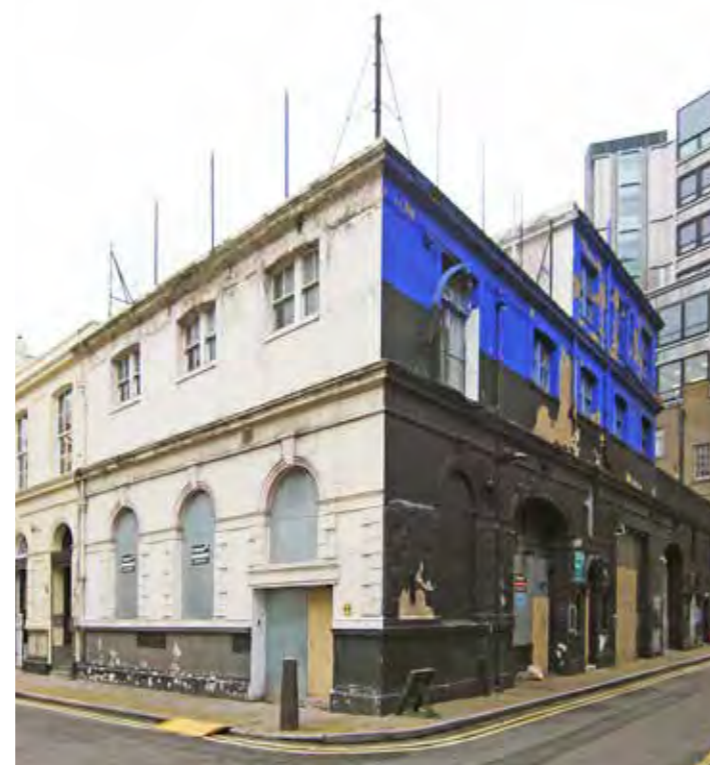
Existing Facade Condition as seen from West Central Street

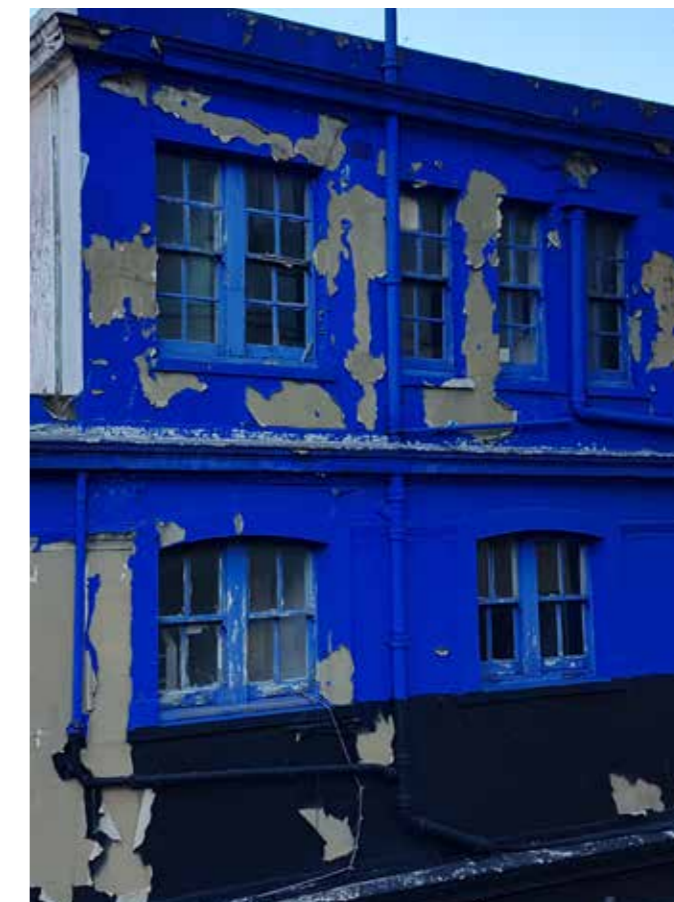
Existing Facade Condition

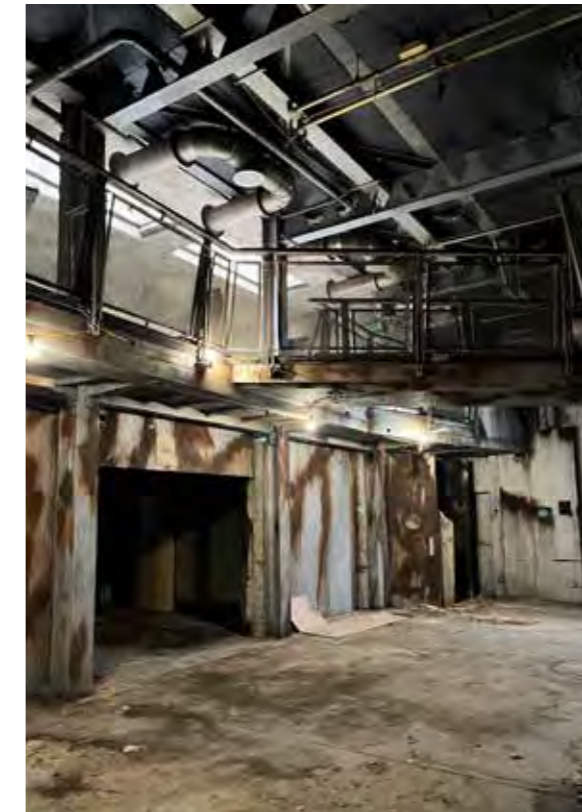
Existing ground floor condition 16A-18 West Central Street

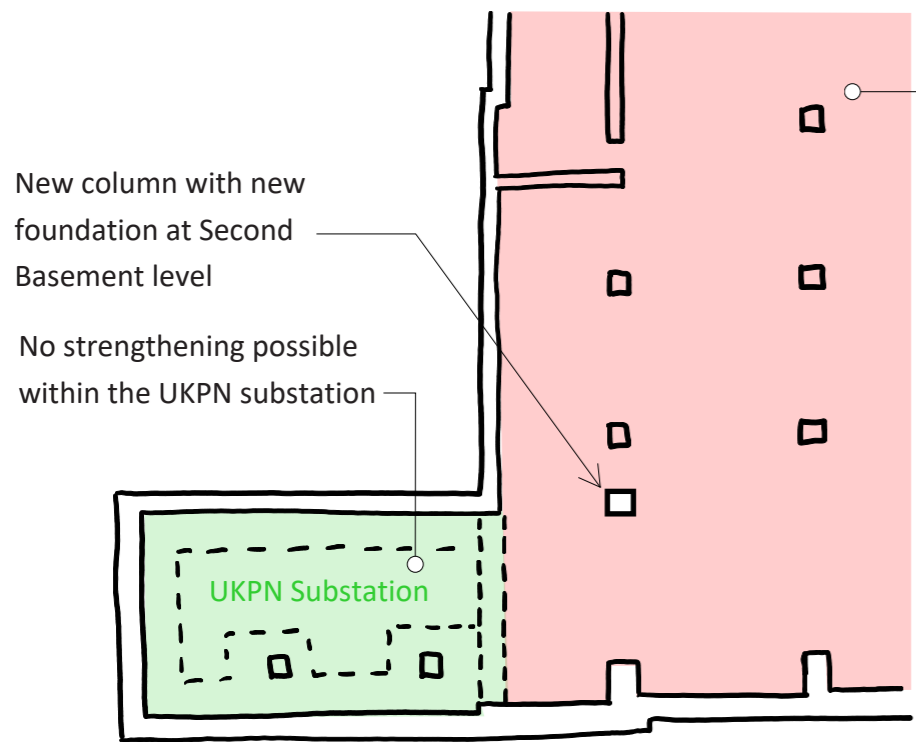
First Basement Floor Plan

B1 demolished as part of current proposal for the Museum Street basement

Additional massing to incorporate new stability and will require new foundations at ground and second basement level

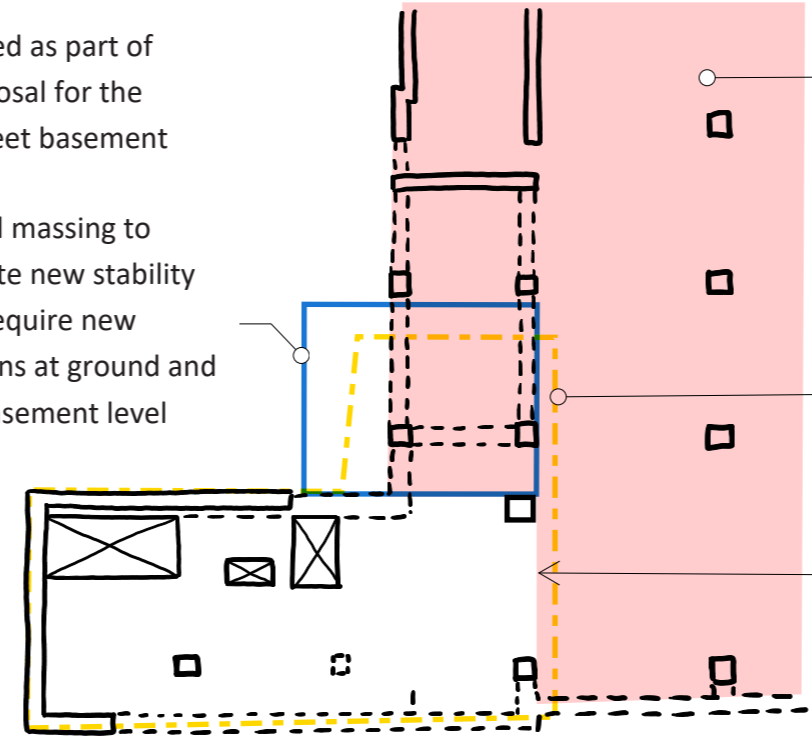
Ground Floor Plan

Ground floor slab to be demolished to new ground floor structure to support Vine Lane

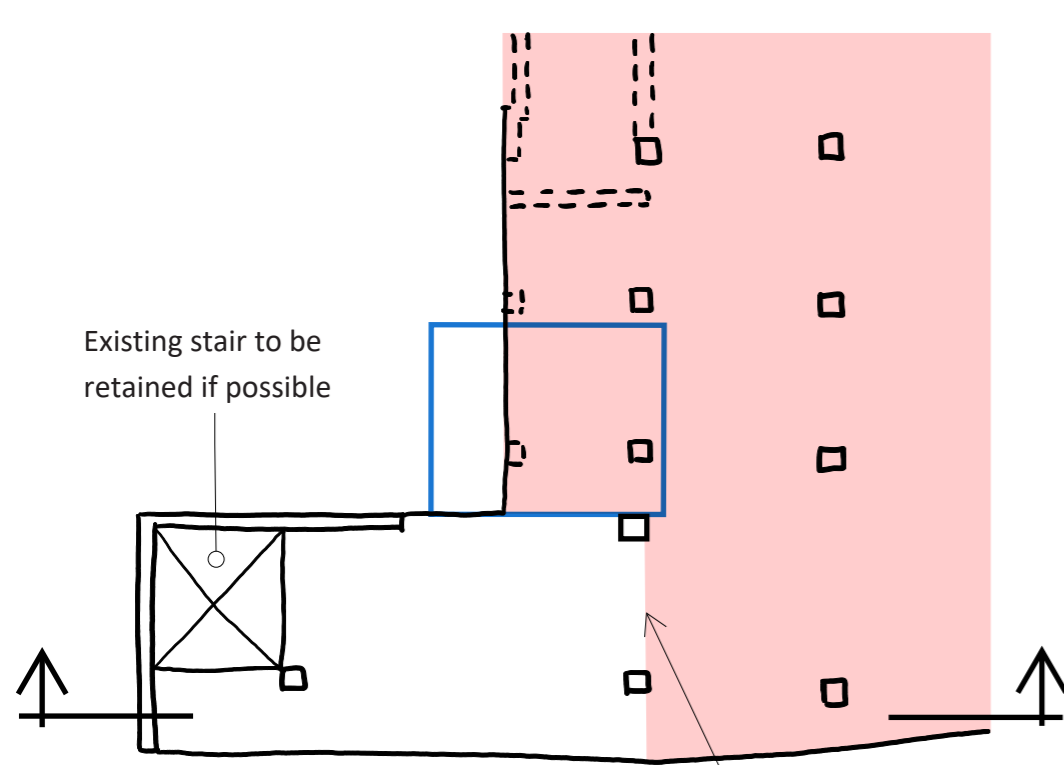
First Floor Plan

Slab to be cut back to existing column line. Existing columns to be retained

Level 2 slab to be retained depending option

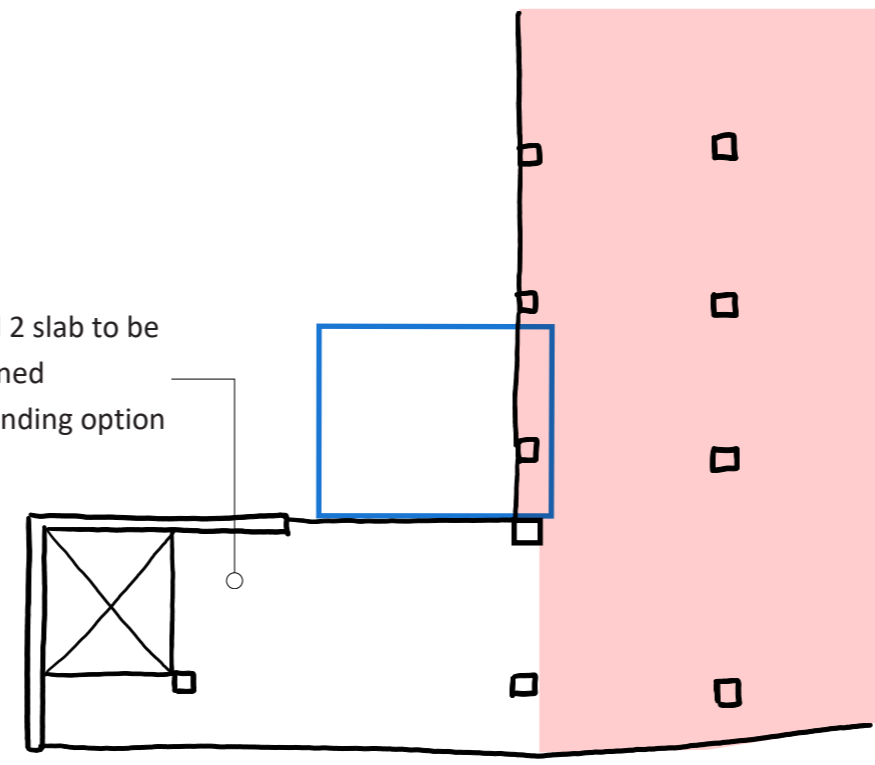
Second Floor Plan

Height of additional massing not limited by UKPN substation

Level 3 slab to be retained depending option

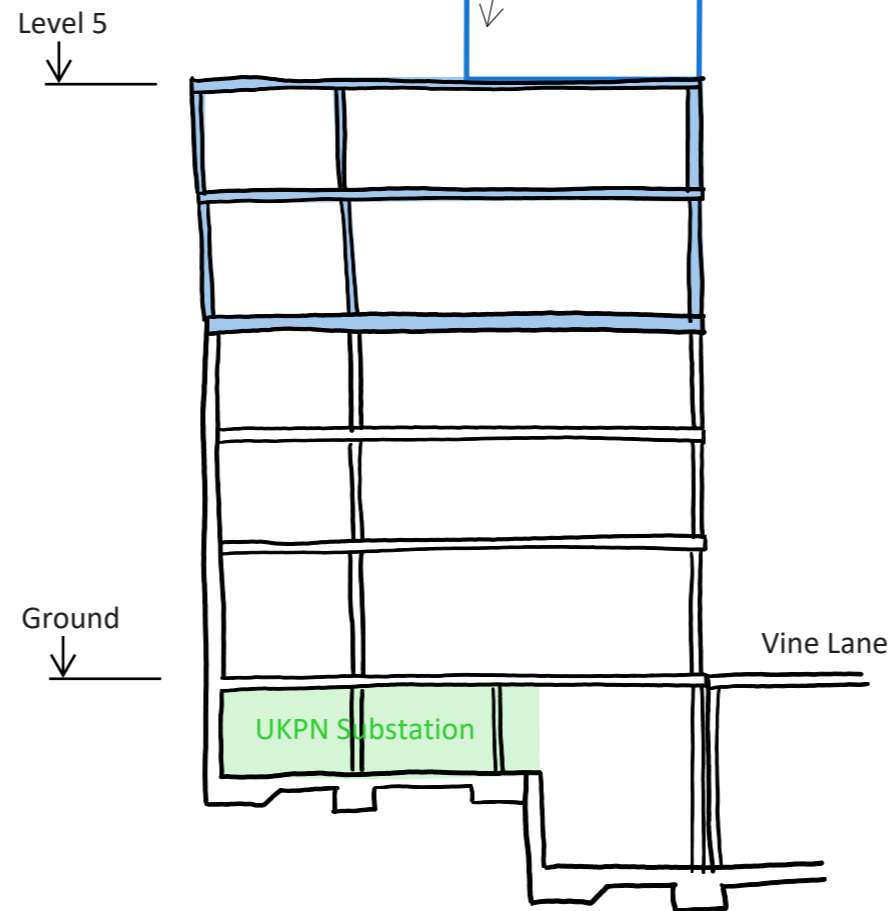
Option 2

+ Existing roof demolished  
 + New lightweight 2-storey extension  
 + Possible column strengthening required

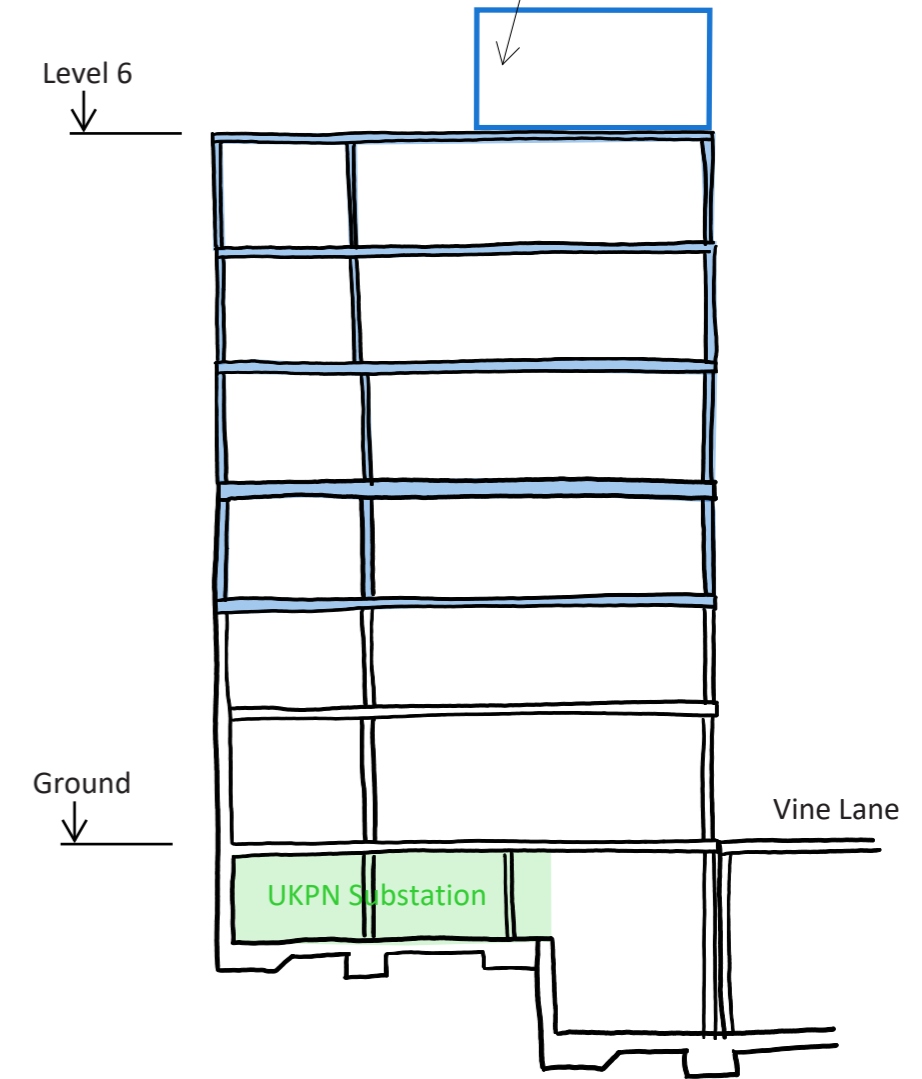
Option 3

+ Existing roof and second floor slab demolished  
 + New lightweight 4-storey extension  
 + Possible column strengthening required
