Connick Tree Consultants

ARBORICULTURAL REPORT (Microdrill)

OUR REFERENCE	203781/RT
CLIENT	Paramount International Networks
SITE	17-29 Hawley Crescent, Camden, London. NW1 8TT
SURVEY & REPORT BY	Mr Richard Tilling
DATE	27 th June 2024
DATE OF INSPECTION	26 th June 2024
PEER REVIEWED	4 th July 2024 Mark Haddock BSc (Hons) CEnv

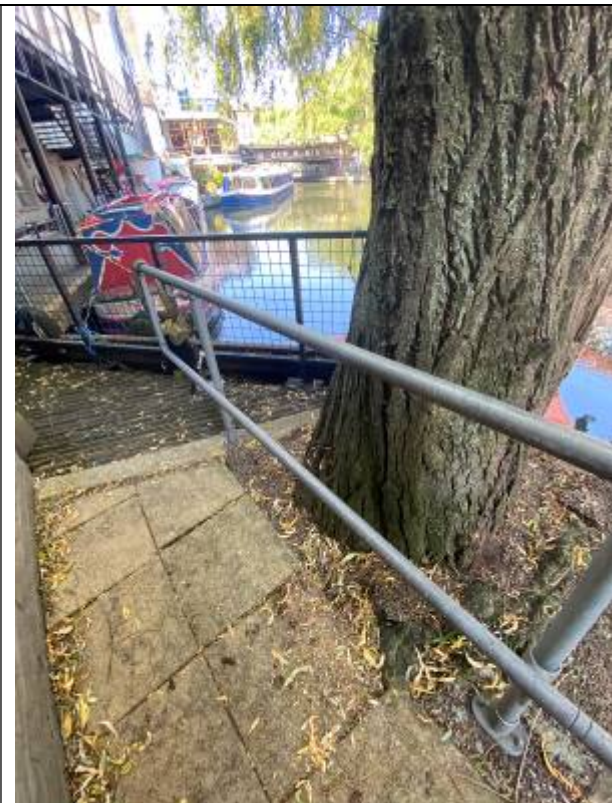
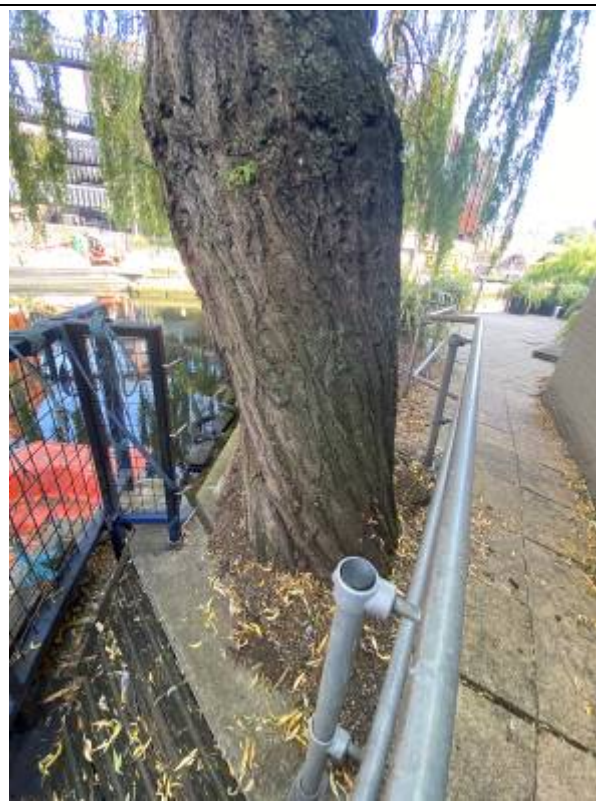
The subject Weeping Willow is a mature specimen growing to the rear of 17-29 Hawley Crescent bordering the historic canal lock and weir. **Images 1 and 2** show the restricted nature of the rooting area. There was evidence of smaller diameter fibrous root bundles extending along the wharf edge into the water and roots visible in the canal up to 11 metres away by the weir.

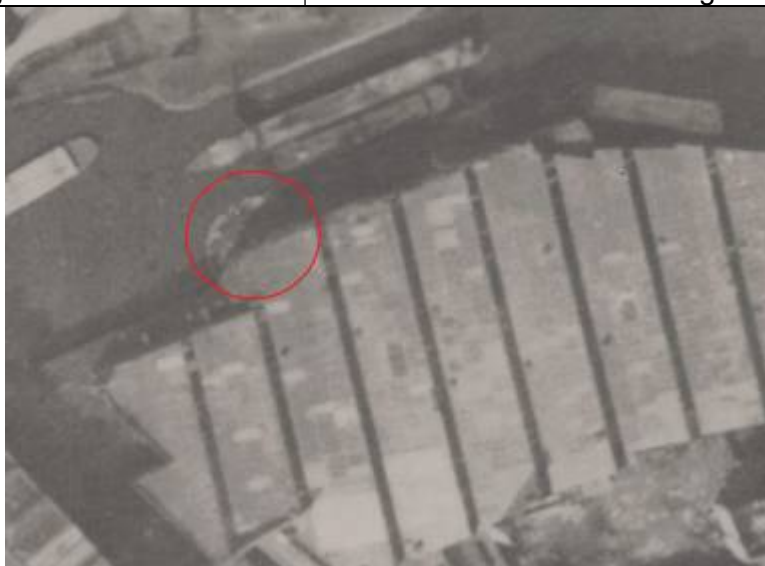
Image 3

Anecdotally, there is photograph evidence of a young willow at the current location. The picture being taken from the adjacent bridge circa 1970 (Image not viewed). This ties in with **Image 3**, which shows an aerial photograph of the site taken between 1944 and 1950 (OS 1:1,250 air photos, 1944-190 National Library of Scotland geo referenced maps). There is no sign of a tree in the image and the nature of the site and canal use would preclude the area being used for anything but that related to the works.

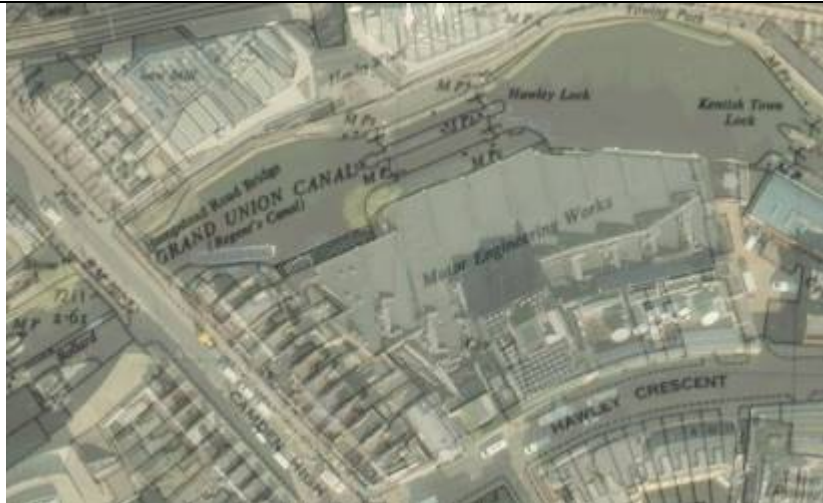
Image 4 shows the OS 1:1,250, 1944-190 National Library of Scotland geo referenced map with an overlay from google maps. The image highlights that the wharf area, now being used as outdoor seating for the offices is an original feature with modern surface layer. It is likely that the area is a poor rooting environment for the subject willow. (**Image 5**)

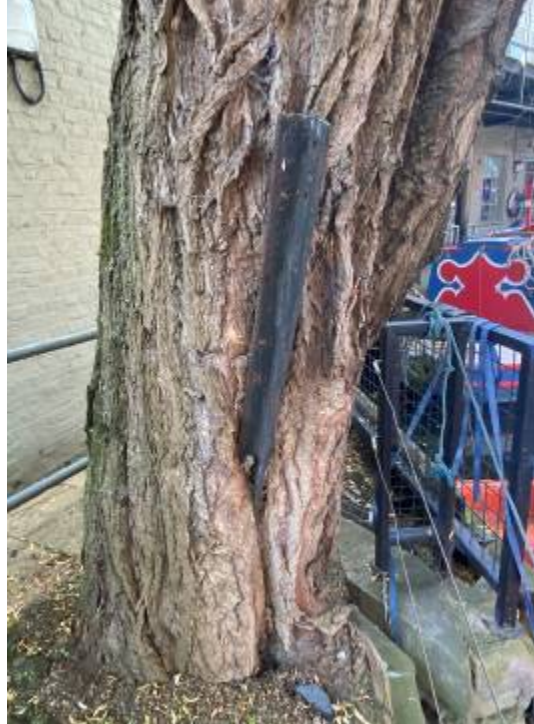
Image 6

The tree has grown in a restricted site and has occluded a section of angle iron likely to be an original boundary fence support. (**Image 6**) The lower stem has a helical twist which goes from the lower southwest stem around to the northwest at approximately 3 metres, the section of low resonance stem is adjacent to the helical feature and directly below a decayed branch stub. (**Image 7**)

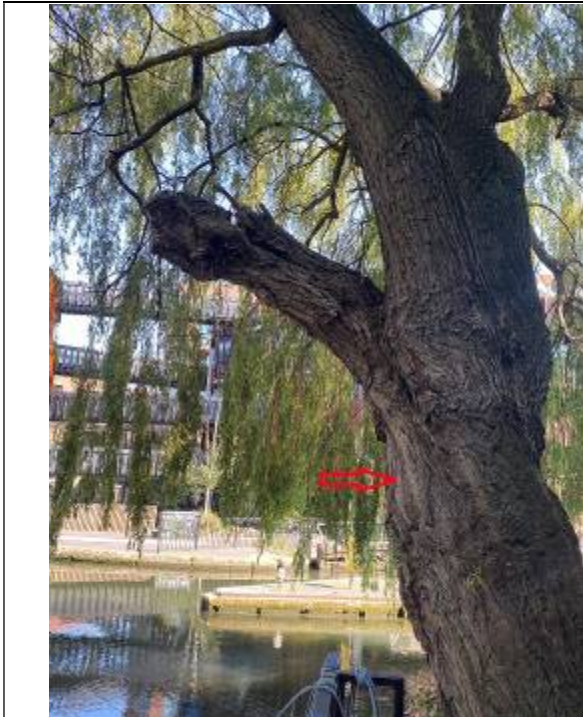
Image 7

The low resonance section of stem is 1.7 metres above ground level on the northwest side of the stem, measuring 400 mm wide by 700 mm in height. The stem section was found to be dysfunctional and partially decayed at this location. The end branch stub above this area may be related to the feature.

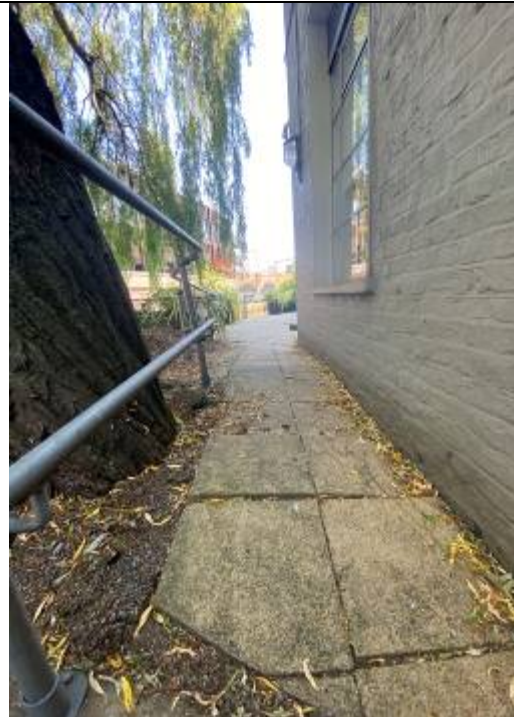
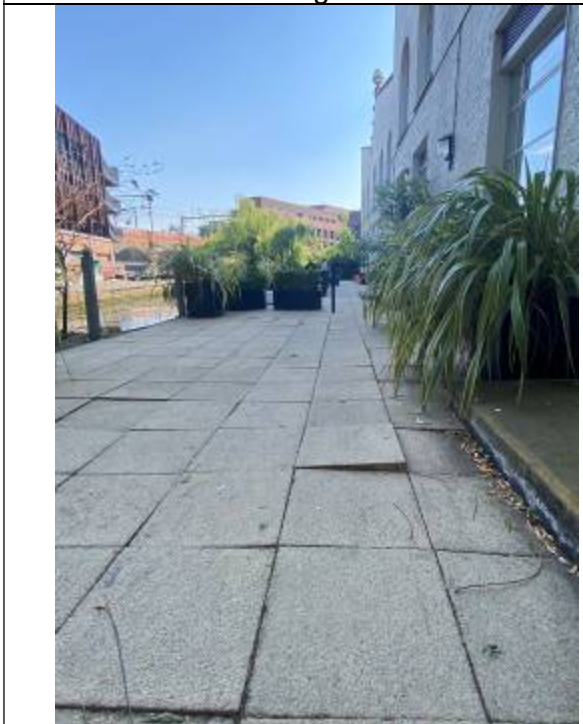
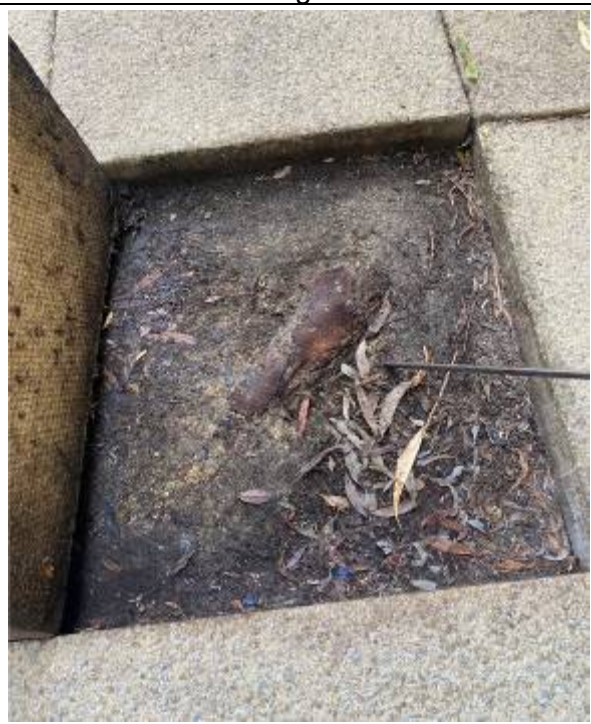
The surrounding paved area has numerous displaced slabs which pose a trip hazard, **Images 8, 9 and 10**. A slab was lifted to confirm root displacement. Roots are displacing the paving to a distance of 12 metres from the stem. The root depth is shallow due to the wharf construction and restricted depth of the rooting environment.

There is little that can be done with the roots if the tree is to remain. It may be prudent to look into raising the ground level to the rear of the building by means of a raised composite deck. This would have a minimal impact on the willow roots if constructed above current paving levels.

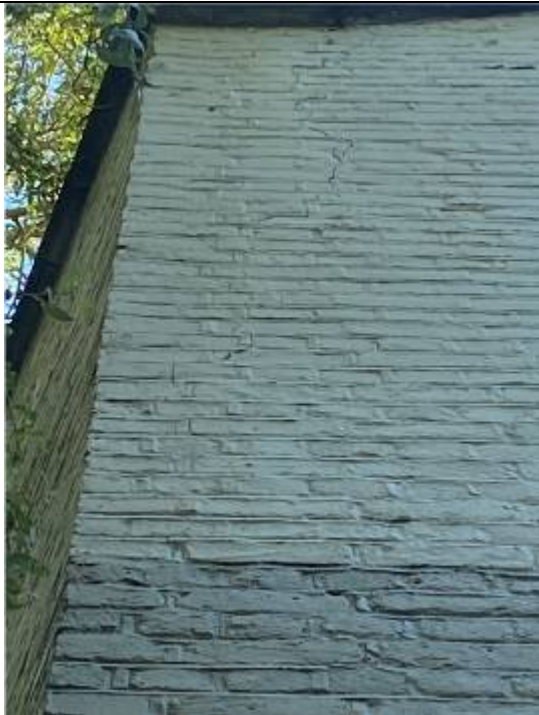
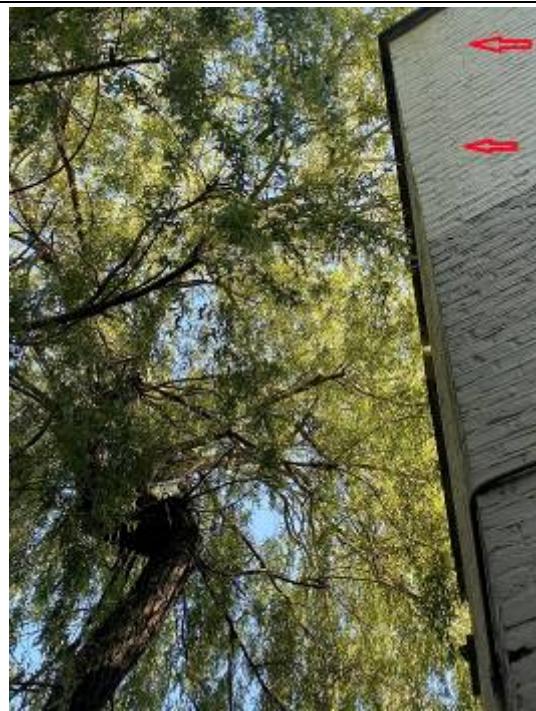
The historic exposed brickwork adjacent to the Willow has cracks around 10 metres from ground level and adjacent to the tree. (**Images 11 and 12**) The cracks should be investigated by a structural engineer. A desktop study of water demand relating to trees on clay soils should be read with caution as there is little documented data that reflect the site conditions.

Further investigations into the structural condition of the building should be undertaken by a structural engineer.

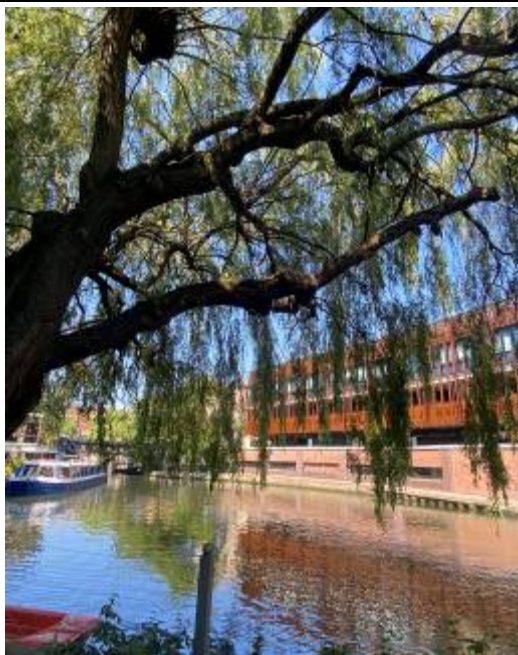
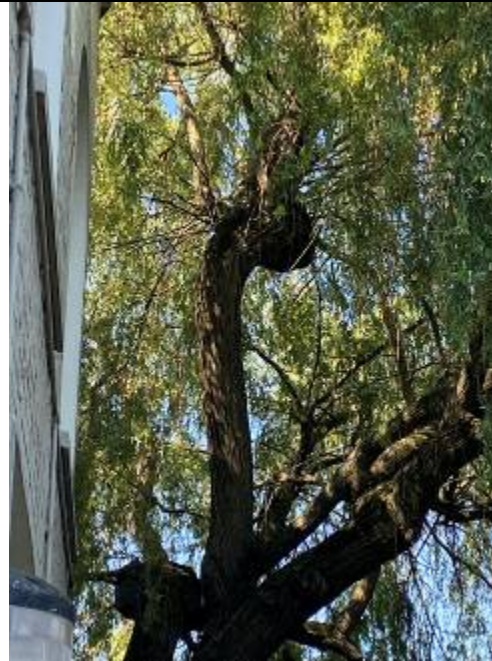
The crown is healthy, asymmetrical with extended weeping growth to the north and west over the canal. The crown shows evidence of historic crown reduction pruning with 4-5 metres of regrowth which appears healthy with abundant leaf. (**Images 13 and 14**).

There is deadwood in the lower crown, but overall, the crown has good leaf coverage of a healthy colour.

It is recommended that the crown of the Weeping Willow is pollarded to the historic pollard/reduction points at 8 metres above ground level.

This recommendation should be repeated in a further 4-8 years from the date of initial pruning. The work is recommended to maintain the crown in proportion to the surrounding infrastructure and prevent excessive wind loading of the branch structure.

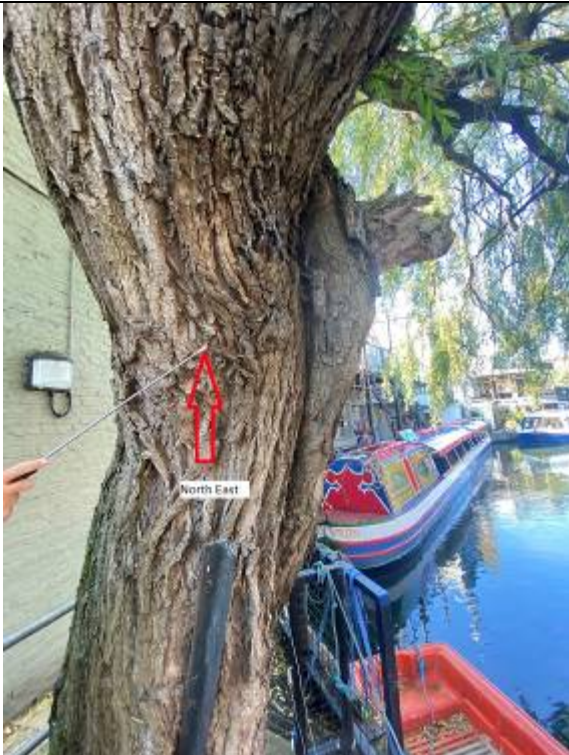
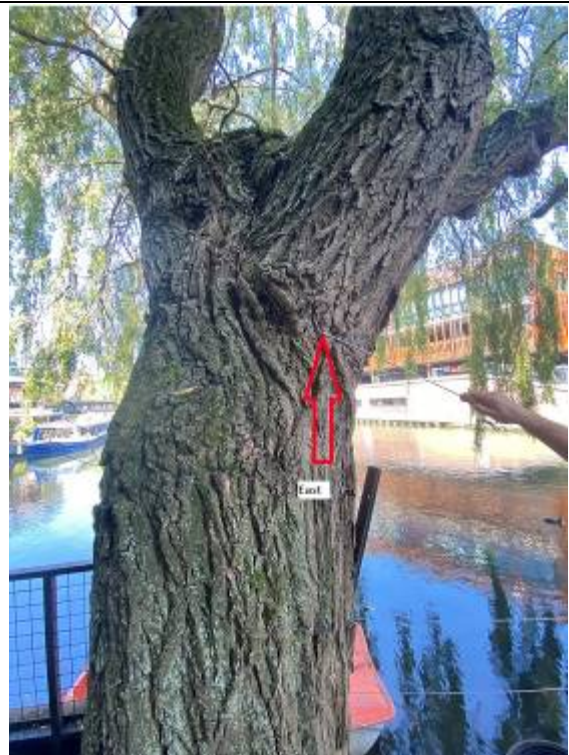
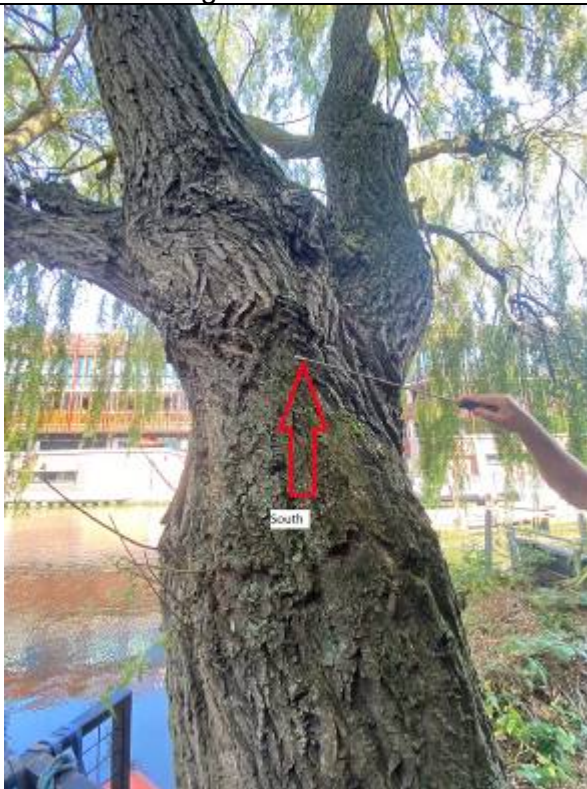
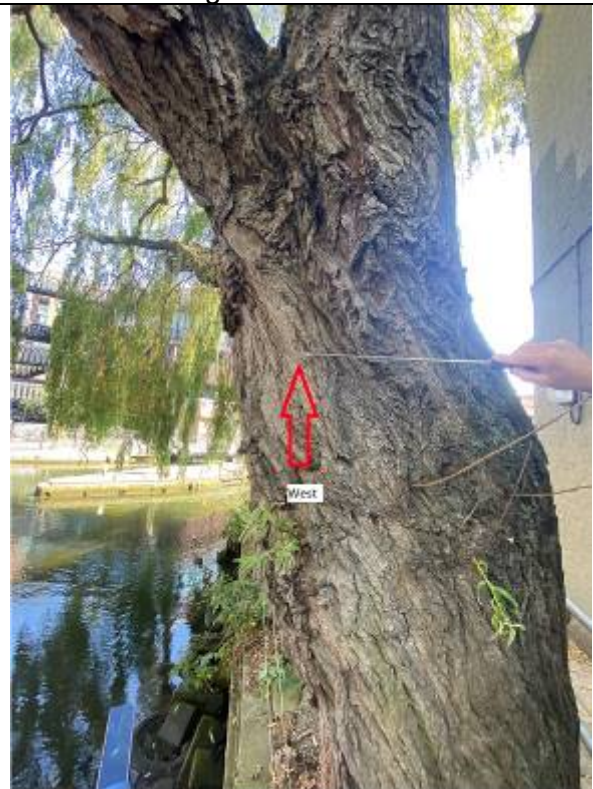
The remaining stem was found to be sound. The crown has been historically managed with a re-grown natural appearance. The tree lies in a semi-sheltered location. **Images 15-18** below show the location of the drillings.

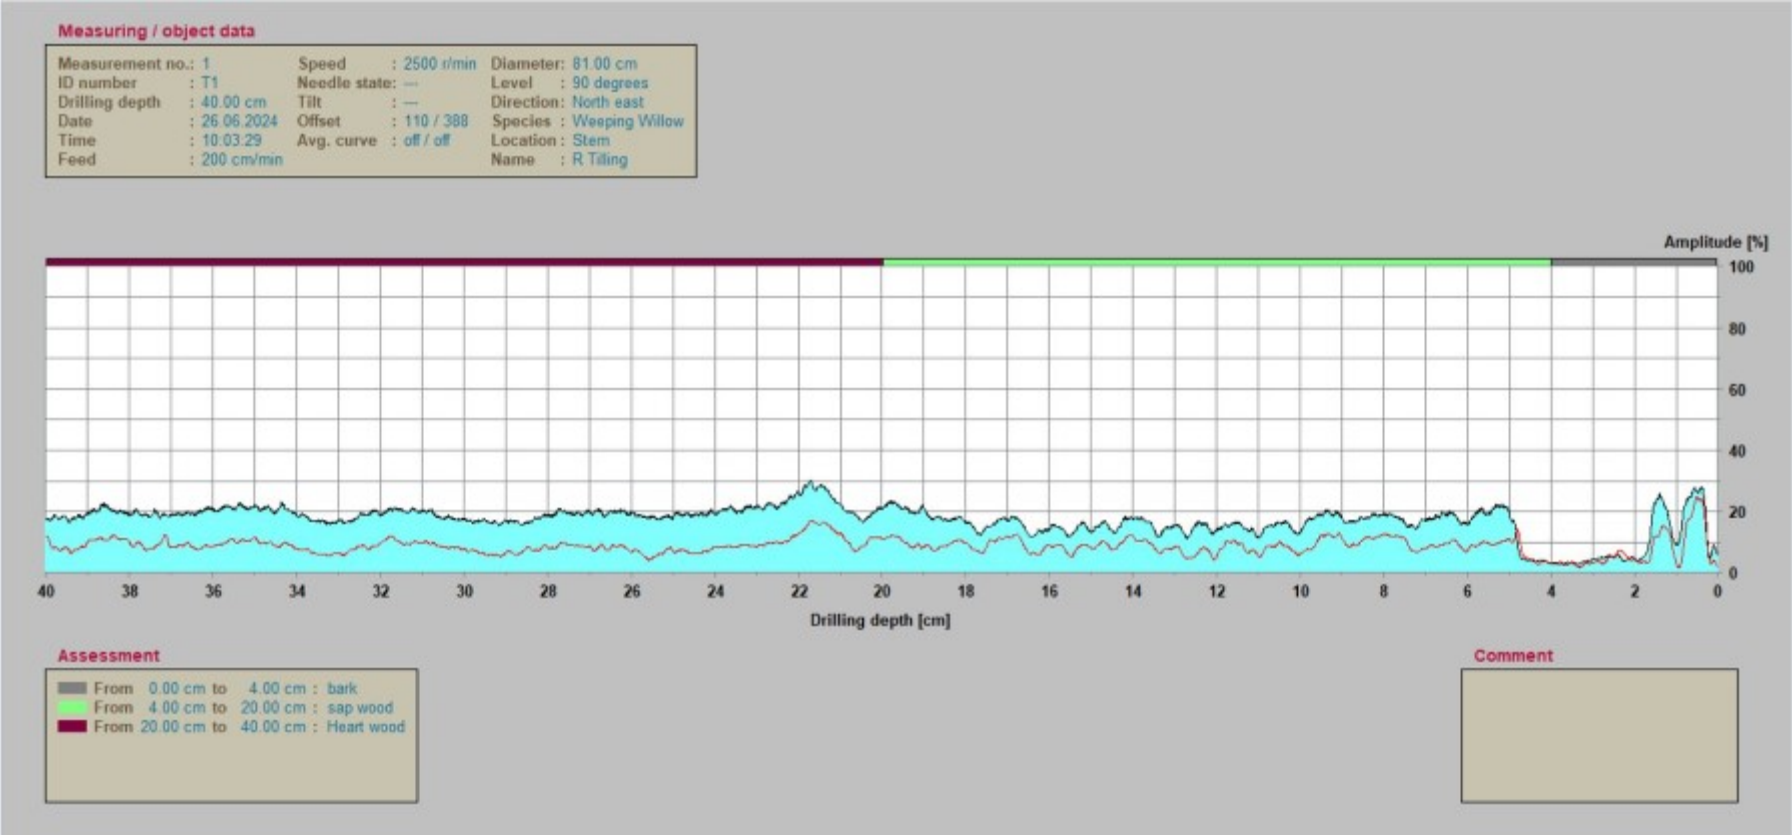
Northeast (1)

Trace 1 indicates a normal pattern of resistance from the beginning to the end of the test. The drop between 2 and 4 cm coming from the transition through bark to sapwood.

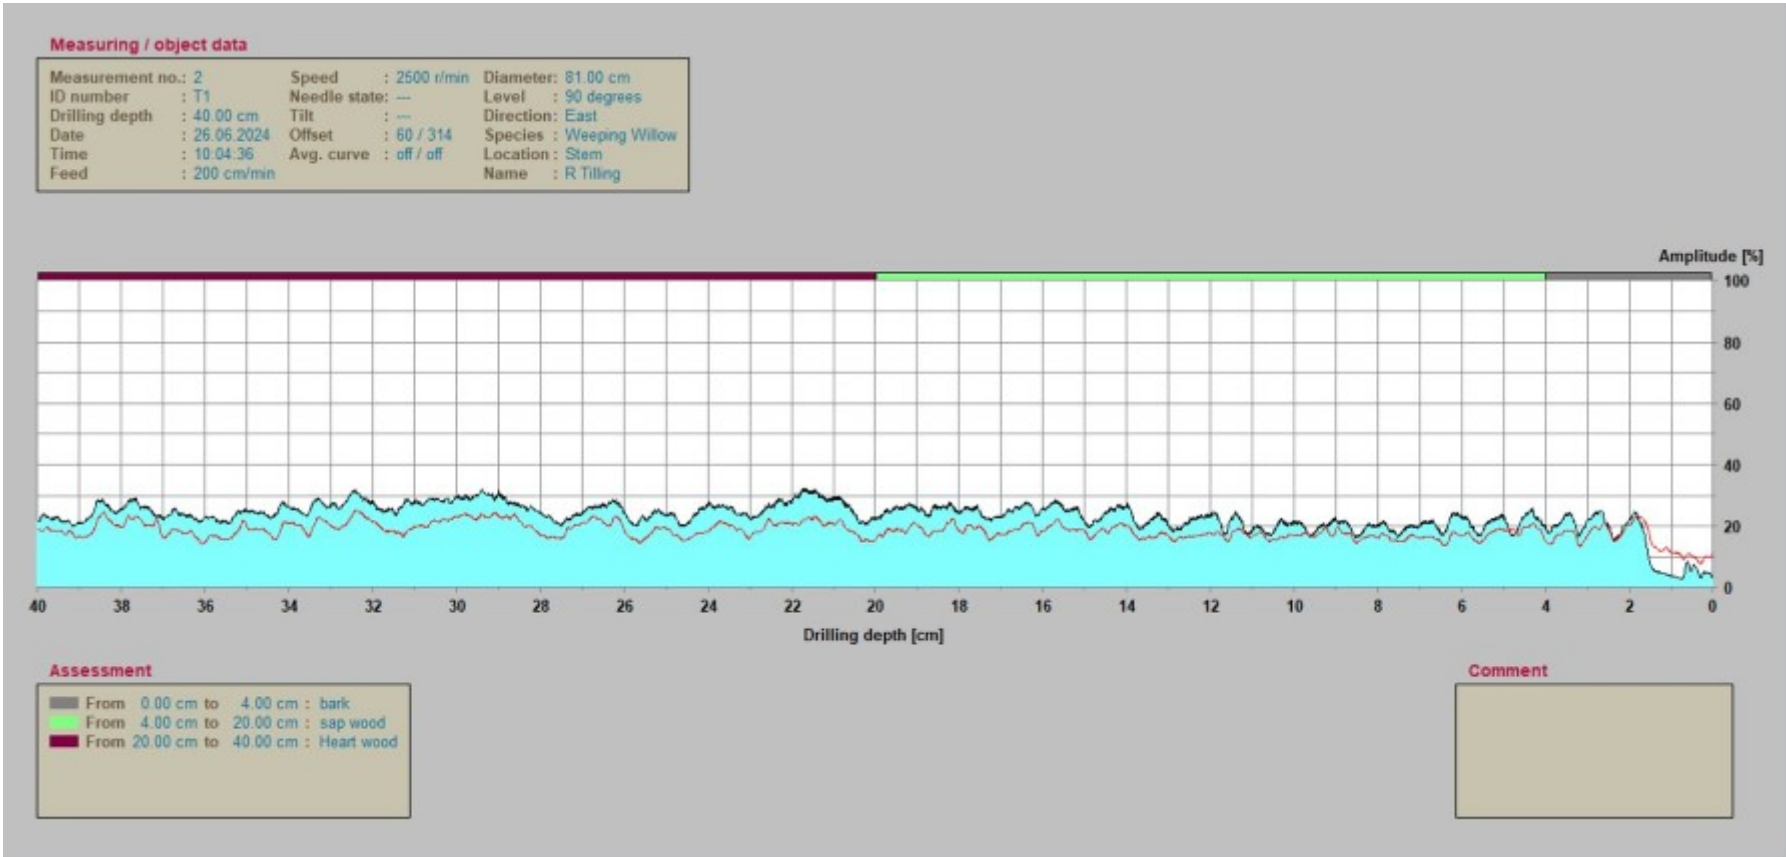
East (2)

Trace 2 indicates a normal pattern of resistance from the beginning of the test.

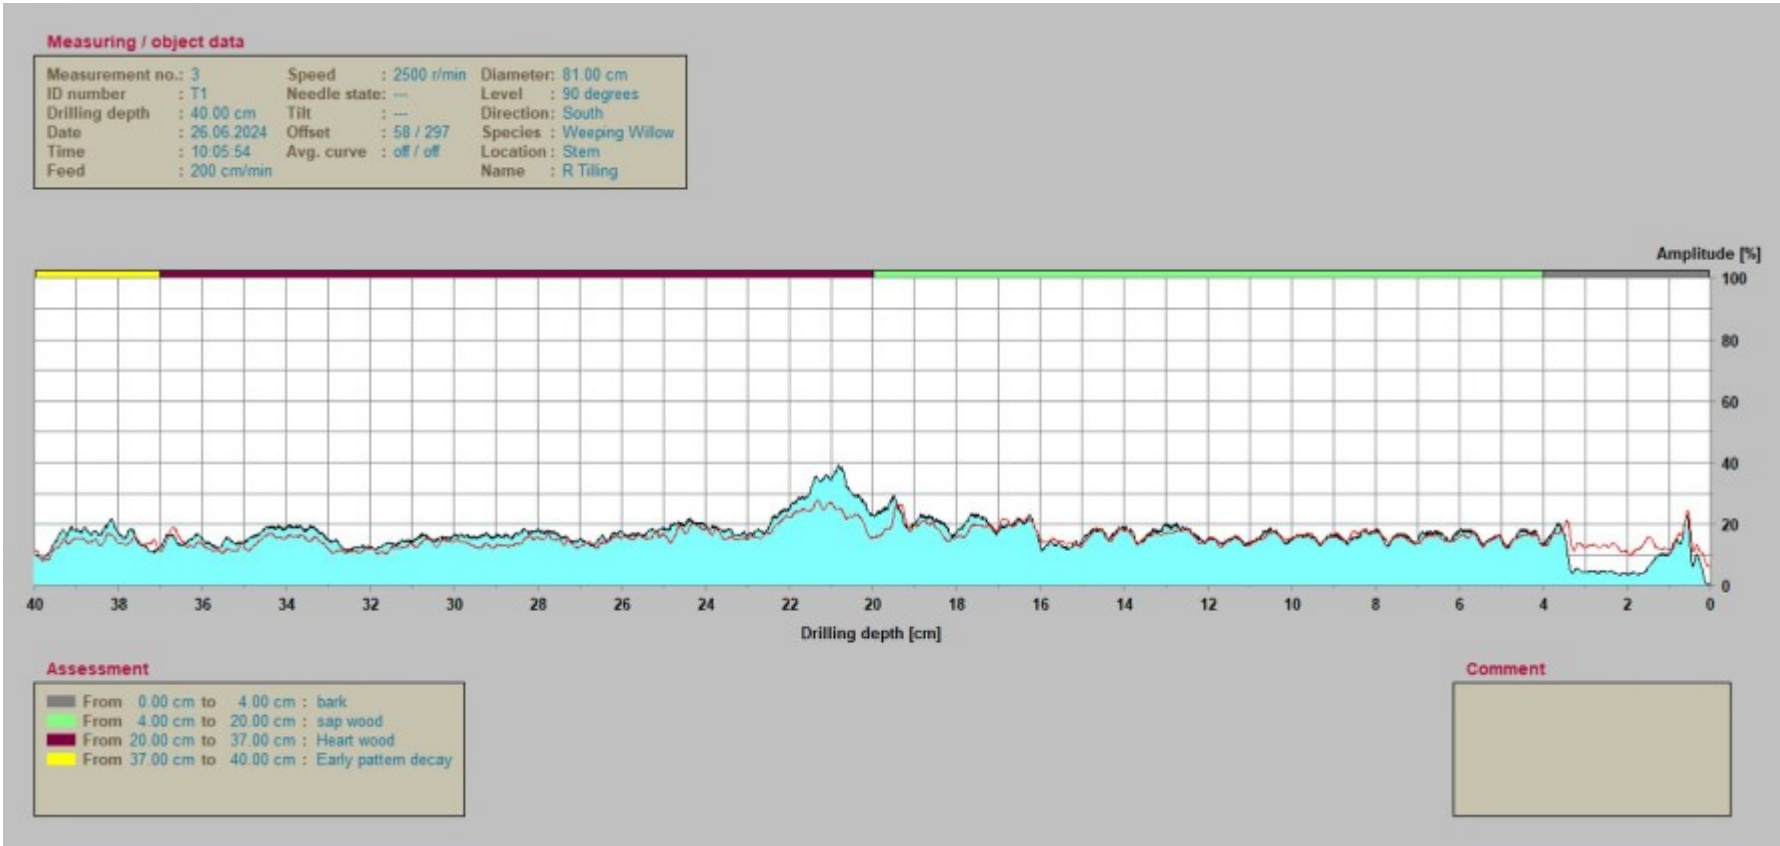
South (3)

Trace 3 indicates a normal pattern of resistance from the beginning to the end of the test. The drop between 2 and 4 cm coming from the transition through bark to sapwood. A possible area of decay was encountered towards the end of the test where the increase in resistance is followed by a drop in amplitude.

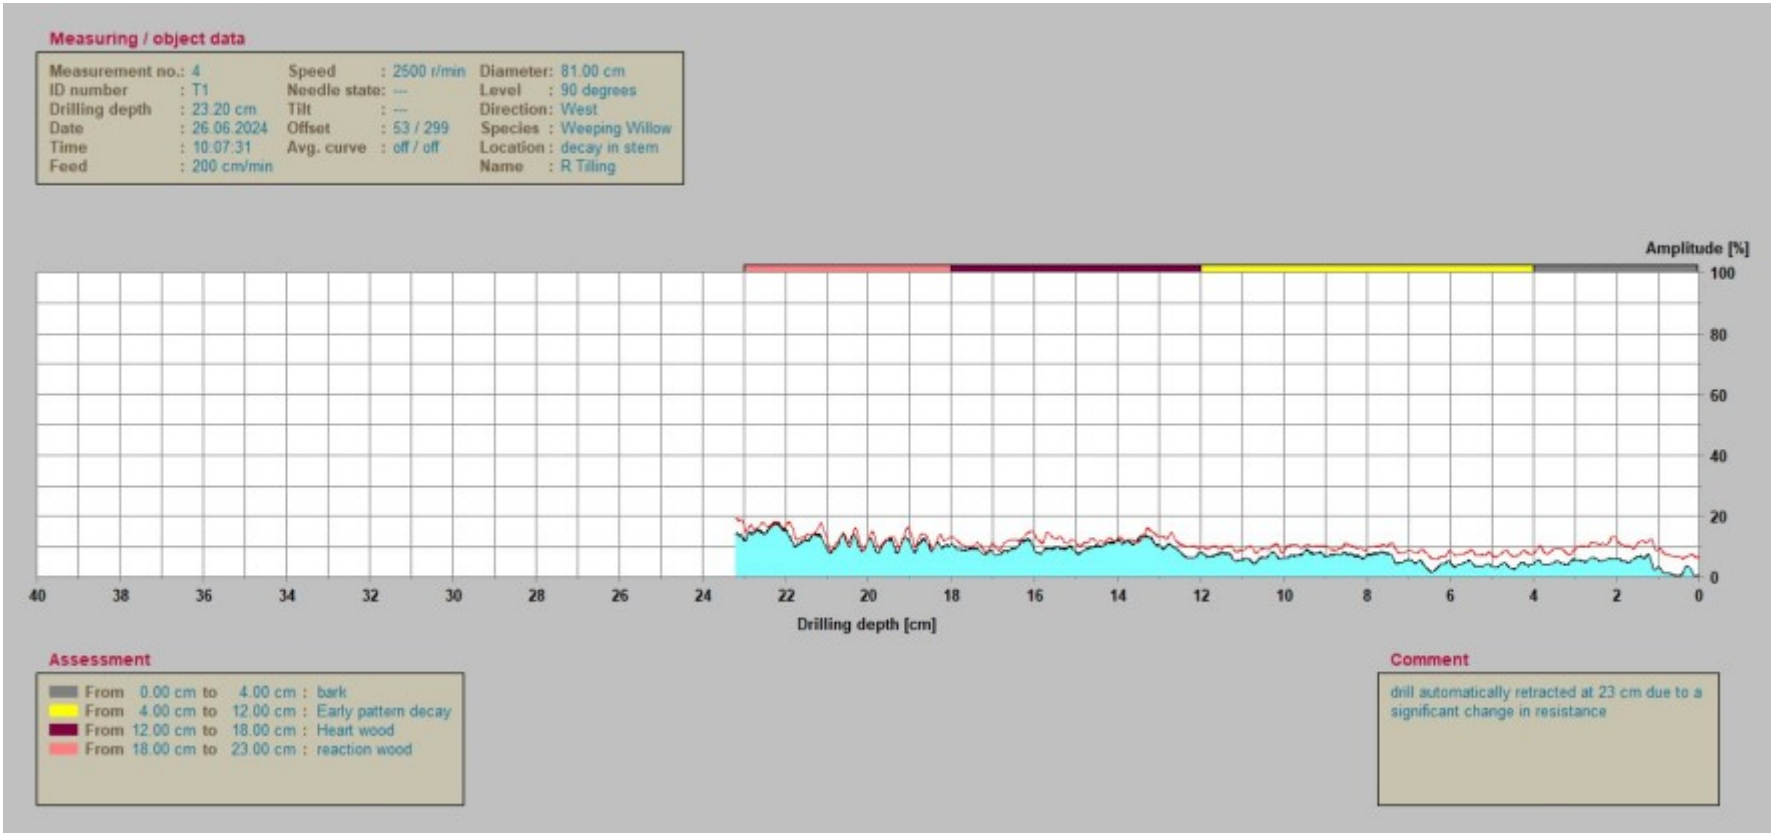
West (4)

Trace 4 indicates a lower resistance and low wave amplitude from dysfunctional wood with an increase in resistance through the ripe wood. The increase in resistance at 21 cm is followed by a resistance spike which retracted the needle automatically.

The microdrill trace results indicate an area of dysfunctional sapwood located on the western stem below the crown break which is the location that low resonance was heard during the sounding with a nylon mallet. The decay is restricted in depth to the sapwood.

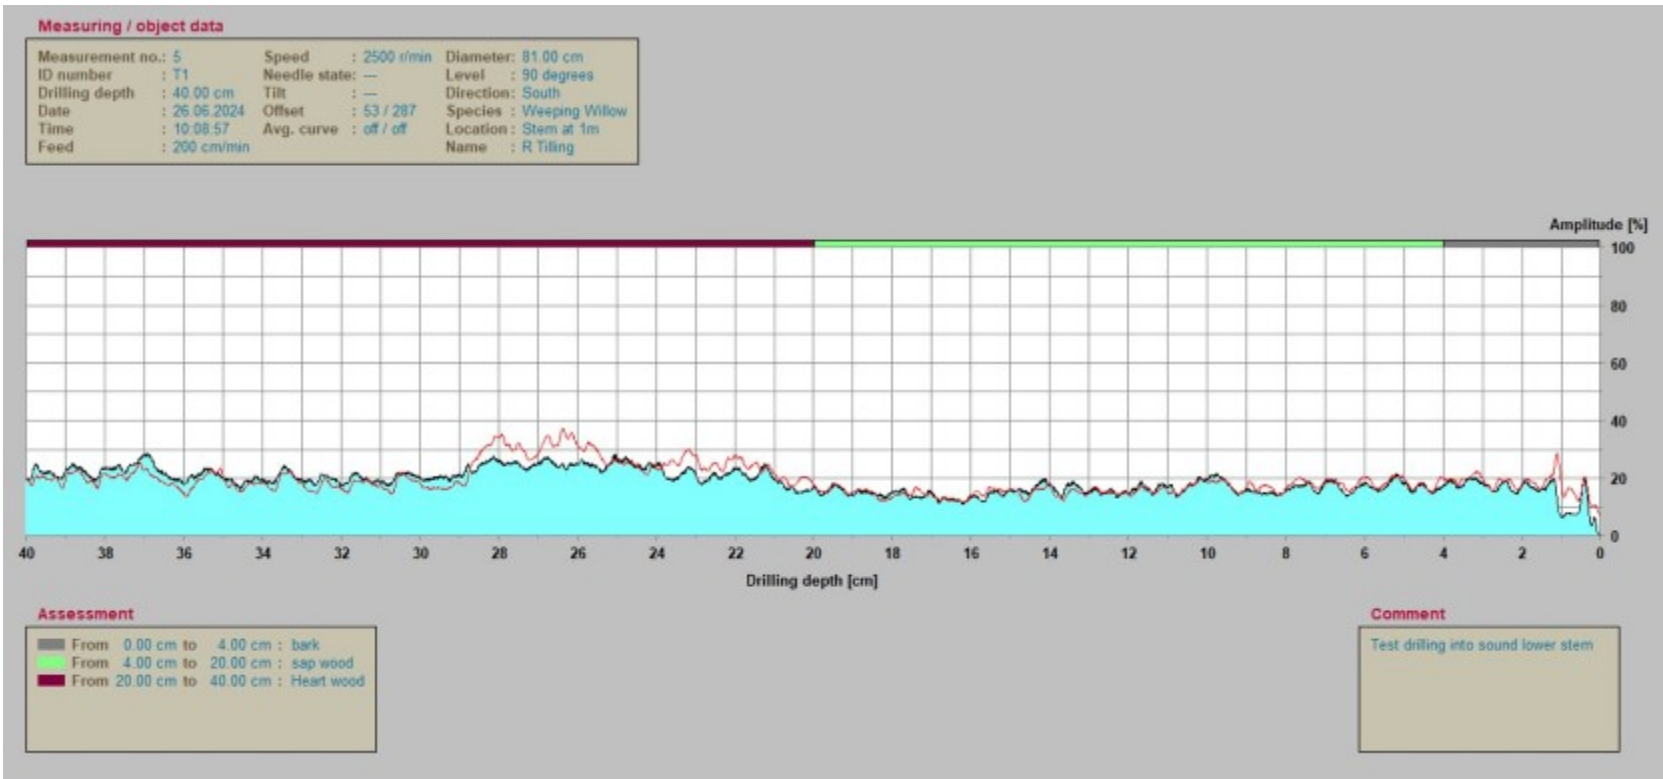
South (5)

Trace 5 indicates normal resistance pattern throughout the trace. This drilling was undertaken at a lower stem level where no defects were thought to exist.
