12. No 8 New Square - Observations and Survey Notes

13. No 9 New Square - Observations and Survey Notes

14. No 10 New Square - Observations and Survey Notes

15. No 11 New Square - Observations and Survey Notes

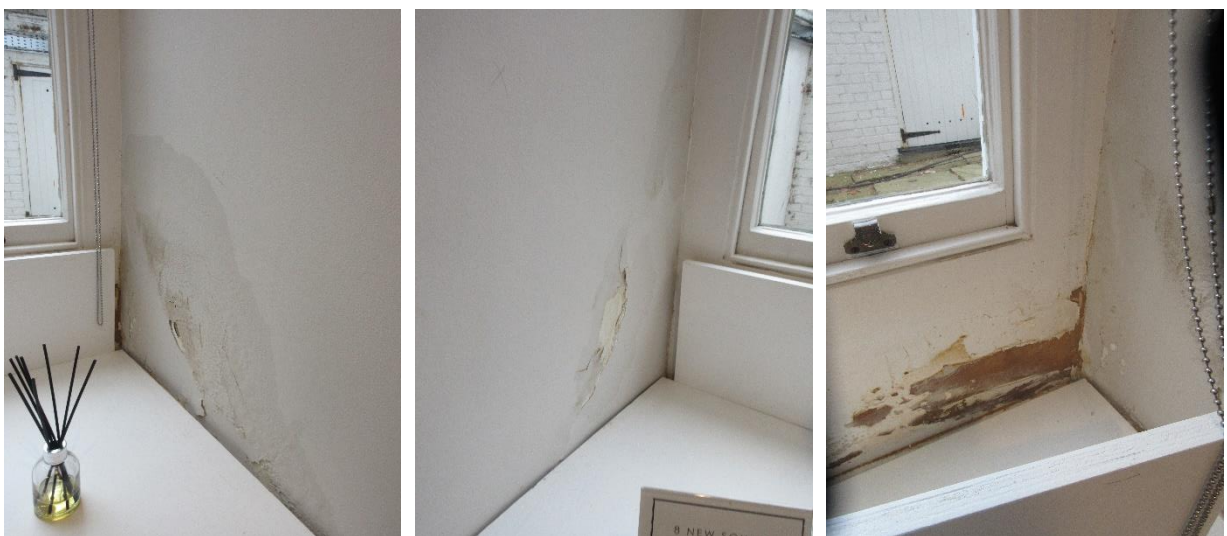
12.3. The render condition is mostly good with approximately 75% well attached. Lining out just discernible in a few small places. Slate drip with mortar fillet applied over triangular brick fillet. Airbricks painted over at low level. Decorative condition fair. Excessive damp to WB04 in Room 8BNS/B2 may be linked to the condition of the drip above and a possible backfall which is feeding water into the wall, but the entrance terrace may also be the issue. The plinth may be cement rendered.

12.5. To the two windows in Room 8BNS/B3 I observed no evidence of moisture ingress. The walls are panelled and have been stripped of their paint. The general condition is good, but with some areas of decay at low level but I have no reason to believe this is recent. To window WB03 in Room 8BNS/B2 there is no evidence of damp present but to window WB04 extensive damp is present to the cill and both reveals. The plaster is onto solid masonry and evidence of moisture is much more extensive internally than externally. The damp plaster is concealed with loose fitting boarding for aesthetic reasons. High moisture meter readings were recorded.

Above left: Damp to the south reveal of WB04 in Room 8BNS/B3.

Above central: Damp to the north reveal of WB04 in Room 8BNS/B2.

Above right: Damp above the cill board of WB04 in Room 8BNS/B2.

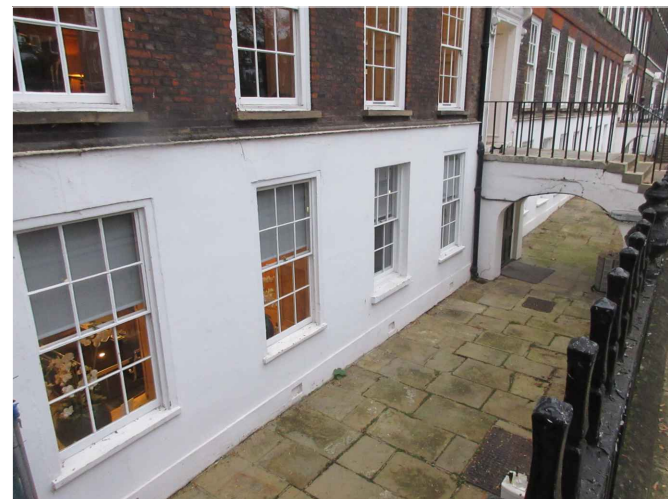
No8 New Square (South)

Possible defect to high level hopper

Water drips off broken pediment

Possible backfall to slate

Extensive damp to both reveals and u/s of cill

Painted slate (?) drip with mortar fillet above (no lead flashing)

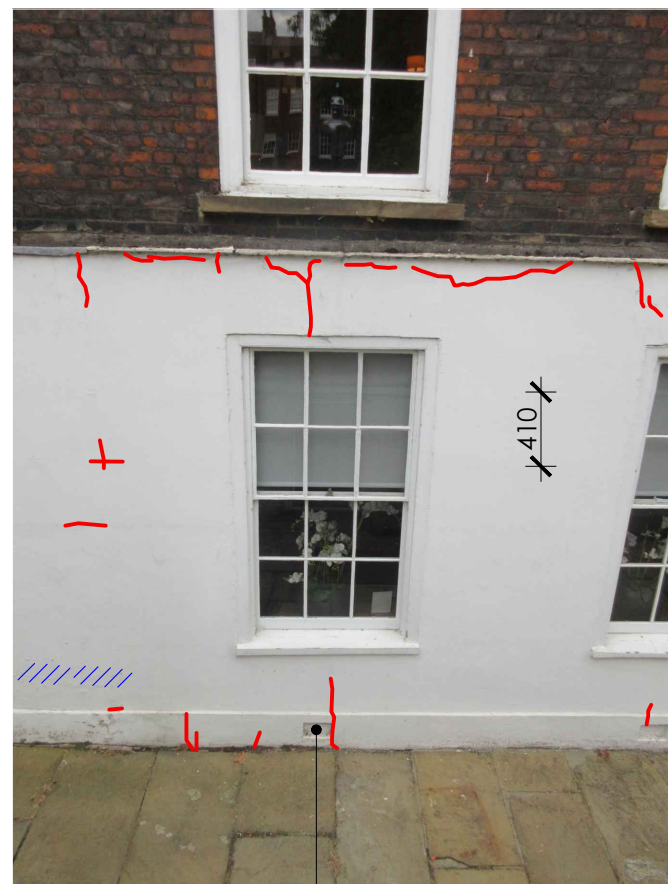
No8 - WB01

Painted over cast iron vent

- 16.7. All air bricks would benefit from being carefully stripped of multiple layers of paint to maximise ventilation to the void(?) behind. Following stripping, they should be repainted to match the limewash colour.

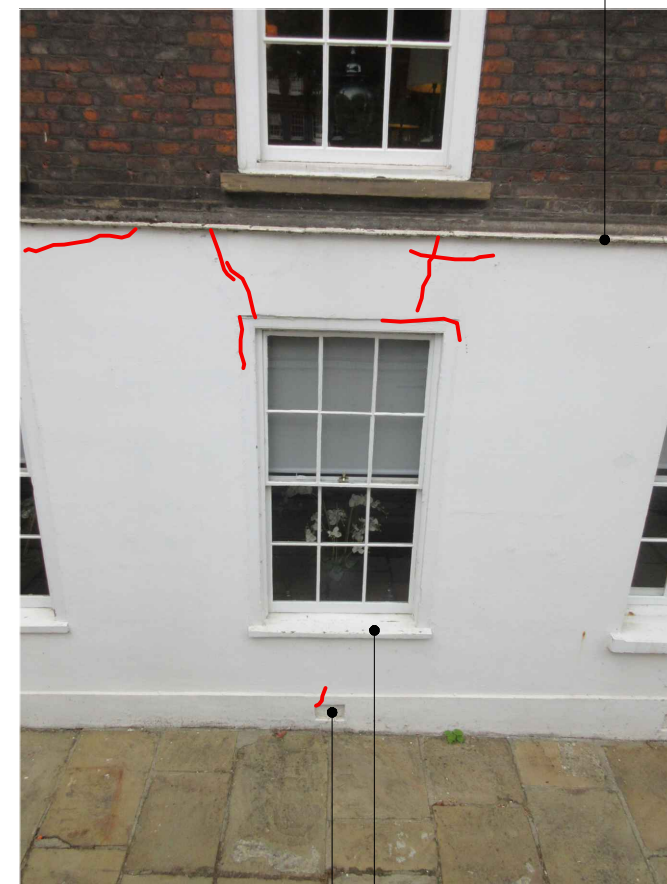
No8 - WB02

Timber cill

Painted over cast iron vent

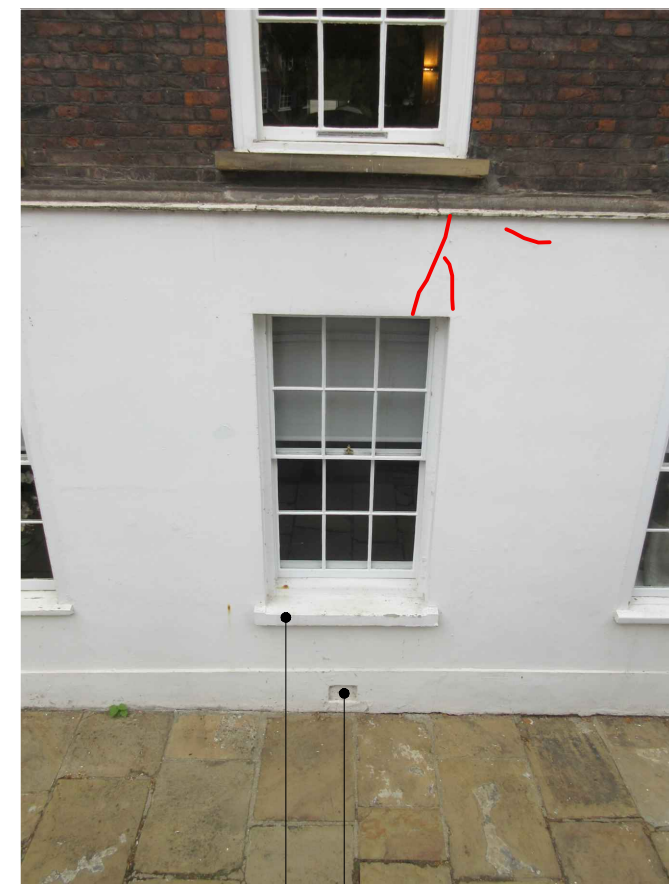
No8 - WB03

Painted over cast iron vent

Stone cill

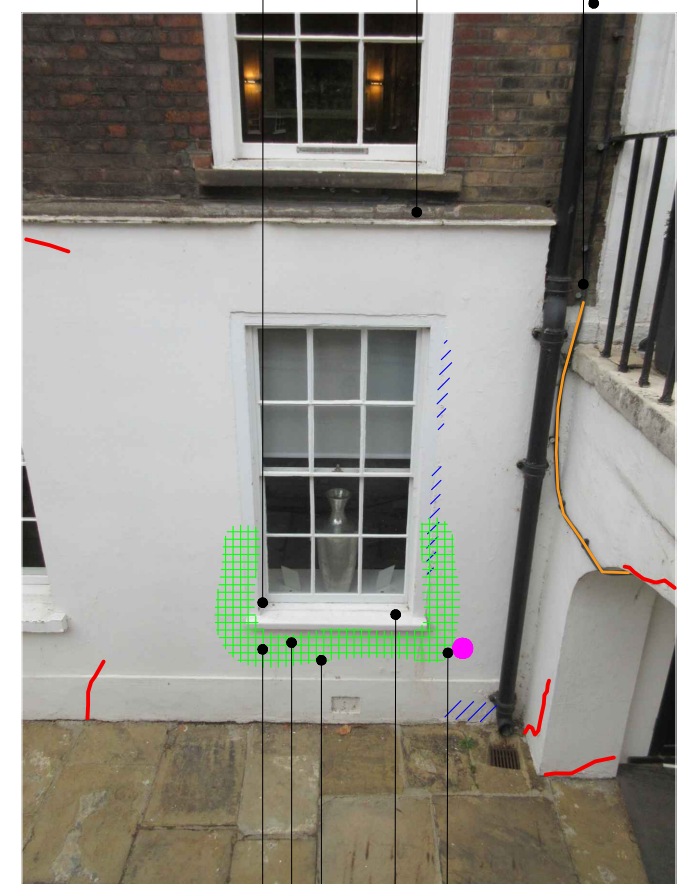
No8 - WB04

This is a high strength uncarbonated Portland cement based render at c.1: 3 to 4 (binder : aggregate by volume). The aggregate is coarse quartz and flint sand. This is very likely to be a 20th century material.

Rose of Jericho Sample No 8

Timber cill

Ground level dropped

Extensive damp to both reveals and water cill

Damp to internal wall under cill boards

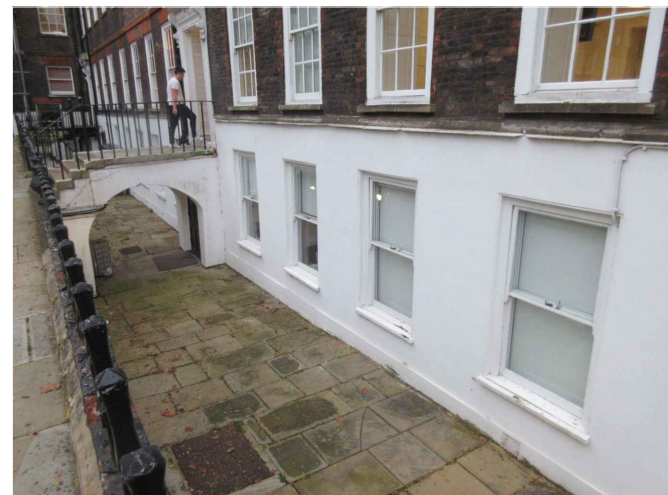
No8 New Square (North)

Missing drip

Painted slate (?) drip with mortar fillet above

Drip displaced

Failing mortar fillet

Drip damaged

Decayed cill

Painted over vents

Ground level has dropped

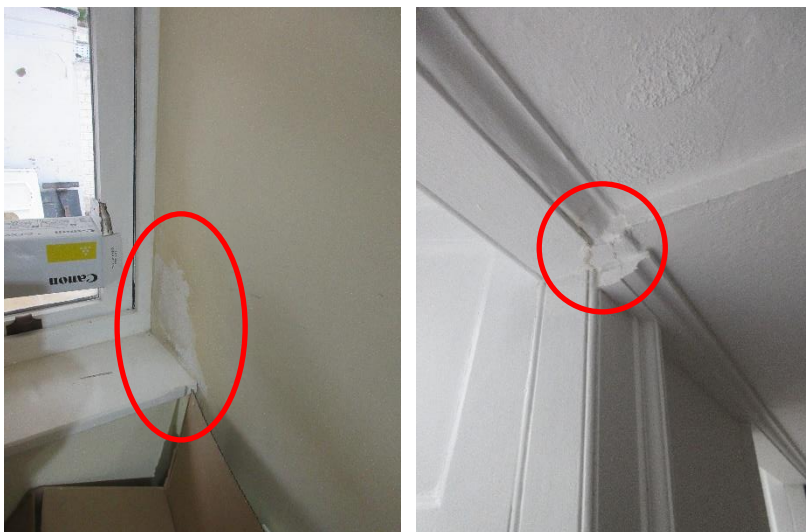
13.5. To Rooms 9NS/B1 & 9NS/B2 shutters are present. The reveals and internal wall surfaces have been plaster lined and covered with woodchip wallpaper. The plaster is probably lime. The decorative condition of all surfaces is good with no evidence of damp. To the small window to Room 9NS/B11 under the entrance landing, the walls have been dry lined but damp is present around the window cill. The moisture almost certainly relates to water ingress through the entrance bridge.

I note that the ground levels inside may be lower than that outside. A possible small area of damp to the upper south side of WB06 - this damp appears to be more internalised and may relate to a leak in pipes in the floor above. This needs to be checked.

Above left: Damp to window reveal under entrance bridge. Room 9NS/B11.
Above right: Small area of moisture staining above WB06 in Room 9NS/B6.

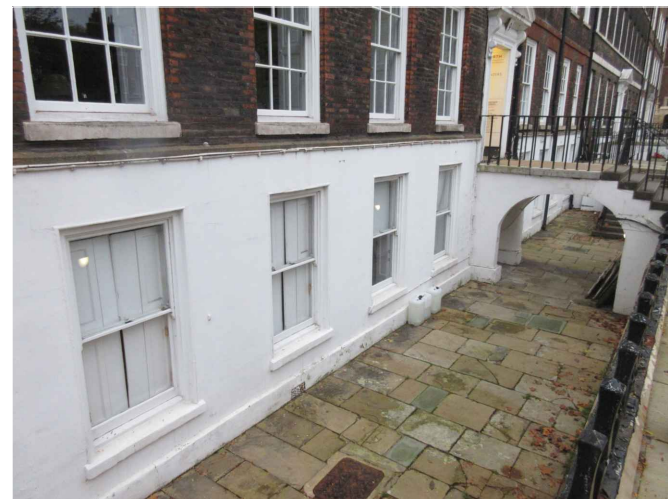
No9 New Square (South)

Painted slate (?) drip with mortar fillet above
 Painted over cast iron vent
 Window housing decay accelerated by failed drip above
 Cracking follows fill relating to lining out
 Damaged drip
 Damp to window reveal under entrance landing

No9 - WB01
 Note plinth height change

No9 - WB02
 Decayed cast iron vent

No9 - WB04
 Painted cast iron vent
 Water splash / run off from pediment over door
 Rose of Jericho Sample No 9

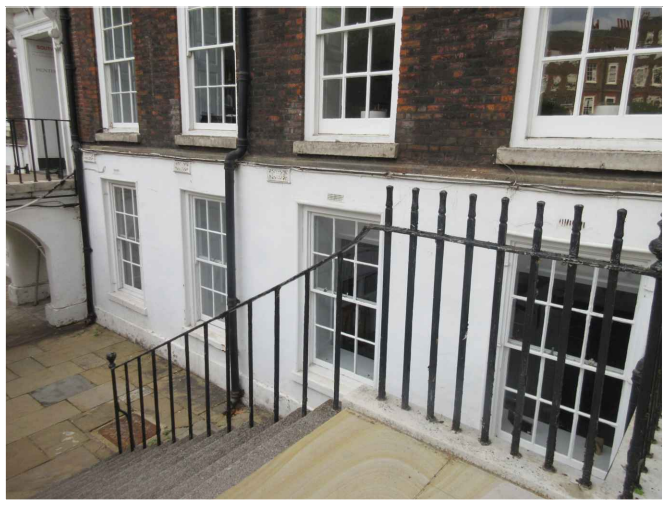
No9 New Square (North)

Large decorative iron vents

Failing mortar fillets
Damaged drip

Painted slate (?) drip with mortar fillet above
Cast iron vent
Damaged drip

Decayed sandstone cill
Small area of damp staining to upper part of window lining internally. Issue could relate to a radiator above.

Painted stone plinth
Downpipe not fixed to wall

No gully at base of downpipe
Damp ground conditions

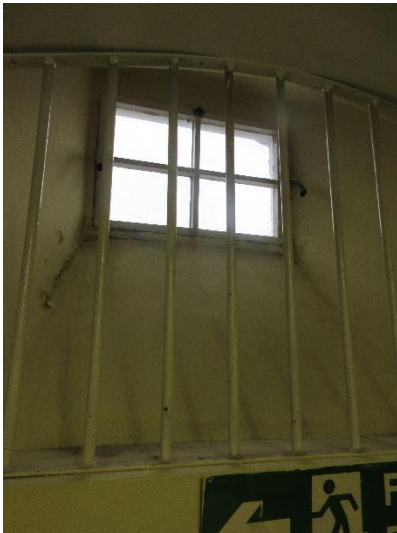
14.5. To window WB01 in 10ANS/B3b there is damp to the reveals and cill. To DB0, no weather bar is present at the base of the door and there are high damp readings to the plaster reveals at low level. Positively, there is a slight step up from the ground level outside.

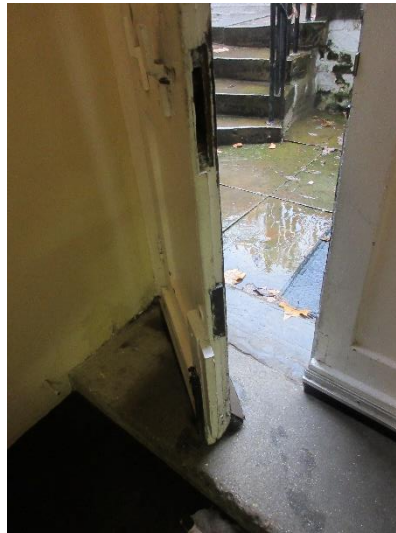
Above left: Peeling paint to the cill and reveals to WB01 in Room 10ANS/B3b.
Above right: Damp to door reveals at base of door DB01. No weather bar.

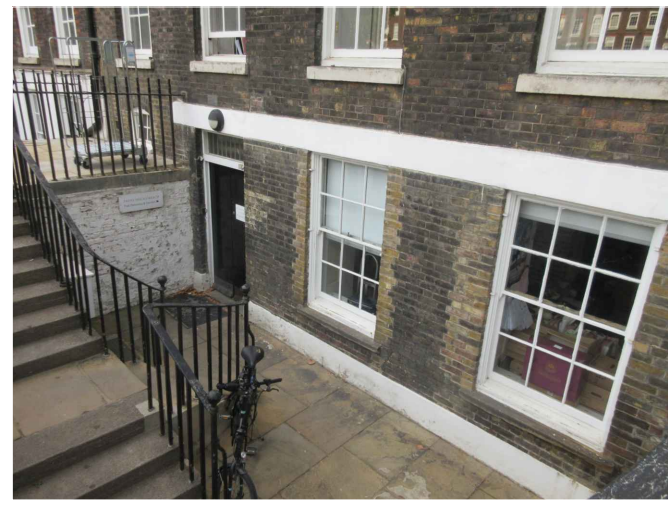
No10 New Square (South)

14.3. The walls are brickwork with a small offset present above render band above the windows. The plinth is rendered with localised paint failure. The window reveals have been rebuilt and the pointing here is probably cement. The brickwork is very dirty. The rendered band above the windows includes some hairline cracks – the render appears very hard and is probably cement based. There is no lead cover flashing. Decay to sandstone window cills.

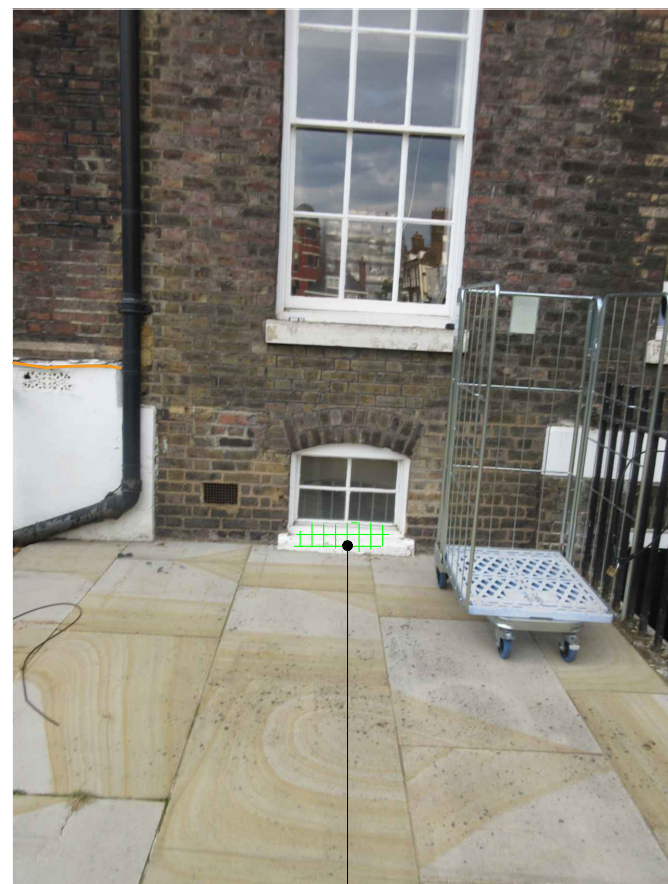
No10 - WB01

Peeling paint to internal cill and reveals. Slight damp recorded.

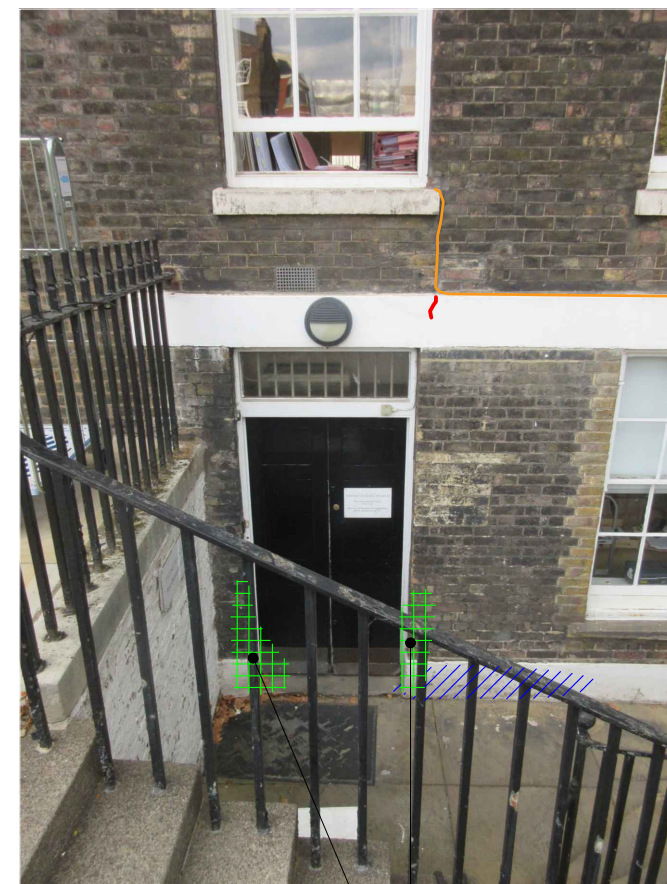
No10 - DB01

Damp to reveals at base of door. No weather bar to door.

- 16.9. The traditional repair of windows should take place in parallel with render repairs and replacement with particular attention given to ensuring that no Portland Cement is retained around the woodwork as this will accelerate decay. In some instances, pieced-in stonework repairs are required to the masonry cills.
- 16.10 The introduction of a weather bar is recommended below doors to prevent wind-blown water ingress under doors.

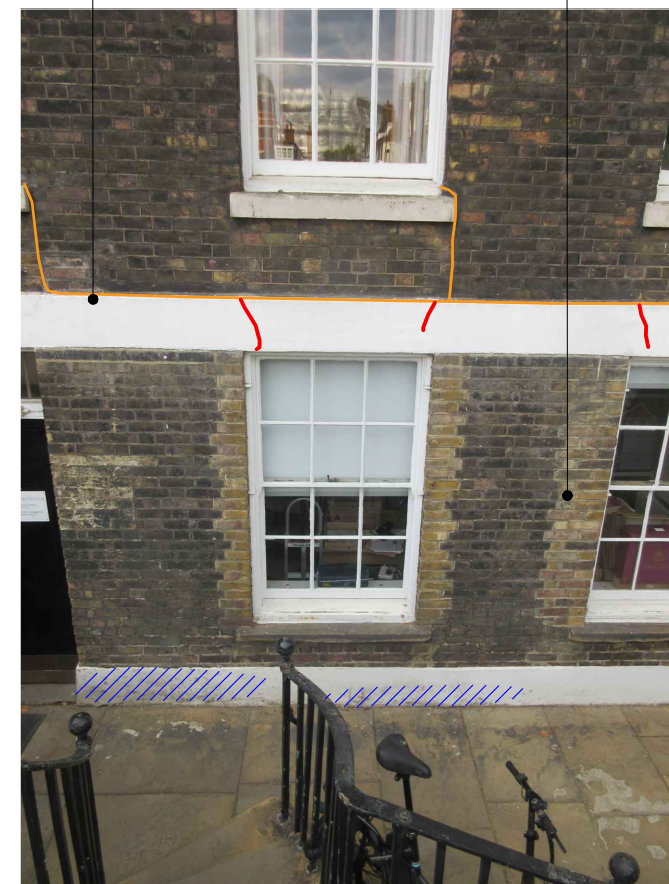
No10 - WB02

Brckwork reveals rebuilt

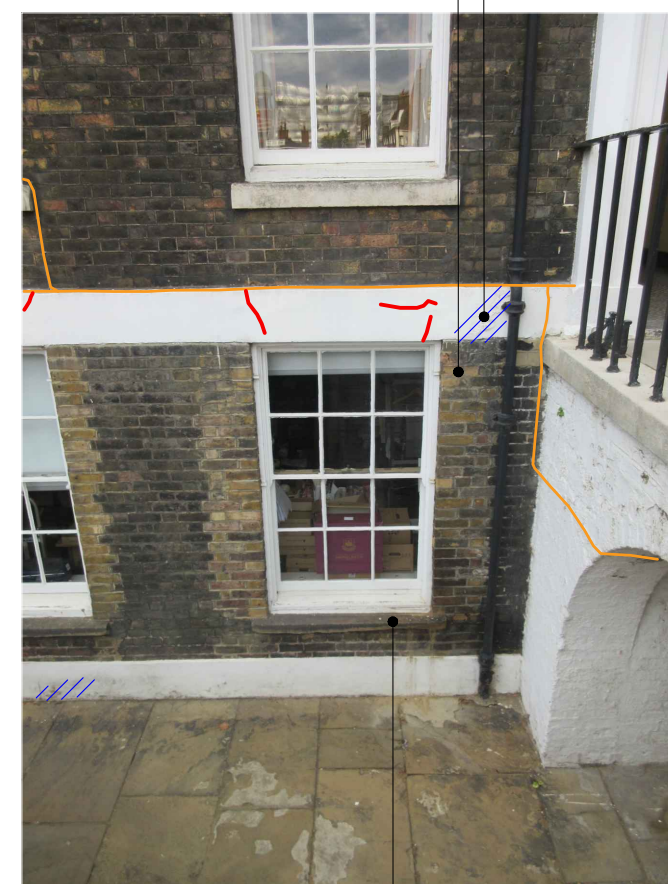
No10 - WB03

Cill damaged / decayed

Run off water damage
Brick decay

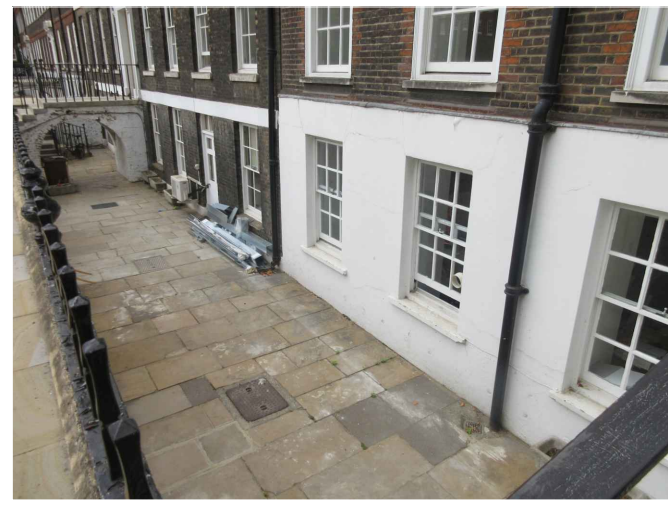
No10 New Square (North)

Cement render suspected

No flashing to offset

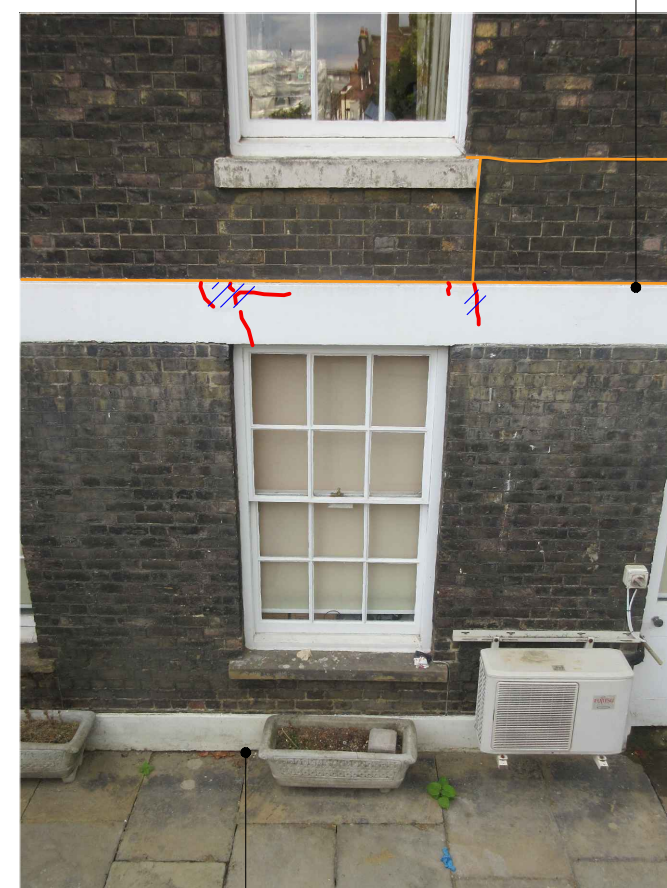
No10 - WB05

Ground level dropped slightly

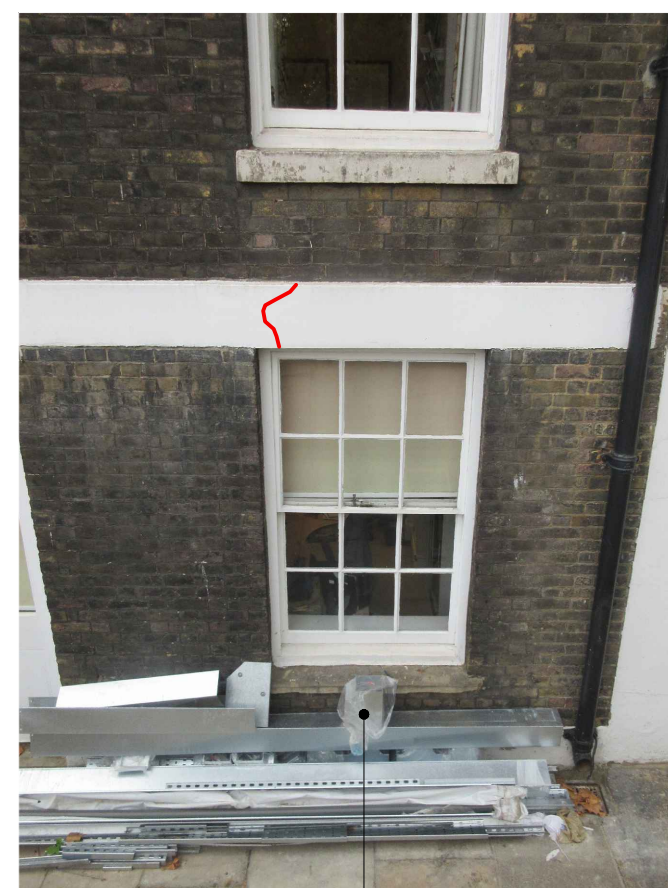
No10 - WB06

Cast iron vent under window

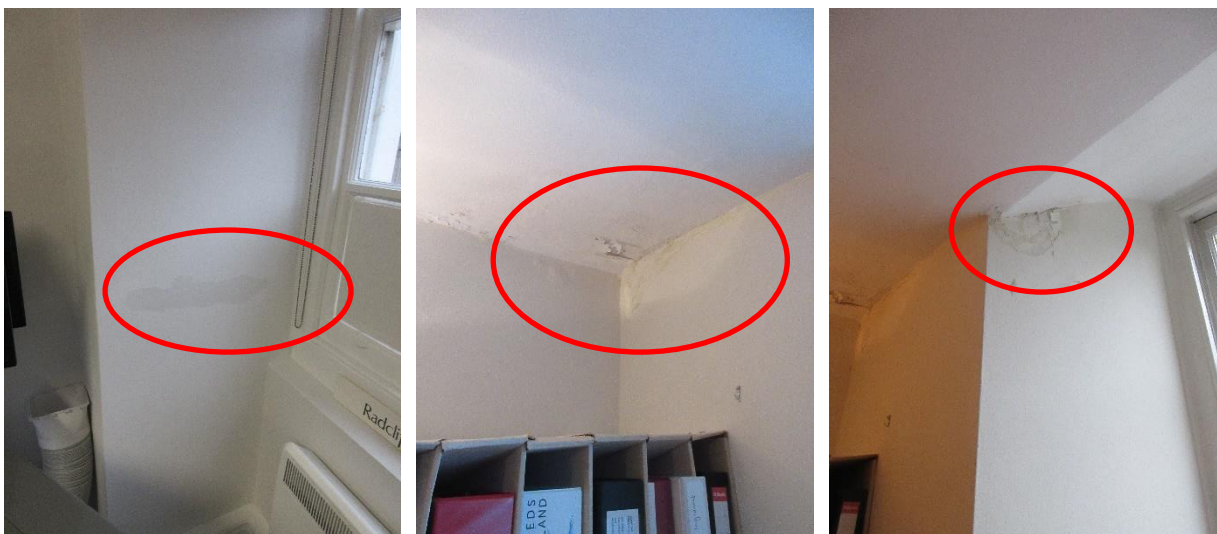
15.4. In room 11NS/B3 the walls have a modern plaster directly applied to the masonry behind. Damp was observed approximately 900mm off the floor to the northern reveal of window WB02. In 11NS/B4 (Window WB03) there is peeling in decoration and damp to the upper part of the northern reveal on the inner face and adjacent there is damp in the inner northeast corner of the room. The problem could be caused by either the failure of the mastic at the top of the render or as a result of moisture penetrating the front door entrance terrace.

Above left: Damp patch to north side of WB02 in Room 11NS/B5.

Above central: Damp parch at high level in the northeast corner of Room 11NS/B4.

Above right: Damp parch to the northern reveal of WB03 in Room 11NS/B4.

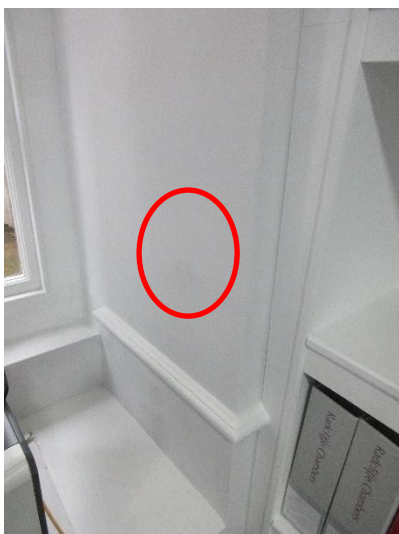
Above left: Damp patch to south side of WB04 in Room 11NS/B9.

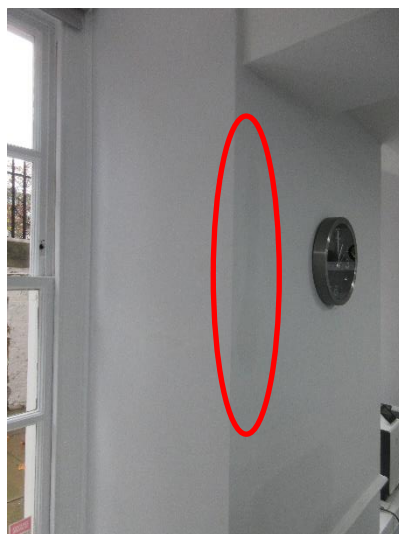
Above central: Damp to the southern side of WB05 in Room 11NS/B9.

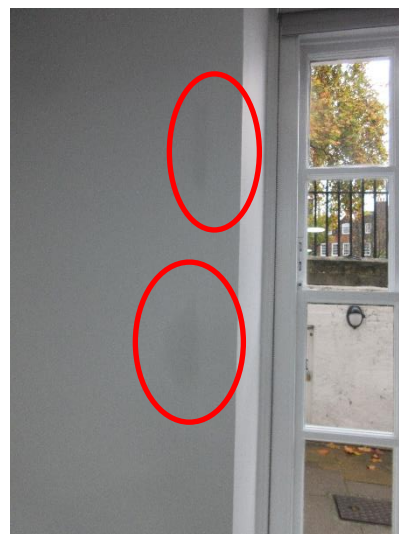
Above right: Damp to the northern side of WB05 in Room 11NS/B9.

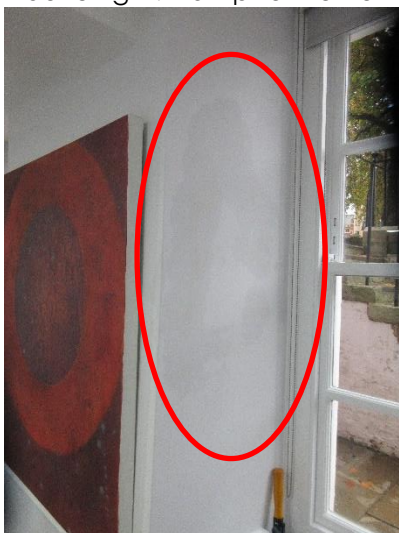
In room 11NS/B10, extensive damp was revealed on the north reveal of window WB06 north side and a horizontal damp line on the south side approximately 1500mm above FFL.

Above left: Large damp patch to the north of WB06 in Room 11NS/B10.

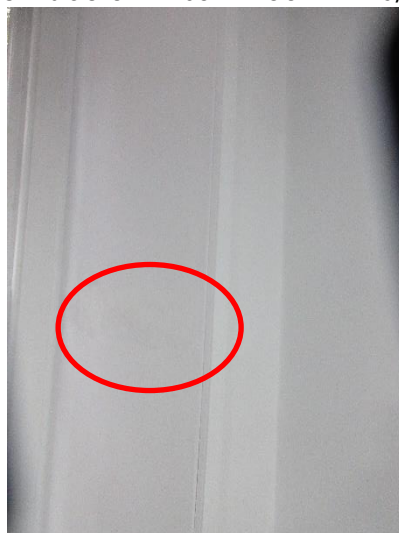
Above central: Damp patch to the south of WB06 in Room 11NS/B10.

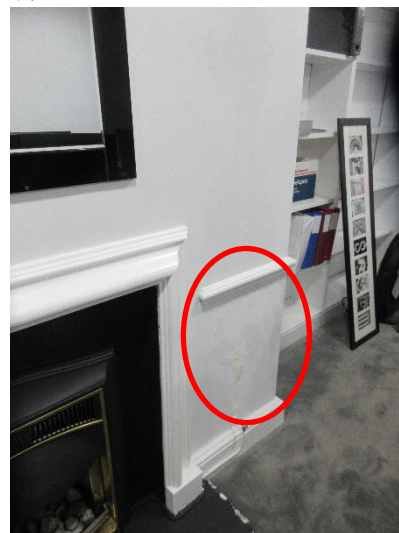
In Room 11NS/B10, Damp was also observed in the east side of the fireplace. The wall is an external retaining structure with the Porter's Lodge constructed over. No tanking system appears to be present so this wall will always be vulnerable to damp. The WC drainage immediately above may be a factor meanwhile open joints in the paving at ground level could make the situation worse.

Above right: Damp patch to the east of the fireplace in Room 11NS/B10.

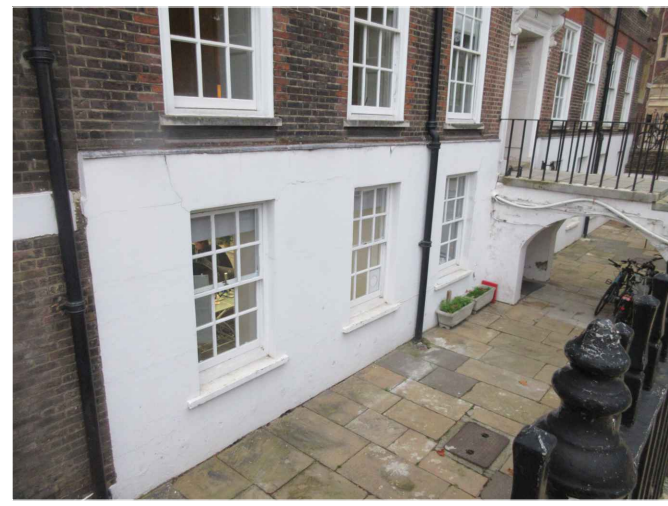
No 11 New Square (South)

15.3. The wall is cement rendered and the wall surfaces are characterised by horizontal cracks. Modern circular vents in the wall have been painted over. The introduction of these vents suggests a rubble filled core. The render is capped with a lead drip with brick fillet above and mastic sealed (failing). The render condition is poor and the decorative condition similarly so. The paint may be a limewash. The presence of cement render is the primary cause of the damp observed internally.

Brick fillet detaching

Moss growing out of cracks

Paint / render skim detachment

Lead cover flashing with triangular brick fillet over lead mastic used

High level damp to window reveal internally.

Brick fillet detaching open joint

Peeling paint and damp in corner at high level - ceiling and two wall surfaces.

Damp to window reveal internally

Modern cavity vents

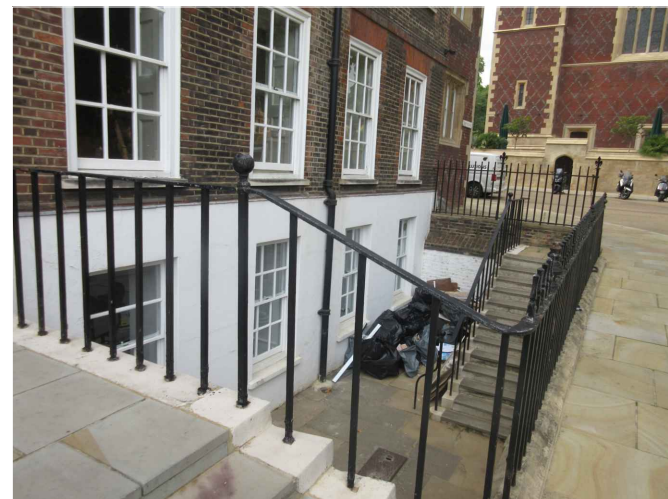
No 11 New Square (North)

Lead cover flashing with triangular brick fillet over and mastic ??
 Horizontal damp patch to south reveal.
 Vertical damp patches to inner wall
 Large damp patch to window reveal.

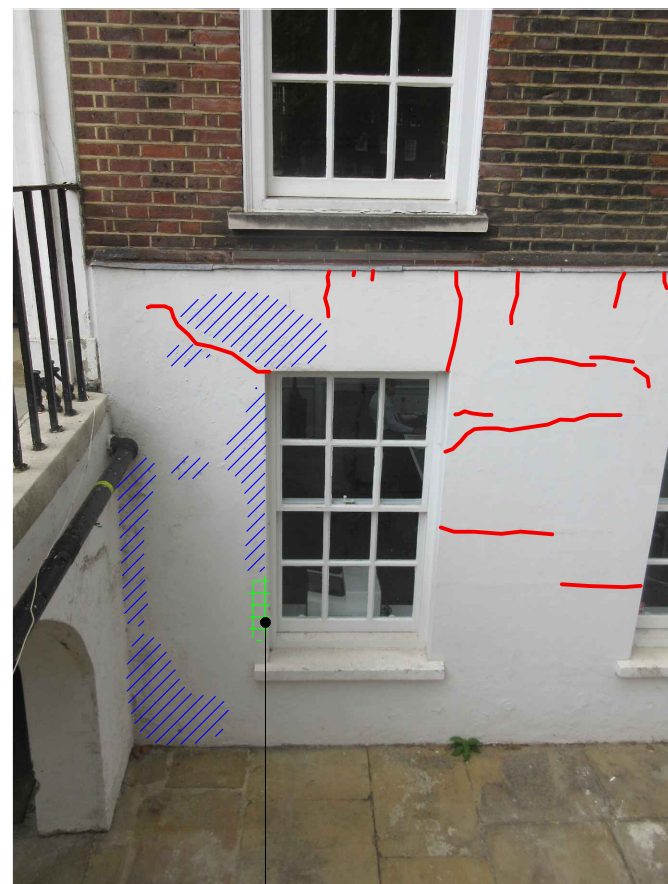
No 11 - WB04

Small patch of damp to south reveal

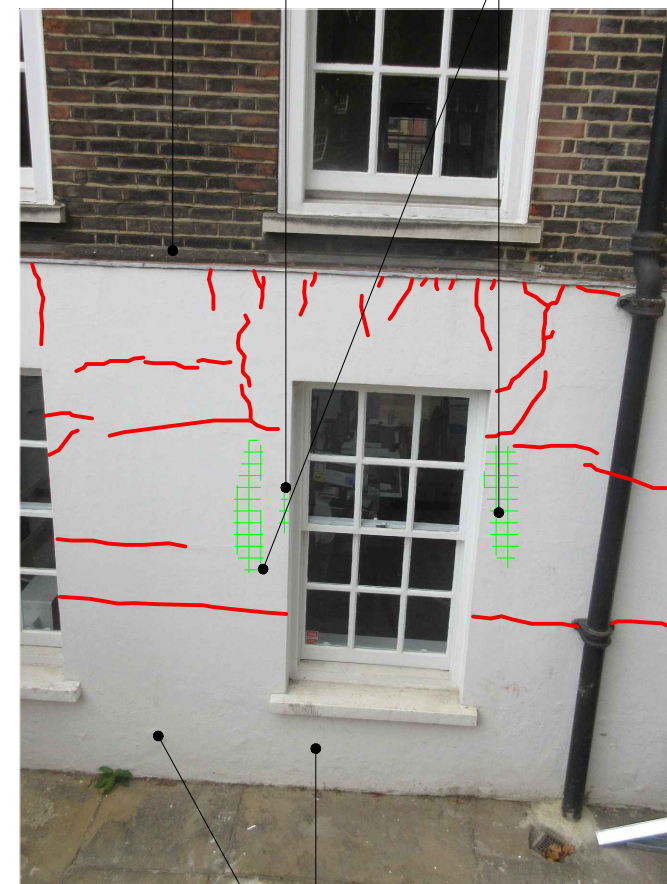
No 11 - WB05

Modern cavity vents

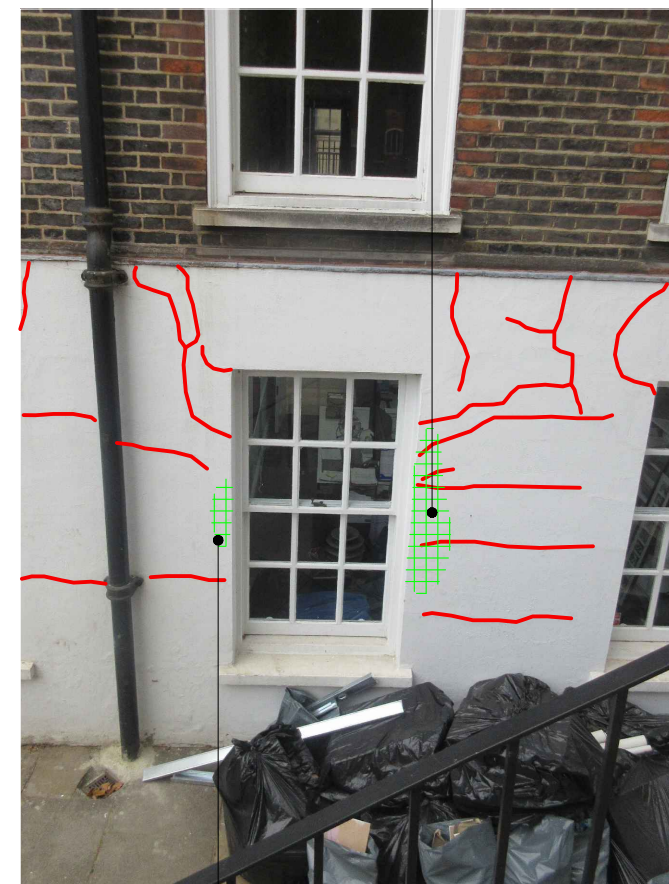
No 11 - WB06

Horizontal damp patch 1500mm above floor level
