New Square No.6 1:50
Roof Plan PROPOSED

Job No 0400	Site LINCOLN'S INN - NEW SQUARE		
Proj No 206	Title N6 Roof Plan PROPOSED		
Scale 1:50 at A1	This document is copyright and the property of Chartery Conservation Architects Ltd. Any copies of this drawing made by any method must also include a copy of this legend. ©Chartery Conservation Architects Ltd

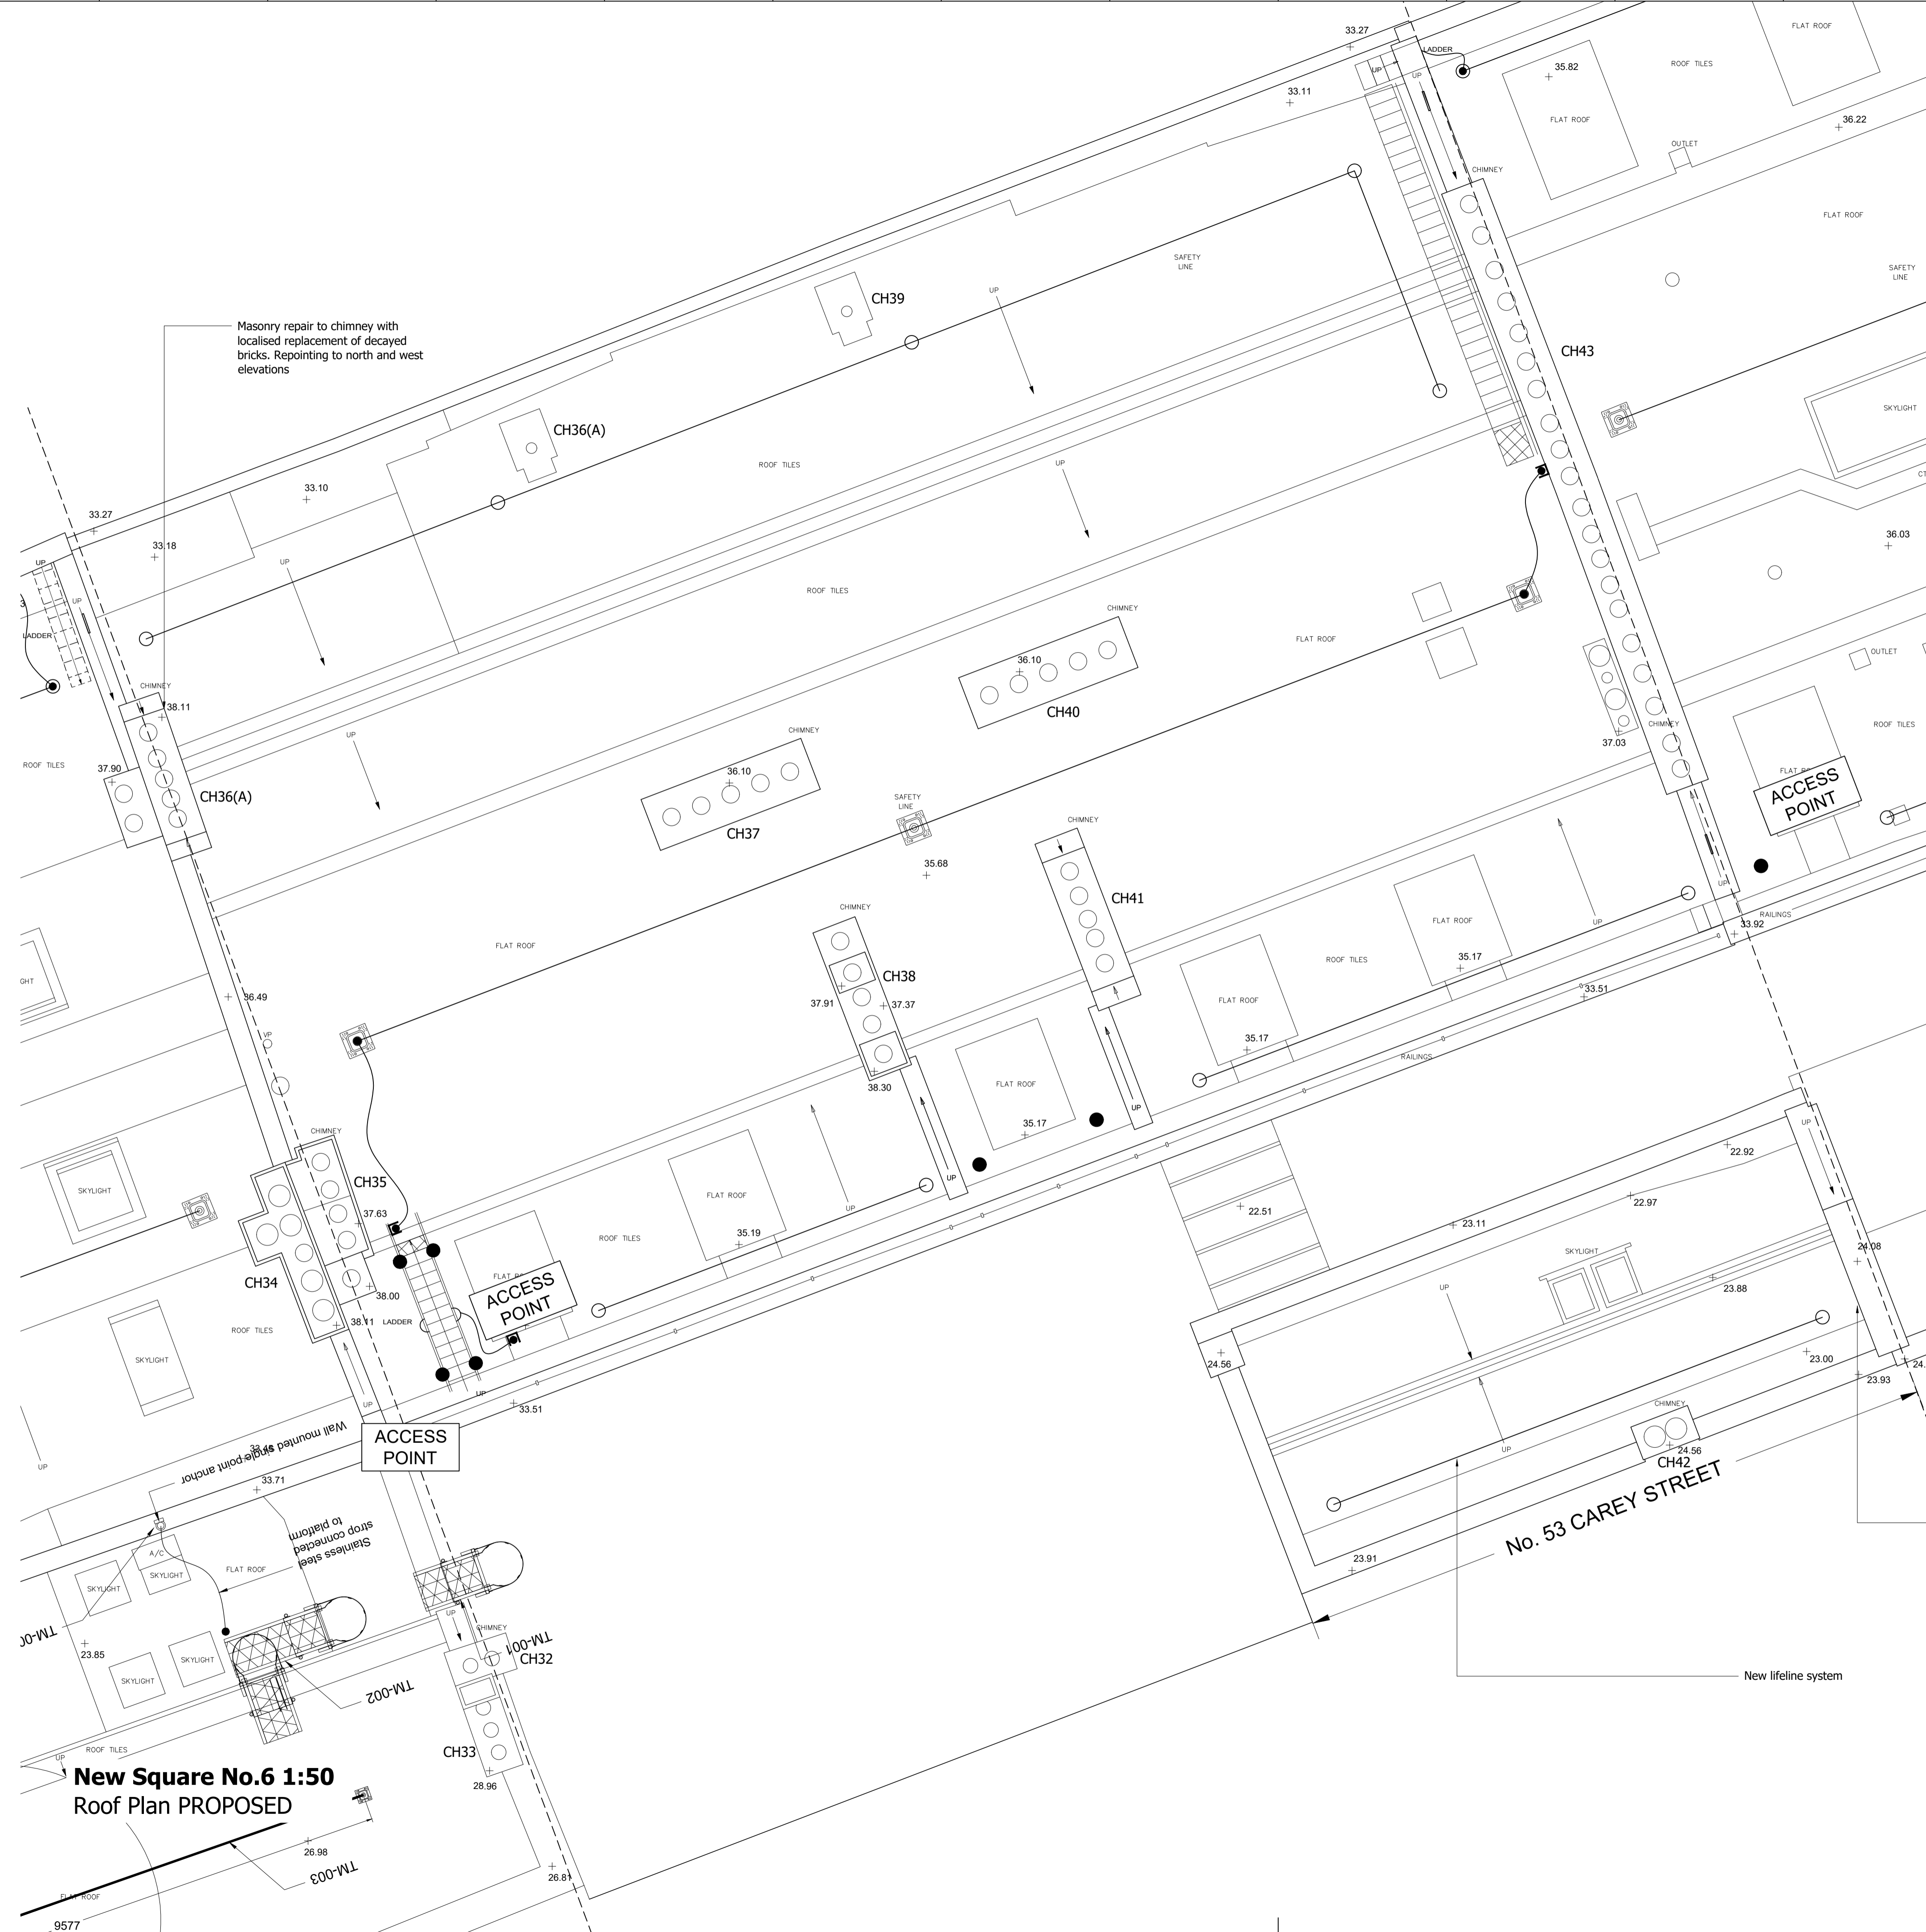
No. 53 CAREY STREET

Masonry repair to chimney with localised replacement of decayed bricks. Repointing to north and west elevations

New lifeline system

New stainless steel harness fixing point.
