**New Square No.2 1:50**  
Front West Elevation  
PROPOSED

Job No 0400	Job LINCOLN'S INN - NEW SQUARE		
Dwg No 223	Title W2 Front Elevation PROPOSED		
Scale 1:50 at A1			<small>This document is copyright and the property of Chartery Conservation Architects Ltd. Any copies of this drawing, made by any method must also include a copy of this notice. ©Chartery Conservation Architects Ltd</small>

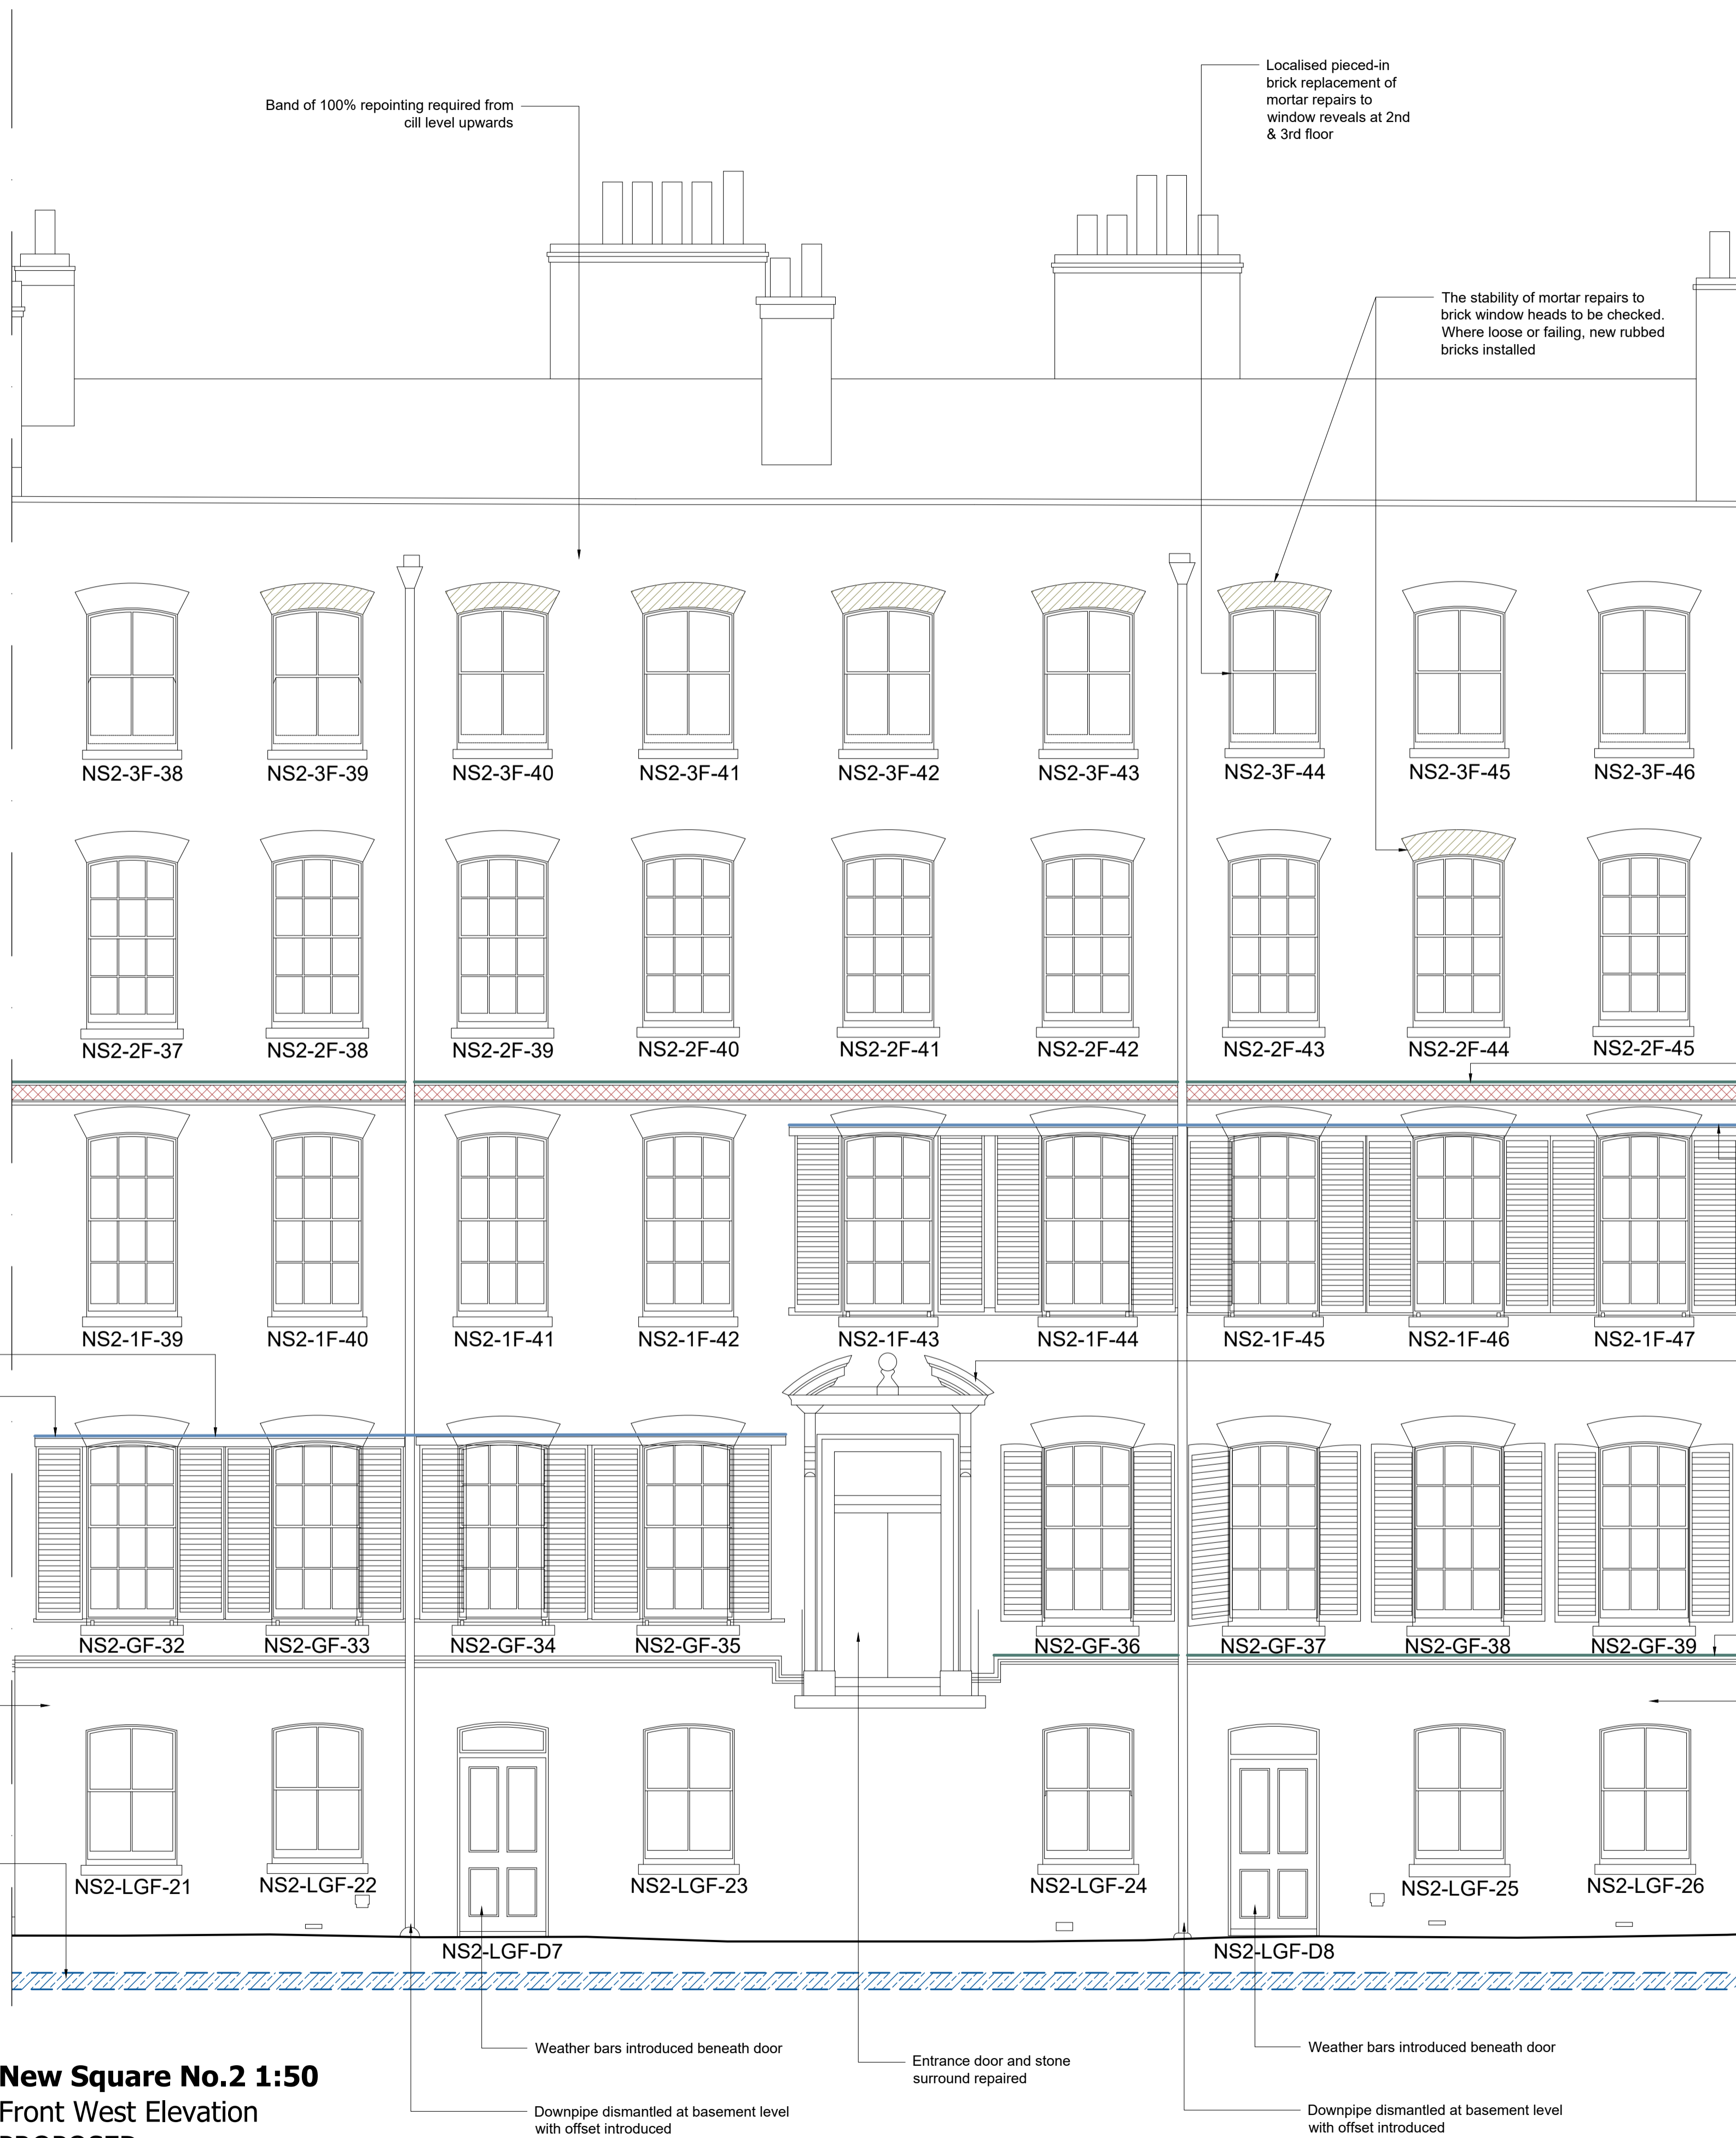
Boot scrapers need repainting  
Railing repairs and redecoration. Pieced-n stone repair to damaged stone

Brickwork is to be repointed where missing or failing. Cement mortars where failing will be replaced with a hydraulic lime mortar (NHL 2.0). Mortar mix to be agreed. Badly damaged or mortar repaired bricks are to be cut out and replaced with salvaged bricks sourced to match the existing. Assume 10% repointing unless described otherwise. All masonry lightly Thermatech cleaned. Air bricks cleaned of paint to maximise ventilation and then redecorated.

Gauged brick string courses  
Thermatech cleaned and badly decayed bricks, inappropriate cement mortar repairs, unstable areas and cement pointing removed.  
Replacement new gauged bricks installed with lime putty pointing.

All cast-iron and lead downpipes and cast iron soil pipes require redecoration. Colour: Black to match the existing.

Shutters to be overhauled and repaired with scarf repairs. Racked shutters to be dismantled and reglued. All joinery to be thoroughly prepared and redecorated. New lead cover flashing to top rail.

Fractured and badly decayed gauged brickwork or mortar repairs to window heads to be cut out and replaced on a brick-by-brick basis. Washed out joints repointed with a non-hydraulic lime putty.

Stone window cills Thermatech cleaned and where necessary poulticed to remove extensive deposits. Mortar repairs to localised damage. All windows overhauled with scarf joinery repairs to decayed sections. Putty replaced where missing, detaching or cracked. All joinery redecorated. Draught-proofing seals and strips surface fixed to the existing windows.

All railings to Areas, bridges and steps to be rubbed down and repainted. Decayed ends opened up, painted and releaded. Localised damaged stonework to the bridge and plinths require a combination of pieced-in or mortar repairs. Open joints between paving slabs and steps to be repointed (NHL 5.0).

Basement Areas - Paving lifted and relaid to falls to existing channels and gully positions. New stone sourced to match existing when badly fractured or missing.

French Drain installed immediately in front of the building at basement level and concealed beneath the paving.

Basement Area walls - Decayed bricks and cement mortar repairs are to be repaired with salvaged bricks to match the originals. Wall surfaces cleaned of loose paint and relime-washed. Scarf repairs to existing doors and redecoration.
