New Square No.3 1:50 Front West Elevation PROPOSED

New Square No.3 1:50 Front North Elevation PROPOSED

Drawn JW	Rev 0400	Notes For List B / Faculty and Tender	
Job No 0400	Site LINCOLN'S INN - NEW SQUARE	Drawn 225	
Title Nº3 Front Elevations PROPOSED			<small>This document is copyright and the property of Chartery Conservation Architects Ltd. Any copies of this drawing made by any method must also include a copy of this notice. ©Chartery Conservation Architects Ltd</small>

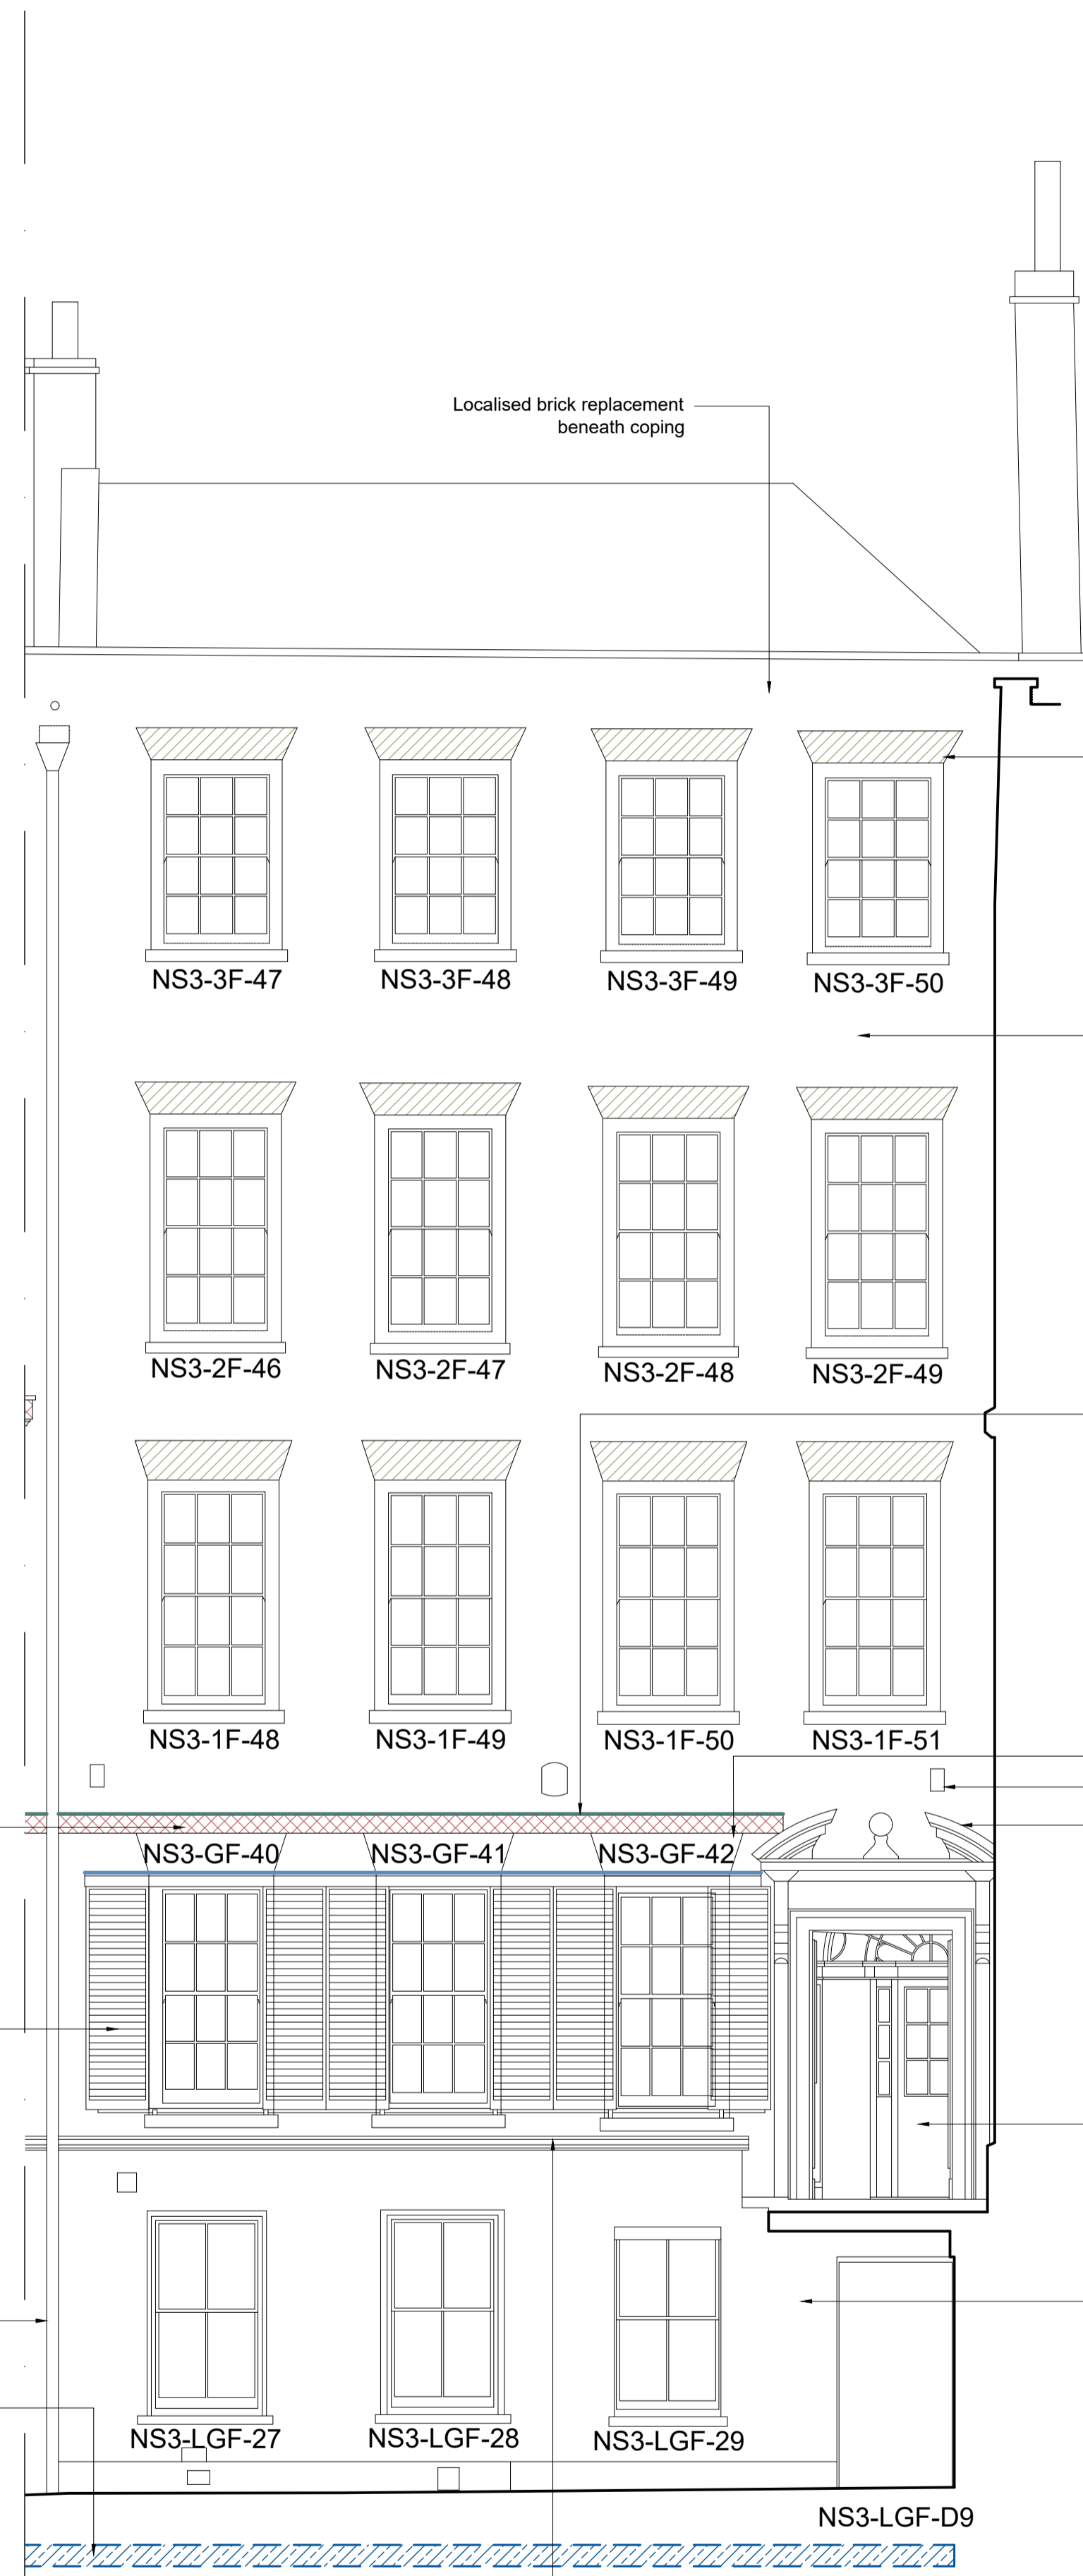
Railing repairs and redecoration. Pieced-in stone repair to damaged stone

Investigate, repair and reset dropped step

Brick string course cleaned, decayed bricks cut out, mortar repairs cut and new gauged bricks inserted

Shutters overhauled, repaired and redecoration

Downpipe dismantled at basement level with offset introduced. Render repaired behind

Mortar fillet removed and new brick plinth course installed above slate drip which is to be retained and repaired and covered with a new lead cover flashing. Cross refer to drawing no: 400.001 RevA

The stability of mortar repairs to brick window heads to be checked. Where loose or falling, new rubbed bricks installed

100% repointing required at 3rd floor level

New lead cover flashing to top of shutter rail

Gauged brick window heads cleaned to remove salts and band of cement pointing removed from between gauged brickwork

Vents require redecoration  
New painted Code 6 lead flashing to broken pediment with weir to direct water away from wall face

Entrance door and stone surround repaired

Render locally repaired. Allow 10% replacement using 1 part Natural Hydraulic Lime mixed 2.25 parts yellow-brown quartz sand <2.36mm and circa 0.25 parts brown pigment as Rose of Jericho report 5523. Render painted with Keim Soldalit

3 no. sections of damaged coping replaced

100% repointing above window head

Localised pieced-in brick replacement of mortar repairs to window reveals at all levels

Brick replacement of course mortar repair

Gate requires redecoration and securing

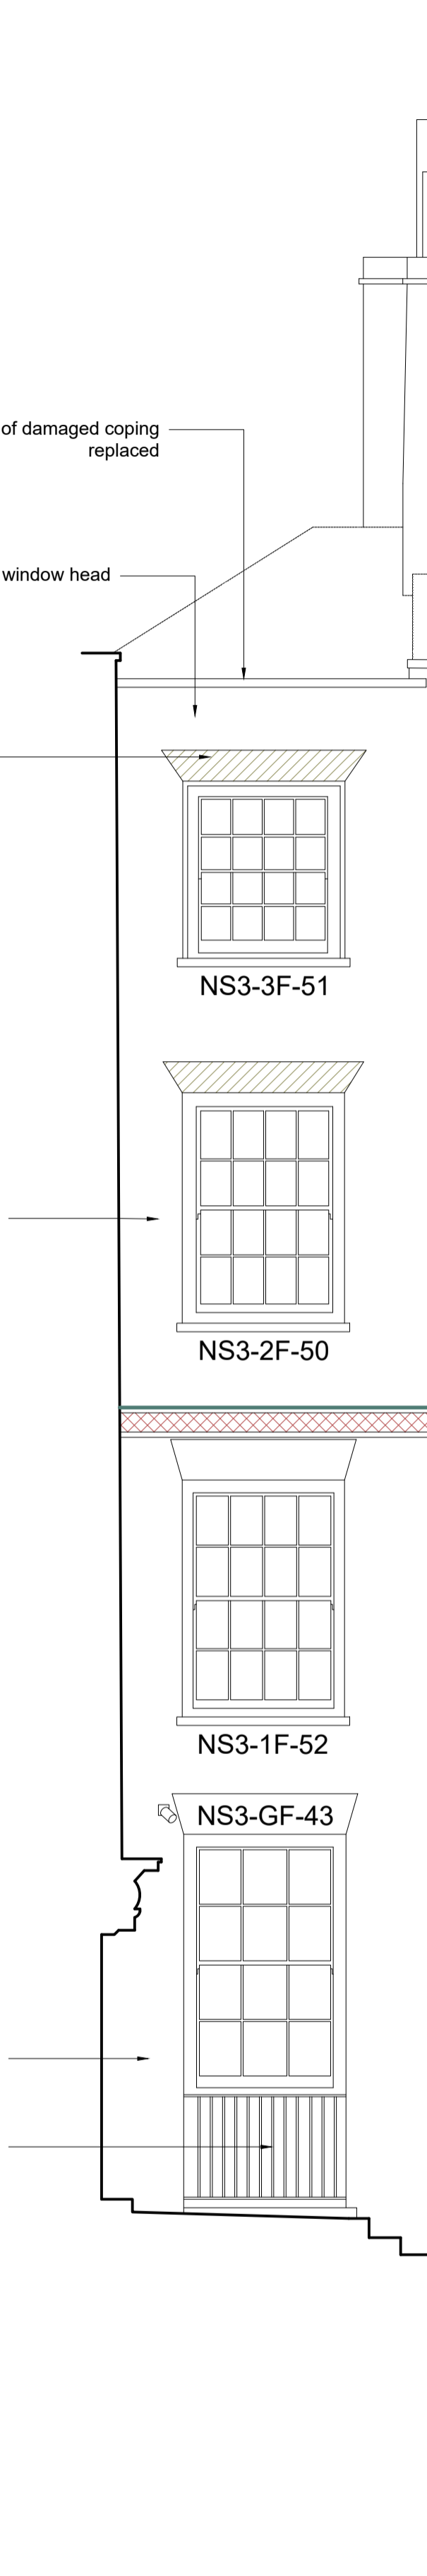
French drain installed immediately in front of elevation at basement level
