New Square No.6 1:50
Rear South Elevation PROPOSED

Drawn	Rev	Notes
JW		For List B / Faculty and Tender
Job No	Job	Client
0400	LINCOLN'S INN - NEW SQUARE	
Drawn	Drawn	Drawn
234	NS6 Rear Elevation PROPOSED	
Scale	This document is copyright and the property of Chartery Conservation Architects Ltd. Any copies of this drawing made by any method must also include a copy of this sheet.	
1:50 at A1	©Chartery Conservation Architects Ltd

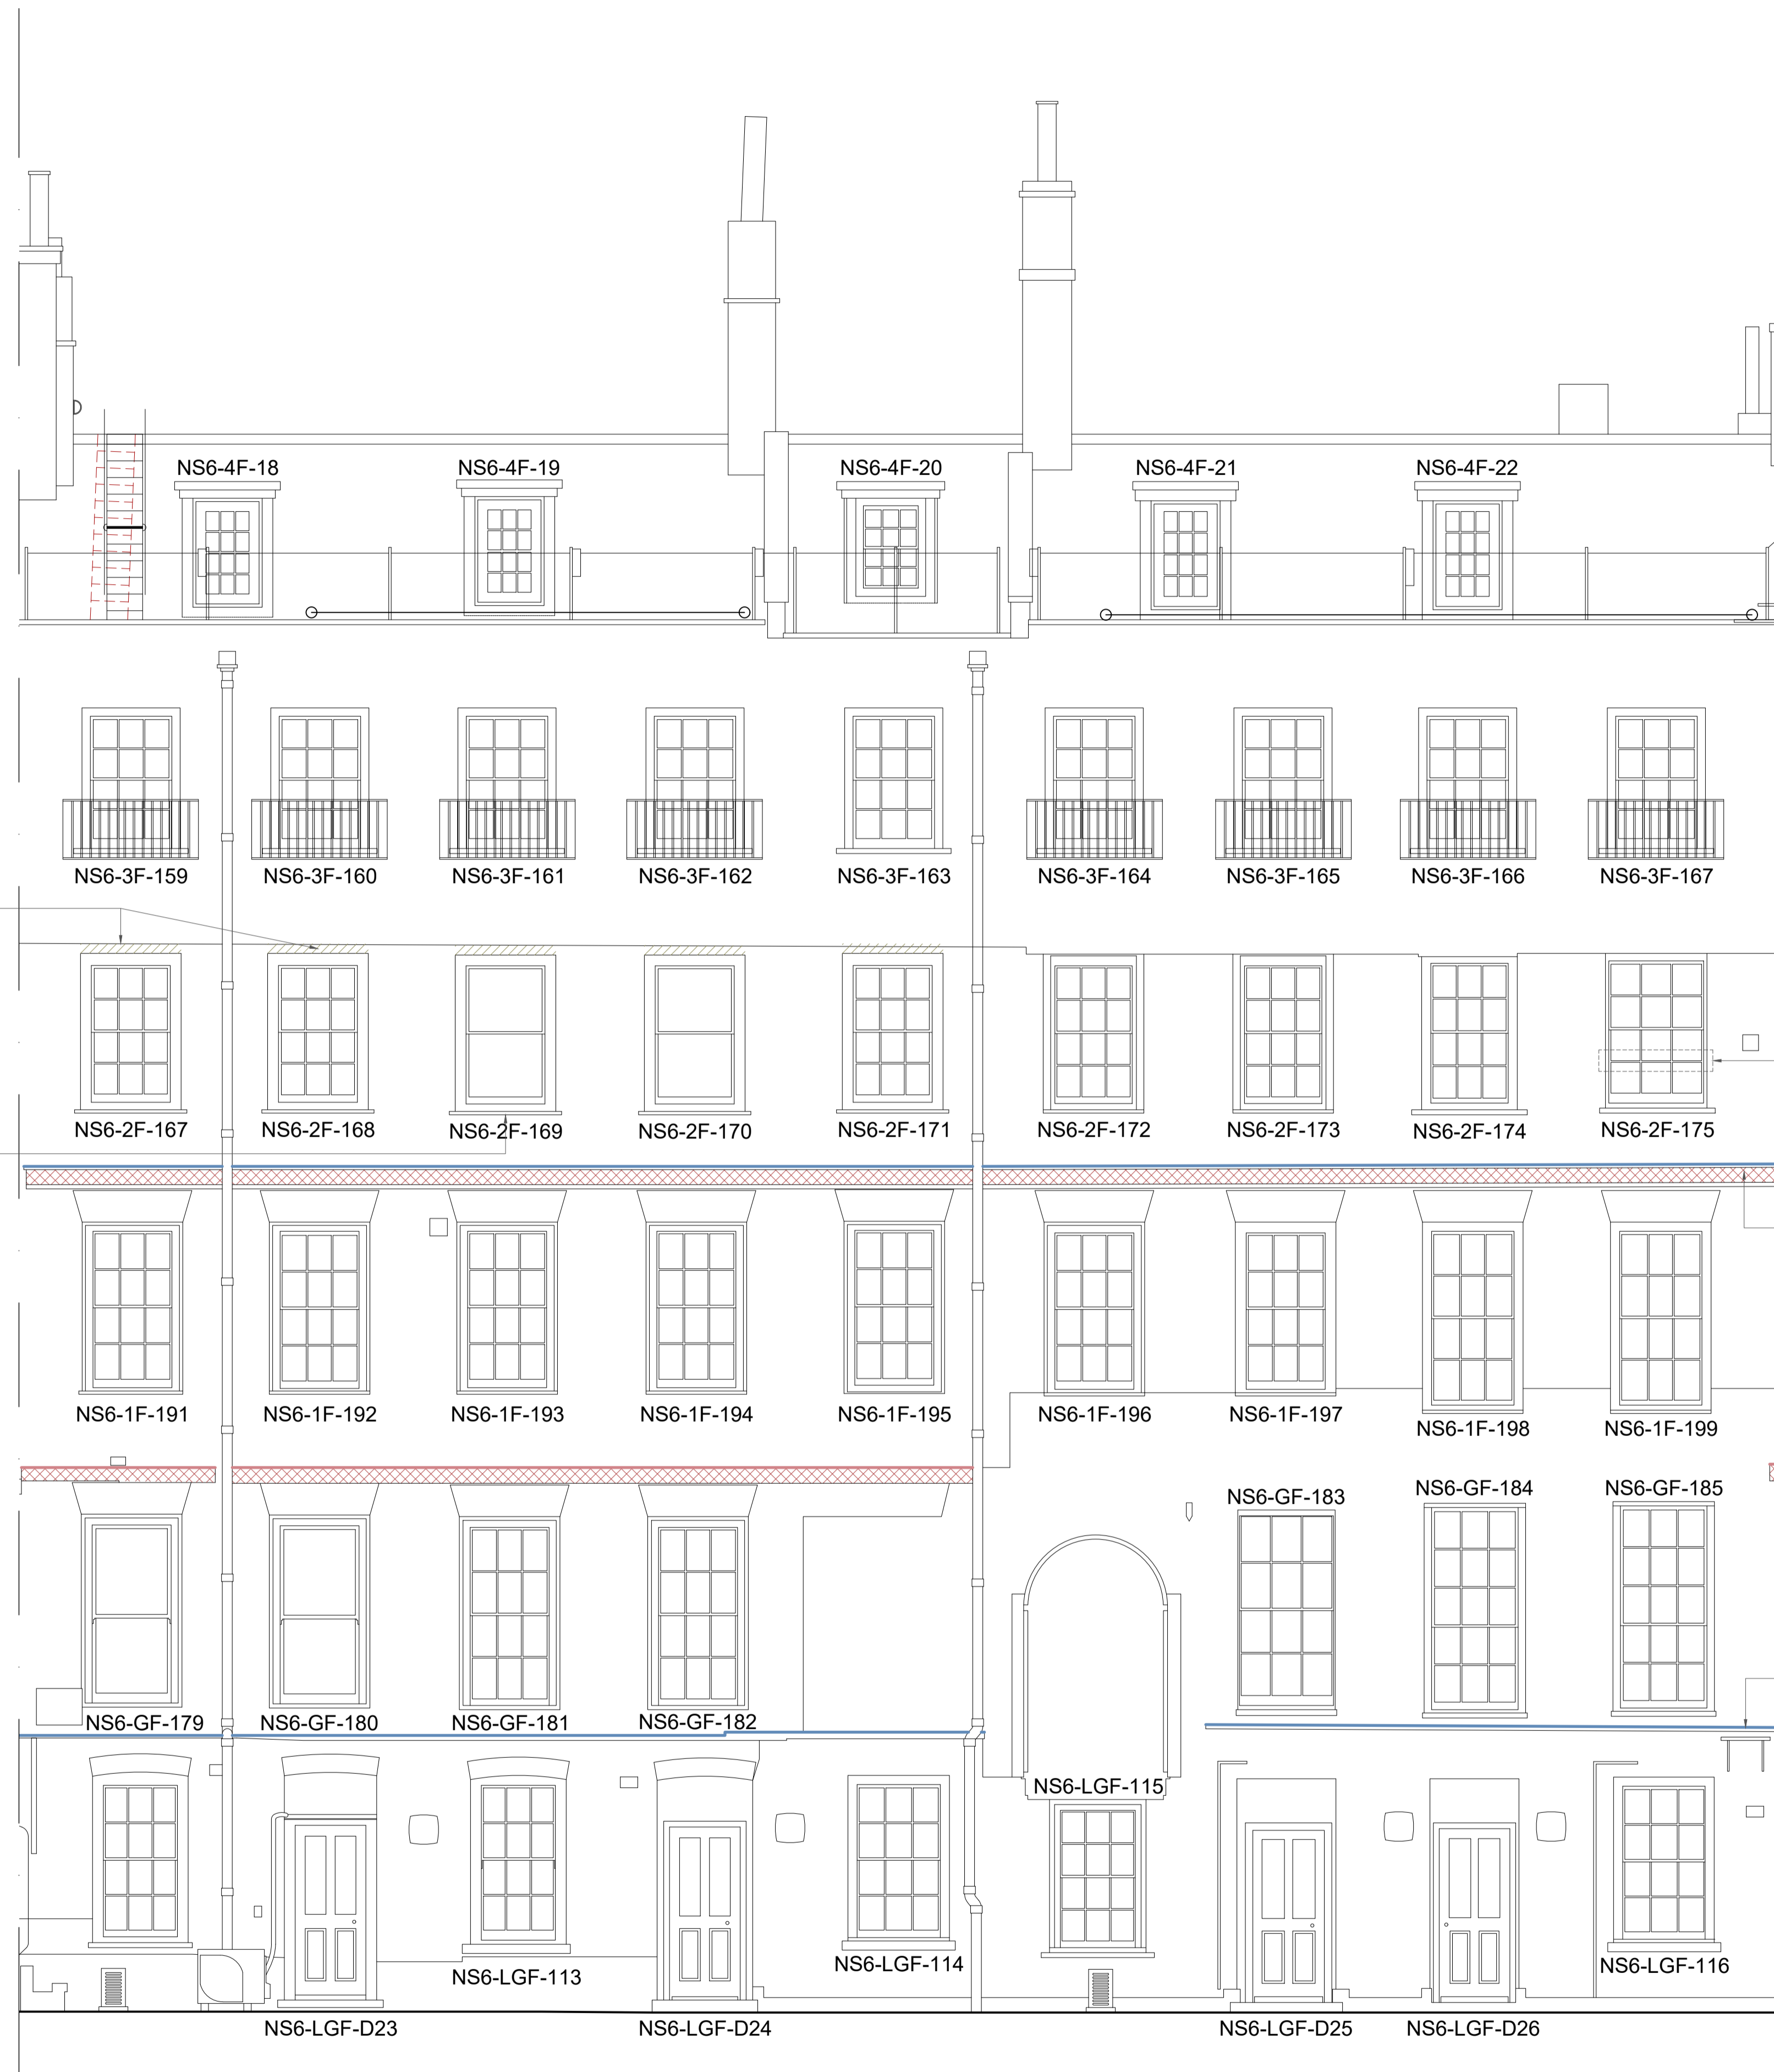
The stability of mortar repairs to brick window heads to be checked. Where loose or failing, new rubbed bricks installed. The stability of the gauged brickwork needs to be checked to all 2nd floor windows (west end)

Brickwork is to be repointed where missing or failing. Cement mortars where failing will be replaced with a hydraulic lime mortar (NHL 2.0). Mortar mix to be agreed. Badly damaged or mortar repaired bricks are to be cut out and replaced with salvaged bricks sourced to match the existing. Assume 10% repointing unless described otherwise. All masonry lightly Thermatech cleaned. Air bricks cleaned of paint to maximise ventilation and then redecorated.

Gauged brick string courses
Thermatech cleaned and badly decayed bricks, inappropriate cement mortar repairs, unstable areas and cement pointing removed.
Replacement new gauged bricks installed with lime putty pointing.

New lead drip in Code 5 lengths not exceeding 1200mm

Existing lead drip renewed in Code 5 lengths not exceeding 1200mm.

New mortar fillet - NHL 5.0.

All cast-iron and lead downpipes and cast iron soil pipes require redecoration. Colour: Black to match the existing.

Shutters to be overhauled and repaired with scarf repairs. Racked shutters to be dismantled and reglued. All joinery to be thoroughly prepared and redecorated. New lead cover flashing to top rail.

Fractured and badly decayed gauged brickwork or mortar repairs to window heads to be cut out and replaced on a brick-by-brick basis. Washed out joints repointed with a non-hydraulic lime putty.

Stone window cills Thermatech cleaned and where necessary poulticed to remove extensive deposits. Mortar repairs to localised damage. All windows overhauled with scarf joinery repairs to decayed sections. Putty replaced where missing, detaching or cracked. All joinery redecorated. Draught-proofing seals and strips surface fixed to the existing windows.

New stone cills or indent repairs to stone cills.

New tiled cills.

All railings to Areas, bridges and steps to be rubbed down and repainted. Decayed ends opened up, painted and releaded. Localised damaged stonework to the bridge and plinths require a combination of pieced-in or mortar repairs. Open joints between paving slabs and steps to be repointed (NHL 5.0).

Basement Areas - Paving lifted and relaid to falls to existing channels and gully positions. New stone sourced to match existing when badly fractured or missing.

French Drain installed immediately in front of the building at basement level and concealed beneath the paving.

Basement Area walls - Decayed bricks and cement mortar repairs are to be repaired with salvaged bricks to match the originals. Wall surfaces cleaned of loose paint and relime washed. Scarf repairs to existing doors and redecoration.

Tile repair to cill

Missing glazing bars reinstated

Brick string course cleaned, decayed bricks cut out, mortar repairs cut and new gauged bricks inserted. New lead drip installed over existing tile drip course. Tiles replaced where damaged

New lead drip over existing slate drip
