New Square No.9 1:50

Front East Elevation PROPOSED

| Drawn | Rev | Notes |
|---|---|---|
| 0400 | LINCOLN'S INN - NEW SQUARE | |
| 243 | NS9 Front Elevation PROPOSED | |

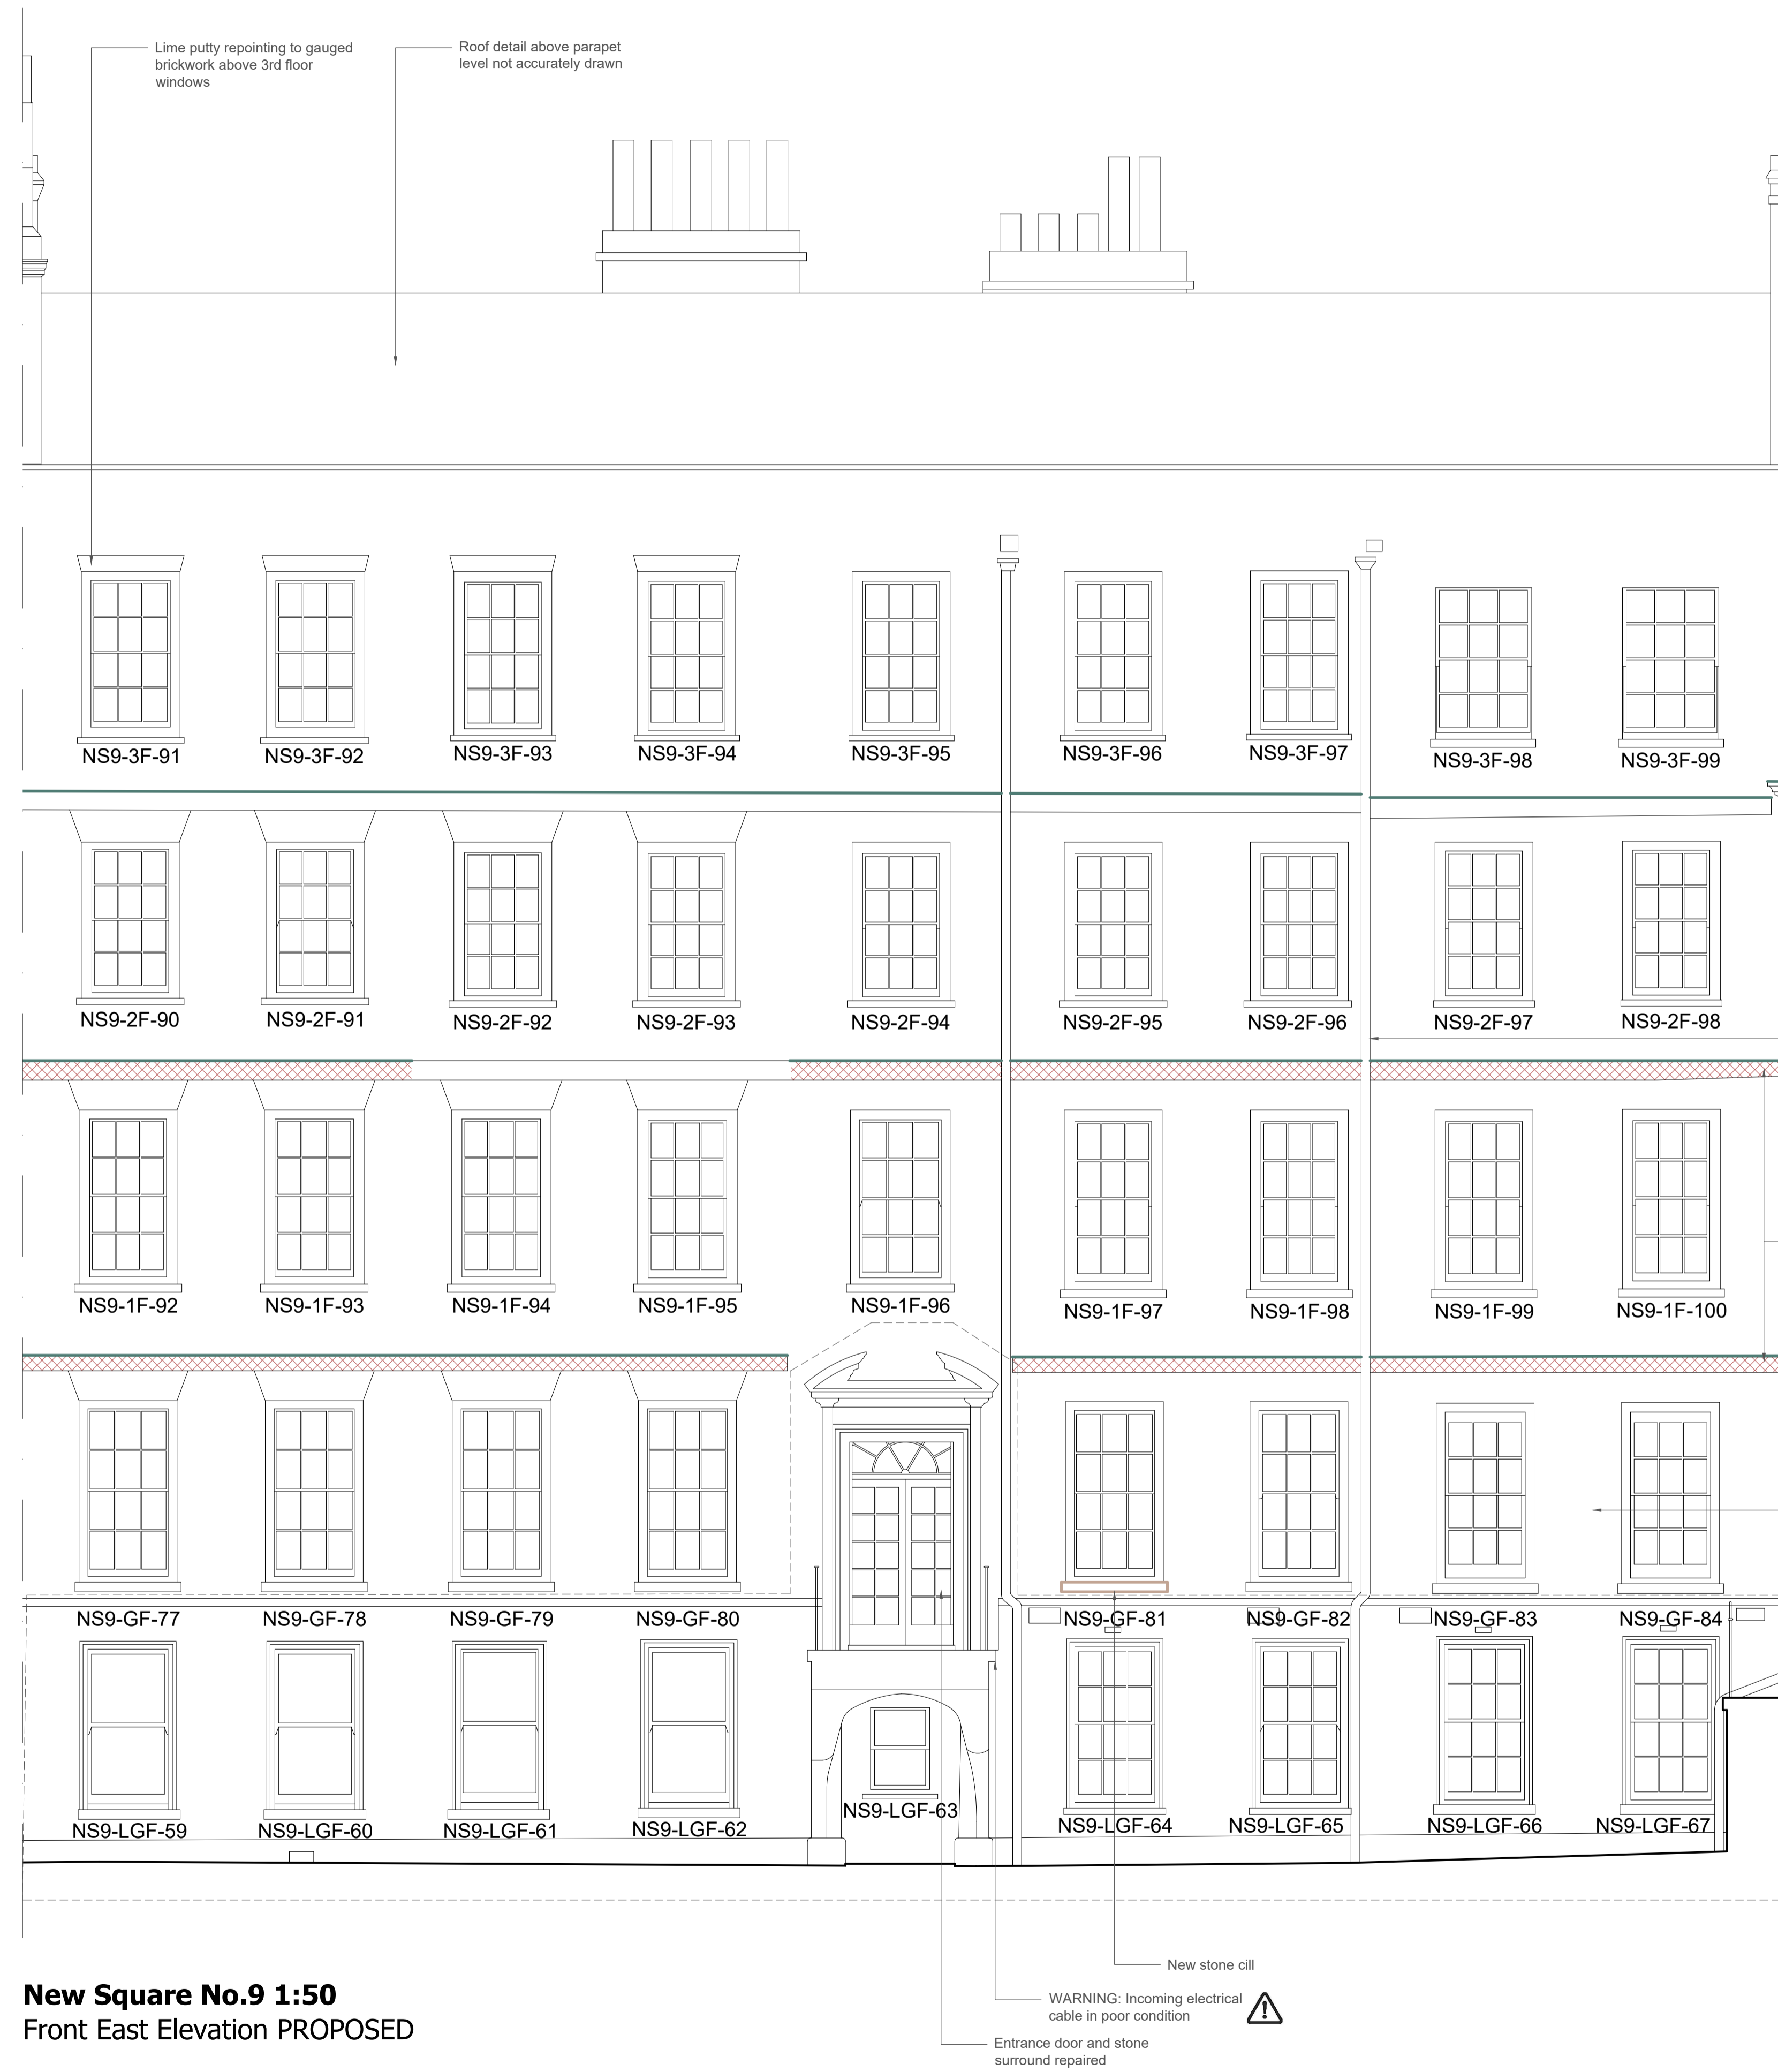
Open joints need repointing (NHL 5.0)

Railing repairs and redecoration. Pieced-in stone repair to damaged stone

Basement steps
Open joints need repointing

Brickwork is to be repointed where missing or falling. Cement mortars where failing will be replaced with a hydraulic lime mortar (NHL 2.0). Mortar mix to be agreed. Badly damaged or mortar repaired bricks are to be cut out and replaced with salvaged bricks sourced to match the existing. Assume 10% repointing unless described otherwise. All masonry lightly Thermatech cleaned. Air bricks cleaned of paint to maximise ventilation and then redecorated.

Gauged brick string courses Thermatech cleaned and badly decayed bricks, inappropriate cement mortar repairs, unstable areas and cement pointing removed. Replacement new gauged bricks installed with lime putty pointing.

New lead drip in Code 5 lengths not exceeding 1200mm

Existing lead drip renewed in Code 5 lengths not exceeding 1200mm.

New mortar fillet – NHL 5.0.

All cast-iron and lead downpipes and cast iron soil pipes require redecoration. Colour: Black to match the existing.

Shutters to be overhauled and repaired with scarf repairs. Racked shutters to be dismantled and reglued. All joinery to be thoroughly prepared and redecorated. New lead cover flashing to top rail.

Fractured and badly decayed gauged brickwork or mortar repairs to window heads to be cut out and replaced on a brick-by-brick basis. Washed out joints repointed with a non-hydraulic lime putty.

Stone window cills Thermatech cleaned and where necessary poulticed to remove extensive deposits. Mortar repairs to localised damage. All windows overhauled with scarf joinery repairs to decayed sections. Putty replaced where missing, detaching or cracked. All joinery redecorated. Draught-proofing seals and strips surface fixed to the existing windows.

New stone cills or indent repairs to stone cills.

New tiled cills.

All railings to Areas, bridges and steps to be rubbed down and repainted. Decayed ends opened up, painted and releaded. Localised damaged stonework to the bridge and plinths require a combination of pieced-in or mortar repairs. Open joints between paving slabs and steps to be repointed (NHL 5.0).

Basement Areas - Paving lifted and relaid to falls to existing channels and gully positions. New stone sourced to match existing when badly fractured or missing.

French Drain installed immediately in front of the building at basement level and concealed beneath the paving.

Basement Area walls - Decayed bricks and cement mortar repairs are to be repaired with salvaged bricks to match the originals. Wall surfaces cleaned of loose paint and relimewashed. Scarf repairs to existing doors and redecoration.
