New Square No.11 1:50  
Front East Elevation PROPOSED

Drawn	Rev	Notes
JW		For List B / Faculty and Tender
0400		LINCOLN'S INN - NEW SQUARE
247		NS11 Front Elevation PROPOSED

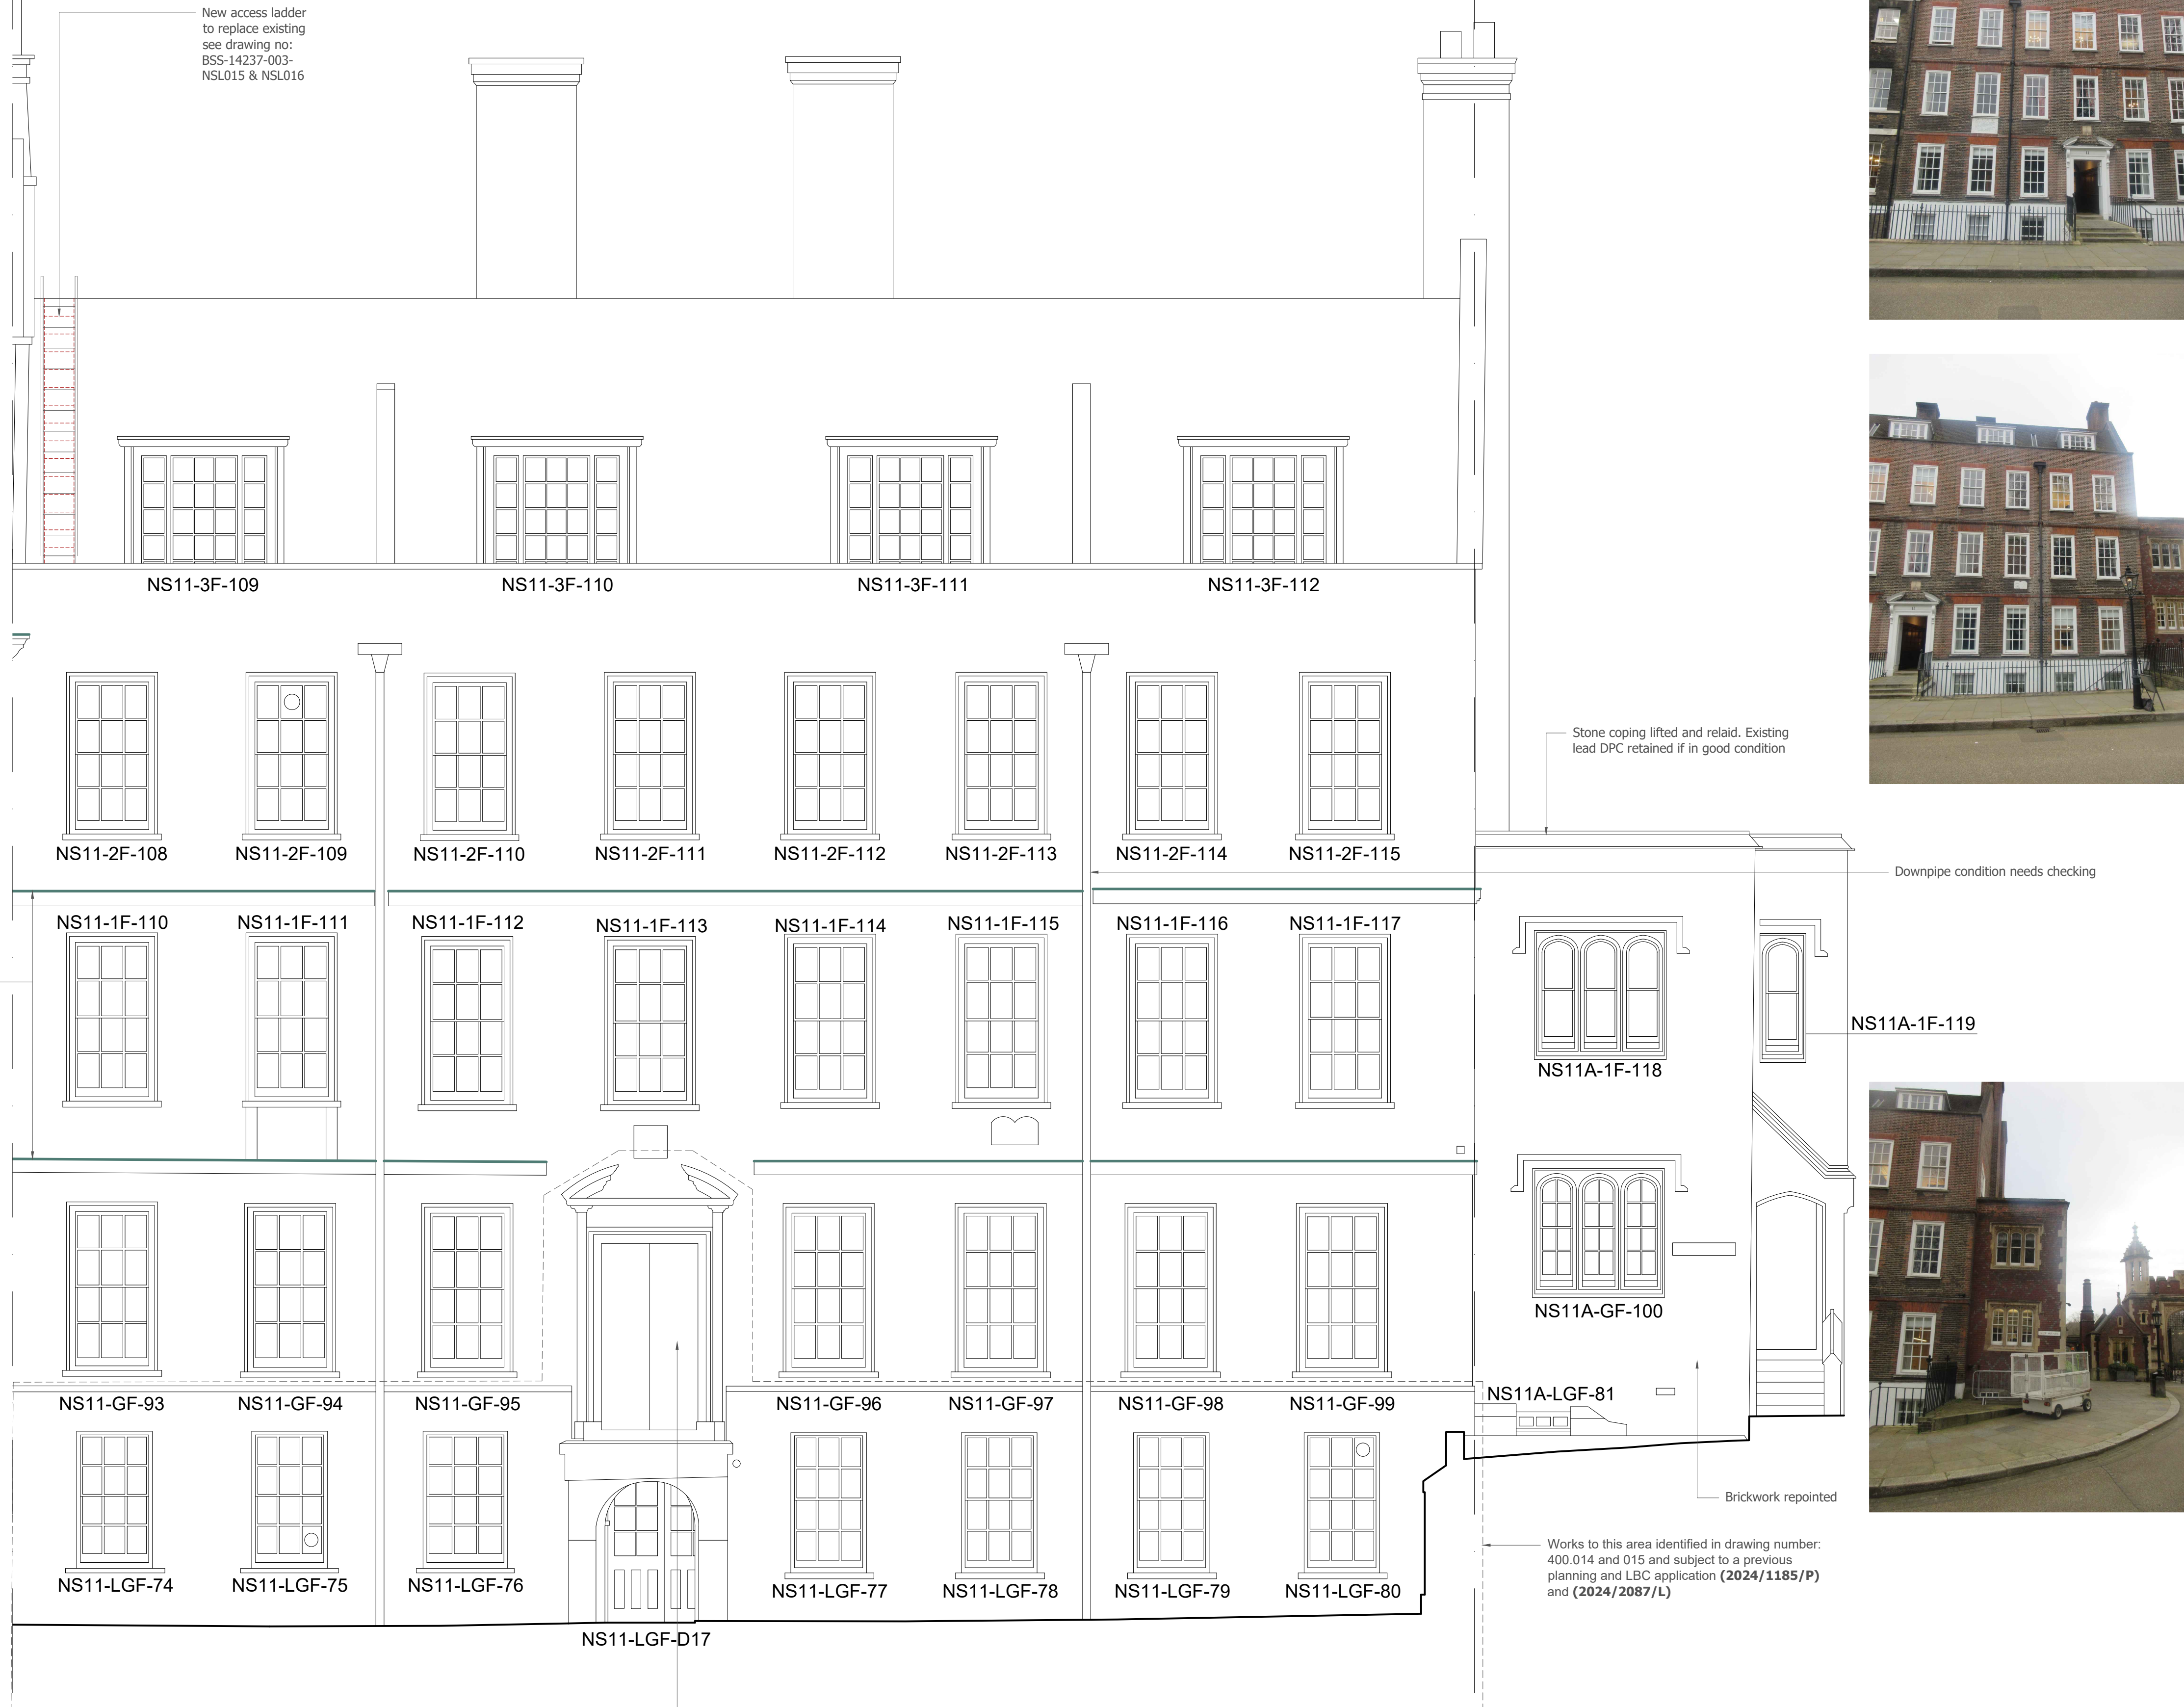
Open joints need repointing (NHL 5.0)

Railing repairs and redecoration. Pieced-in stone repair to damaged stone

Entrance door and stone surround repaired

New access ladder to replace existing see drawing no: BSS-14237-003-NSL015 & NSL016

Brickwork is to be repointed where missing or failing. Cement mortars where failing will be replaced with a hydraulic lime mortar (NHL 2.0). Mortar mix to be agreed. Badly damaged or mortar repaired bricks are to be cut out and replaced with salvaged bricks sourced to match the existing. Assume 10% repointing unless described otherwise. All masonry lightly Thermatech cleaned. Air bricks cleaned of paint to maximise ventilation and then redecorated.

Gauged brick string courses Thermatech cleaned and badly decayed bricks, inappropriate cement mortar repairs, unstable areas and cement pointing removed. Replacement new gauged bricks installed with lime putty pointing.

Shutters to be overhauled and repaired with scarf repairs. Racked shutters to be dismantled and reglued. All joinery to be thoroughly prepared and redecorated. New lead cover flashing to top rail.

Fractured and badly decayed gauged brickwork or mortar repairs to window heads to be cut out and replaced on a brick-by-brick basis. Washed out joints repointed with a non-hydraulic lime putty.

Stone window cills Thermatech cleaned and where necessary poulticed to remove extensive deposits. Mortar repairs to localised damage. All windows overhauled with scarf joinery repairs to decayed sections. Putty replaced where missing, detaching or cracked. All joinery redecorated. Draught-proofing seals and strips surface fixed to the existing windows.

All railings to Areas, bridges and steps to be rubbed down and repainted. Decayed ends opened up, painted and releaded. Localised damaged stonework to the bridge and plinths require a combination of pieced-in or mortar repairs. Open joints between paving slabs and steps to be repointed (NHL 5.0).

Basement Areas - Paving lifted and relaid to falls to existing channels and gully positions. New stone sourced to match existing when badly fractured or missing.

French Drain installed immediately in front of the building at basement level and concealed beneath the paving.

Basement Area walls - Decayed bricks and cement mortar repairs are to be repaired with salvaged bricks to match the originals. Wall surfaces cleaned of loose paint and relimewashed. Scarf repairs to existing doors and redecoration.

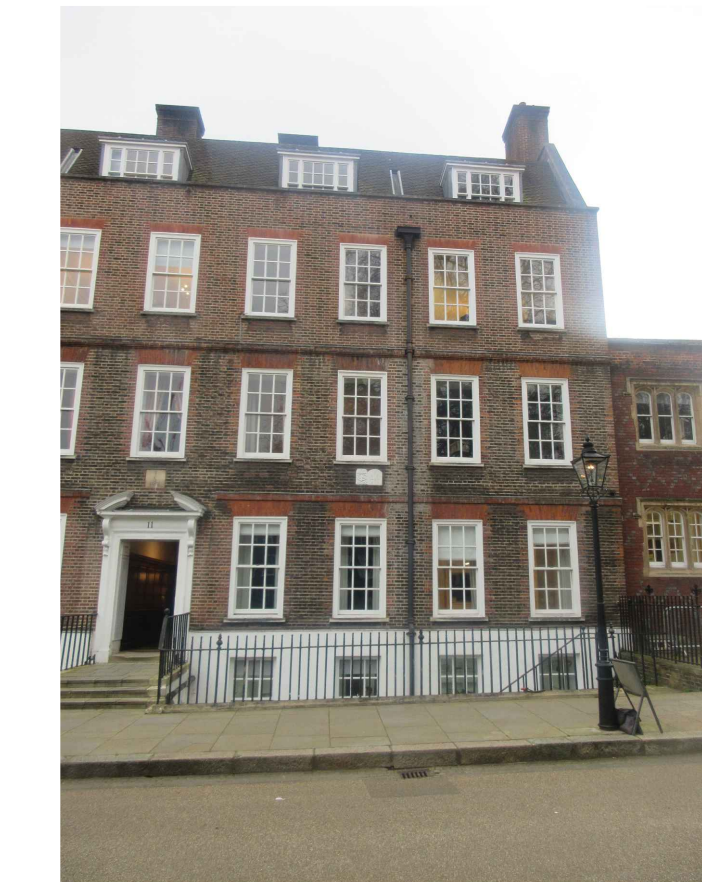
Downpipe condition needs checking

All cast-iron and lead downpipes and cast iron soil pipes require redecoration. Colour: Black to match the existing.
