**New Square No.11 1:50**  
Rear West Elevation PROPOSED

Job No 0400	Site LINCOLN'S INN - NEW SQUARE		
Dwg No 24B	Title N11 Rear Elevation PROPOSED		
Scale 1:50 at A1	This document is copyright and the property of Chartery Conservation Architects Ltd. Any copies of this drawing, made by any method, must also include a copy of this notice. ©Chartery Conservation Architects Ltd

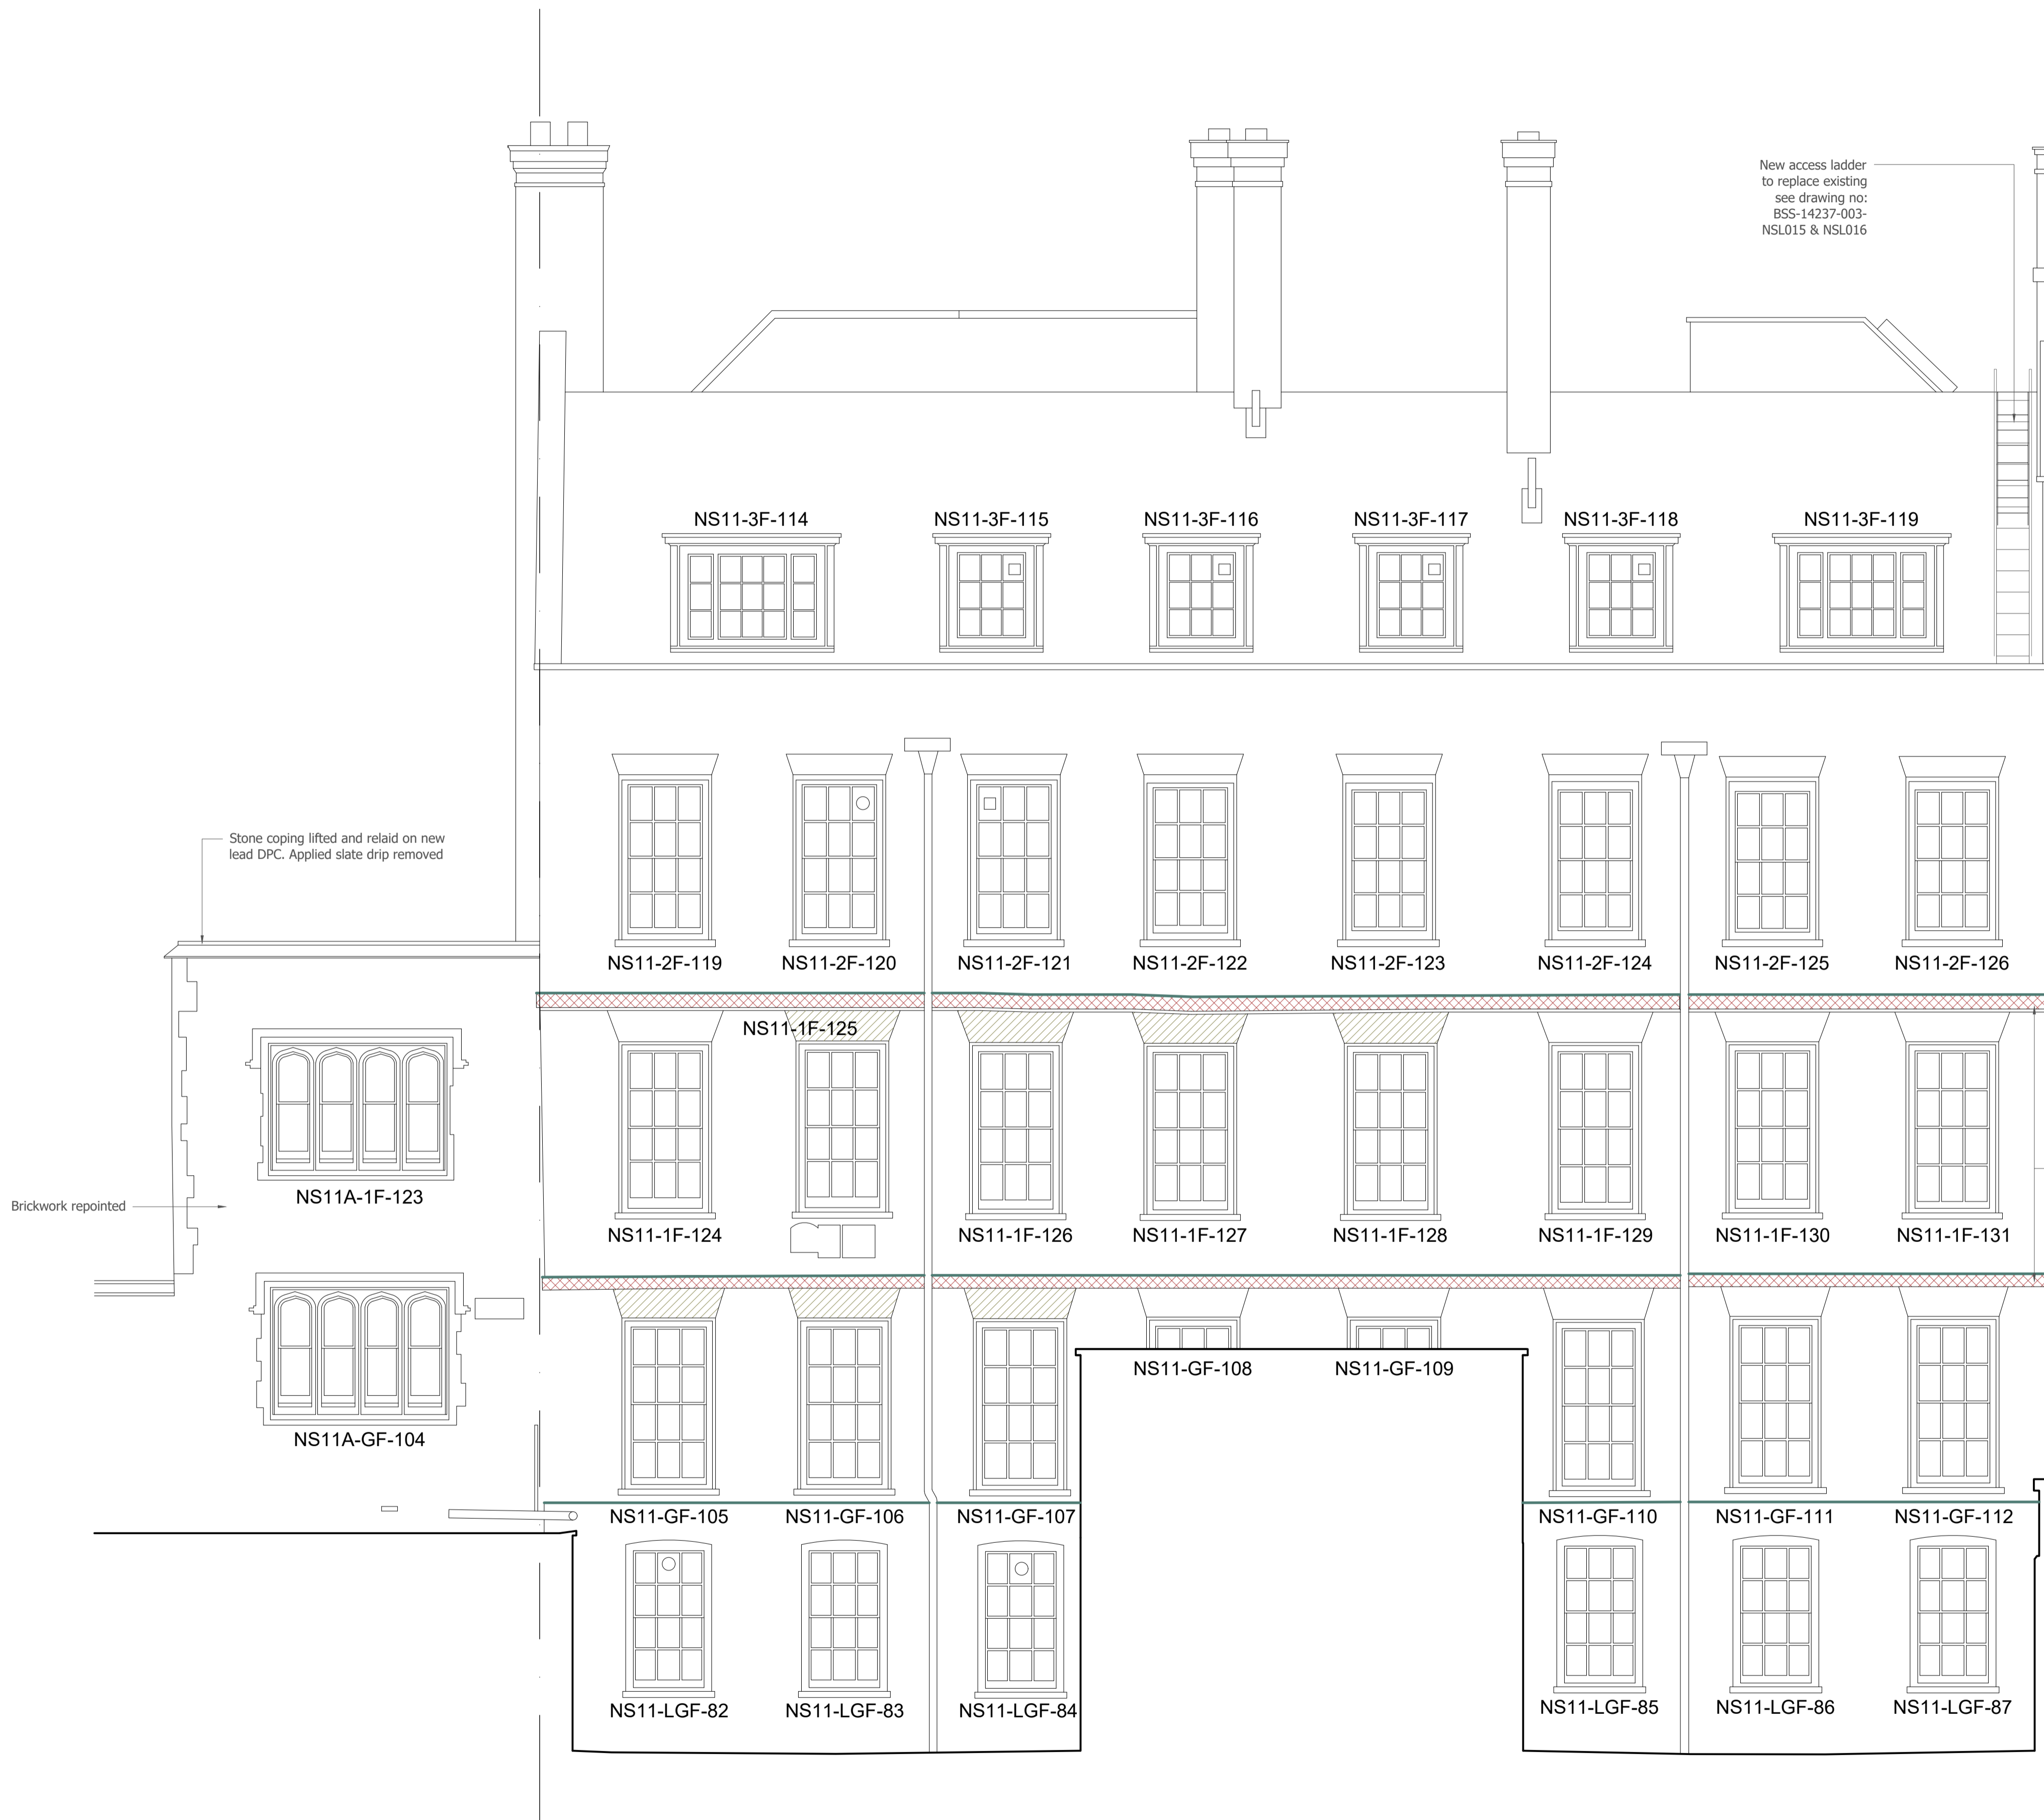
Brick string course cleaned, decayed bricks cut out, mortar repairs cut and new gauged bricks inserted some sections need full reconstruction

Brickwork is to be repointed where missing or failing. Cement mortars where failing will be replaced with a hydraulic lime mortar (NHL 2.0). Mortar mix to be agreed. Badly damaged or mortar repaired bricks are to be cut out and replaced with salvaged bricks sourced to match the existing. Assume 10% repointing unless described otherwise. All masonry lightly Thermatech cleaned. Air bricks cleaned of paint to maximise ventilation and then redecorated.

Gauged brick string courses  
Thermatech cleaned and badly decayed bricks, inappropriate cement mortar repairs, unstable areas and cement pointing removed.  
Replacement new gauged bricks installed with lime putty pointing.

New lead drip in Code 5 lengths not exceeding 1200mm

Existing lead drip renewed in Code 5 lengths not exceeding 1200mm.

New mortar fillet - NHL 5.0.

All cast-iron and lead downpipes and cast iron soil pipes require redecoration. Colour: Black to match the existing.

Shutters to be overhauled and repaired with scarf repairs. Racked shutters to be dismantled and reglued. All joinery to be thoroughly prepared and redecorated. New lead cover flashing to top rail.

Fractured and badly decayed gauged brickwork or mortar repairs to window heads to be cut out and replaced on a brick-by-brick basis. Washed out joints repointed with a non-hydraulic lime putty.

Stone window cills Thermatech cleaned and where necessary poulticed to remove extensive deposits. Mortar repairs to localised damage. All windows overhauled with scarf joinery repairs to decayed sections. Putty replaced where missing, detaching or cracked. All joinery redecorated. Draught-proofing seals and strips surface fixed to the existing windows.

New stone cills or indent repairs to stone cills.

New tiled cills.

All railings to Areas, bridges and steps to be rubbed down and repainted. Decayed ends opened up, painted and releaded. Localised damaged stonework to the bridge and plinths require a combination of pieced-in or mortar repairs. Open joints between paving slabs and steps to be repointed (NHL 5.0).

Basement Areas - Paving lifted and relaid to falls to existing channels and gully positions. New stone sourced to match existing when badly fractured or missing.

French Drain installed immediately in front of the building at basement level and concealed beneath the paving.

Basement Area walls - Decayed bricks and cement mortar repairs are to be repaired with salvaged bricks to match the originals. Wall surfaces cleaned of loose paint and relime washed. Scarf repairs to existing doors and redecoration.
