# HIGHGATE CEMETERY

## INSPECTION AND REPORT ON THE CONDITION OF BUILDINGS AND STRUCTURES

### VOLUME 2 PARTS 5 to 12: THE FUNERARY BUILDINGS

JANUARY- MARCH 2022  
REVISION A: DECEMBER 2022

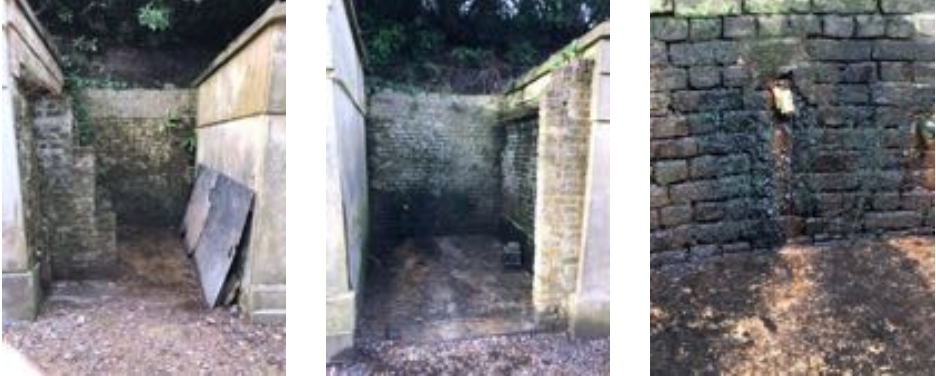
5.2.2	WALLS	
	<p>Without access to any of the sealed chambers, it is hard to be certain, but there is no reason to think that the walls are defective. In the 'gaps', however, the back wall is very wet, and at No. 10, water runs from piped outlets continuously.</p>

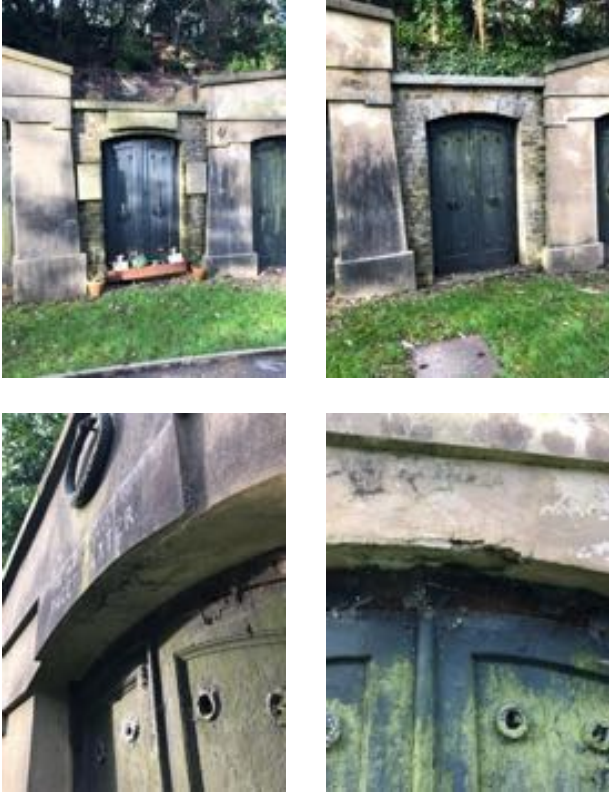
5.2.3	FACADES	
	<p>All are essentially sound, but would benefit from control of roof run-off that should be going to the drain behind. The 'conserve as found' principles of 2010 are holding up well, and only some minor pointing is need to Nos. 1-7.</p> <p>Brickwork to back wall in gaps 8 &amp; 10, and to infill at Nos. 12 &amp; 14 is in need of localised repointing.</p> <p>Render defects to soffits of opening to Nos. 11 &amp; 13.</p>

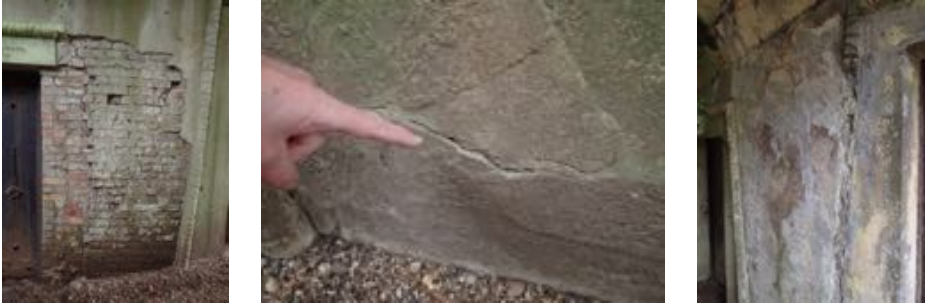
<p>Other conserved render to the facades is continuing to gently decay, but very slowly and only a few areas were found to ring hollow to a random tap-test.</p> <p>One area badly affected by salt mobilisation between EA13 and EA15 is extensively 'hollow'. An area of exposed brick to EA9 is very wet at the bottom, and earlier repairs are rather crude, but it is not actually defective or unstable. At EA6- EA8 there are areas of render near the ground that are actually detaching and these and similar patches will require conservation if they are not to be lost.</p>

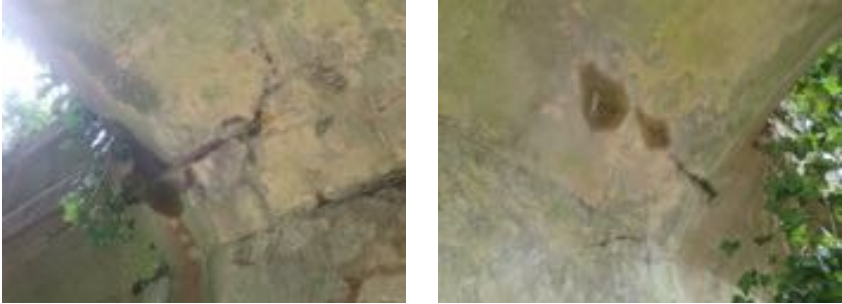
<p>The Avenue side of the vault has a hairline crack following the concealed arch-ring, and very small lateral cracks at the spring of the arch both sides, visible more by the water staining that they allow through than the cracks themselves. Subject to engineer's corroboration this is not of concern but should be monitored from year to year in case the defects are or become progressive.</p>

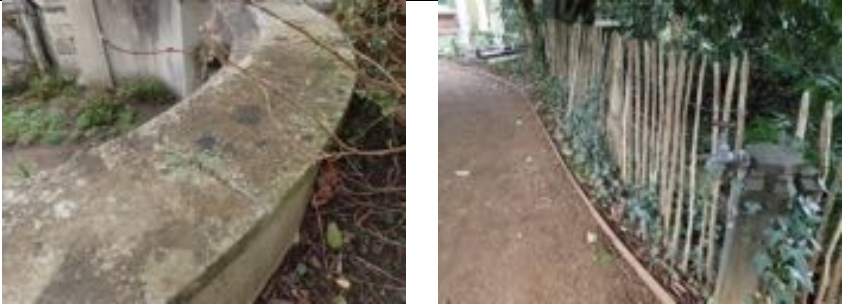
<p>On the outer side of the portal the wall head forms a substantial parapet to the footpath above. There are some cracks in coping joints but only minor repairs are essential. This parapet, at approx. 900mm high, does not meet current regulations for the context but it is substantial and safe in the context of the Cemetery. The protection of the dangerous drop to the other side (into the Avenue cutting) is only a low iron railing and a split lath fence, and this needs to be reviewed.</p>

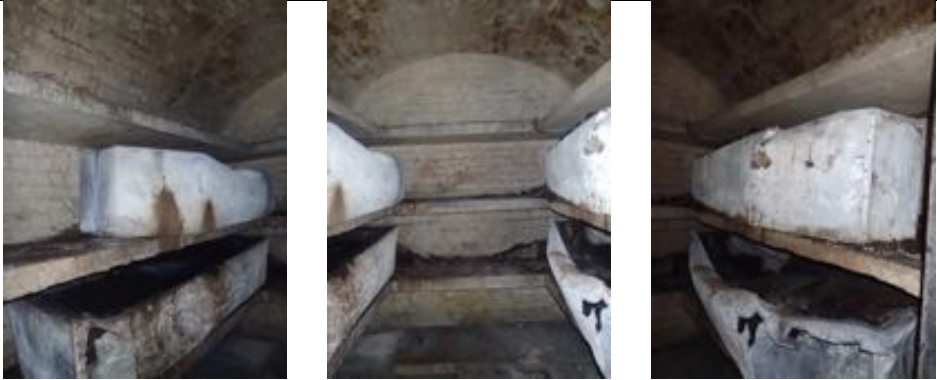
<b>WALLS</b>	
	Brick. No structural defects. Pointing repairs needed around the door.

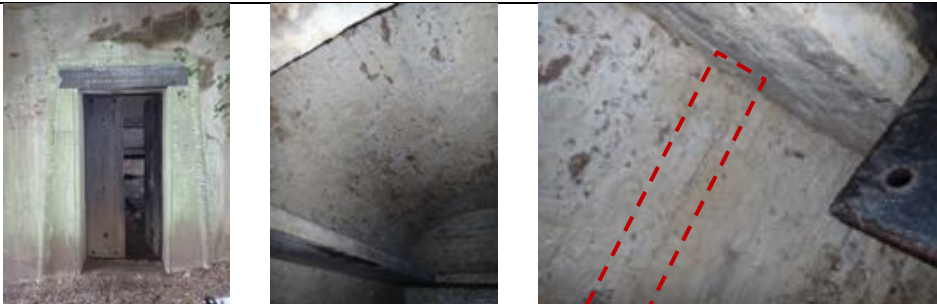
6.3.2	<b>EA3 DALZIEL VAULT 1</b>

<b>GENERAL</b>	
	Generally as EA1. Plinth and 3 shelves all around. 2 coffins on middle shelf.	
	<b>CEILING</b>	
	No defects. Hairline crack in the longitudinal joint, 3 courses to the right of the crown of the arch, approx. 900mm long.

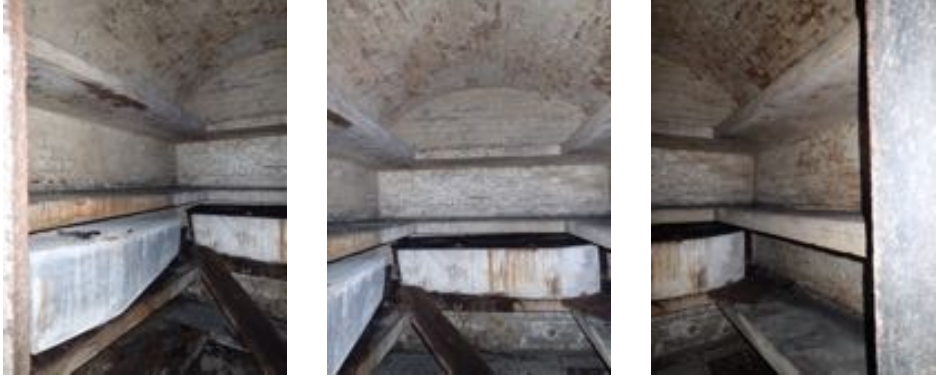
WALLS	
	No structural defects. Some open joints and missing collar joint around the door frame.

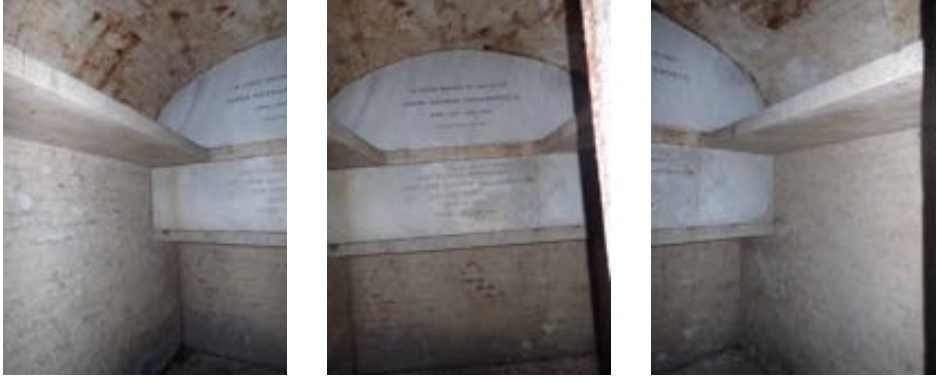
<b>WALLS</b>	
	No defects. Few small tree roots. Big hole over left hand side of the door arch inside.

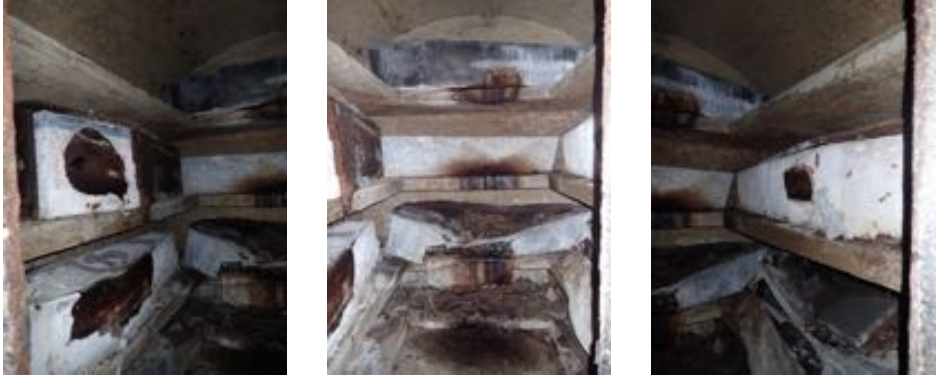
<p><b>WALLS</b></p> <p>Not fully visible but no defects seen. Door lining outside has displaced up to 75mm away from the door frame at the top. Inside face of the wall not displaced. Collar joint issues at door frame.</p>

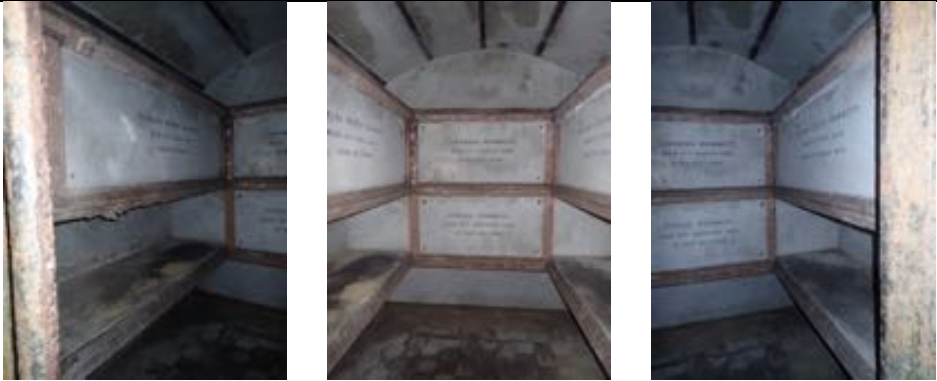
<b>WALLS</b>	
	<p>Similarly lined in large marble slabs. Shelves in stone with red marble mouldings on front edges. Mouldings are detaching in places, and shelves have delamination to the underside. Red marble lining to door opening is cracked and broken. Repairs required.</p>

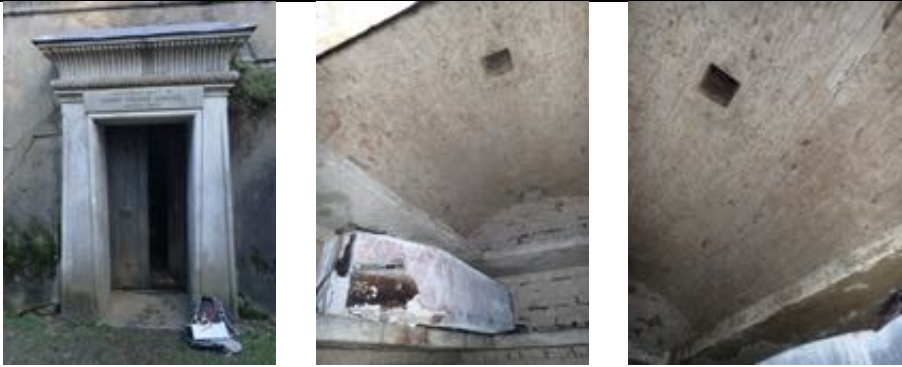
<b>GENERAL</b>	
	Tapered chamber with elliptical brick vault. 4 shelves on 3 sides. 8 adult and 3 child coffins.	
	<b>CEILING</b>	
	Sound, other than a longitudinal crack in 2 bed joints, i.e. 5 <sup>th</sup> and 6 <sup>th</sup> joint to the right hand side of the centreline. Small but significant. Structural Engineer's advice needed, together with monitoring before decisions are taken regarding remedial works.

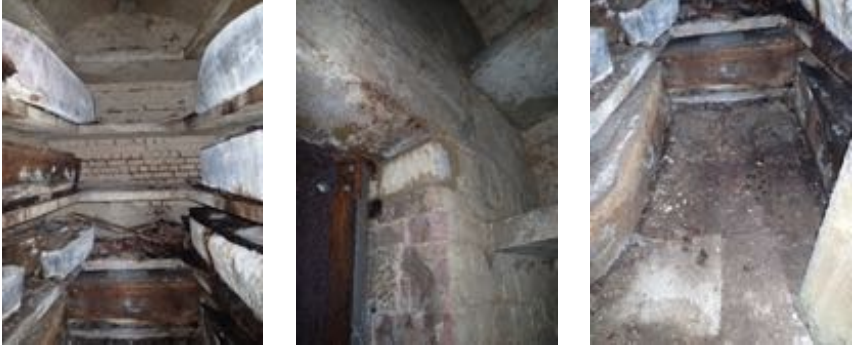
<p><b>WALLS</b></p>	
	<p>No clear defects. Some small cracking around left end of stone lintol (looking in). Pointing repairs needed around the door.</p>	
	<p><b>FLOOR</b></p>	
	<p>Stone slabs. Very dirty and very wet but not obviously defective.</p>	
	<p><b>DOOR</b></p>	
	<p>Light corrosion. The steel frame is vulnerable and will need to be checked and treated.</p>

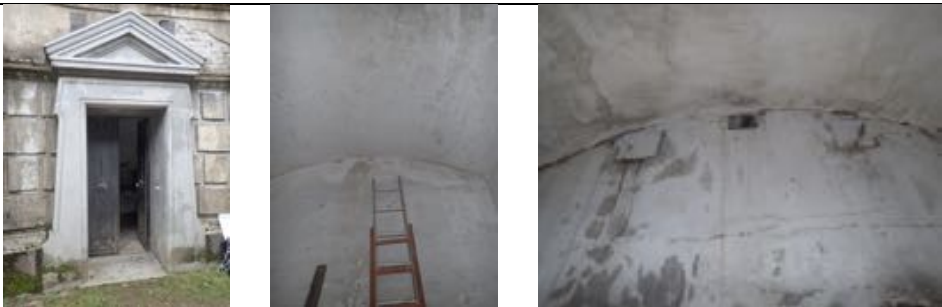
<b>GENERAL</b>	
	Walls and ceiling all rendered. 1 shelf at low level on 3 sides. 2 coffins.	
	<b>CEILING</b>	
	Plastered segmental vault. No cracks except at abutment to front wall (1-2m long). Needs Structural Engineer's advice.

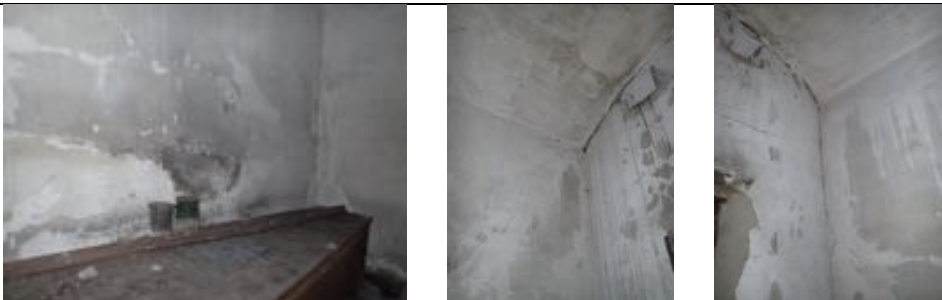
<b>WALLS</b>	
	Rendered. Generally in good condition but very uneven/repared above the shelf on left hand side. Crack to upper part of both front corners and diagonal crack down from the front right hand corner at the top. Small horizontal crack halfway up left hand wall. Extensive making good around the door frame required.

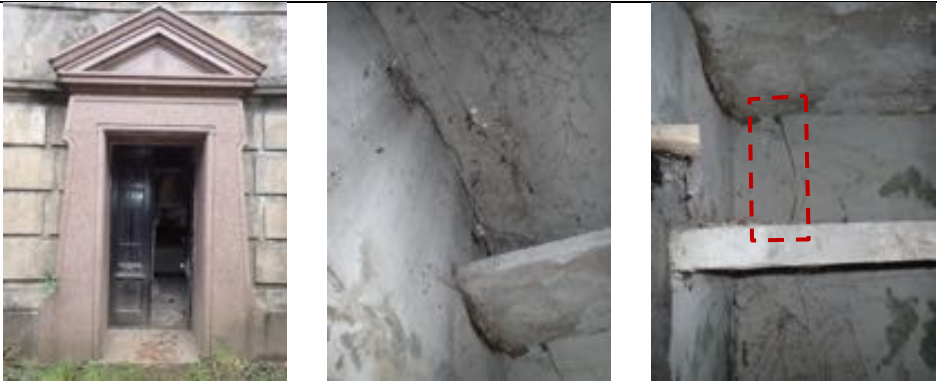
<b>GENERAL</b>	
	Rendered segmental vault. Rendered walls. 4 shelves to 3 sides. 3 adult coffins and 1 sealed shelf. Pillar with bust sculpture.	
	<b>CEILING</b>	
	No cracking to the vault itself but there is a big crack (5mm wide) at abutment to the front wall, larger at left hand corner. Structural Engineer's advice needed.

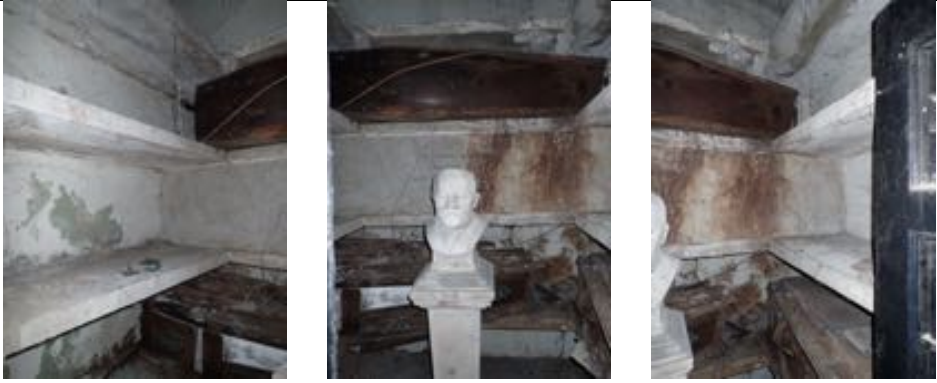
<b>WALLS</b>	
	Only parts visible. Render is quite sound but there are a lot of fibrous roots. Substantial vertical crack in left hand wall from the top front corner

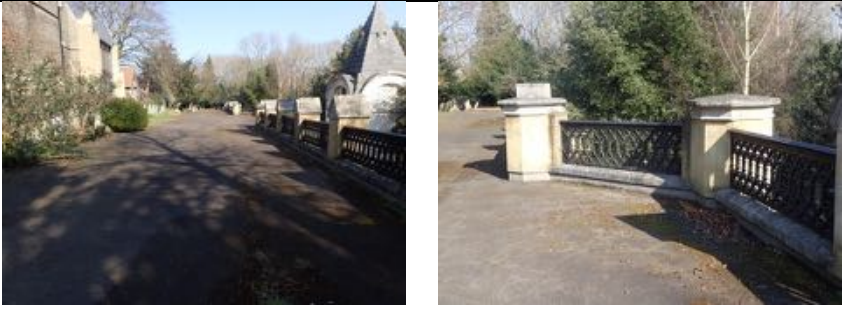
<p>The tarmac terrace surface has cracks, cracks at joints and low points all of which encourage and harbour plants and moss. This is a self-perpetuating and escalating problem which needs to be addressed. Each low point relates to a drain, but the organic growth makes it apparent that these hold water, at least temporarily.</p> <p>There are 8 plate-glass oculus rooflights fitted into concrete frames flush with the tarmac surface. Two of these are badly cracked and it is clear from below that the joints around them are not fully waterproof.</p> <p>There is a skirting upstand of what appears to be asphalt along the front parapet wall, but how or whether that links to the asphalt is not clear.</p> <p>As noted below it is clear that the roof continues to allow water penetration, and it will be necessary to resurface the roof with a properly waterproof membrane, protected by a wearing surface against damage from pedestrian and other traffic.</p> <p>At the same time the broken rooflights should be replaced and the sound ones reviewed to minimise water ingress. Drainage should be reviewed (again) to ensure that it is fully functional.</p>

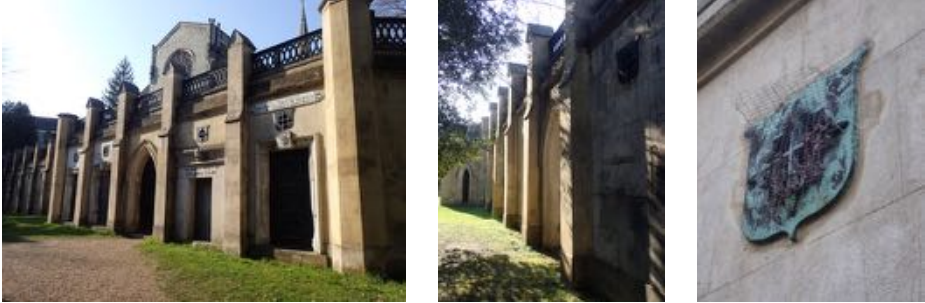
8.1.2.1	<p><b>CENTRAL BAYS (W3-E3 inclusive)</b>  The render is clearly affected by the wall fabric behind it being damp, with localised blistering along hairline cracks. However light defrassing reveals sound surface below, without serious visual impact, so repairs may be minimal. The render is clearly of two different mixes, and the yellower one is more affected than the greyer one. Random tap-testing did not reveal any debonding and there are no cracks indicating structural movement.</p>

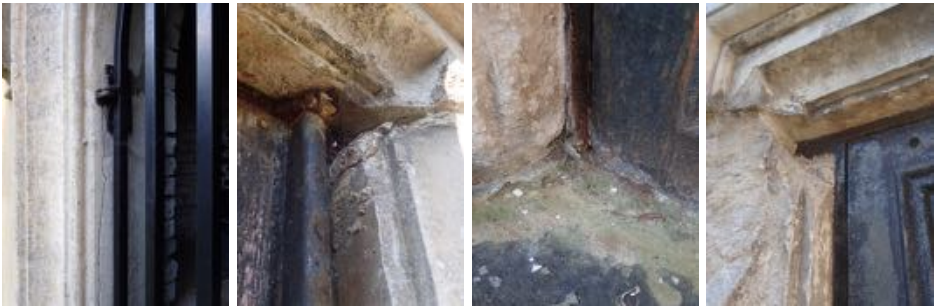
<p>There is light plant growth around WV2, and the marble facing to the wall around the entrances to WV1 (Broxholm) and WV2 (Beetles) has some cracking and displacement without being actually loose.</p>

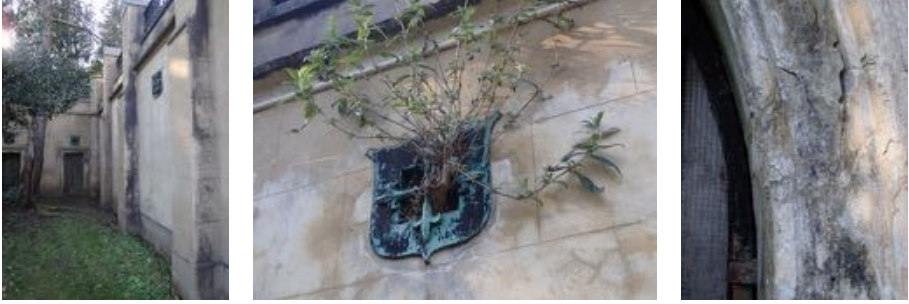
<p>8.1.2.3</p>	<p>WEST WING RETURN</p>	
	<p>The façade to vaults WV3 and WV4 has no particular defects other than a vertical crack at the abutment to the octagonal pier beside WV4. This however shows no sign of render detachment when tap-tested so a simple repair should suffice if done before it gets worse. A repair will be the easiest way to monitor for any progressive movement, and this crack could be on the list for referral to the engineer.</p>

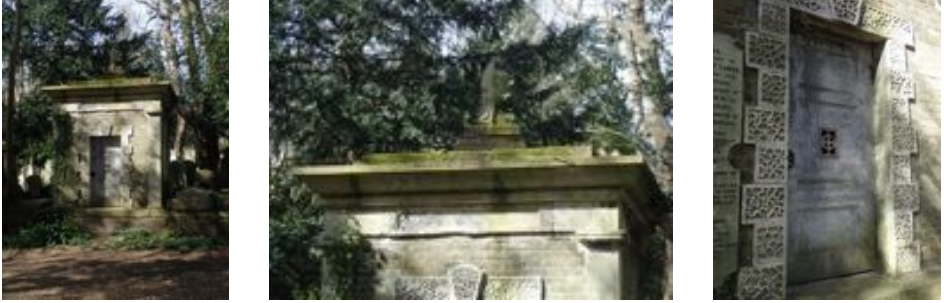
11.1	EXTERIOR	
11.1.1	<p><b>ROOF</b></p> <p>The roof was viewed only from ground level. Moss-covered and clearly leaking through the cornice joints, but there appears to be no displacement of stones other than in the rear right hand corner where ivy has rooted in the fabric.</p> <p>In this corner there is substantial displacement and open joints.</p> <p>Repairs are needed following proper and full removal of the vegetation.</p>

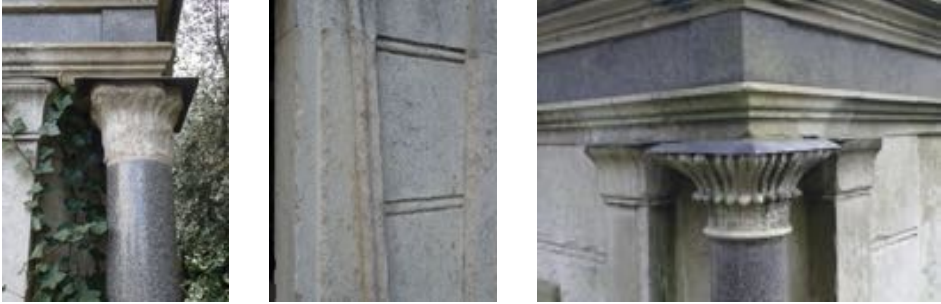
<p>A former window in rear elevation has been very crudely plastered over.</p> <p>Ivy growth should be better controlled.</p> <p>To conserve the mausoleum 'as found' without improvement the repairs will be limited to minor pointing and masonry repairs and substantial control of vegetation. Improvement of the treatment of the former window would be a benefit.</p>
