Unlocking Highgate Cemetery project, Highgate, London

Structural Appraisal Report

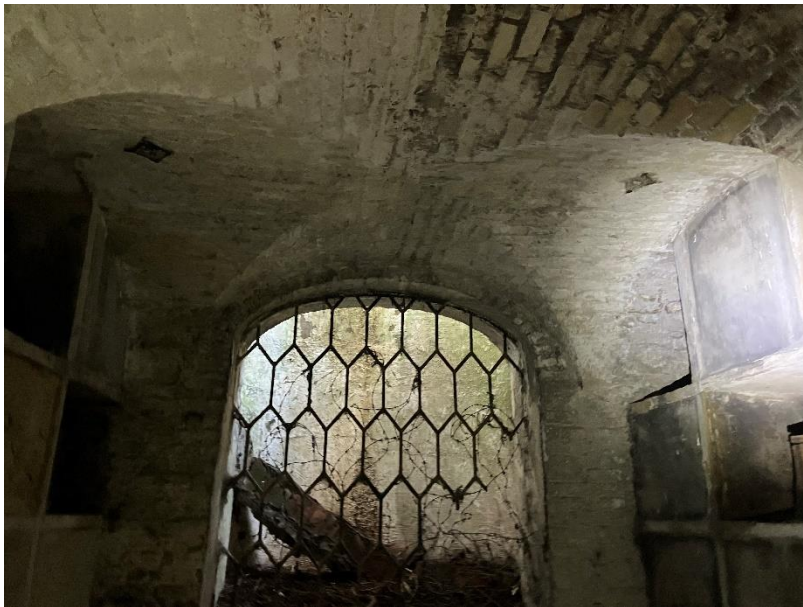
Photograph 1: Terrace Catacombs – typical view of groined vault brickwork in the central aisle.

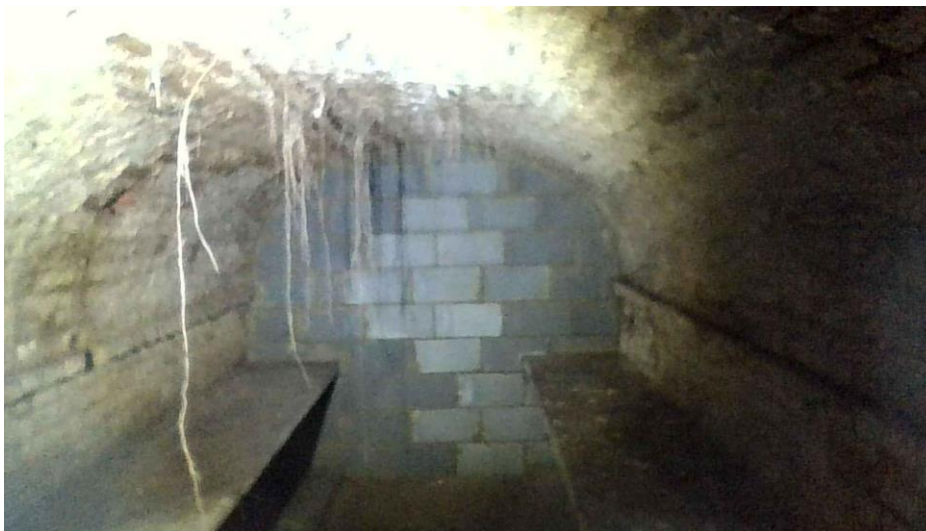
Photograph 2: Unnamed vault at eastern end – root penetration and probable cracking to the vault intrados.

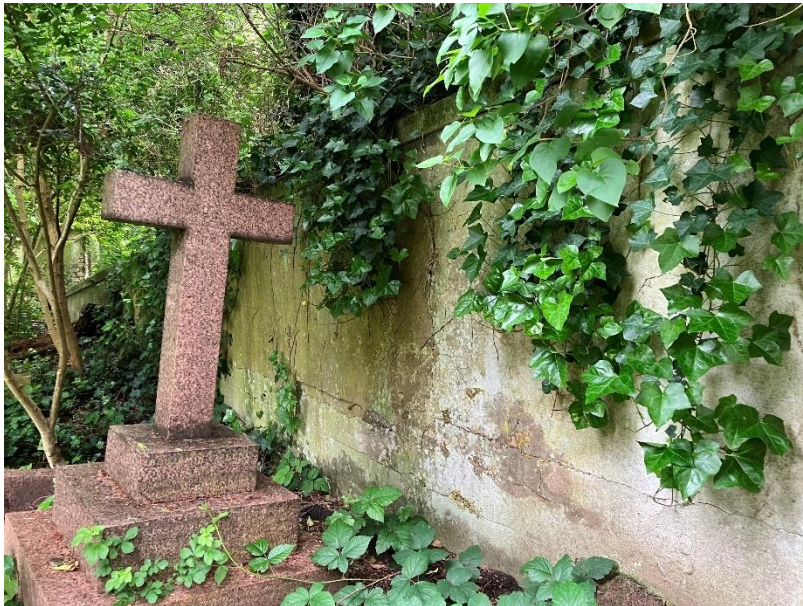
Photograph 3: Failing retaining wall at western end of the Terrace Catacombs.

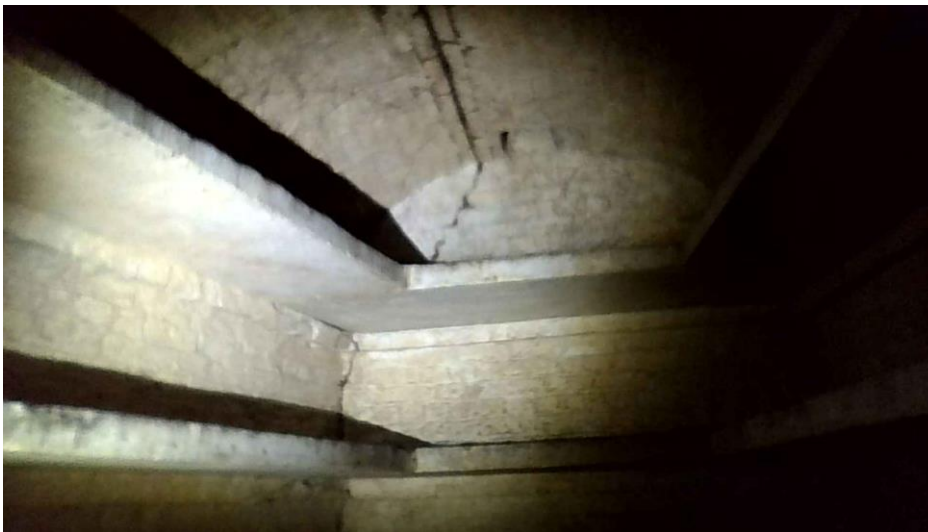
Photograph 4: Inner Circle Vault 1: Typical example of longitudinal cracking at the vault intrados and more isolated example of cracking to the rear wall.

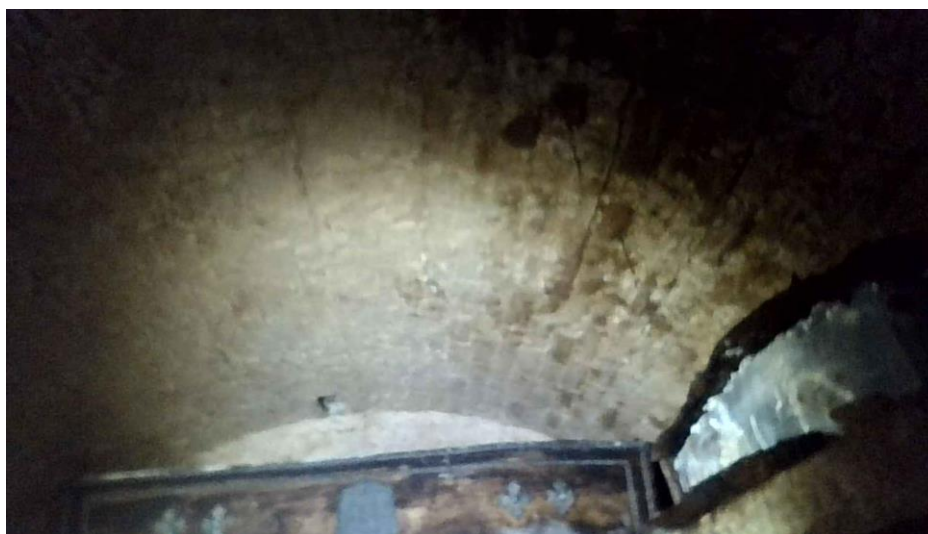
Photograph 7: Egyptian Avenue – typical view of brick vault intrados showing some dampness and limited fine root penetration.

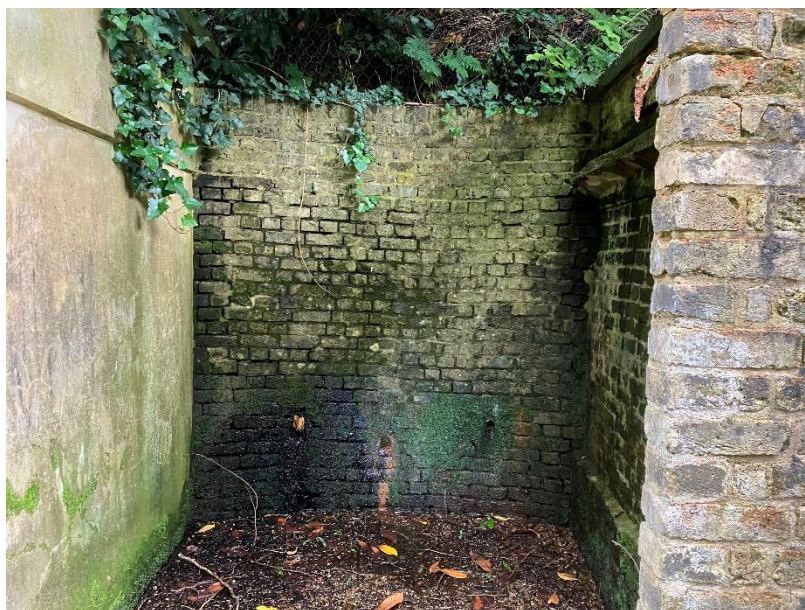
Photograph 11: Water draining out through existing weep holes and brickwork joints and ponding on the ground under.

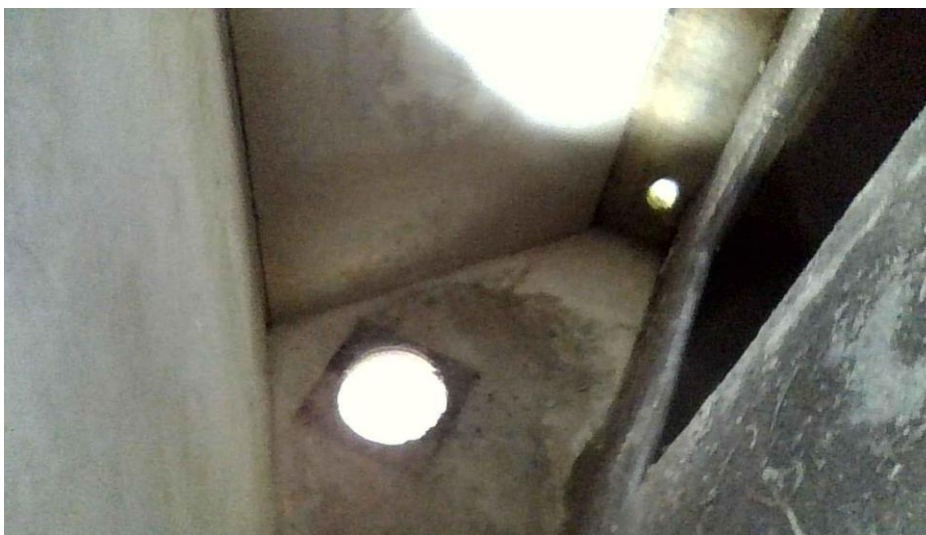
Photograph 13: Rosa – partial view of vault interior (rotated)

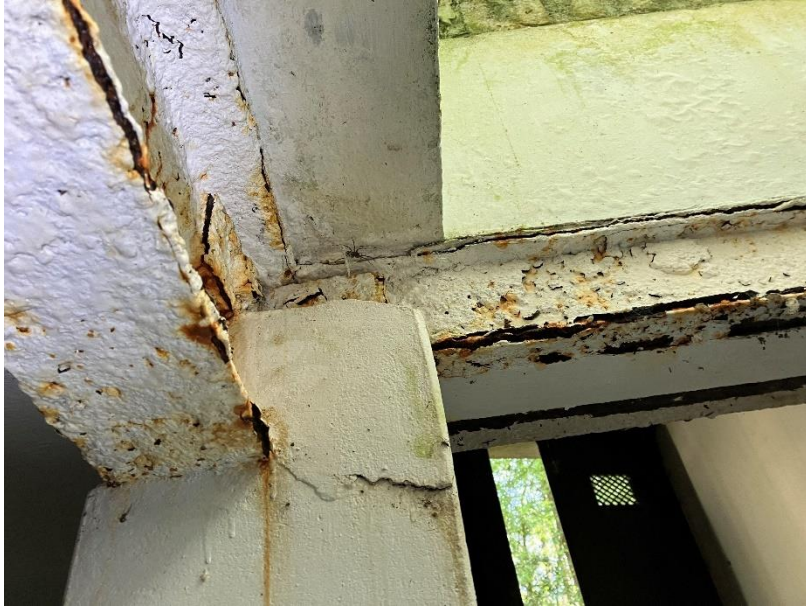
Photograph 14: Otway vault interior – entrance area

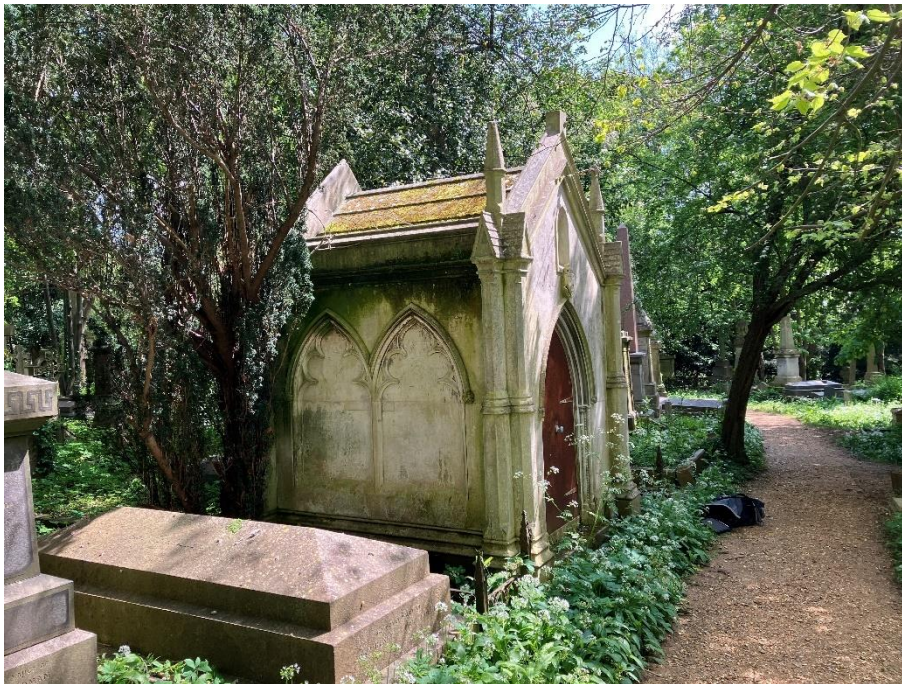
Photograph 17: Foster mausoleum – north elevation

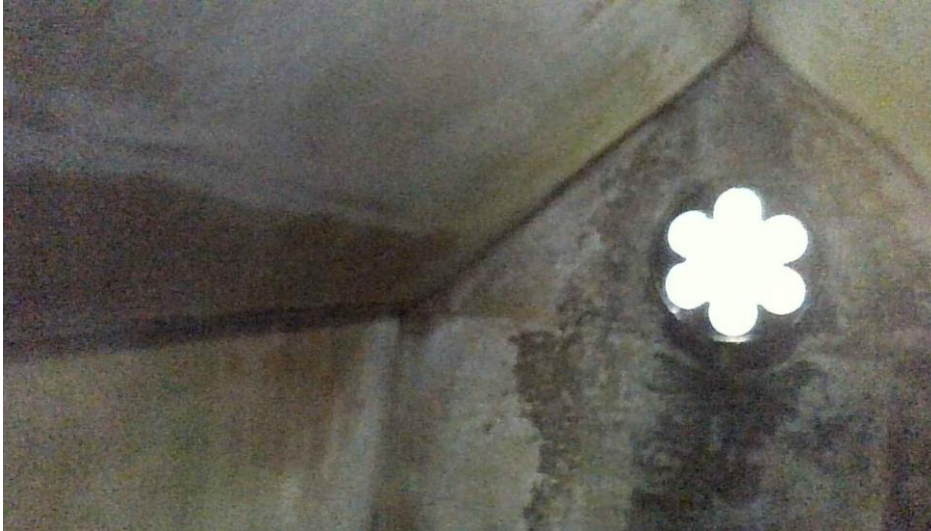
Photograph 18: Foster mausoleum – partial interior view looking west.

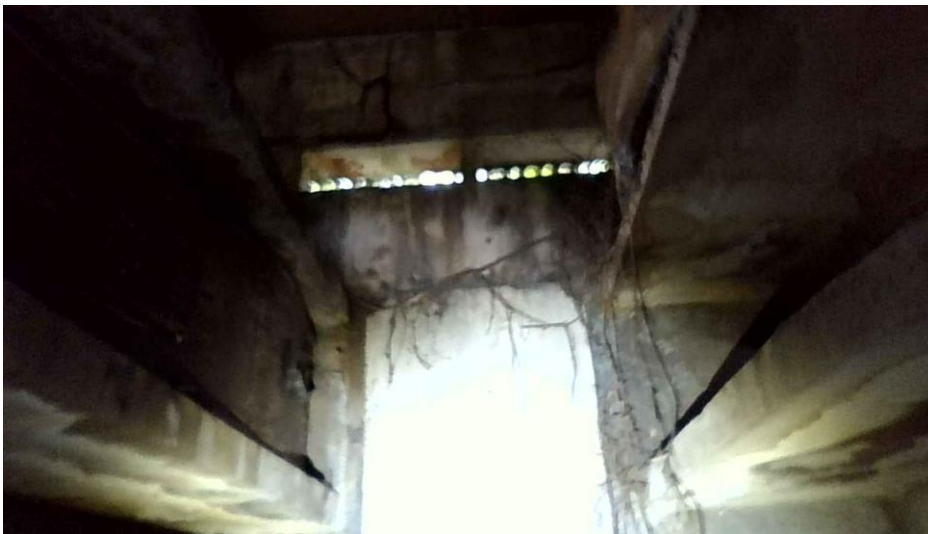
Photograph 19: Morgan – partial view of vault interior

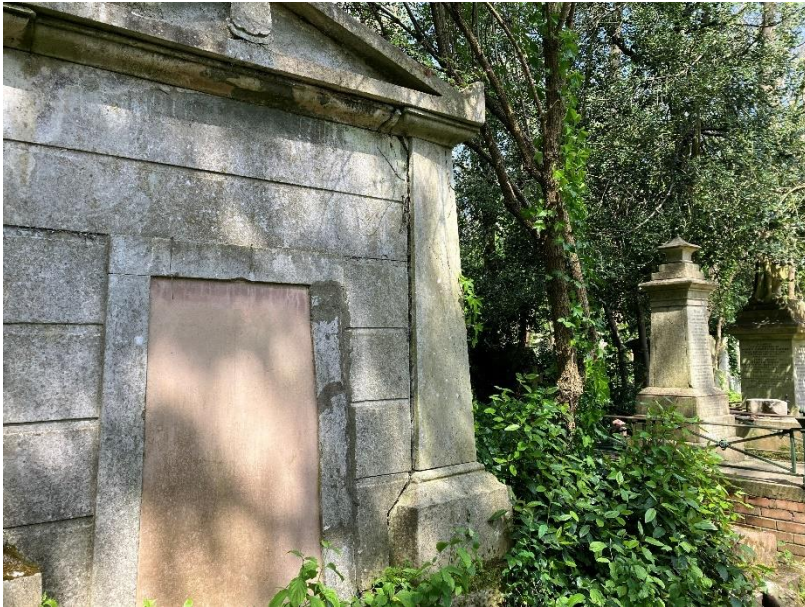
Photograph 20: Da Silva - rotational movement at the south east corner pilaster

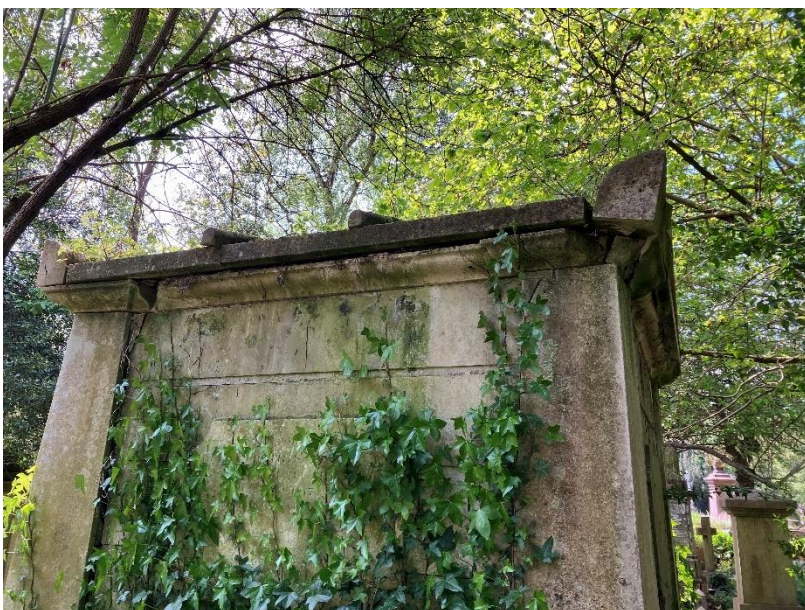
Photograph 21: Da Silva - movement at the cornice units and rear pediment

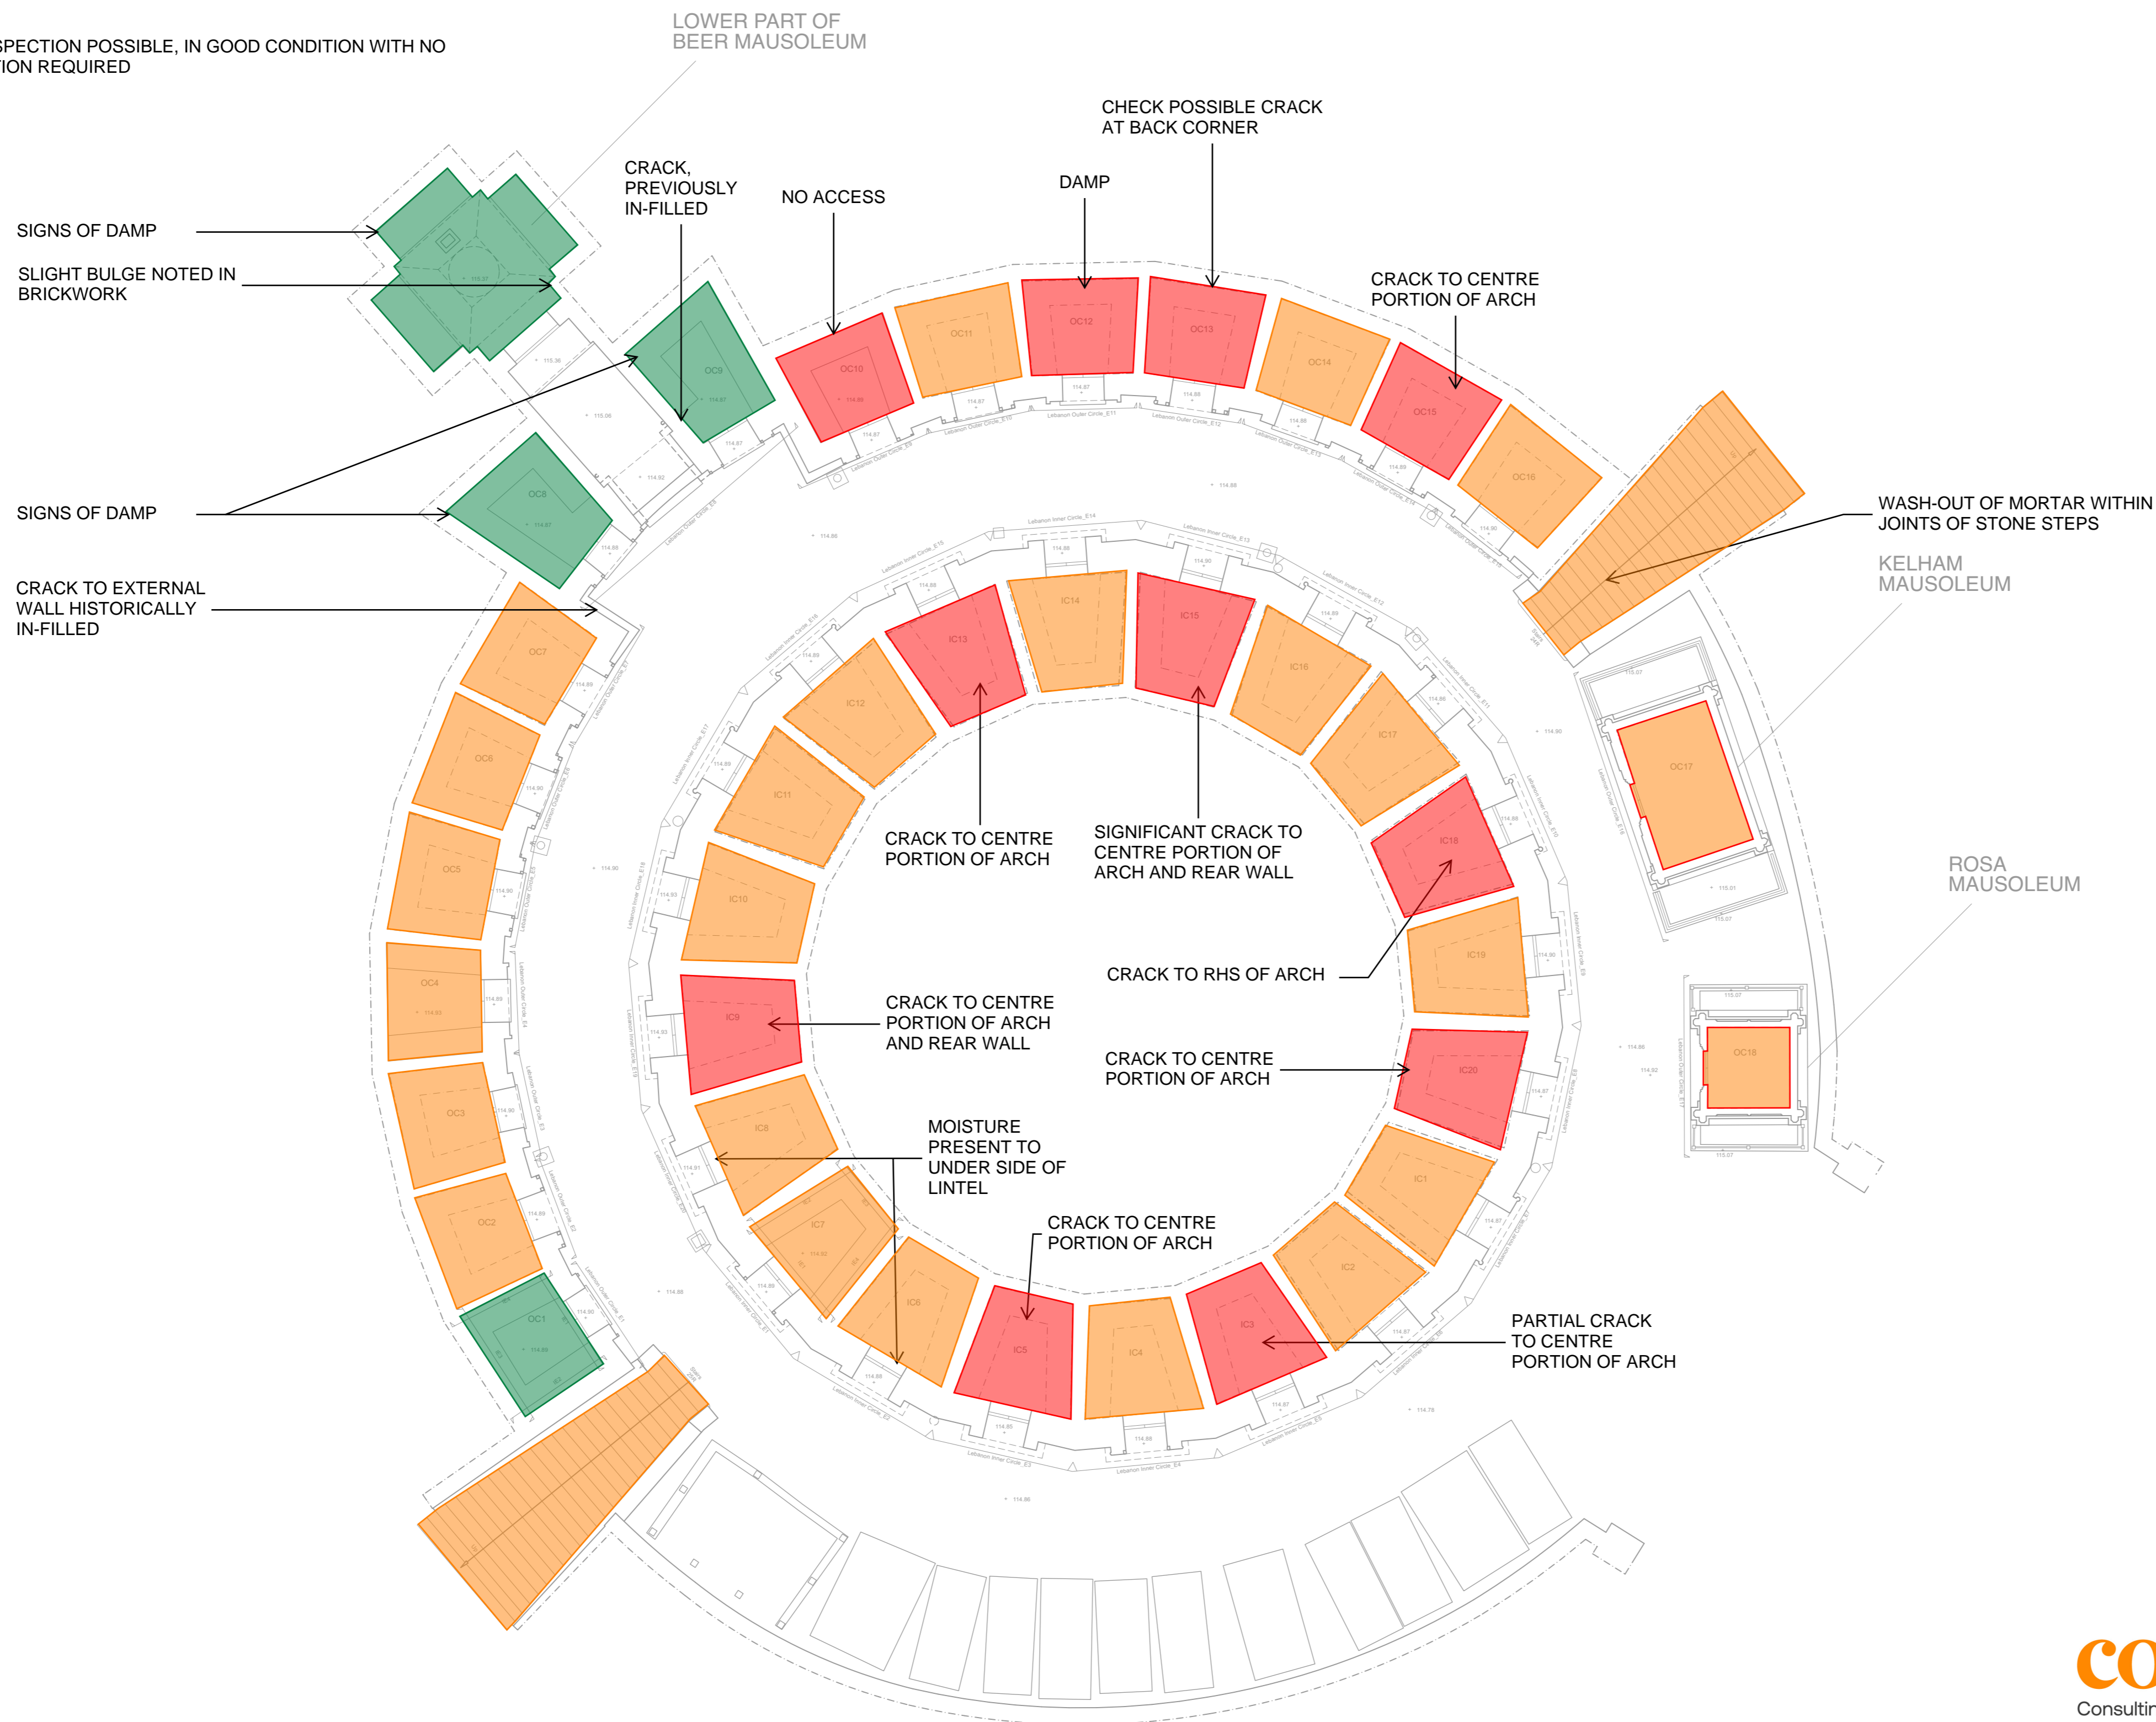
- DENOTES DEFECT NOTED AND/OR FURTHER INVESTIGATION REQUIRED DUE TO NO ACCESS
- DENOTES CATACOMB WHERE BORESCOPE INSPECTION WAS CARRIED OUT HOWEVER FURTHER INSPECTION WHEN DOORS ARE OPENED IS REQUIRED
- DENOTES FULL INSPECTION POSSIBLE, IN GOOD CONDITION WITH NO FURTHER INSPECTION REQUIRED

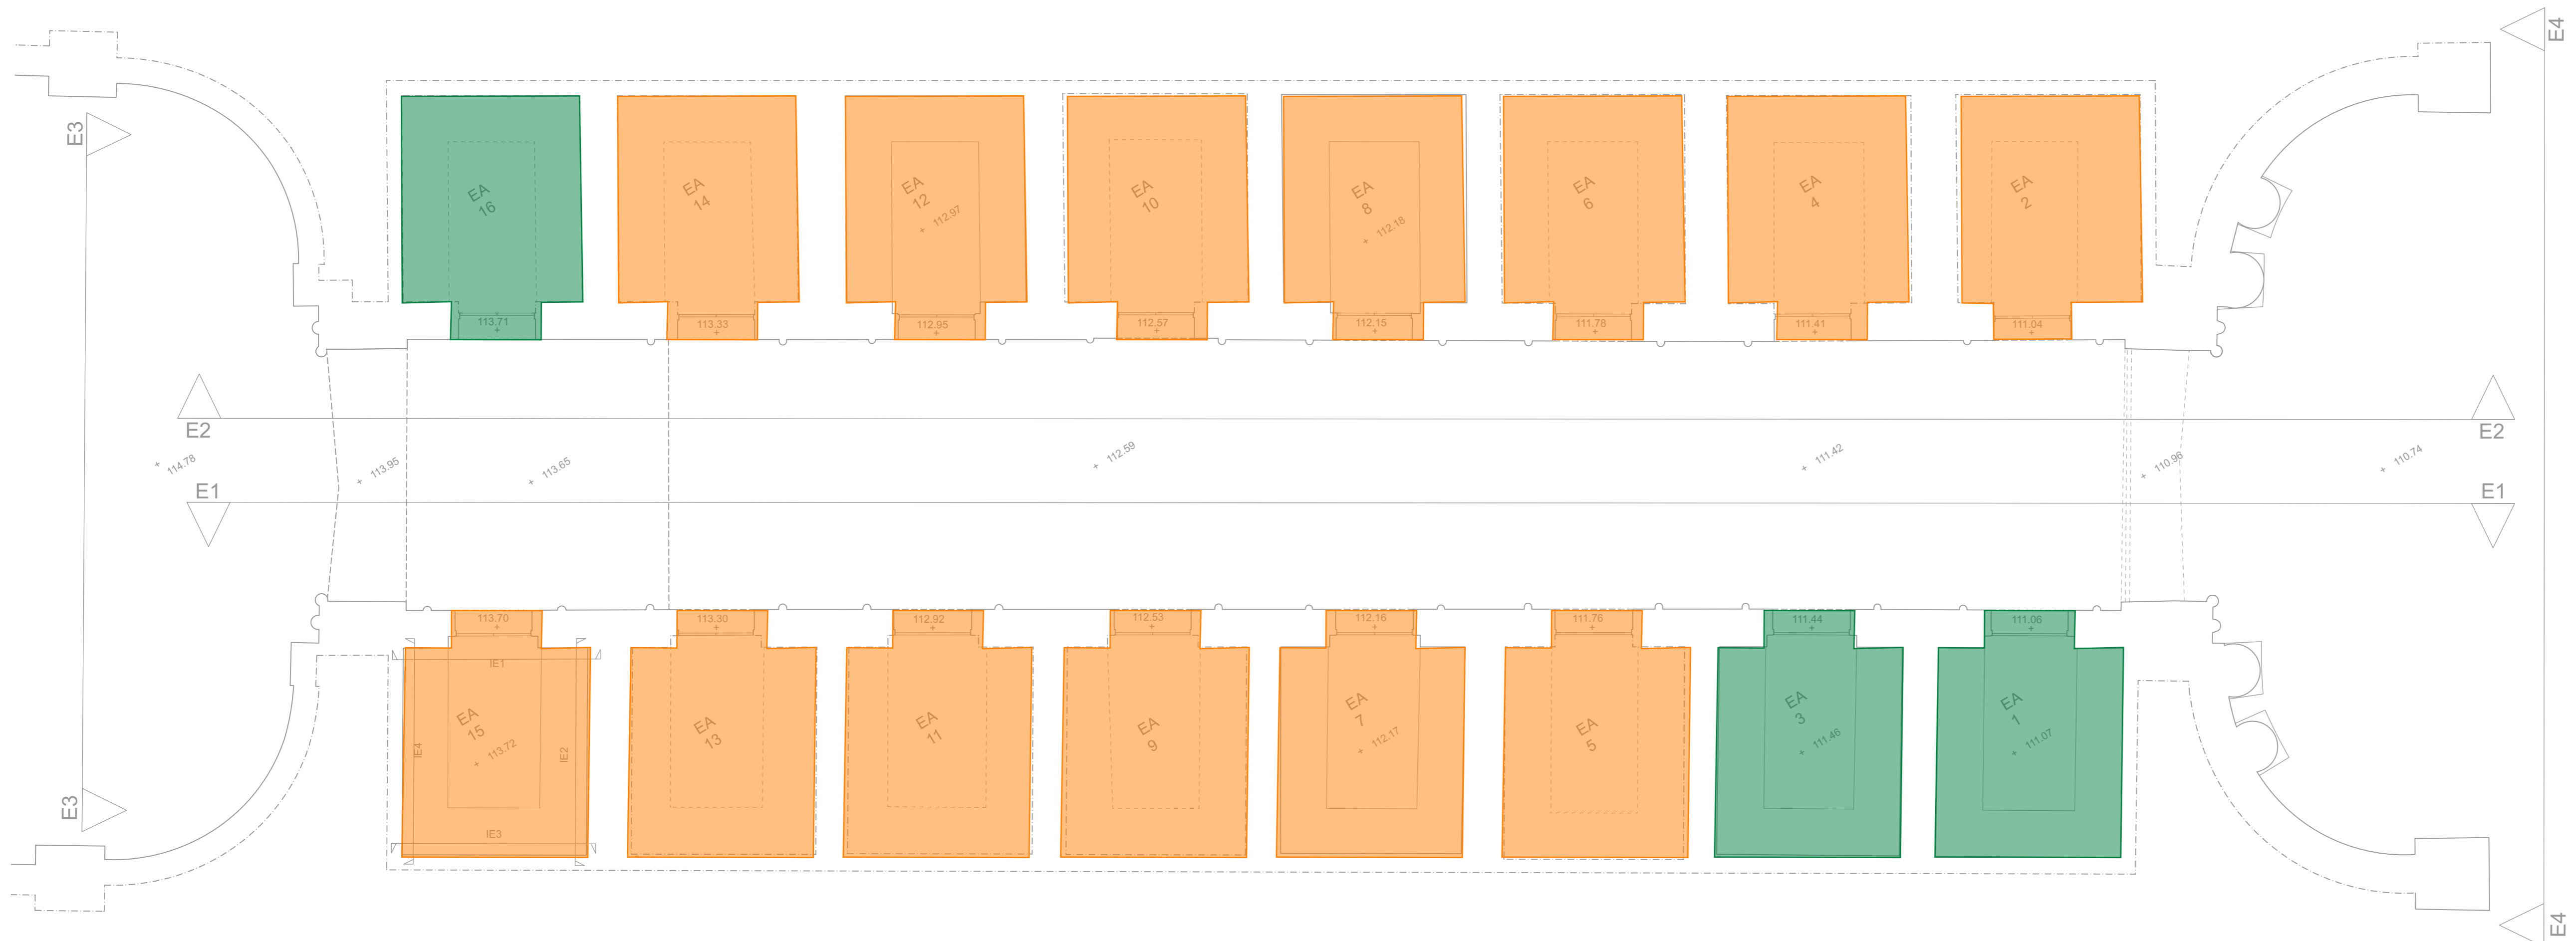
- DENOTES DEFECT NOTED AND/OR FURTHER INVESTIGATION REQUIRED DUE TO NO ACCESS
- DENOTES CATACOMB WHERE BORESCOPE INSPECTION WAS CARRIED OUT HOWEVER FURTHER INSPECTION WHEN DOORS ARE OPENED IS REQUIRED
- DENOTES FULL INSPECTION POSSIBLE, IN GOOD CONDITION WITH NO FURTHER INSPECTION REQUIRED

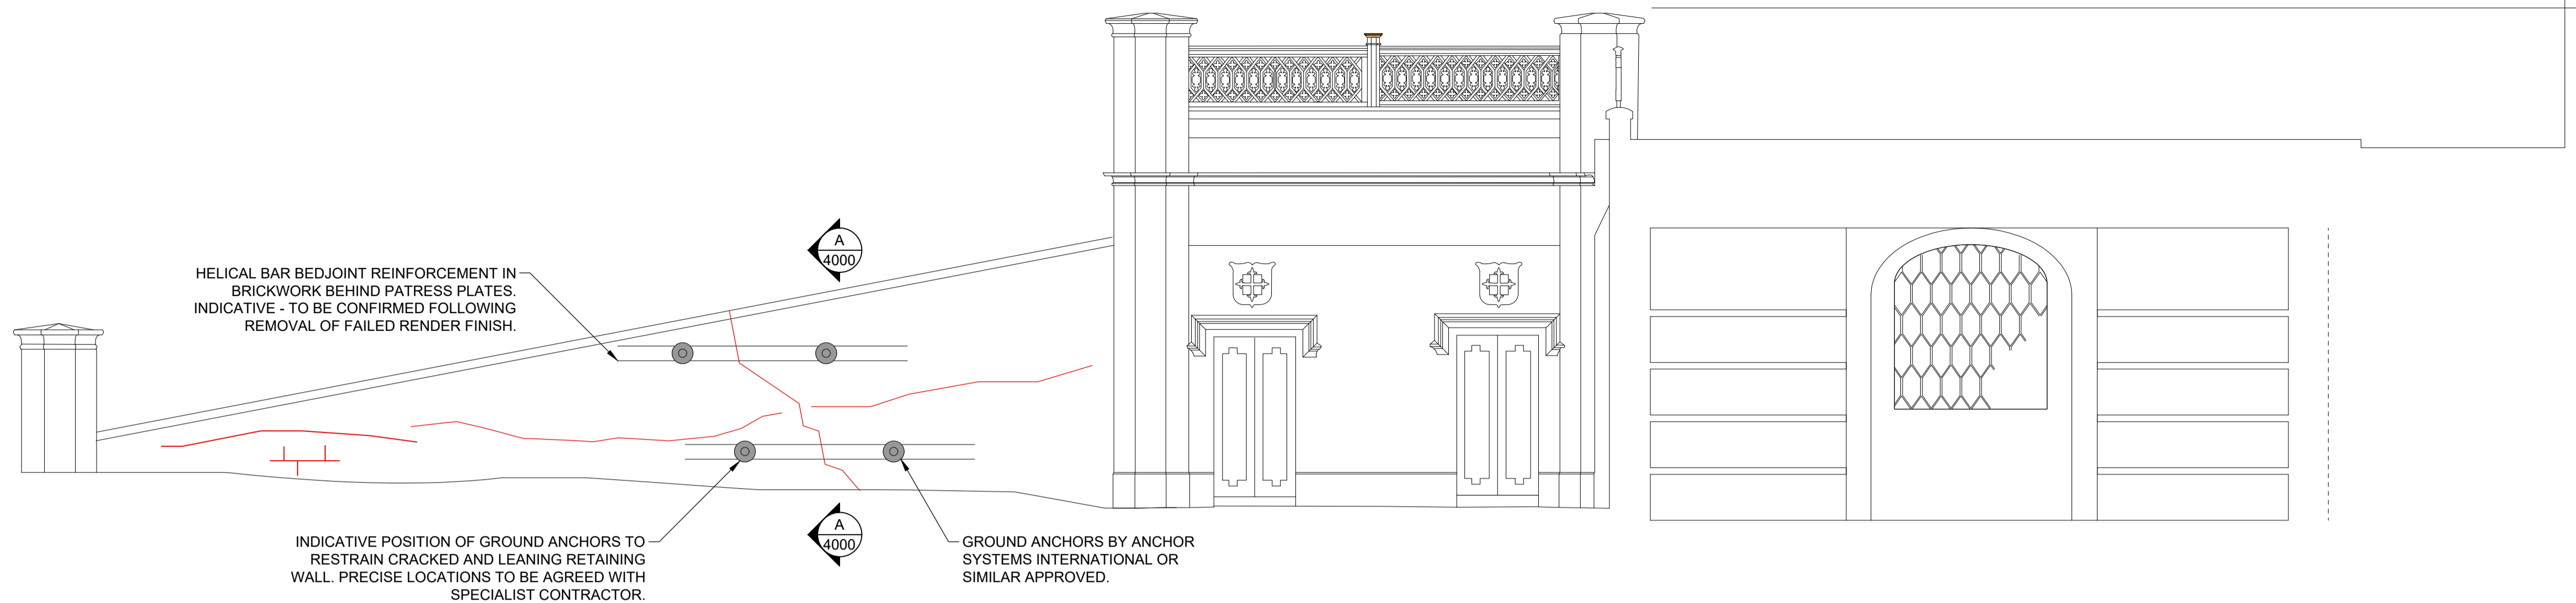
GROUND ANCHORS TO FAILING RETAINING WALL - INDICATIVE ELEVATION
scale 1:50@A1

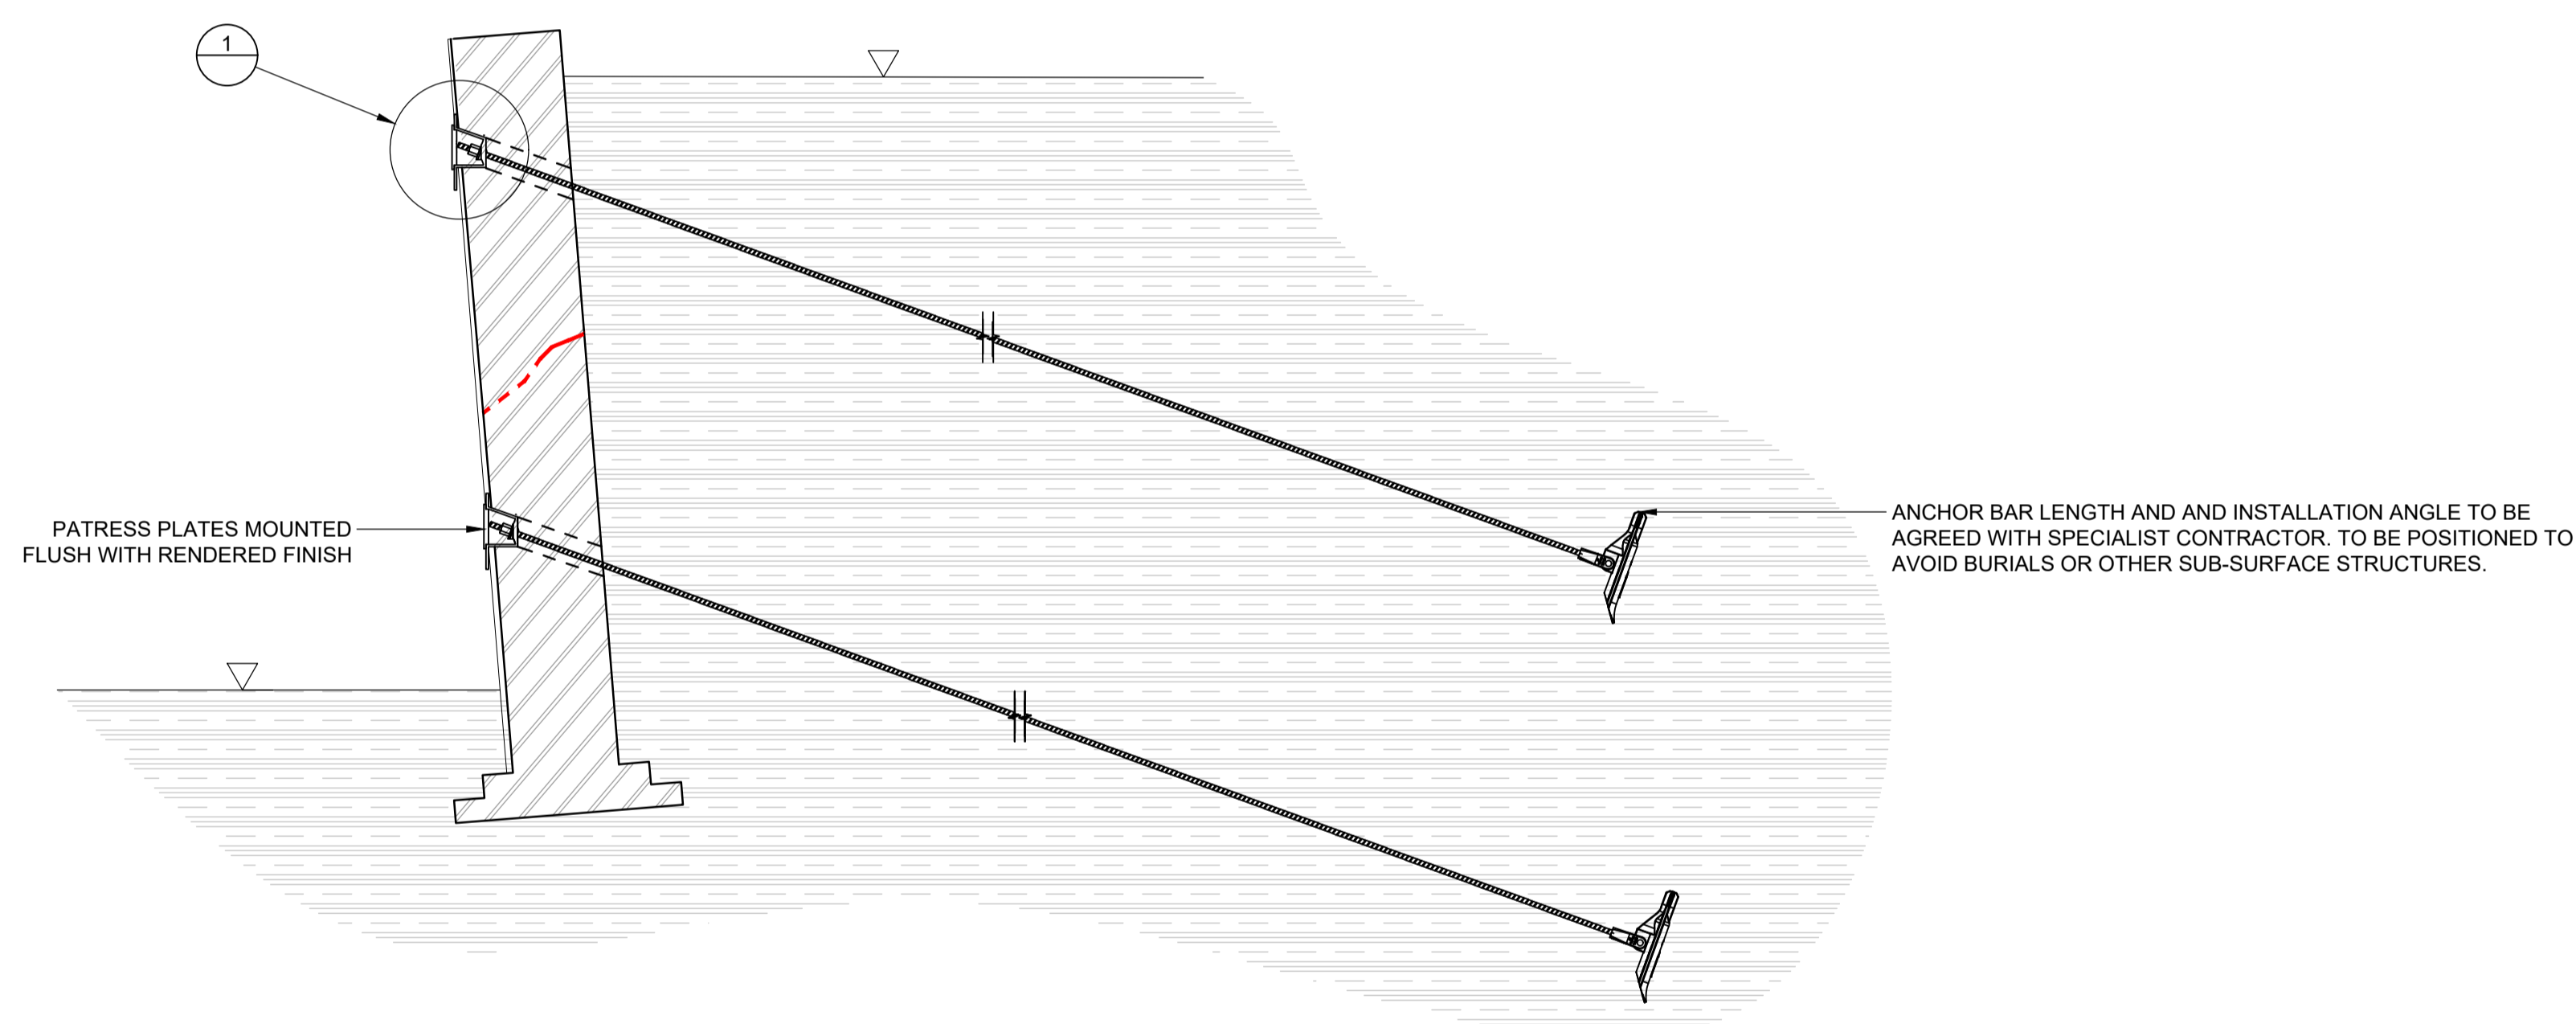
SECTION A-A: TYPICAL ANCHOR ARRANGEMENT
scale 1:20@A1

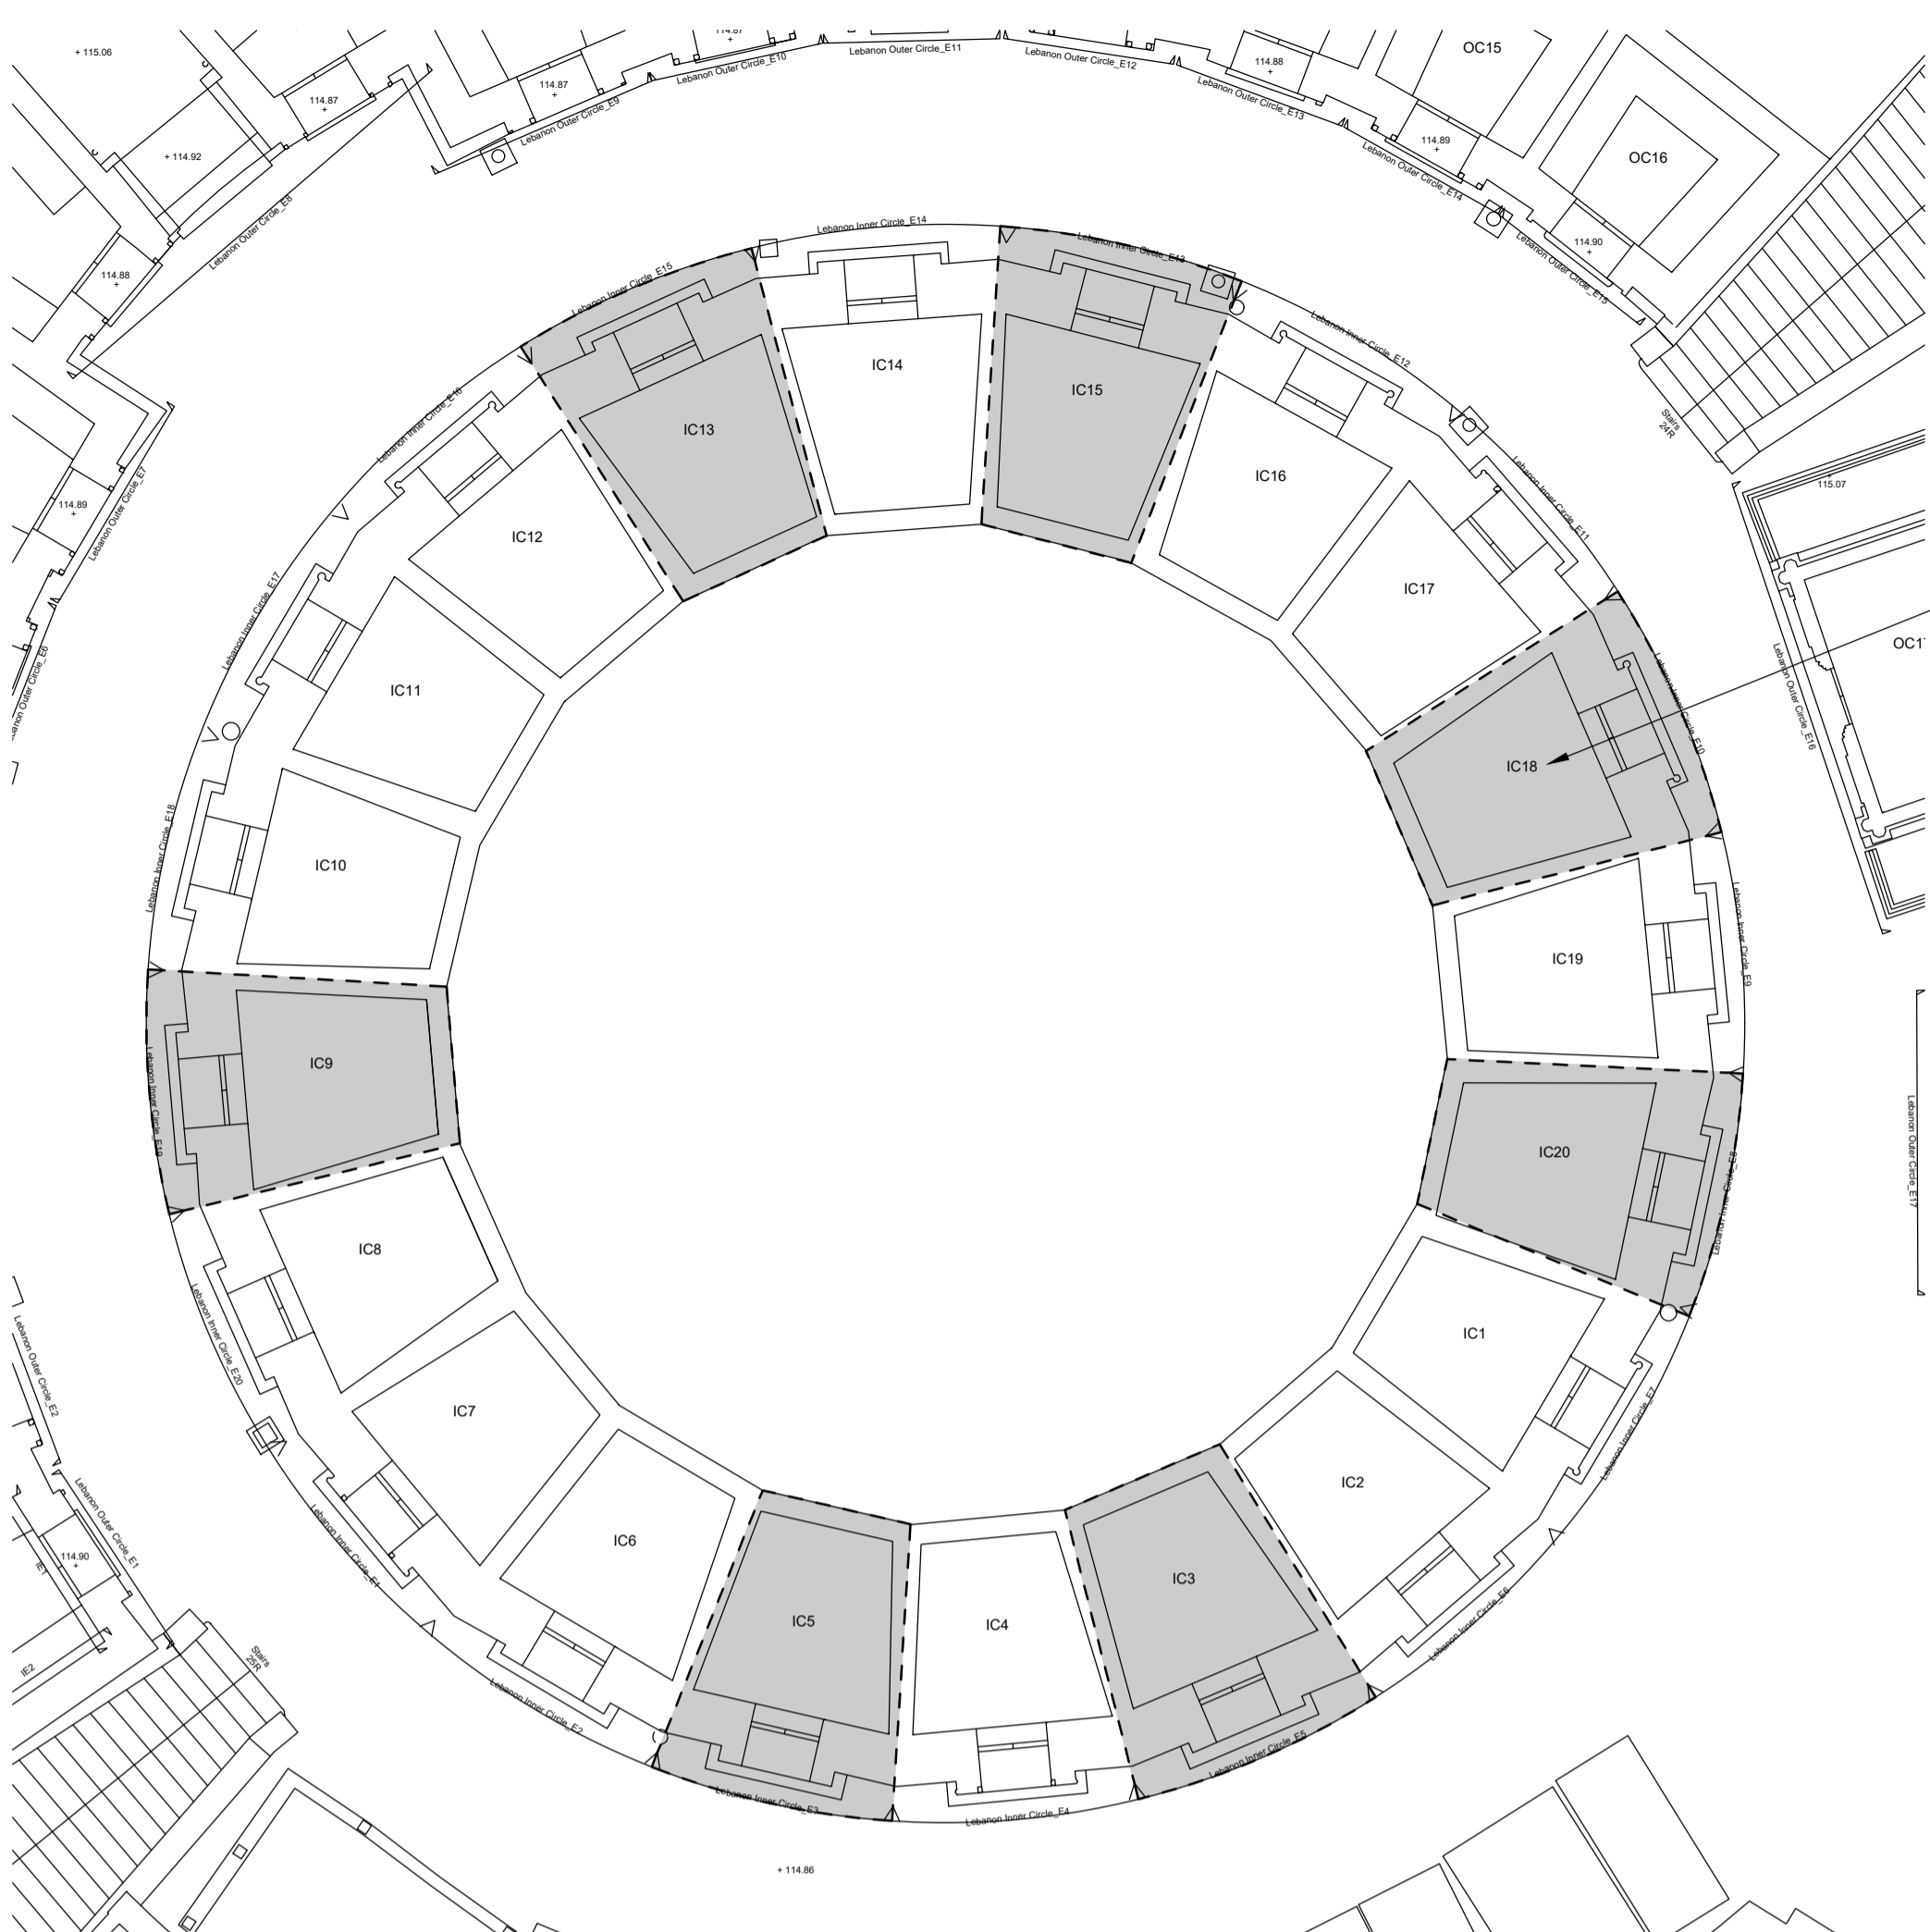
KEY PLAN HIGHLIGHTING LOCATIONS FOR INNER CIRCLE OF LEBANON CRACK STITCHING REPAIRS
scale 1:100@A1
