Unlocking Highgate Cemetery project, Highgate, London

Structural Appraisal Report

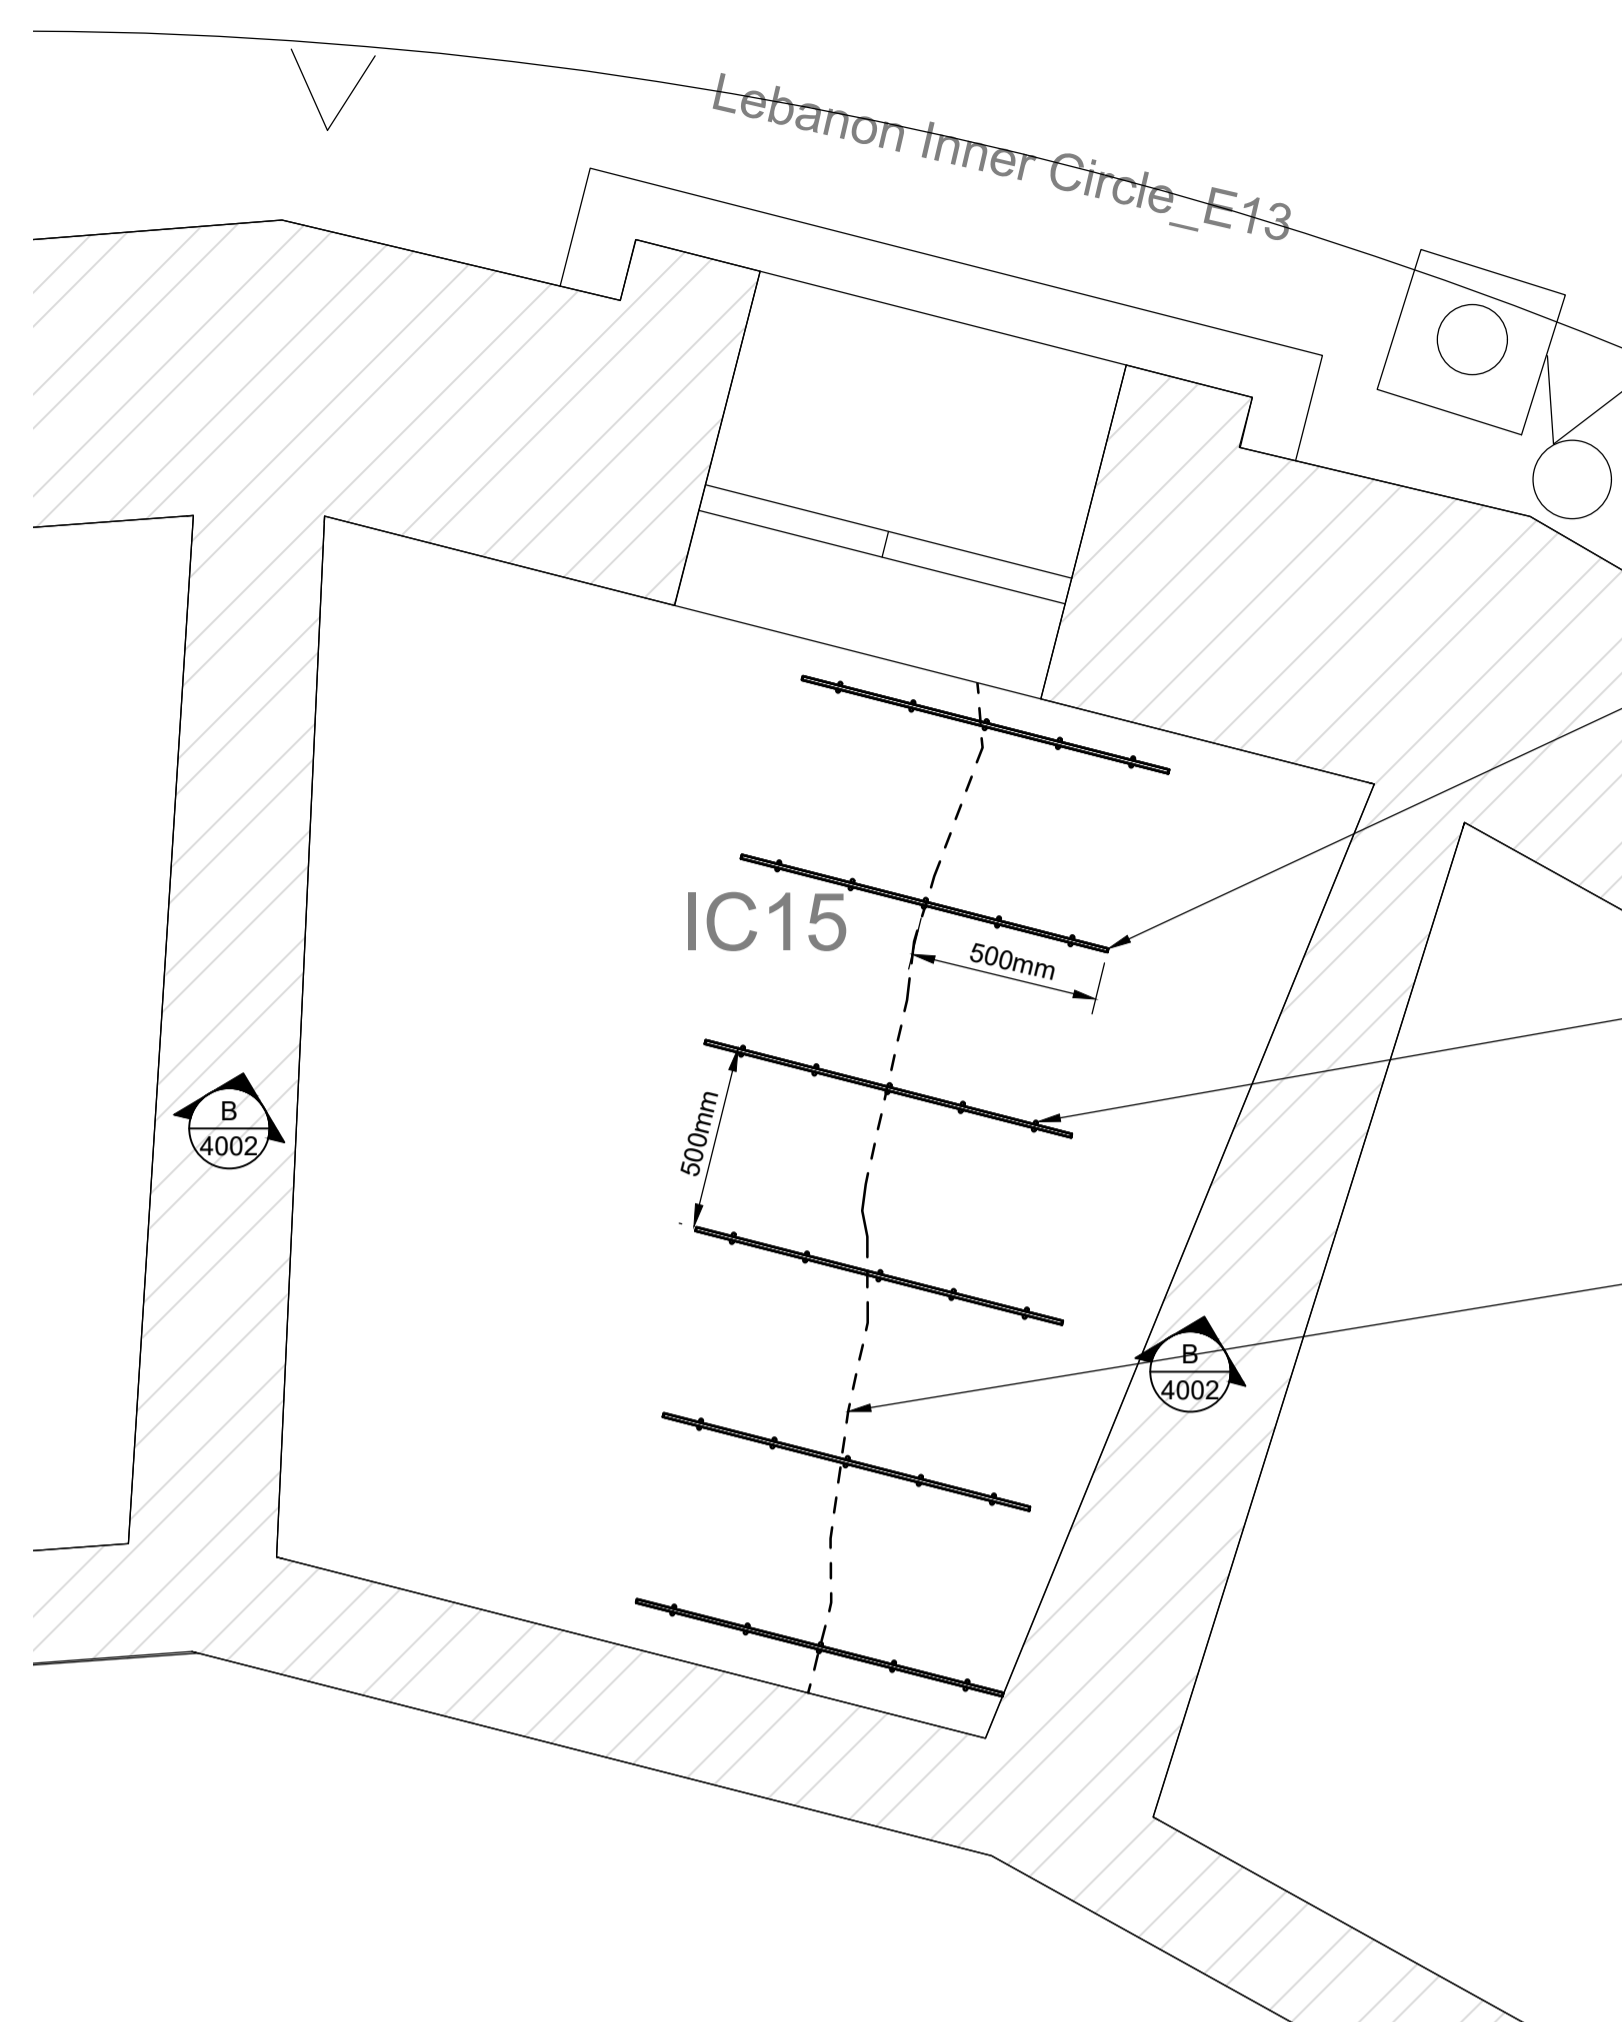
TYPICAL INNER CIRCLE OF LEBANON PLAN SHOWING CRACK STITCHING REPAIR
scale 1:20@A1

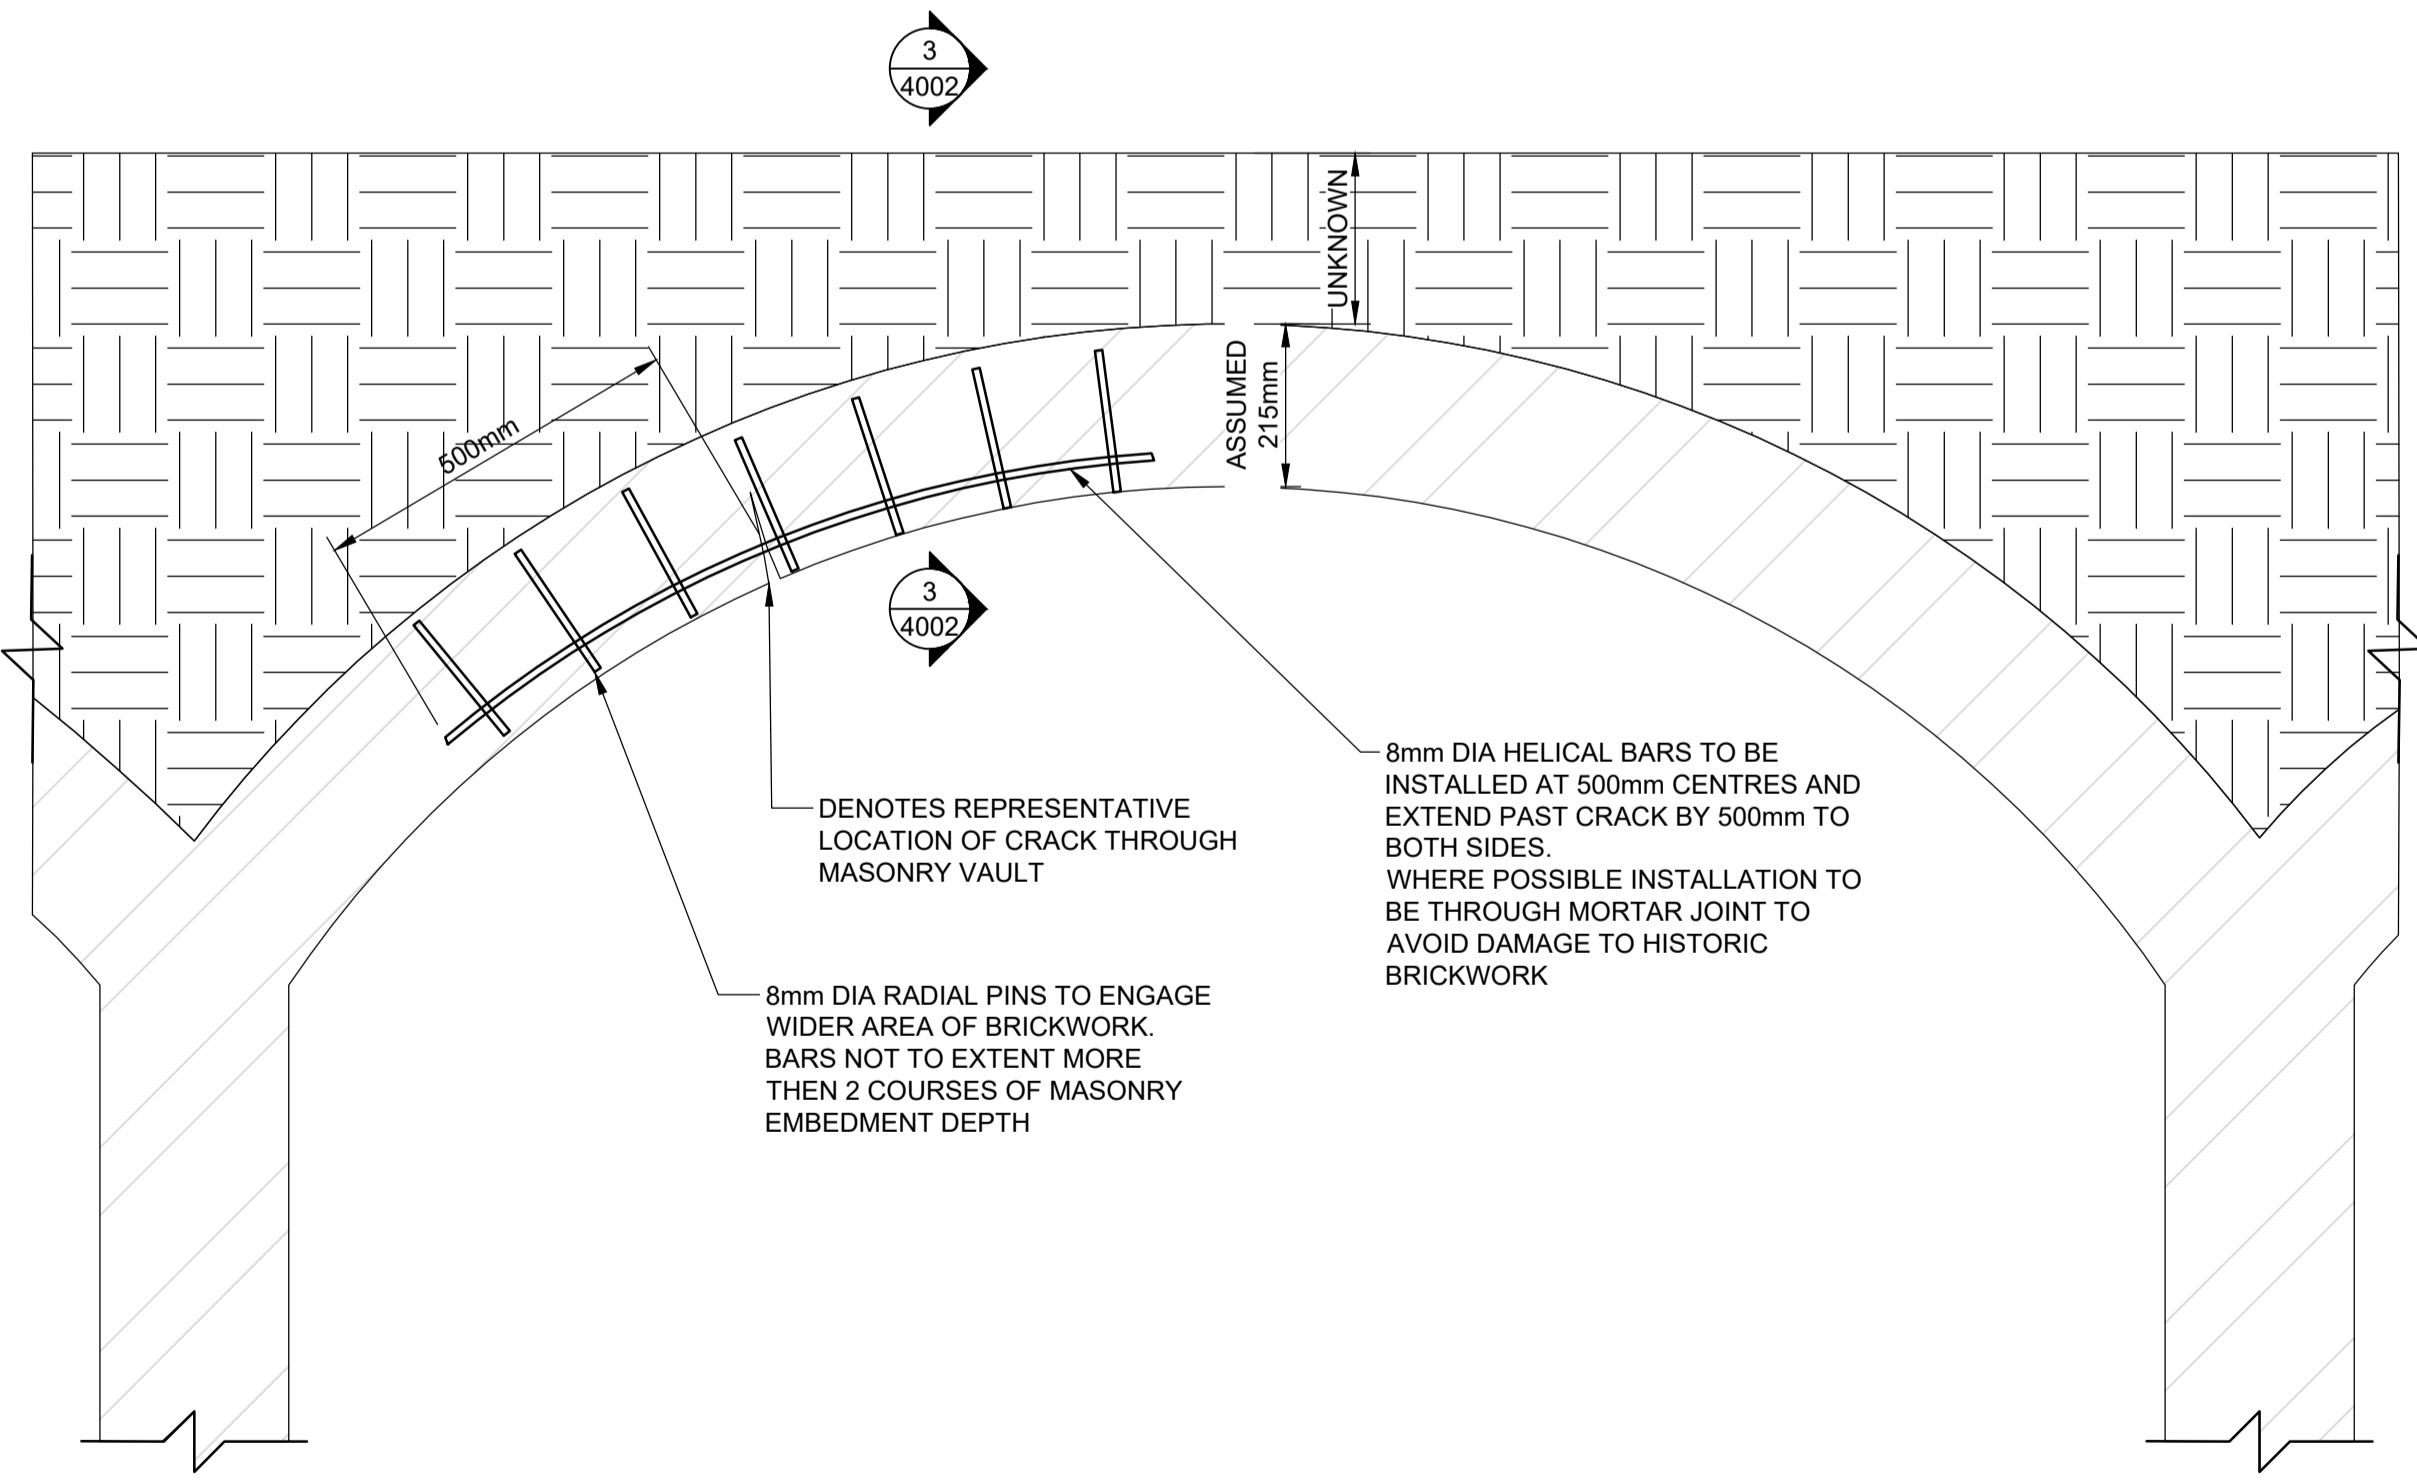
SECTION B - INNER CIRCLE OF LEBANON - CRACK STITCHING TO MASONRY VAULTS
scale 1:10@A1

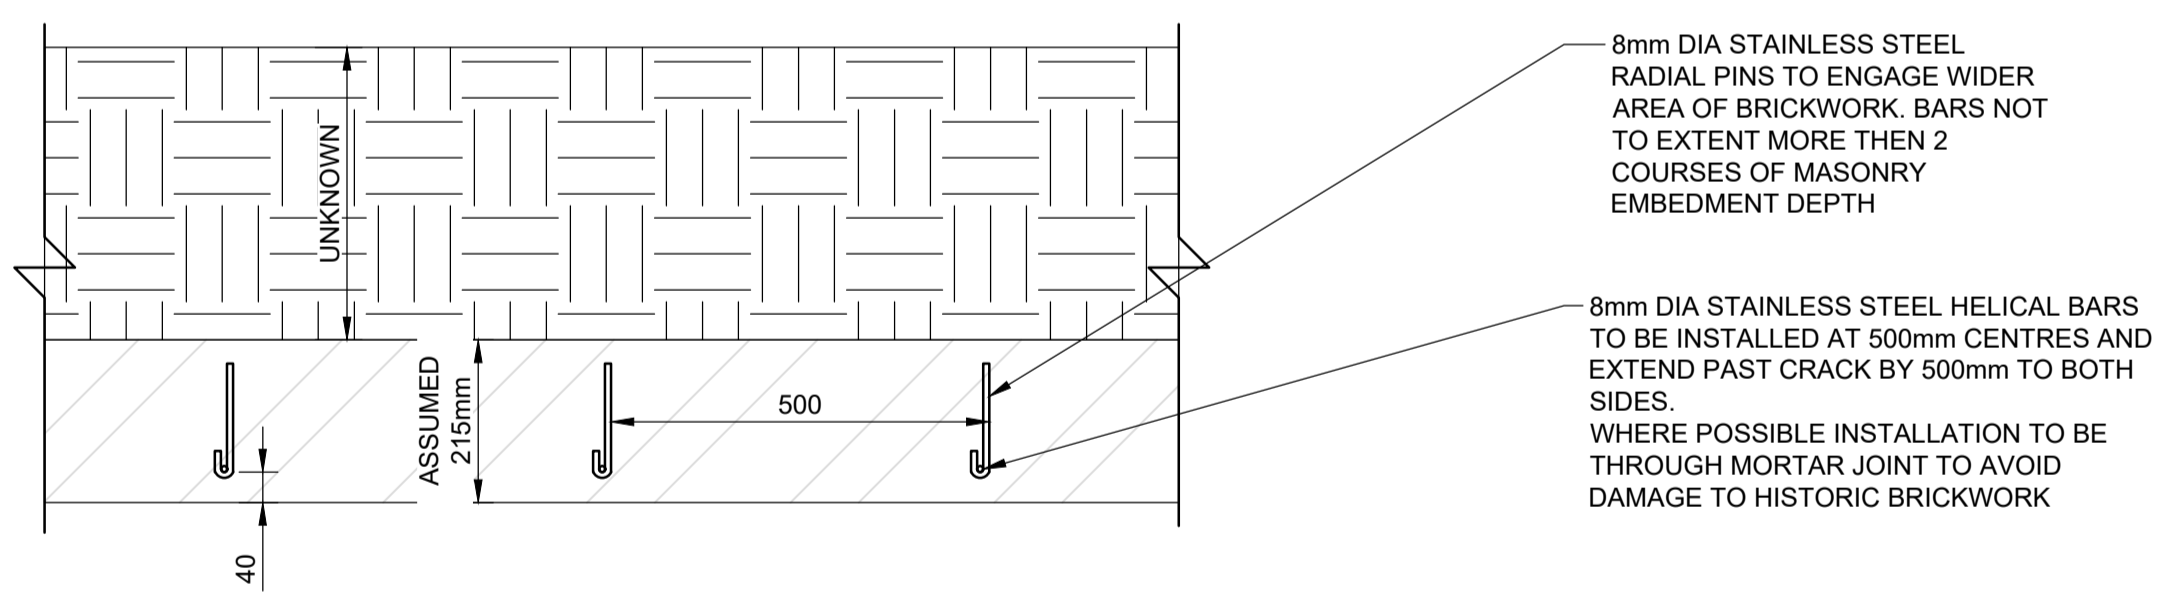
DETAIL 3 - INNER CIRCLE OF LEBANON - CRACK STITCHING TO MASONRY VAULTS
scale 1:10@A1

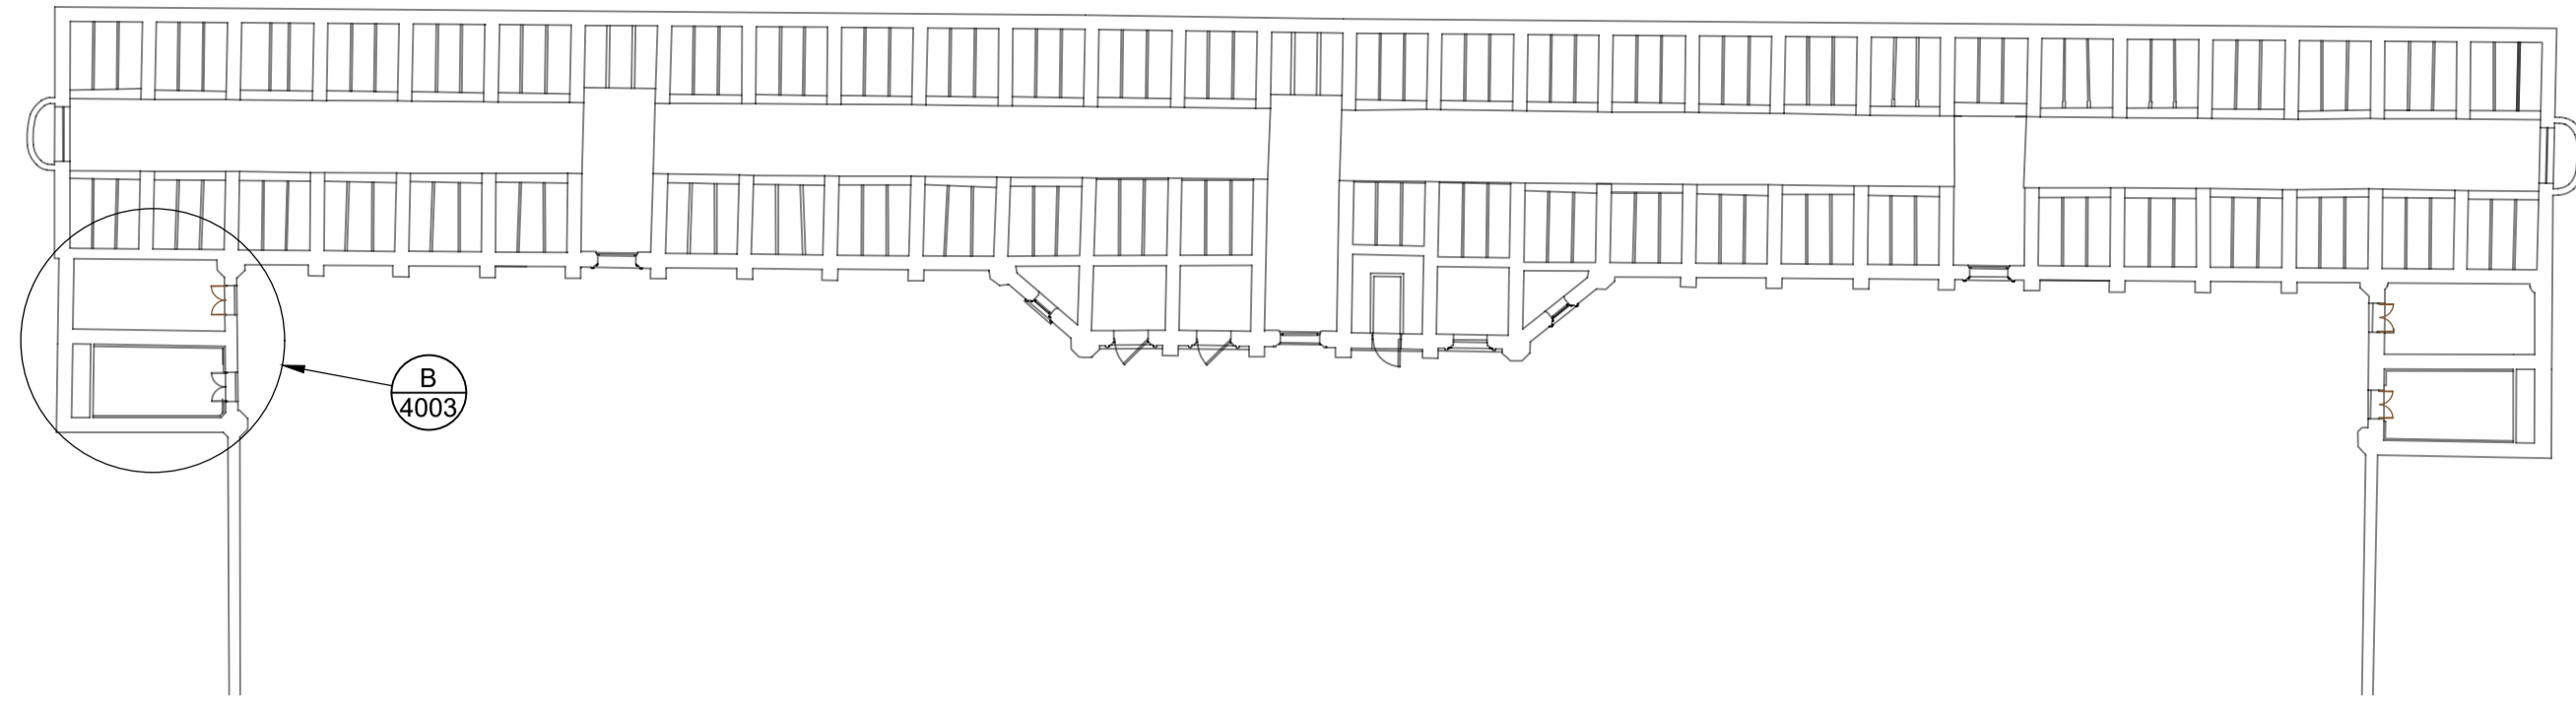
KEY PLAN SHOWING COMMON VAULT LOCATION - CATACOMBS TERRACE
scale 1:250@A1

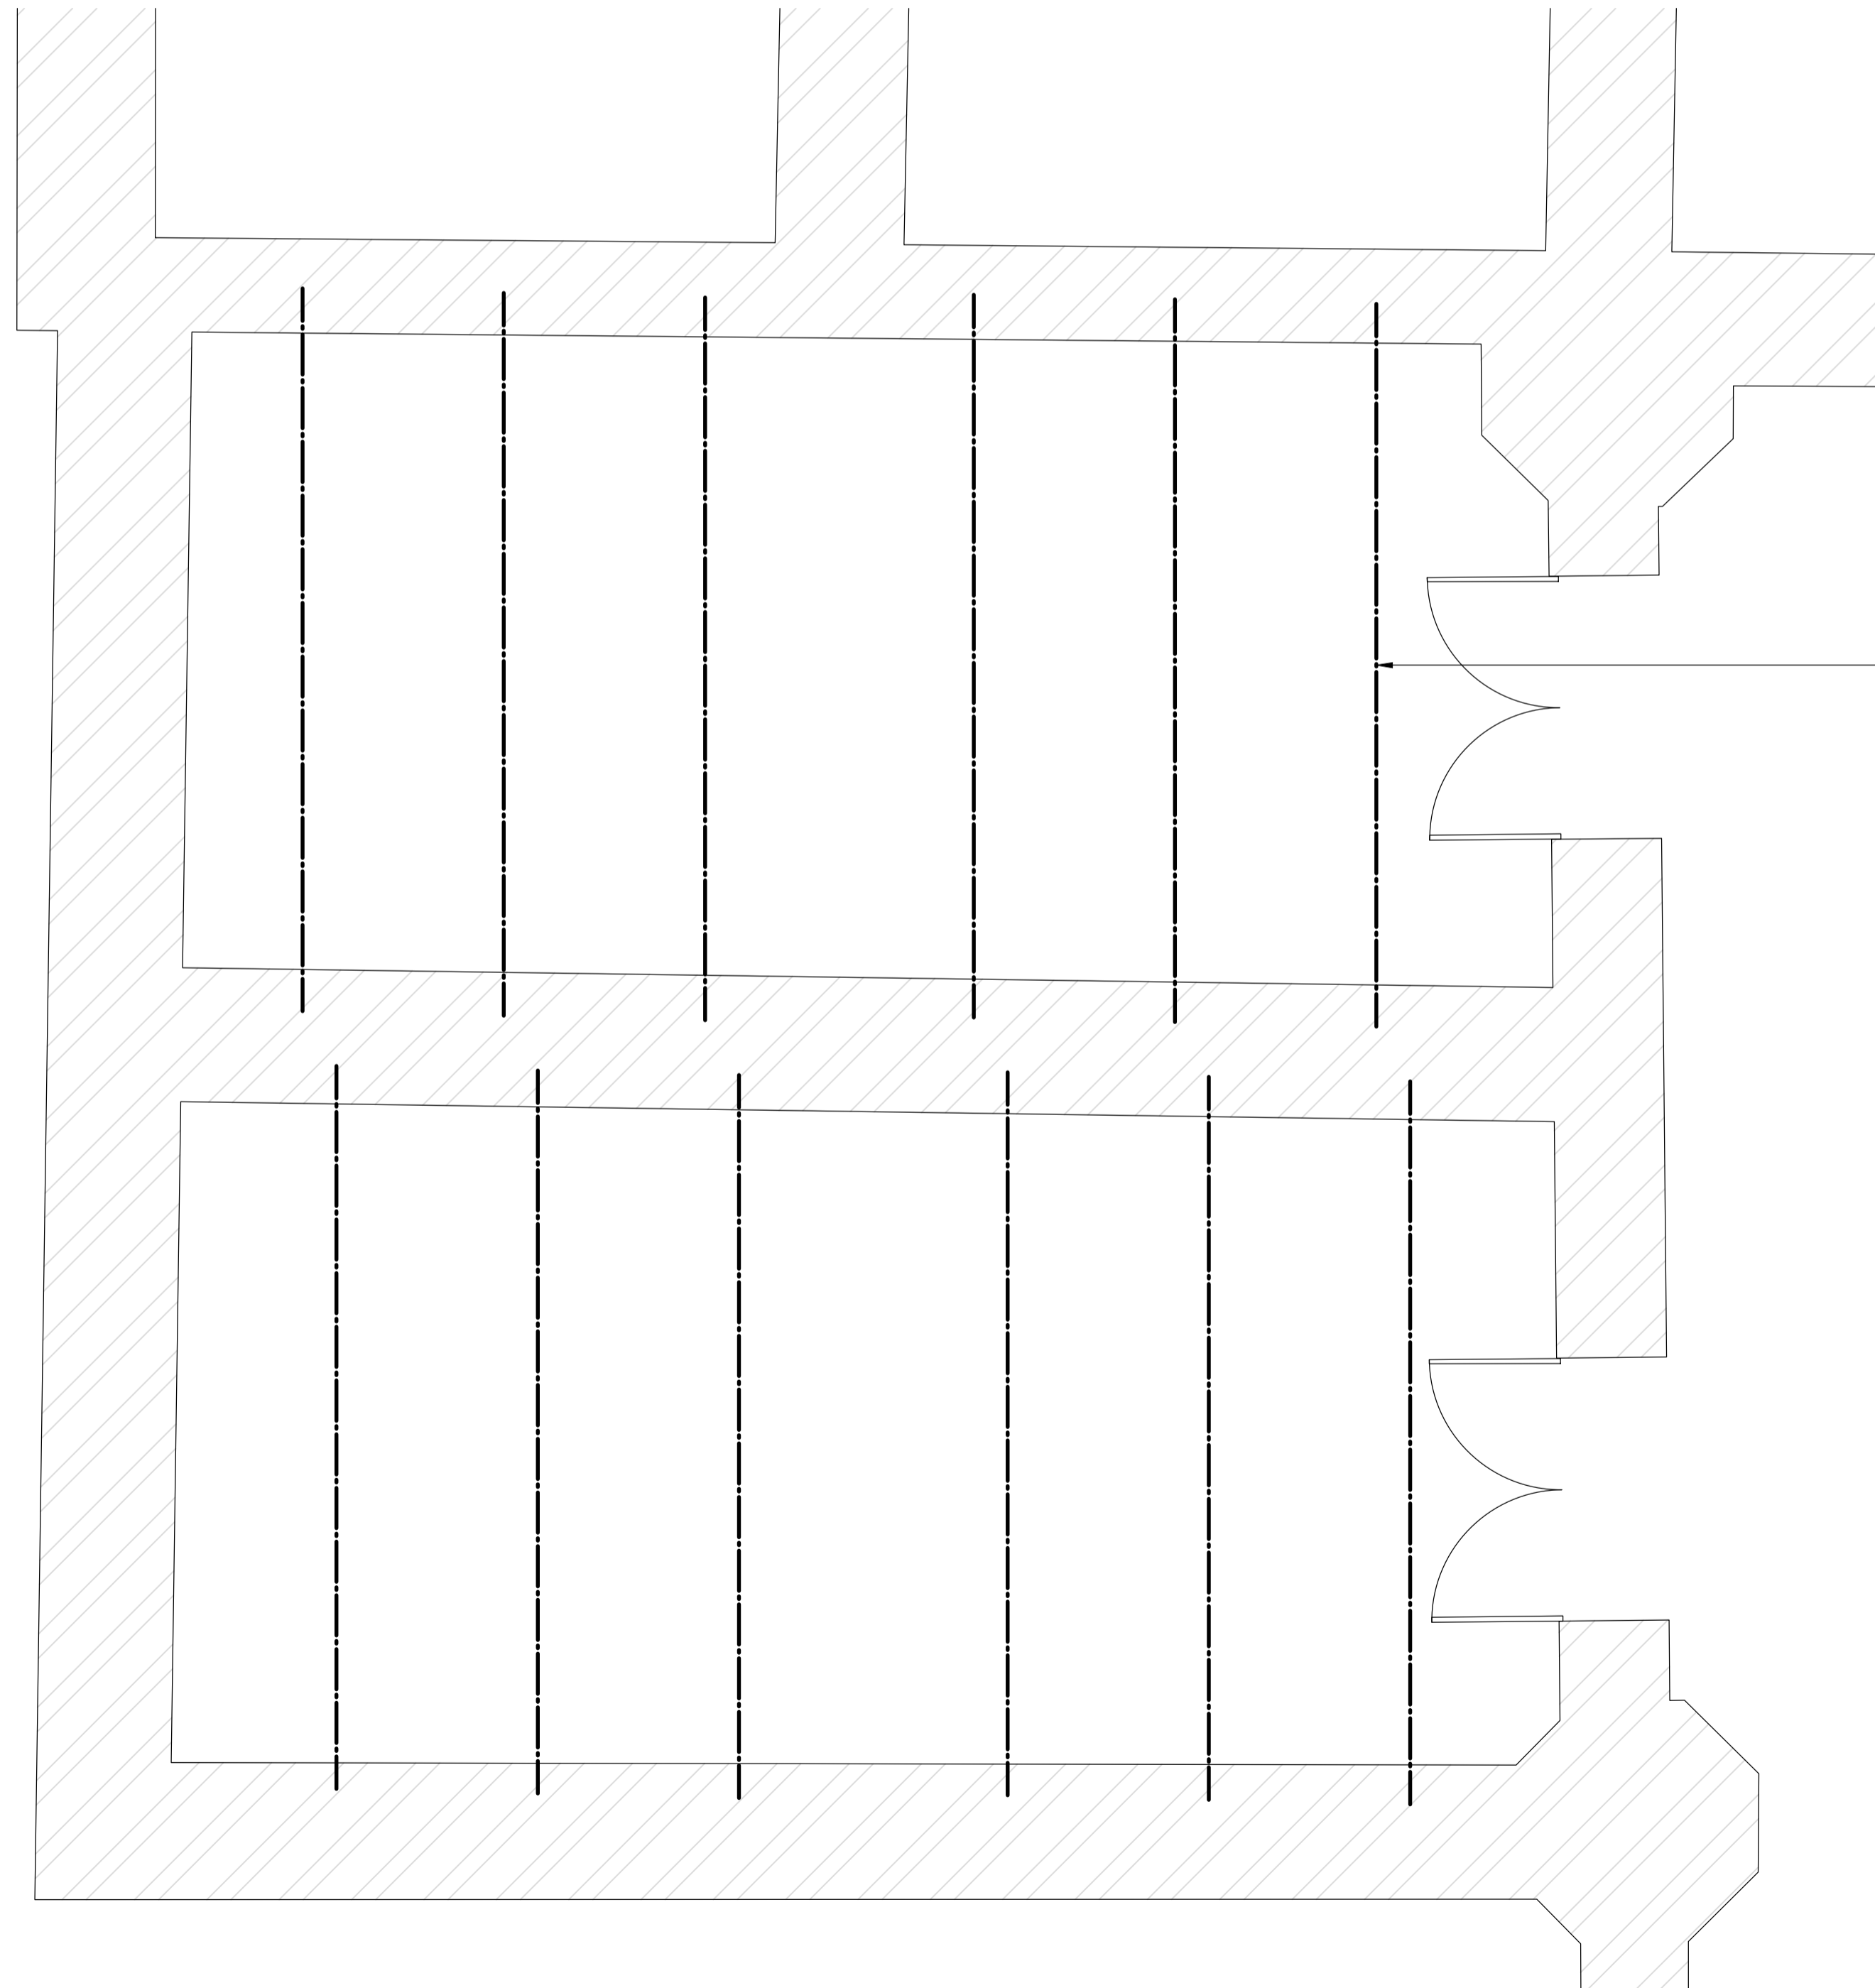
EXISTING IRON T'S SHOWING SIGNS OF CORROSION. COMMON VAULTS TO BE CLEARED FOR MORE DETAILED CONDITION INSPECTION. EXISTING T'S ALSO DON'T PROVIDE ENOUGH BEARING AREA FOR COFFINS. 2 POSSIBLE OPTIONS FOR REPAIR:
