Project Name: Highgate Cemetery

Project Date: 06/03/2024

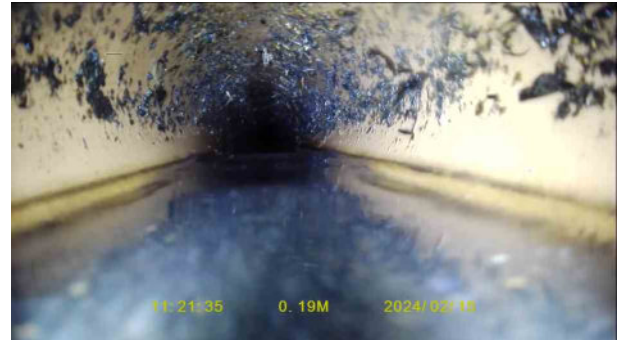
0a57784d-e58e-4407-8287-cf7a23f7a03b.jpg, 00:00:18, 0.19
m
Settled deposits, fine, 20% cross-sectional area loss, start

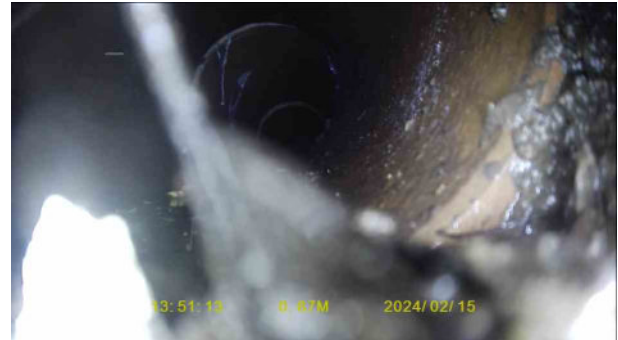
afcd81bb-6da3-4ec1-b5c4-cda859859e55.jpg, 00:00:23, 0.67 m
Joint displaced, large

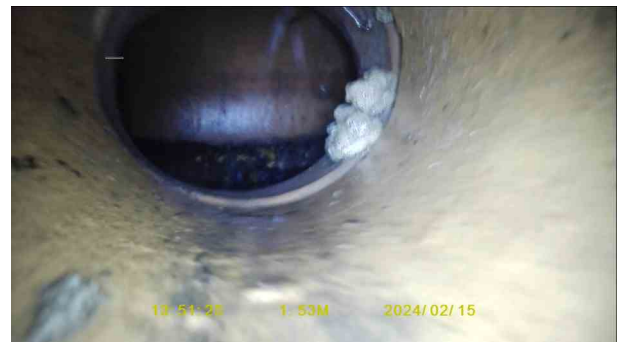
f1f2450b-46f3-4ac6-8aa2-235a2dc617f9.jpg, 00:00:34, 1.53 m
Attached deposits, encrustation at joint from 3 o'clock to 4 o'clock, 15% cross-sectional area loss

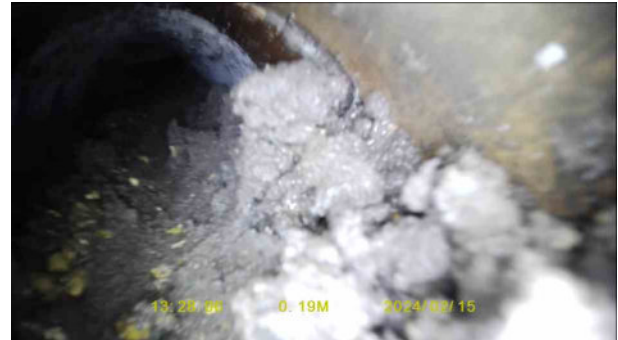
397b982f-a76e-453f-83c7-2e7946c7e29a.jpg, 00:00:01, 0.01
m
Broken pipe at joint from 8 o'clock to 11 o'clock

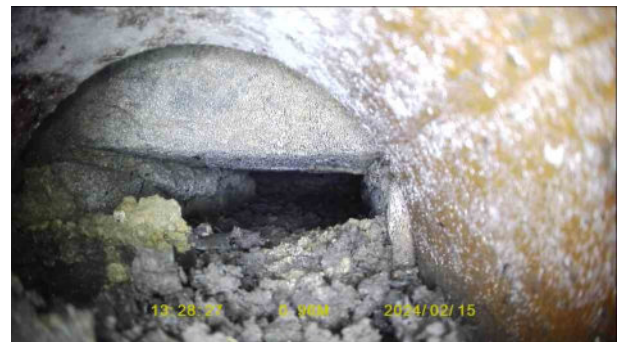
506d008a-a4ca-4920-9f11-68f6314c14b6.jpg, 00:00:21, 0.29
m
Joint displaced, medium

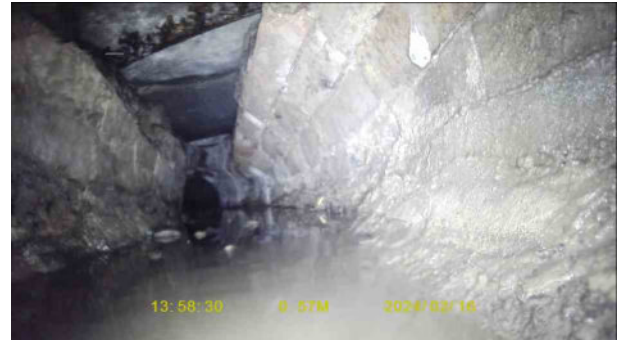
fe6ca740-4cf9-47e2-9136-ef9903ed7e3e.jpg, 00:00:09, 0.01
m
Hole in drain or sewer from 10 o'clock to 2 o'clock, start

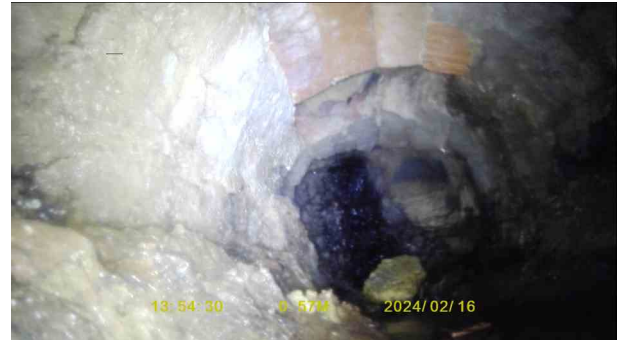
4ef6300e-2f9d-4306-95ef-b6cd0994d147.jpg, 00:00:14, 0.41
m
Broken pipe from 8 o'clock to 9 o'clock, start

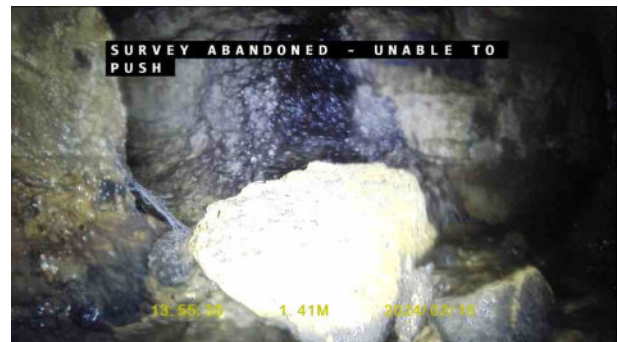
0231ad88-5588-41bb-b1e0-f9aa52024e8c.jpg, 00:01:04, 1.41
m
Settled deposits, coarse, 30% cross-sectional area loss

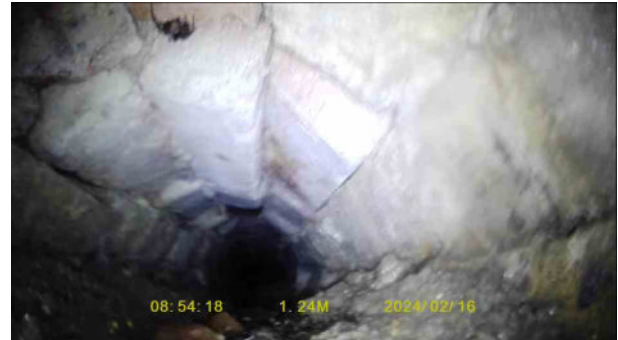
84b0b716-2f8d-4276-9b3f-552035c7ef7e.jpg, 00:00:19, 1.15 m
Settled deposits, coarse, 20% cross-sectional area loss, start

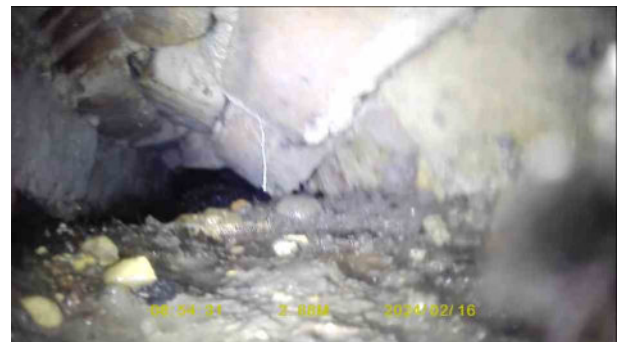
e31a2e52-a6f1-4f0a-b689-c60b44c4b2d1.jpg, 00:00:44, 2.69 m
Settled deposits, coarse, 40% cross-sectional area loss,

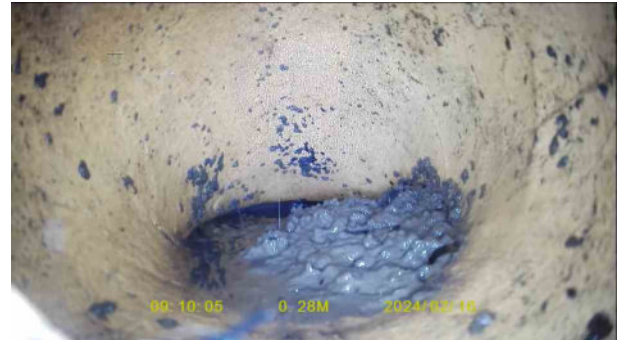
8f0bf5e6-2d78-4aa6-8b3c-8a2c8bcc296.jpg, 00:00:20, 0.19
m
Joint displaced, medium

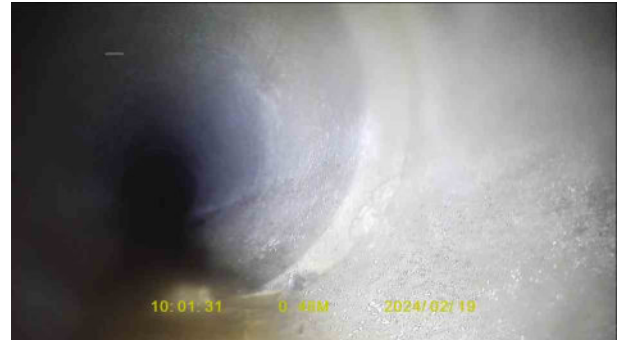
665fee94-ec28-4250-ae46-7b492f39d699.jpg, 00:00:39, 0.28
m
Joint displaced, medium

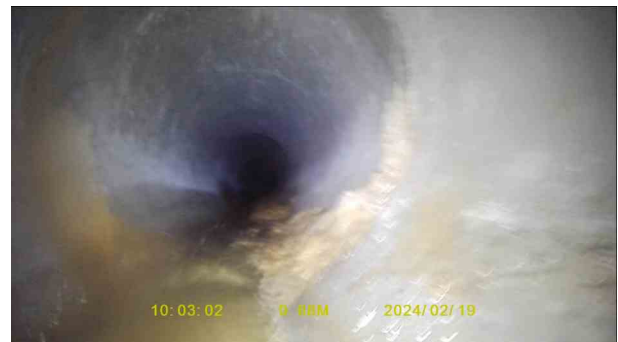
40adf8c3-9121-4654-9bc3-ba28ca5e23bb.jpg, 00:02:26, 8.28
m
Attached deposits, encrustation at joint from 12 o'clock to 5

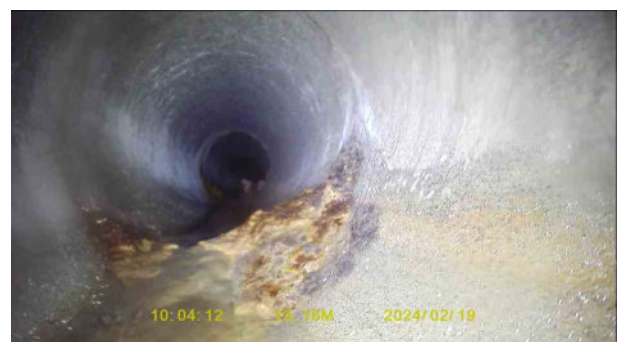
4af5cef2-5db1-4131-aa13-0ebe6428aa7f.jpg, 00:02:43, 10.00
m
Attached deposits, encrustation from 3 o'clock to 6 o'clock,

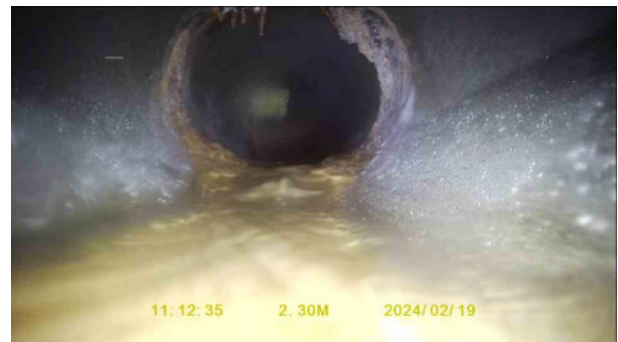
32e4f982-7d43-48bf-8c44-f932a7952cc4.jpg, 00:00:41, 2.30 m
Attached deposits, encrustation at joint from 12 o'clock to 12
o'clock, 15% cross-sectional area loss

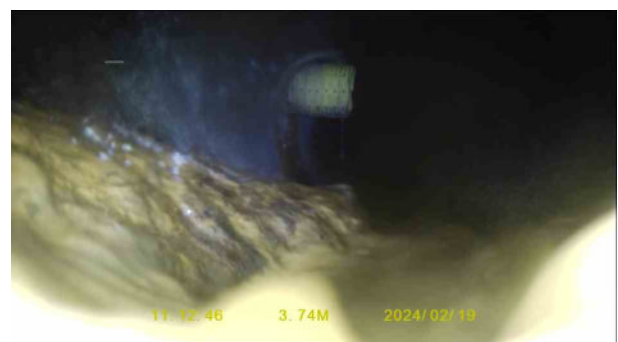
25429ab5-a586-4df5-9b40-2c0439df4630.jpg, 00:00:53, 3.74
m
Connection defective, connecting pipe is intruding at 10

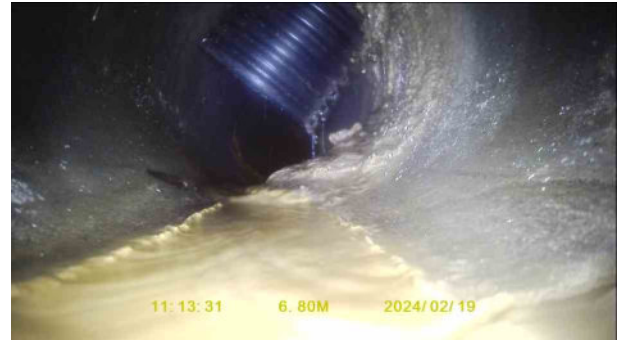
9fe7f2ed-5c9a-4730-af14-163464b89487.jpg, 00:01:37, 6.80
m
Connection defective, connecting pipe is intruding at 1 o'clock,

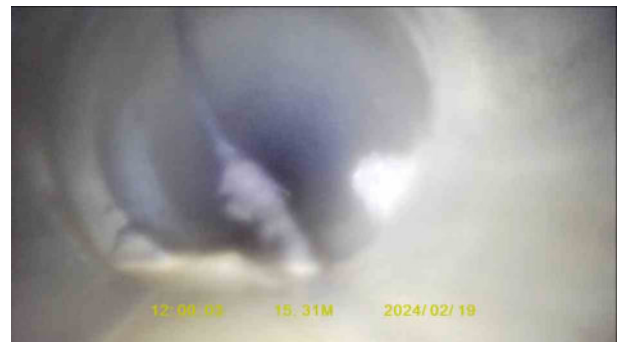
5bc5e9c3-7372-459e-bec9-e99023f639ba.jpg, 00:01:44, 15.51 m
Joint displaced, large

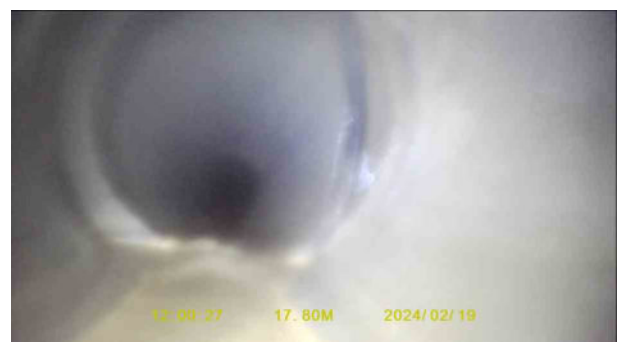
077590d8-4c9b-4e1f-9992-55e9dadfdb62.jpg, 00:02:08, 17.89 m
Joint displaced, large

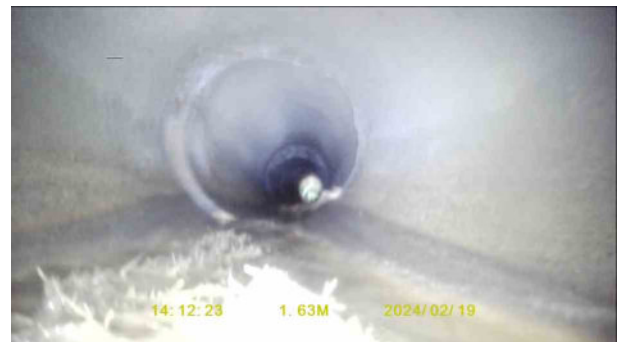
979dab86-6af4-43fd-83df-ea5f15483789.jpg, 00:00:39, 1.63 m
Joint displaced, large

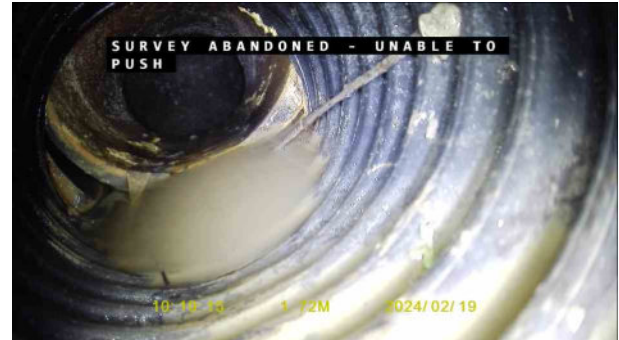
46a9c229-a384-4b90-8825-e392ff907ccf.jpg, 00:01:00, 1.72 m
Joint displaced, large

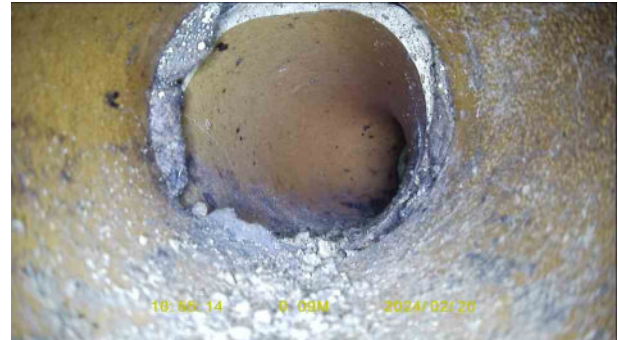
e02efbb9-b02d-404c-88dc-d7230a88ceff.jpg, 00:00:13, 0.09 m
Broken pipe at joint from 9 o'clock to 4 o'clock
