## Completed section inspection

Town or Village:	Highgate	Inspection Direction:	Downstream	Upstream Node:	MH11
Road:	Swains Lane	Inspected Length:	3.07 m	Upstream Pipe Depth:	0.570 m
Location:		Total Length:	3.07 m	Downstream Node:	MH13
Surface Type:		Joint Length:		Downstream Pipe Depth:	
Use:	Surface water	Pipe Shape:	Circular		
Type of Pipe:		Dia/Height:	100 mm		
Flow Control:		Material:	Polyvinyl chloride		
Year Constructed:	Not Specified	Lining Type:	No Lining		
Inspection Purpose:		Lining Material:	No Lining		
Comments:					
Recommendations: Recommend HPWJ

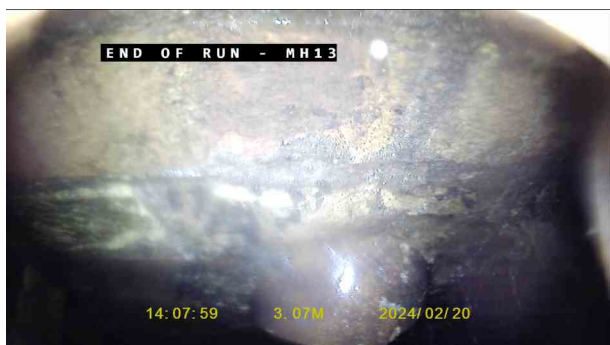
a47afae3-2461-41d6-b149-4bb0abc09f31.jpg, 00:01:11, 3.07  
m  
Finish node, manhole, reference: MH13

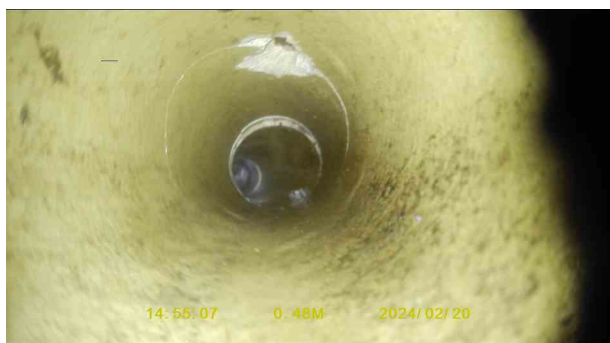
56610fad-0b29-408b-b8e4-c71cc1973af7.jpg, 00:00:17, 0.48  
m  
Crack, circumferential from 8 o'clock to 3 o'clock

Town or Village:	Highgate	Inspection Direction:	Upstream	Upstream Node:	BRANCH A
Road:	Swains Lane	Inspected Length:	1.34 m	Upstream Pipe Depth:	
Location:		Total Length:	1.34 m	Downstream Node:	MH14
Surface Type:		Joint Length:		Downstream Pipe Depth:	0.680 m
Use:	Surface water	Pipe Shape:	Circular		
Type of Pipe:		Dia/Height:	100 mm		
Flow Control:		Material:	Vitrified clay		
Year Constructed:	Not Specified	Lining Type:	No Lining		
Inspection Purpose:		Lining Material:	No Lining		
Comments:					
Recommendations:	Recommend Picote/2XLSR's

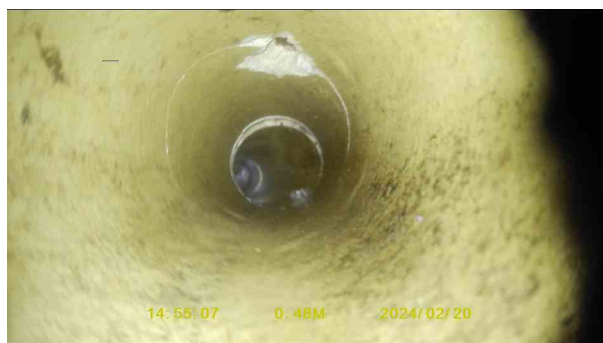
14c3398a-5bdd-49f0-861f-f12273c32275.jpg, 00:00:17, 0.48  
m  
Hole in drain or sewer from 12 o'clock to 1 o'clock

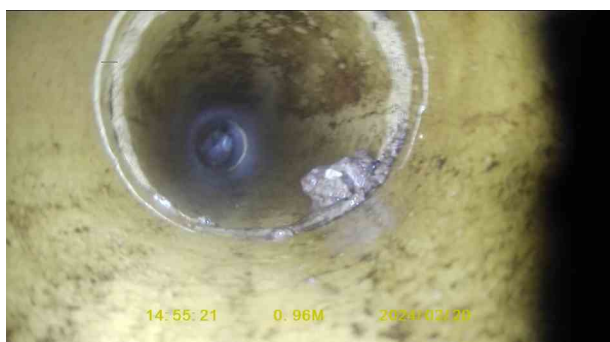
13642834-7cb8-4aee-88aa-db777bf3f6f5.jpg, 00:00:30, 0.96  
m  
Fracture, circumferential at joint from 7 o'clock to 4 o'clock

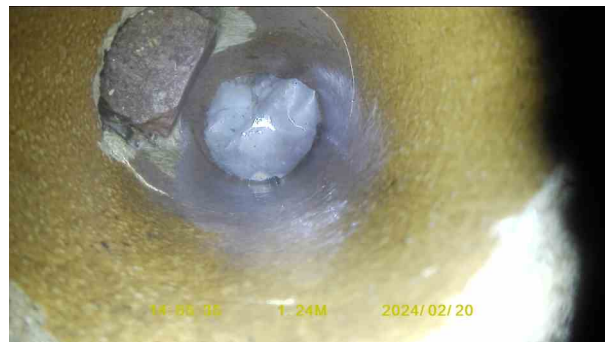
b9f3094d-c5e4-45d2-978c-aa296296d0ac.jpg, 00:00:45, 1.24 m  
Crack, circumferential from 12 o'clock to 3 o'clock

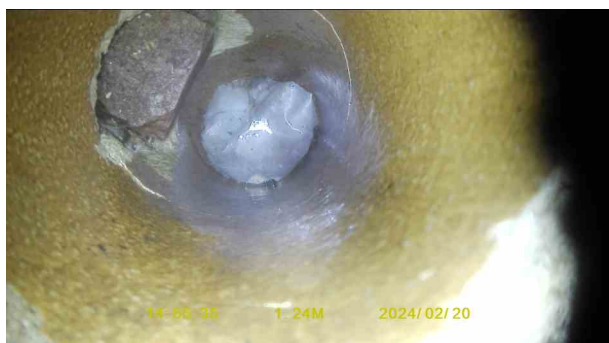
f605058b-0125-4a6f-a3c6-09ad687fb065.jpg, 00:00:45, 1.24 m  
Hole in drain or sewer from 8 o'clock to 12 o'clock

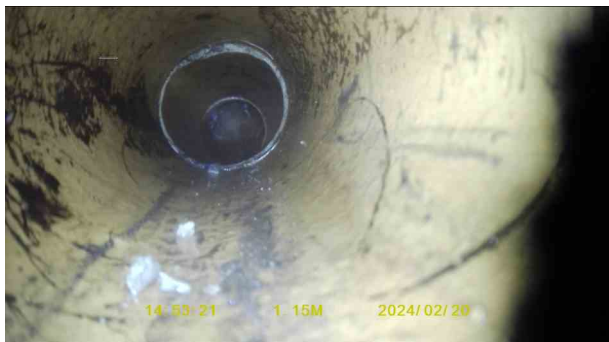
3228861e-72b9-4d30-991e-1a130143f395.jpg, 00:00:21, 1.24  
m  
Broken pipe at joint from 10 o'clock to 2 o'clock

Town or Village:	Highgate	Inspection Direction:	Upstream	Upstream Node:	BRANCH B
Road:	Swains Lane	Inspected Length:	2.11 m	Upstream Pipe Depth:	
Location:		Total Length:	2.11 m	Downstream Node:	MH14
Surface Type:		Joint Length:		Downstream Pipe Depth:	0.680 m
Use:	Surface water	Pipe Shape:	Circular		
Type of Pipe:		Dia/Height:	100 mm		
Flow Control:		Material:	Vitrified clay		
Year Constructed:	Not Specified	Lining Type:	No Lining		
Inspection Purpose:		Lining Material:	No Lining		
Comments:					
Recommendations:	Recommend LSR

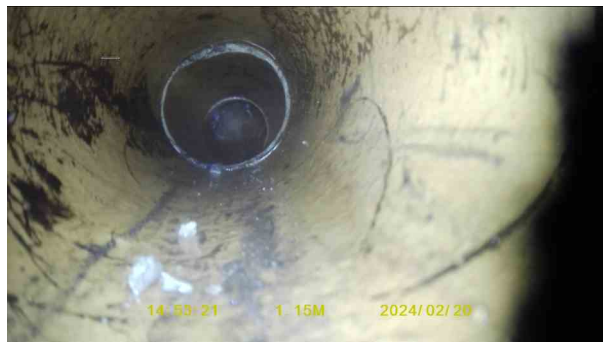
68a53500-c64f-4f04-ad8f-55b714a53d05.jpg, 00:00:21, 1.24  
m  
Fracture, circumferential at joint from 12 o'clock to 6 o'clock

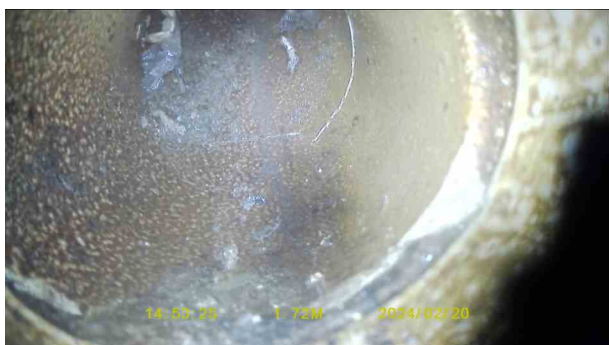
8c6600a3-79e4-415c-8466-92a3d7a63583.jpg, 00:00:24, 1.72  
m  
Fracture, circumferential from 2 o'clock to 6 o'clock, In Rest

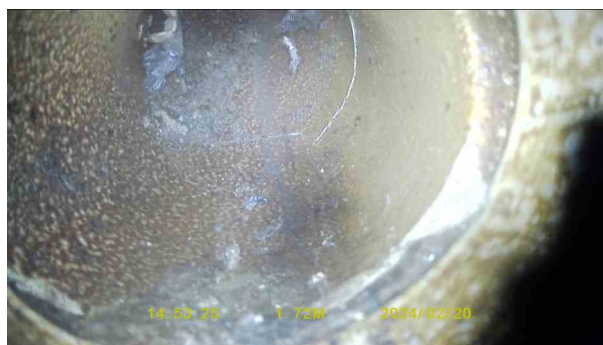
bf2f9e8d-0c9c-493f-a354-865791b645ab.jpg, 00:00:24, 1.72  
m  
Joint displaced, medium, At Rest bend

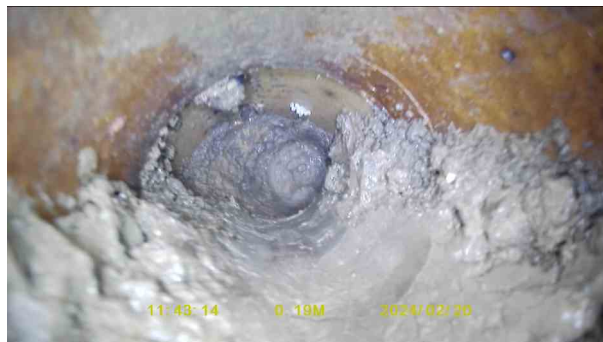
b482562e-aadc-44c9-9627-b559e6baef05.jpg, 00:00:25, 0.19  
m  
Crack, circumferential at joint from 12 o'clock to 3 o'clock

Town or Village:	Highgate	Inspection Direction:	Upstream	Upstream Node:	UPSTREAM
Road:	Swains Lane	Inspected Length:	0.38 m	Upstream Pipe Depth:	
Location:		Total Length:	0.38 m	Downstream Node:	RWG32
Surface Type:		Joint Length:		Downstream Pipe Depth:	
Use:	Surface water	Pipe Shape:	Circular		
Type of Pipe:		Dia/Height:	100 mm		
Flow Control:		Material:	Vitrified clay		
Year Constructed:	Not Specified	Lining Type:	No Lining		
Inspection Purpose:		Lining Material:	No Lining		
Comments:					
Recommendations: Recommend HPWJ/LSR/Resurvey

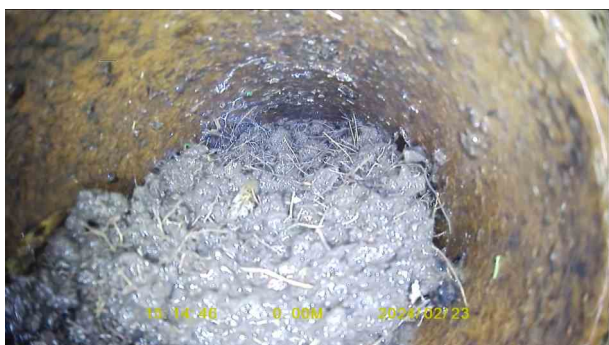
71eb3025-57c9-4381-b2e4-7fcef2da41a.jpg, 00:00:20, 0.01  
m  
Survey abandoned, Camera unable to pass mass

Town or Village:	Highgate	Inspection Direction:	Upstream	Upstream Node:	BRANCH A
Road:	Swains Lane	Inspected Length:	0.01 m	Upstream Pipe Depth:	
Location:		Total Length:	0.01 m	Downstream Node:	RWG53
Surface Type:		Joint Length:		Downstream Pipe Depth:	
Use:	Surface water	Pipe Shape:	Circular		
Type of Pipe:		Dia/Height:	100 mm		
Flow Control:		Material:	Vitrified clay		
Year Constructed:	Not Specified	Lining Type:	No Lining		
Inspection Purpose:		Lining Material:	No Lining		
Comments:					
Recommendations: Recommend Root cut/LSR/Further investigation

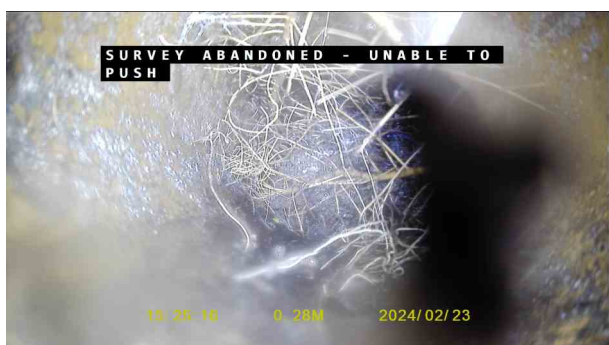
109917c3-37bb-4af2-9d07-aedc3303c8ab.jpg, 00:00:31, 0.28  
m  
Survey abandoned, Camera unable to pass mass roots

**Recommendations:** Recommend Root cut/Resurvey

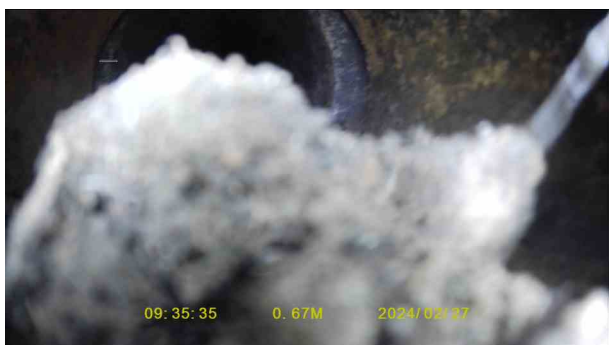
13be3794-4a3c-42f9-94ab-2c411595c588.jpg, 00:00:22, 0.67  
m  
Joint displaced, large

Town or Village:	Highgate	Inspection Direction:	Downstream	Upstream Node:	RWG58
Road:	Swains Lane	Inspected Length:	2.01 m	Upstream Pipe Depth:	
Location:		Total Length:	2.01 m	Downstream Node:	DOWNSTREAM
Surface Type:		Joint Length:		Downstream Pipe Depth:	
Use:	Surface water	Pipe Shape:	Circular		
Type of Pipe:		Dia/Height:	100 mm		
Flow Control:		Material:	Vitrified clay		
Year Constructed:	Not Specified	Lining Type:	No Lining		
Inspection Purpose:		Lining Material:	No Lining		
Comments:					
Recommendations: Recommend HPWJ/Relining/Possible excavation/Resurvey

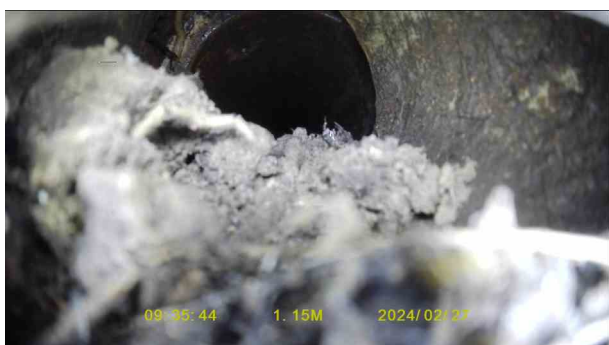
5fc00722-53eb-46b7-a6a4-6f525ee4e3e9.jpg, 00:00:30, 1.15  
m  
Joint displaced, large

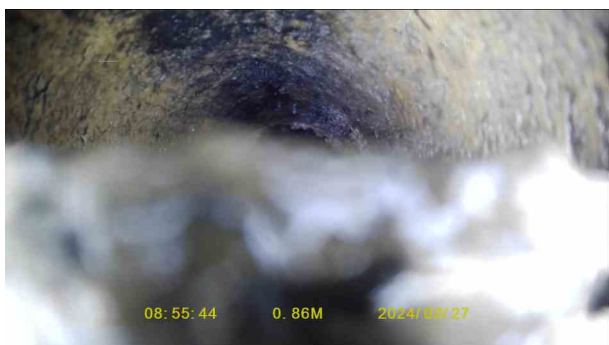
f2d62bf4-19ff-4ca9-a24b-e97f0c05f77f.jpg, 00:00:27, 0.86 m  
Settled deposits, fine, 60% cross-sectional area loss, start

**Recommendations:** Recommend HPWJ/Root cut/Relining/Investigate possible bellies/Resurvey

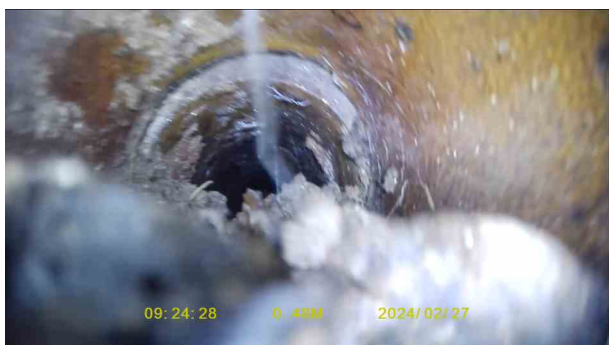
8f6fcdb9-4400-49c7-a77a-26d86cdce044.jpg, 00:00:17, 0.48 m  
Settled deposits, fine, 45% cross-sectional area loss, change

Town or Village:	Highgate	Inspection Direction:	Downstream	Upstream Node:	RWG57
Road:	Swains Lane	Inspected Length:	1.05 m	Upstream Pipe Depth:	
Location:		Total Length:	1.05 m	Downstream Node:	DOWNSTREAM
Surface Type:		Joint Length:		Downstream Pipe Depth:	
Use:	Surface water	Pipe Shape:	Circular		
Type of Pipe:		Dia/Height:	100 mm		
Flow Control:		Material:	Vitrified clay		
Year Constructed:	Not Specified	Lining Type:	No Lining		
Inspection Purpose:		Lining Material:	No Lining		
Comments:					
Recommendations:	Recommend HPWJ/LSR/Resurvey

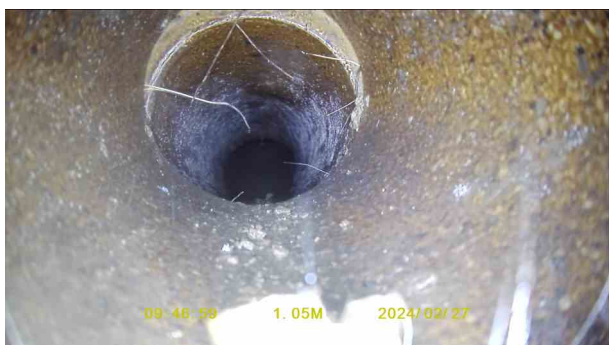
7d1c609c-6dcd-4a59-b297-f576f69144cf.jpg, 00:00:32, 1.15 m  
Roots, fine at joint

Town or Village:	Highgate	Inspection Direction:	Downstream	Upstream Node:	RWG59
Road:	Swains Lane	Inspected Length:	1.82 m	Upstream Pipe Depth:	
Location:		Total Length:	1.82 m	Downstream Node:	DOWNSTREAM
Surface Type:		Joint Length:		Downstream Pipe Depth:	
Use:	Surface water	Pipe Shape:	Circular		
Type of Pipe:		Dia/Height:	100 mm		
Flow Control:		Material:	Vitrified clay		
Year Constructed:	Not Specified	Lining Type:	No Lining		
Inspection Purpose:		Lining Material:	No Lining		
Comments:					
Recommendations:	Recommend root cut/HPWJ/2XLSR's/Investigate possible bellies/Resurvey

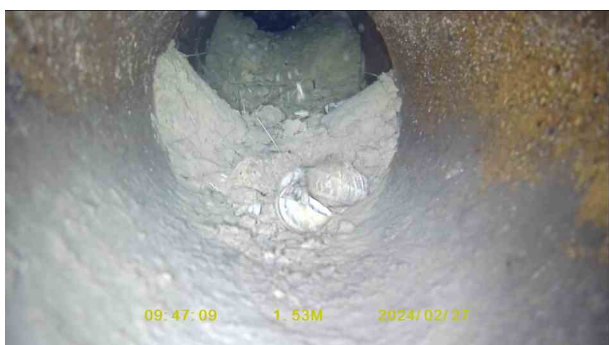
70b3a36a-1734-4176-afbb-6e84314141d8.jpg, 00:00:42, 1.53  
m  
Water level, 100% of the vertical dimension

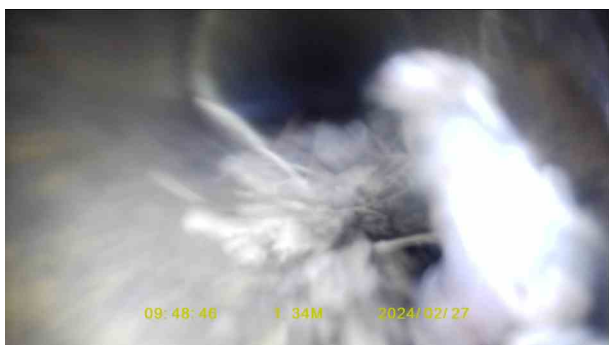
4ea99f23-bac5-42f2-9322-835a3e4b6740.jpg, 00:00:26, 1.34 m  
Roots, fine at joint

Town or Village:	Highgate	Inspection Direction:	Upstream	Upstream Node:	UPSTREAM
Road:	Swains Lane	Inspected Length:	2.01 m	Upstream Pipe Depth:	
Location:		Total Length:	2.01 m	Downstream Node:	RWG59
Surface Type:		Joint Length:		Downstream Pipe Depth:	
Use:	Surface water	Pipe Shape:	Circular		
Type of Pipe:		Dia/Height:	100 mm		
Flow Control:		Material:	Vitrified clay		
Year Constructed:	Not Specified	Lining Type:	No Lining		
Inspection Purpose:		Lining Material:	No Lining		
Comments:					
Recommendations:	Recommend Root cut/Relining/Possible excavation/Resurvey

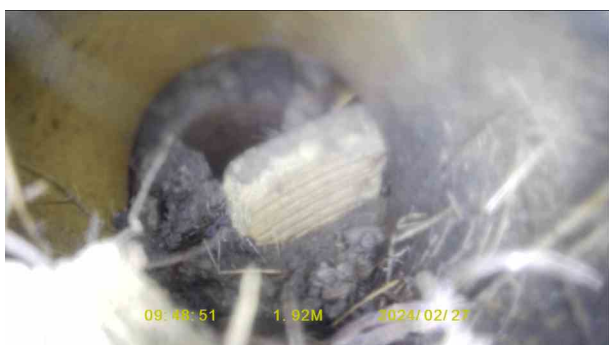
dbfd739f-4c9a-4591-864d-0acc2a40ff49.jpg, 00:00:32, 1.92 m  
Joint displaced, large

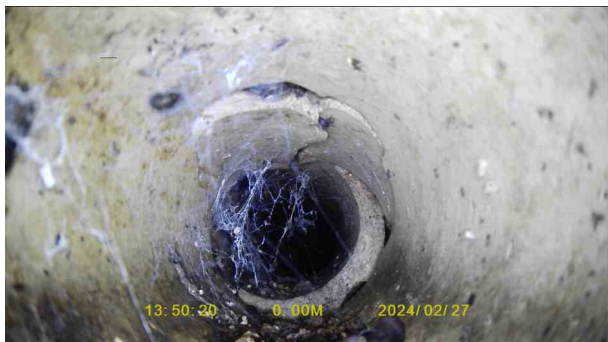
a23b21ca-4fe4-4630-a8de-9b8184f37973.jpg, 00:00:09, 0.01  
m  
Broken pipe from 10 o'clock to 4 o'clock

**Recommendations:** Recommend LSR/Possible excavation

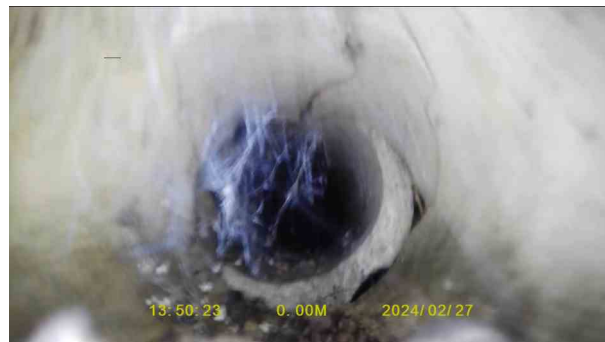
92024dd2-a8b9-4d84-8ba3-8be0c819b077.jpg, 00:00:12, 0.01  
m  
Broken pipe from 12 o'clock to 12 o'clock

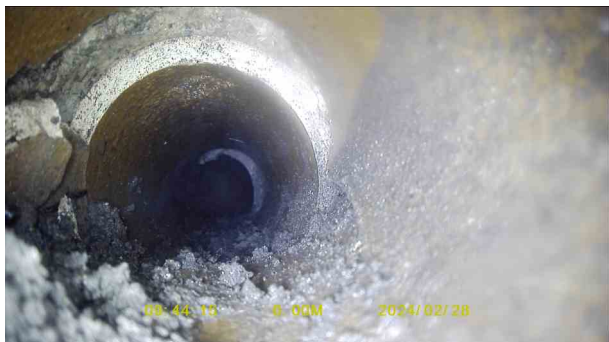
4a8f413a-cc03-46a9-92d0-e4acb1491967.jpg, 00:00:09, 0.01  
m  
Broken pipe from 8 o'clock to 3 o'clock

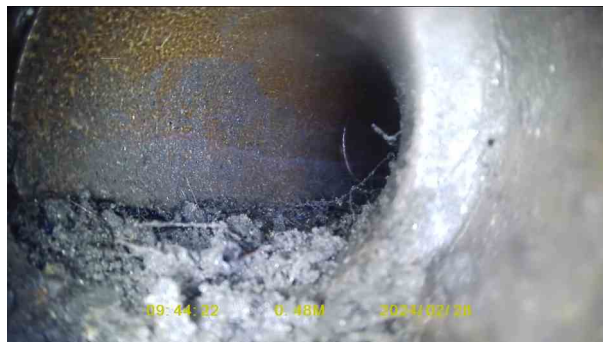
44d792b6-eefa-4f40-84b7-02f252e14b46.jpg, 00:00:16, 0.48  
m  
Joint displaced, large

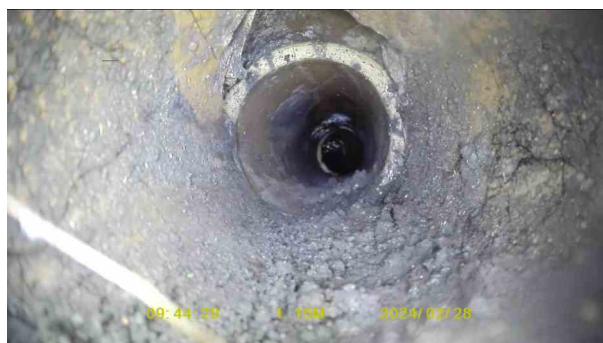
ad9bbb0e-e704-4fa8-9e06-0d4233ff08e1.jpg, 00:00:23, 1.15  
m  
Broken pipe from 10 o'clock to 2 o'clock

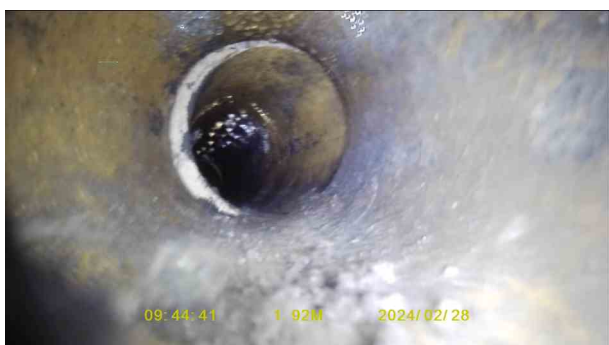
c9997a02-2eea-4949-9ba2-4ea5ffc0ecc9.jpg, 00:00:35, 1.92  
m  
Joint displaced, medium

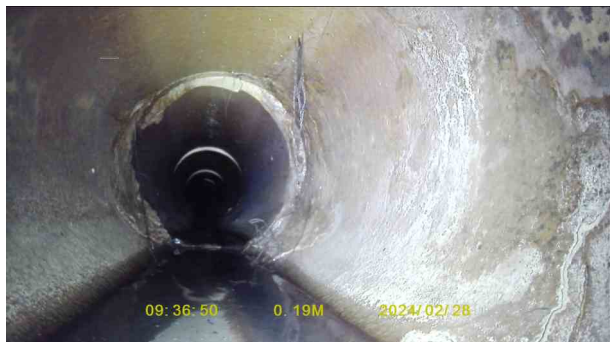
a05d4d2b-05ea-4f8a-a87e-ca702cdcea58.jpg, 00:00:12, 0.19 m  
Crack, circumferential from 1 o'clock to 6 o'clock

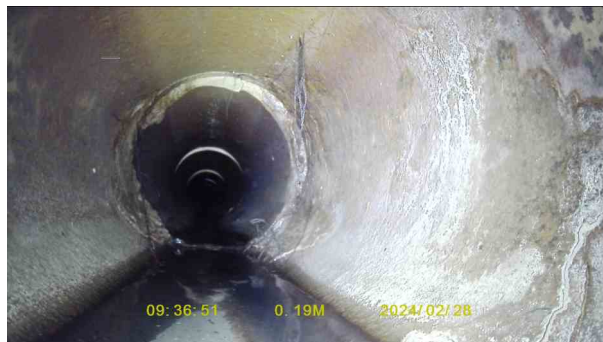
66e9acdb-f6cc-4229-983f-89ccea8f57cd.jpg, 00:00:12, 0.19 m  
Fracture, circumferential at joint from 12 o'clock to 12 o'clock

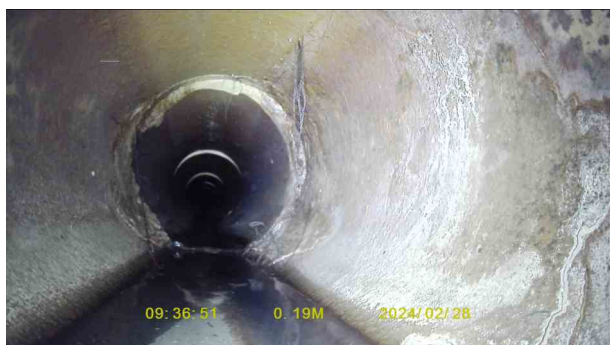
eac5d221-a645-4b00-abdd-63ef763cc8ca.jpg, 00:00:12, 0.19 m  
Broken pipe at joint from 12 o'clock to 12 o'clock

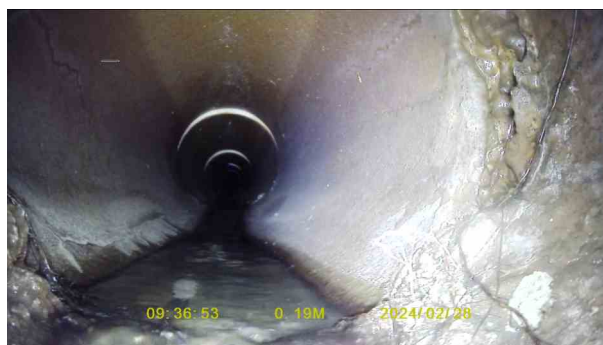
8a625499-afd1-44cf-a783-82c76817da85.jpg, 00:00:15, 0.19 m  
Roots, fine at joint

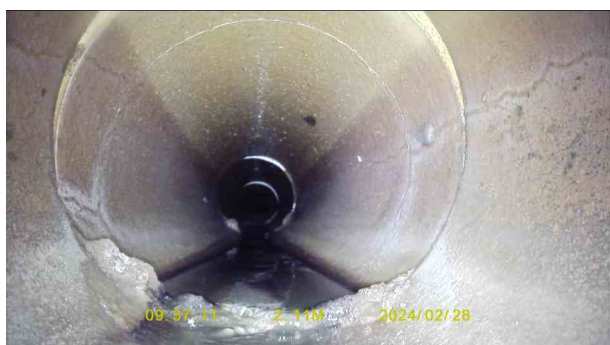
7d2cf0bc-76b2-4766-a352-9a3c8d94249f.jpg, 00:00:33, 2.11 m  
Crack, circumferential at joint from 8 o'clock to 3 o'clock

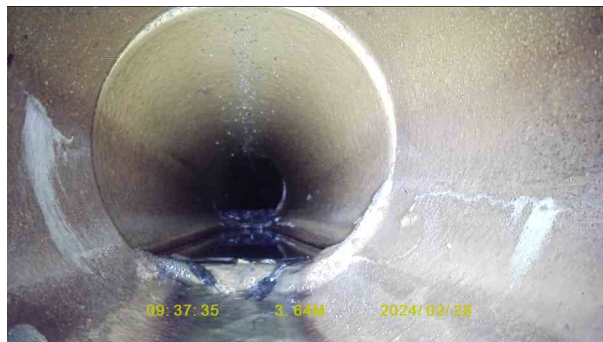
ebd01911-c836-4e43-8486-2d7c7b590947.jpg, 00:00:56, 3.63 m  
Crack, longitudinal at joint at 3 o'clock

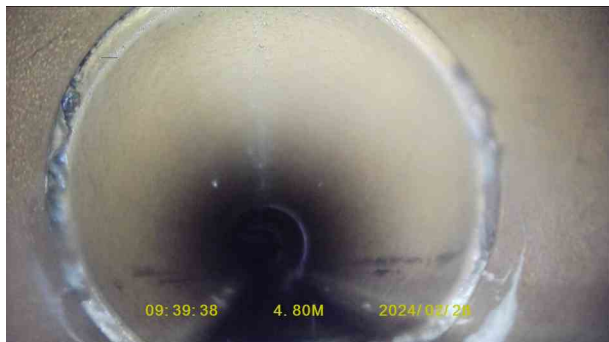
7328ea28-93b8-4f4c-a440-c1fadb94a412.jpg, 00:01:57, 4.80  
m  
Crack, circumferential at joint from 4 o'clock to 8 o'clock

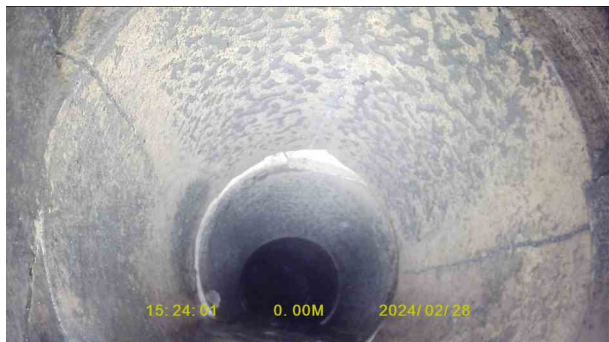
c5435cb3-f286-4d64-b0fc-d3581c1df6cc.jpg, 00:00:11, 0.01 m  
Fractures, multiple at joint from 12 o'clock to 12 o'clock

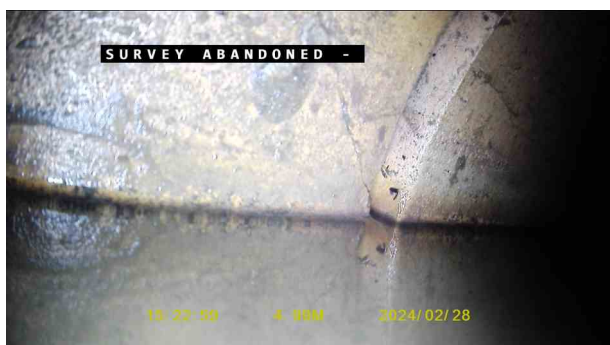
258a5039-6818-4d26-9350-7e27743fc4ad.jpg, 00:02:00, 4.99 m  
Fracture, circumferential from 7 o'clock to 9 o'clock

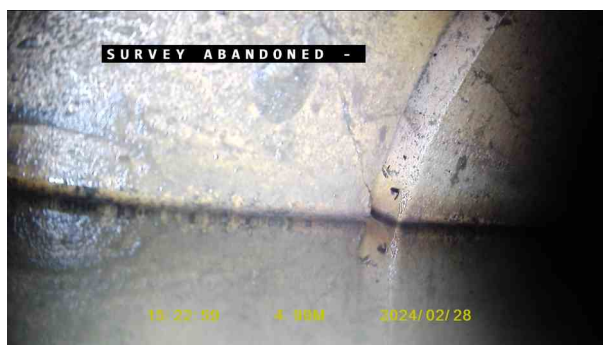
771b3f43-9f23-488c-9af6-9b8f4fbe956f.jpg, 00:02:00, 4.99 m  
Joint displaced, medium
