HIGHGATE CEMETERY: THE FUNERARY STRUCTURES, MAUSOLEA AND SUNDRY LISTED BUILDINGS RIBA STAGE 3 SCHEDULE OF WORKS

Issue Preliminary 5: October 2024. Includes changes to content, format and inclusions with regard to Schedule of Works

Building 3a: NORTH LODGE

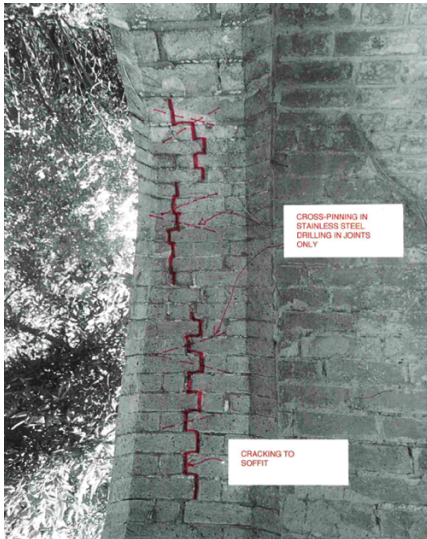
Delamination of arch soffits see item 2

1. Install helical bar repairs to stepped cracking either side of central steps as recommended by Conservation Engineer. Repoint to match work carried out in 2017.
2. Carry out cross pinning to address delamination of the brickwork skins above the two end arches. Rake out and point affected joints in the arch soffits.
3. Rake out and repoint brick plint to rear wall exposed by reduction in floor level, to match work carried out in 2017. Replace isolated defective bricks using reclaimed Cambridge Gault facings.
4. Carry out general overhaul of brickwork including pointing isolated open joints in parapet coping.
