Unlocking Highgate Cemetery project, Highgate, London

Structural Appraisal Report

Ref: 240323/S Wilkinson

Date: 22 May 2024

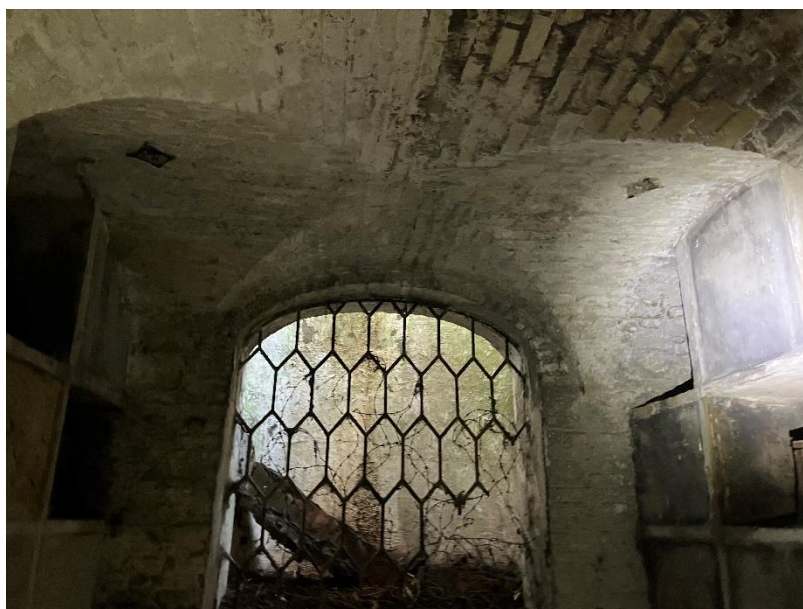
2.1.2 The vaulted brickwork structure of the Terrace Catacombs remains in good overall condition where visible. No structural cracking or movement was visible to the groined vaults in the aisles, or to the barrel vaults over the side chambers and their separating walls. The intradoses of the vaults are only partially visible due to the stone coffin shelves and dividers but we note there was no sign of flattening or distortion and no evidence of cracking or crushing to the brick or stone work, which may be indicative of general structural movement. Similarly, the dividing walls to the rows of chambers to the north and south of the aisles were not showing any signs of any structurally significant cracking or movement.

Photograph 1: Terrace Catacombs – typical view of groined vault brickwork in the central aisle.

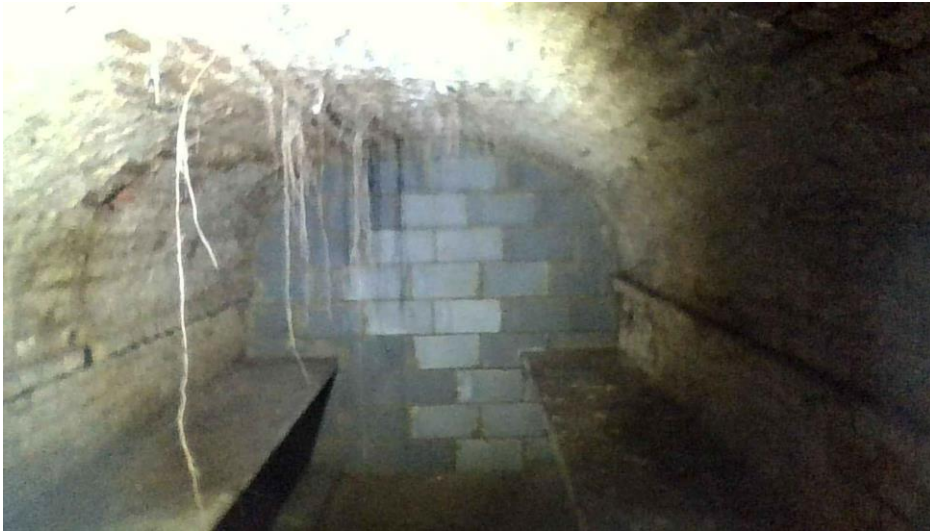
- 2.1.5 The south elevation contains three access doorways and several individual vaults, some of which could be opened and some viewable by remote camera. Few defects were identified and there is no sign of separation between the façade and vault walls, however direct access will still be required to fully confirm condition. The most significant issue seen was root penetration and probable cracking to the unnamed empty vault adjacent to the Simpson vault at the east side. The blockwork walling pictured to the rear of the vault conceals skeletal human remains disinterred from elsewhere in the Cemetery.

Photograph 2: Unnamed vault at eastern end – root penetration and probable cracking to the vault intrados.

- Repair/reconstruction of the west side access steps
- Stabilisation of retaining wall at the west side
- Repair of probable cracking to unnamed vault to east side

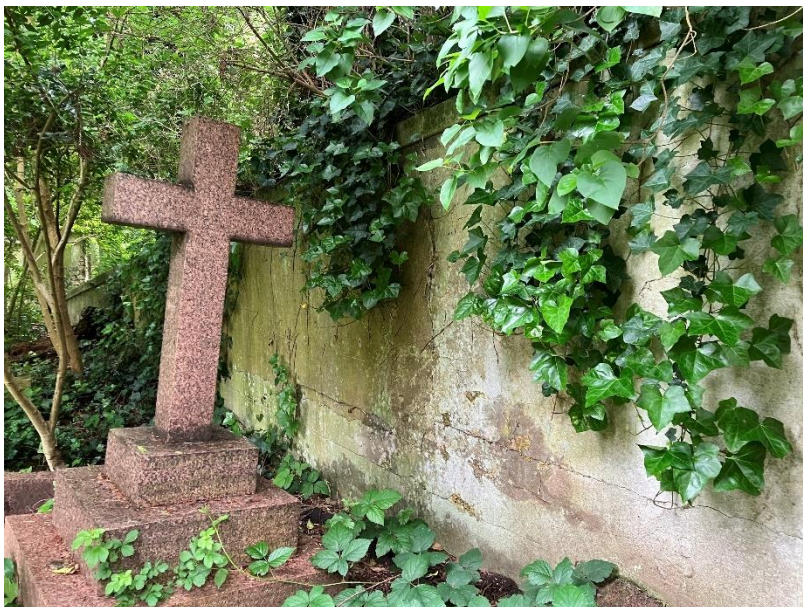
- 2.1.9 The retaining wall at the west side which continues from the steps in a south-easterly direction has been affected by a semi-mature yew tree at the topside. This has resulted in the stuccoed brickwork leaning and bulging outwards. We understand that the yew trees are considered to be a significant feature, so a solution to conserve the fabric and the tree will be needed. We anticipate that ground anchors could be viable option here in the short to medium term but also note that the tree will continue to grow and exert further lateral pressure in the long-term.

Photograph 3: Failing retaining wall at western end of the Terrace Catacombs.

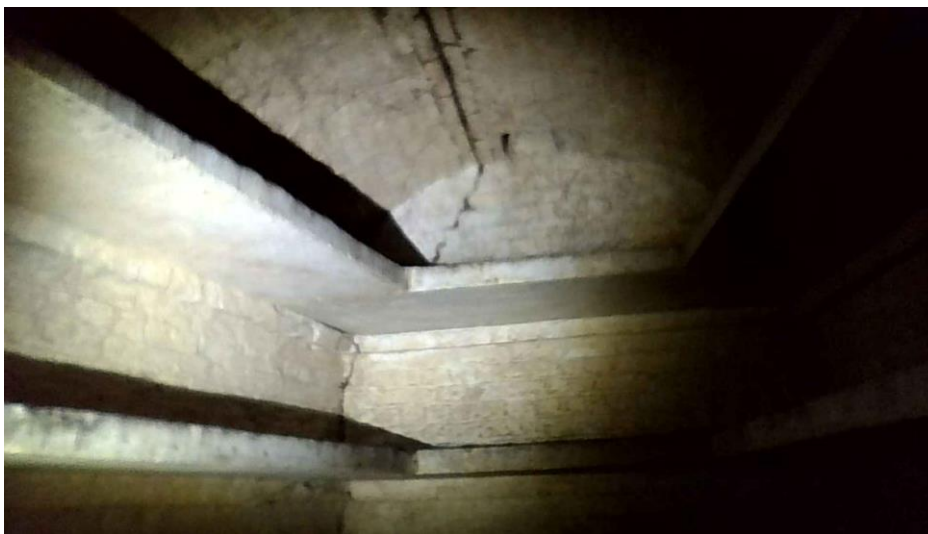
- 3.1.3 Relatively few significant defects were visible in the individual vaults, certainly in the outer circle. Several inner circle vaults exhibited longitudinal cracking to the barrel vault brickwork and more limited diagonal cracking. This may be related to the large cedar tree formerly present in the centre of the circle and merits direct access and further investigation before any remedial works can be recommended. Due to the fact that the vaults are arranged in circular pattern, there is fairly limited potential for lateral movement and flattening or hinging of the vault brickwork, although there may be a degree of unresolved lateral load at the outer perimeter. Nevertheless, we will still need to review the extent of any movement and potential mortar loss.

Photograph 4: Inner Circle Vault 1: Typical example of longitudinal cracking at the vault intrados and more isolated example of cracking to the rear wall.

3.2.2 Structural remedial works will be confirmed following further investigation but grouting and stitching of cracked brickwork arches should be provisionally allowed for.

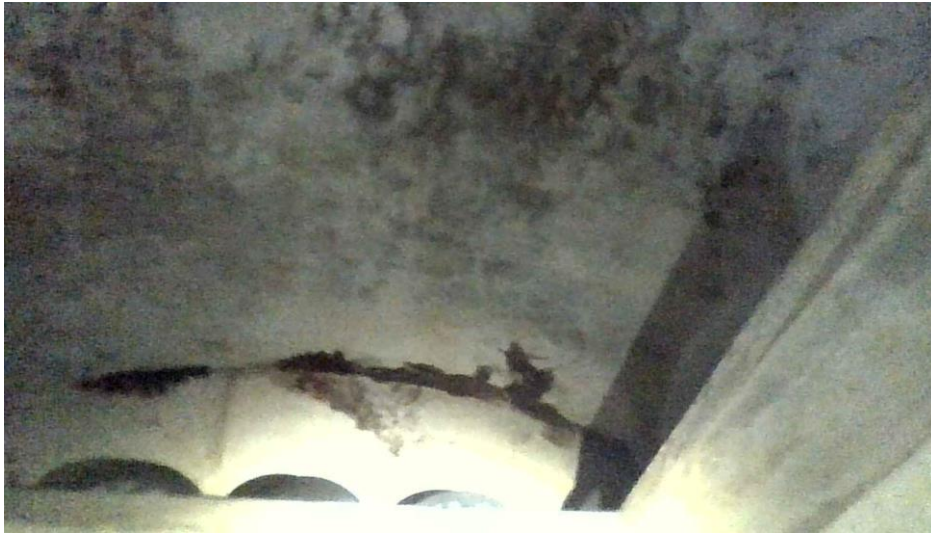
- 3.1.4 Some dampness to the vaults is evident and is unsurprising as the roofs on the outer circle were reportedly defective for long periods; there is also reportedly no waterproofing layer over the inner circle vaults and all have earth retaining brickwork rear walls. Additionally, the original provision for cross ventilation via door and roof vents is now absent or only partially operational. No resulting structural defects seem to have arisen at present but reducing dampness will help the general durability of the structural elements.

Photograph 5: Outer Circle Vault 13 (Brett) – typical dampness at vault intrados

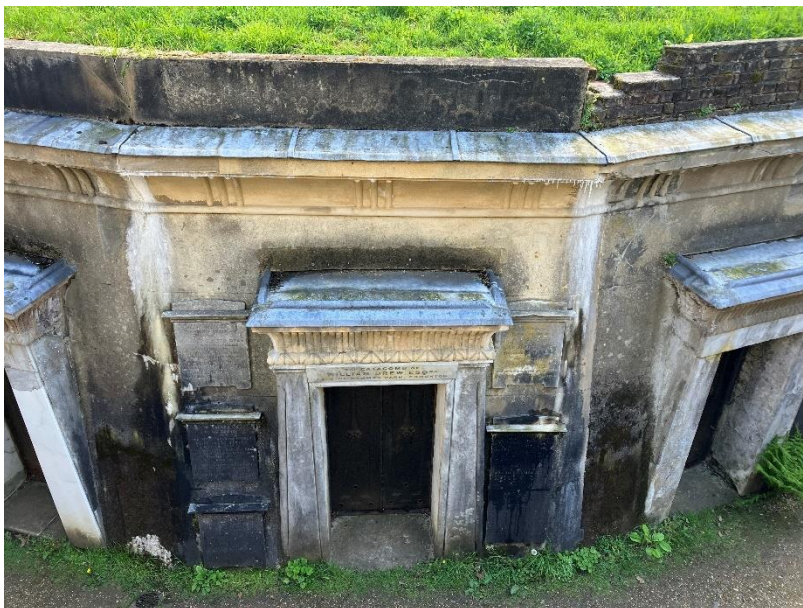
- 3.1.5 Drainage arrangements for the topside of the inner circle seem to be poor and the façade is saturated in some areas. This has not resulted in any clear structural problems but there is extensive local washout of lime mortar evident at cornice/parapet level, which will require remedial work.

Photograph 6: Inner Circle – example of mortar washout at parapet level and dampness at low level due to drainage issues.

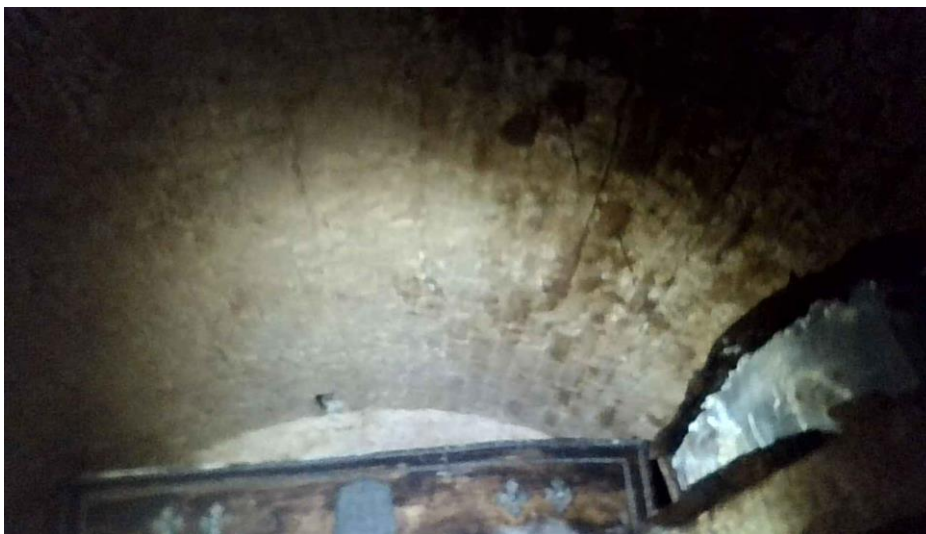
4.1.2 The vault structures appear to remain in good condition. No significant structural cracking was seen. Some minimal root penetration was evident along with some inevitable dampness.

Photograph 7: Egyptian Avenue – typical view of brick vault intrados showing some dampness and limited fine root penetration.

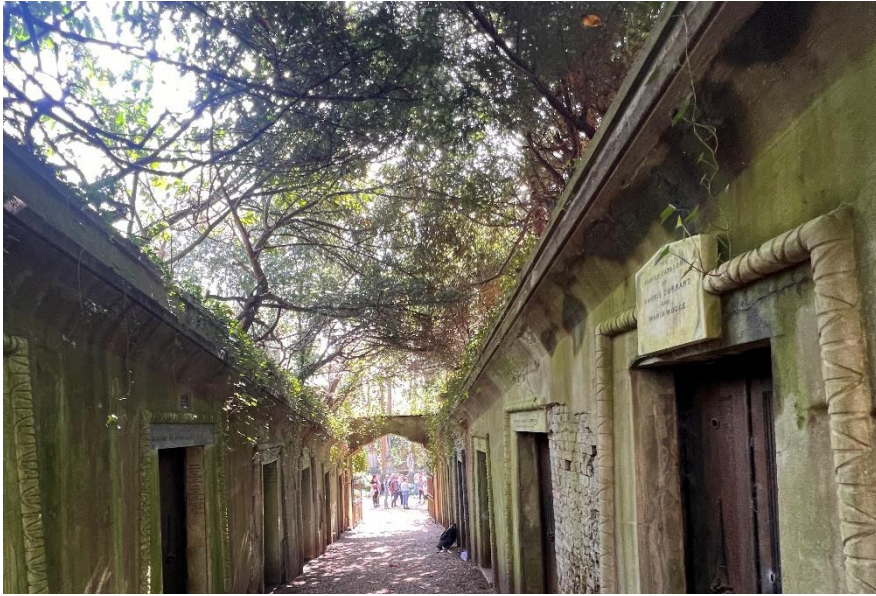
Photograph 8: Egyptian Avenue – general view showing dampness to upper parts of the facades.

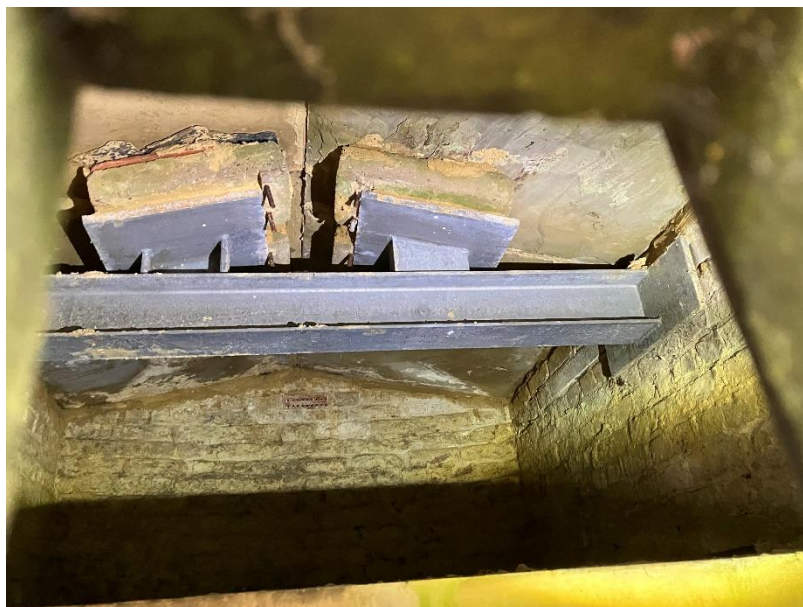
- 5.1.3 There is no evidence of any current lateral movement but we also note that the duo-pitched roofs are formed from stone slabs which abut at the apex without any ridge beam or supplementary support. Some fairly unsympathetic steel work supports have been added inside the externally buttressed Hawes vault, presumably to address possible loss of contact and collapse of the slabs.

Photograph 9: Hawes vault – previous supplementary supports to roof slabs

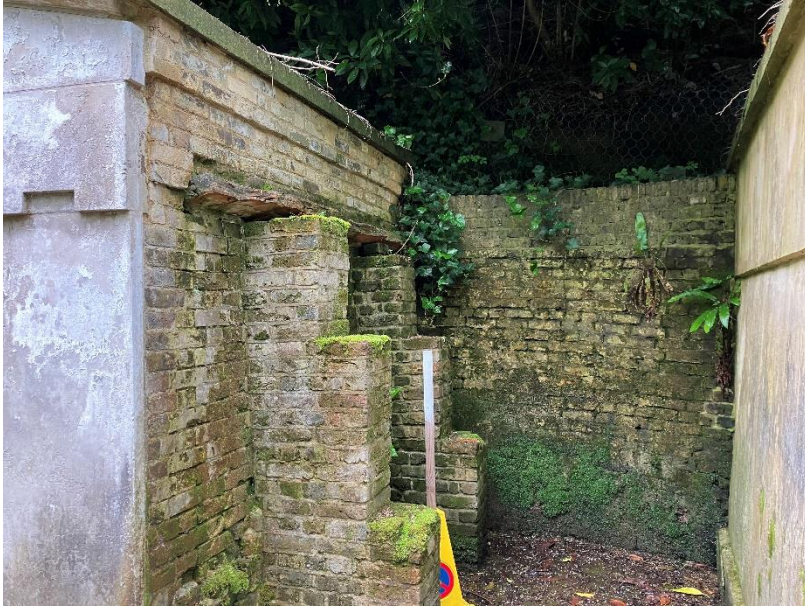
Photograph 10: External buttressing to the Hawes vault with saturated brickwork to the visible retaining wall on the right.

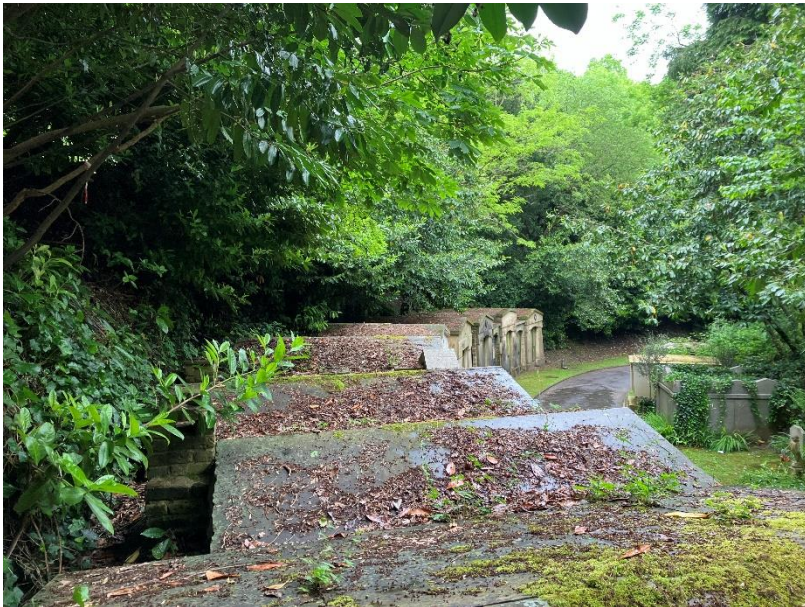
- 5.1.4 The roofs are somewhat vegetated generally and further inspection is recommended to confirm that all slabs are still in contact and all mortar joints filled.

Photograph 11: General view of roof slabs at the north end of the row.

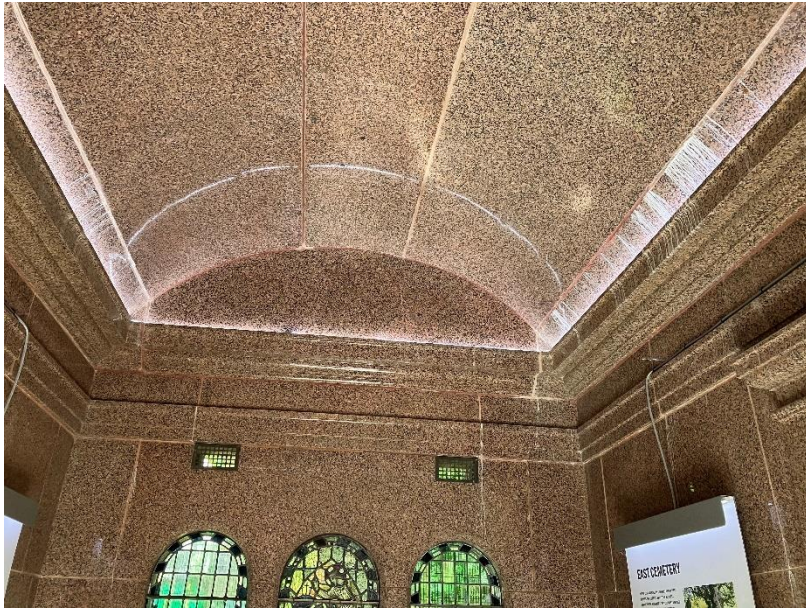
6.4.2 Some leaching of calcium salts was evident to masonry joints in the upper part. This is likely to be due to a roof defect but is not of structural concern currently.

Photograph 12: Strathcona vault interior – mortar leaching is visible

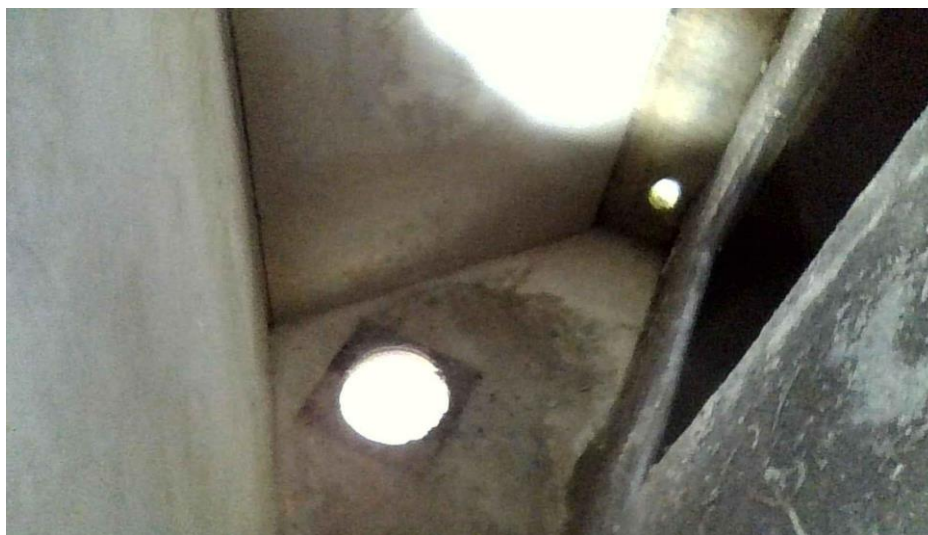
6.8.2 The interior was not accessible as the doorway is sealed with slate/masonry. Limited borescope camera access did not show any defects of structural concern.

Photograph 13: Rosa – partial view of vault interior (rotated)

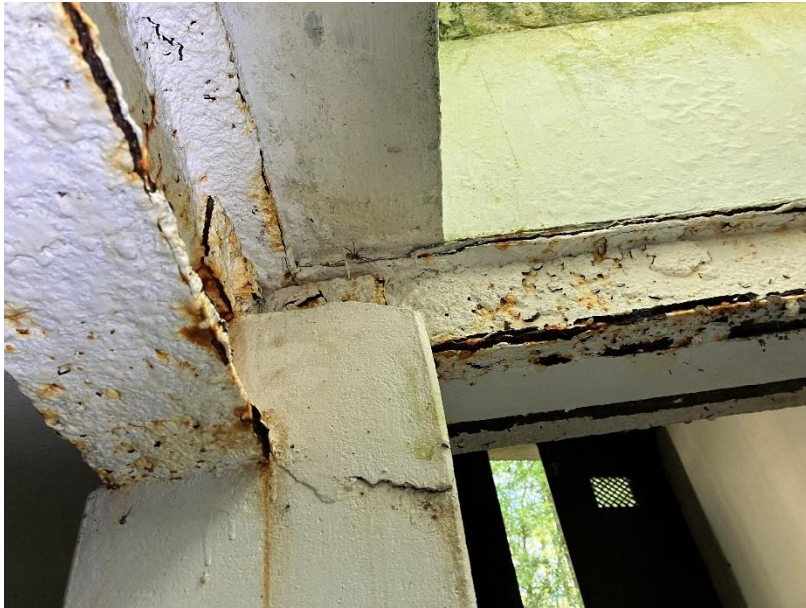
6.10.2 The structural steelwork is corroding and structurally significant section loss appears to have occurred in some locations, particularly around the entrance area. The beams have been previously overpainted but perhaps not well prepared, with the result that the finish is now failing. At least two different beam sizes have been used and there is some indication that supplementary beams were added at a later stage. Detailed measurements of section sizes will help confirm and approximately date any such intervention.

Photograph 14: Otway vault interior – entrance area

6.10.6 Intrusive investigations will be needed to open-up selected beam bearings and connections and clean back corrosion product to be able to assess the extent of section loss. Our initial view is that full replacement of some steel elements will be needed. Other beams with less extensive losses will need thorough cleaning and treatment. Cross ventilation provision should also be reviewed. Full prevention of water ingress is unlikely, so interventions should be focussed on addressing structural defects and increasing durability of vulnerable fabric.

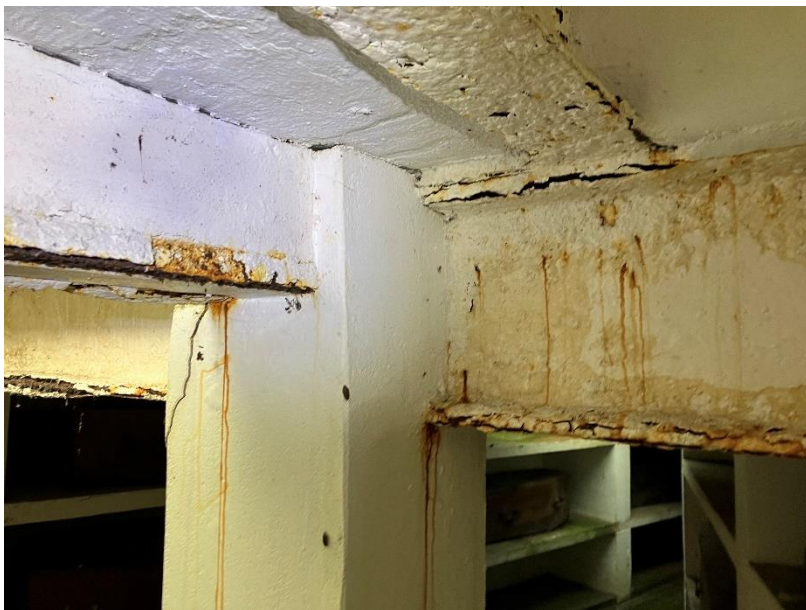
Photograph 15: Otway vault entrance area

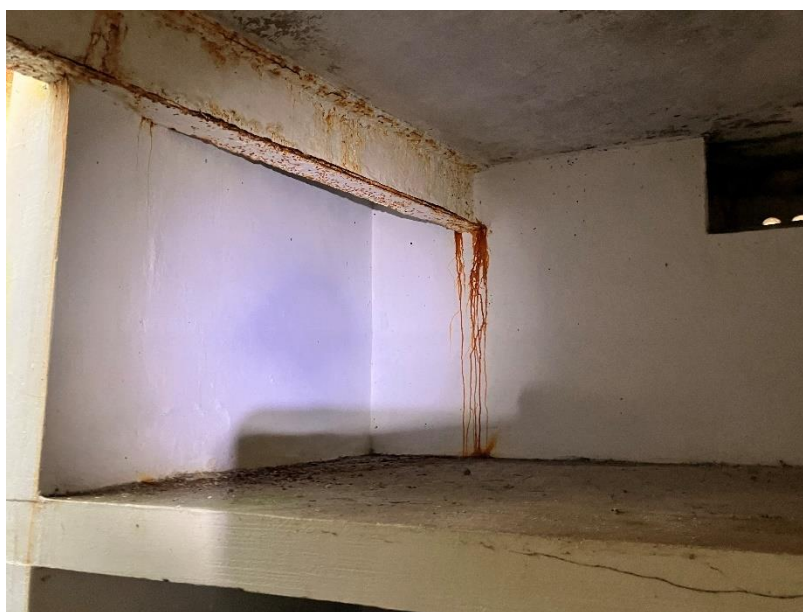
6.10.4 The vault is generally damp with beading water evident on concrete and steel surfaces at the time of inspection. Patterns of staining to surfaces indicates that some leakage is occurring, particularly around the roof lights and some beam bearings. Surface corrosion in more distant areas may then be related to generally damp conditions and poor ventilation, causing condensation.

Photograph 16: Otway Vault – example of water ingress at steel beam bearing

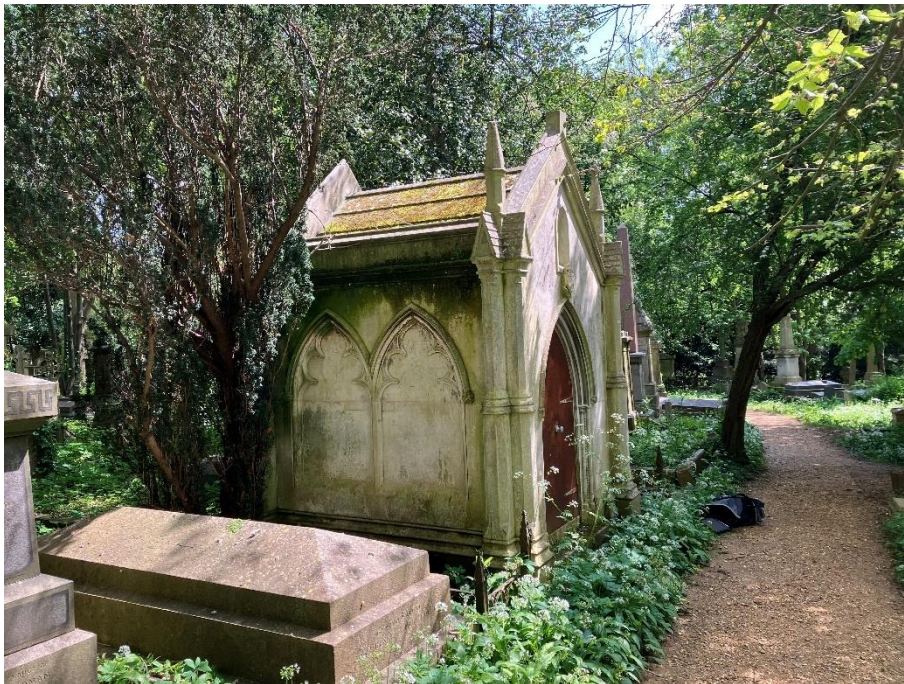
6.12.1 No structural defects are visible to the external elevations although the upper part of the north elevation close to the parapet appeared to be very damp. The vault door could not be opened and a partial inspection of the interior was undertaken by borescope.

Photograph 17: Foster mausoleum – north elevation

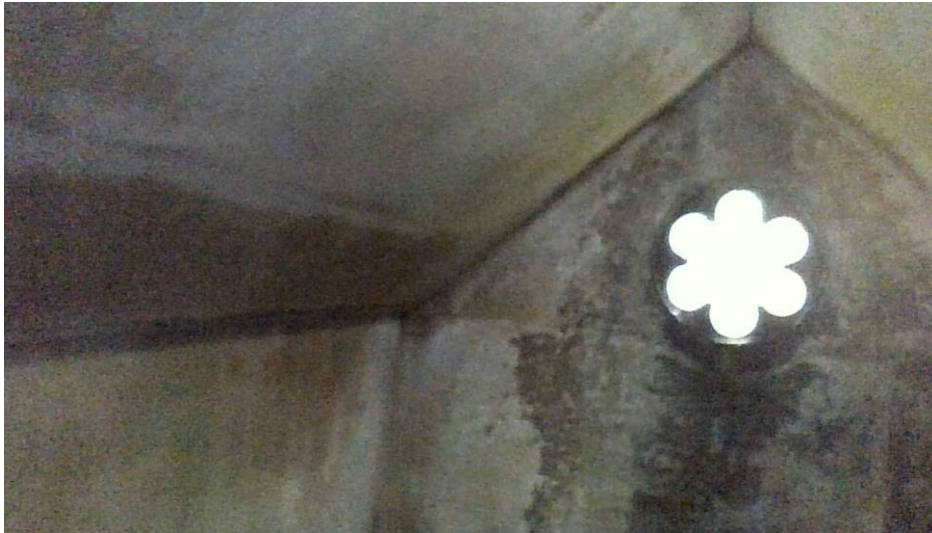
6.12.2 The interior also appeared to be quite damp and some damage to coffins was evident, however no structural defects were visible. Direct inspection to confirm is still recommended once the vault door has been opened.

Photograph 18: Foster mausoleum – partial interior view looking west.

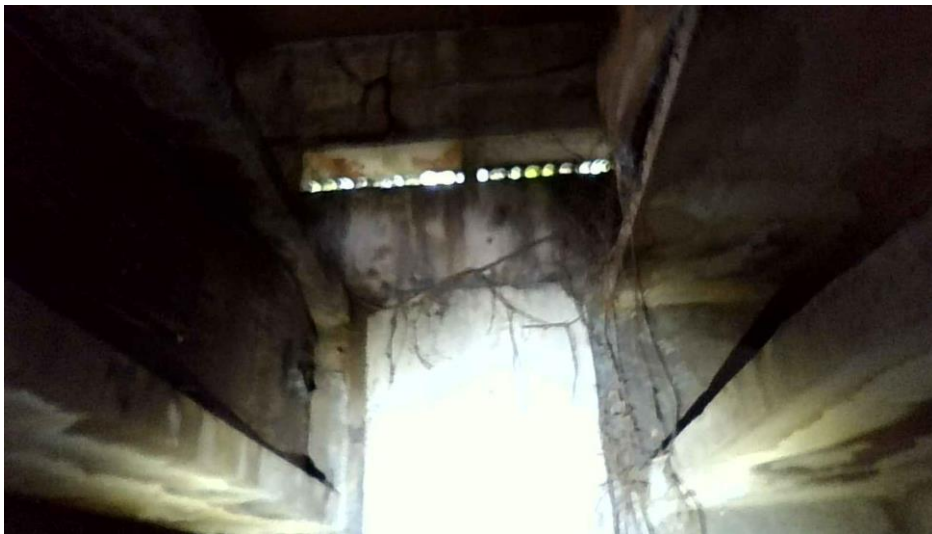
6.14.2 The door could not be opened and limited borescope inspection did not reveal any obvious structural defects internally. Some root penetration to the interior has occurred and direct inspection access is recommend to confirm initial conclusions.

Photograph 19: Morgan – partial view of vault interior

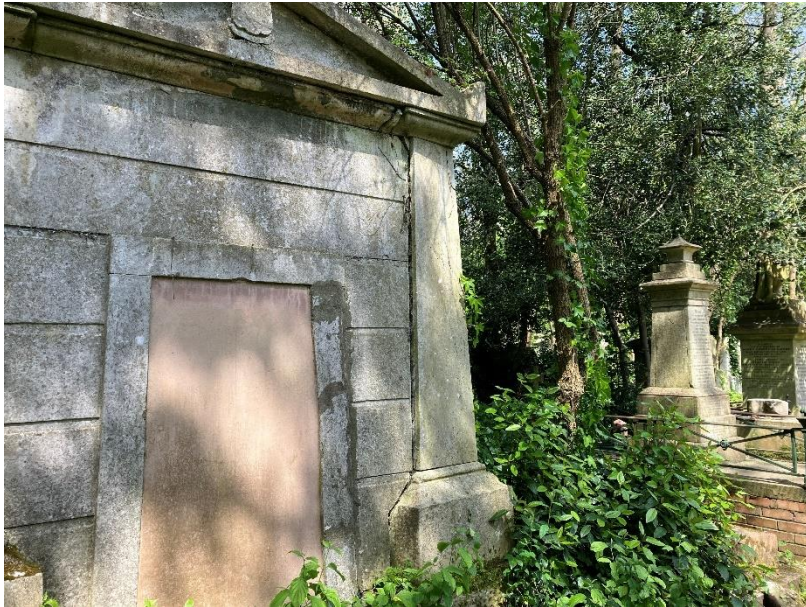
6.15.2 The monument seems to have suffered from structural movement which has led to a degree of roof spread, causing a gap to open between the slabs at the apex. The cornice units at the eaves and the pilaster at the south-east corner have also moved. The rear pediment is currently at risk of falling away.

Photograph 20: Da Silva - rotational movement at the south east corner pilaster

- 6.16 Further investigations will be needed to confirm the full scope of works to this monument but dismantling and reconstruction of the roof structure should be anticipated. Once deloaded, it may be feasible to rotate the pilaster back into position, but the precise construction details will need to be confirmed first.

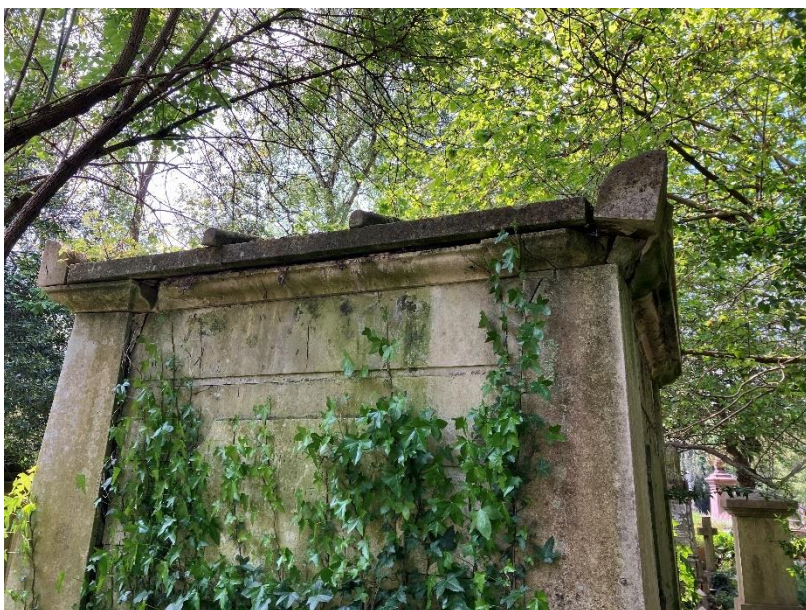
Photograph 21: Da Silva - movement at the cornice units and rear pediment

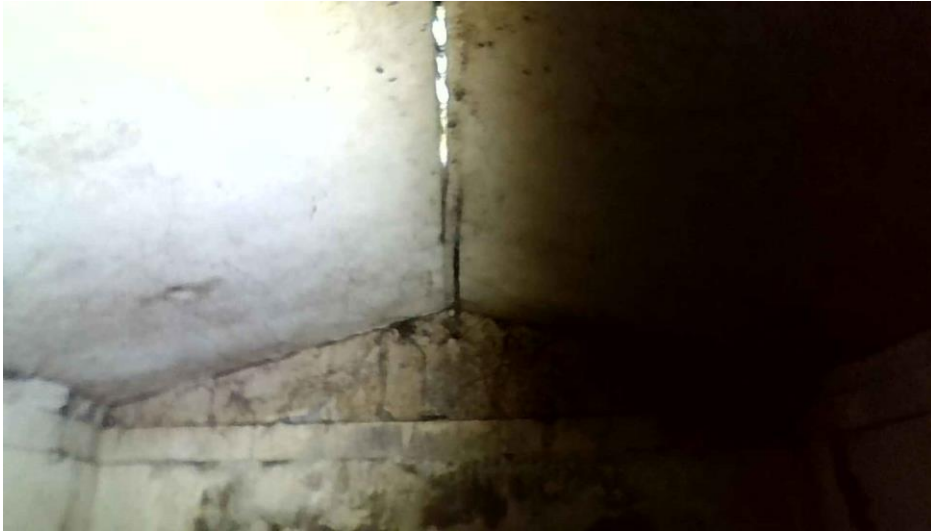
6.15.3 Partial inspection of the interior was possible by borescope. This revealed a gap at the roof apex and extensive damage to the coffins and shelves.

Photograph 22: Da Silva - roof structure

6.15.4 Photograph 22 seems to show that the east roof pitch slab slipped, which would also be consistent with the external movement at the pilaster. It is less clear in Photograph 23 whether the external movement in the pilaster is reflected internally and direct inspection will be required to confirm.

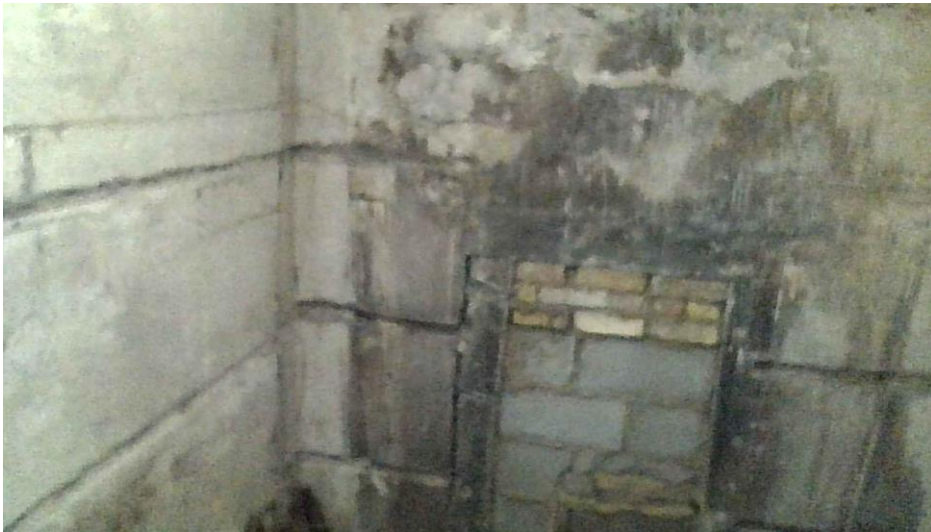
Photograph 23: Da Silva – partial view of interior looking towards the south-east
