Project Name: Highgate Cemetery

Project Date: 06/03/2024

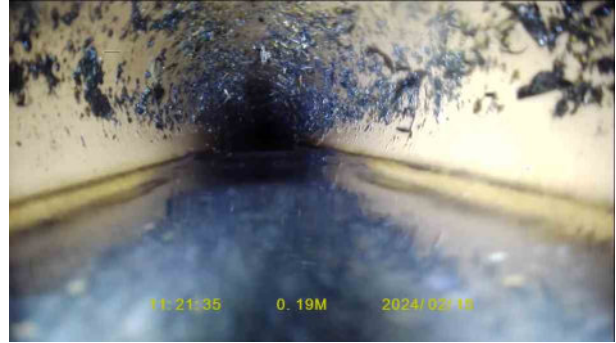
0a57784d-e58e-4407-8287-cf7a23f7a03b.jpg, 00:00:18, 0.19 m
 Settled deposits, fine, 20% cross-sectional area loss, start

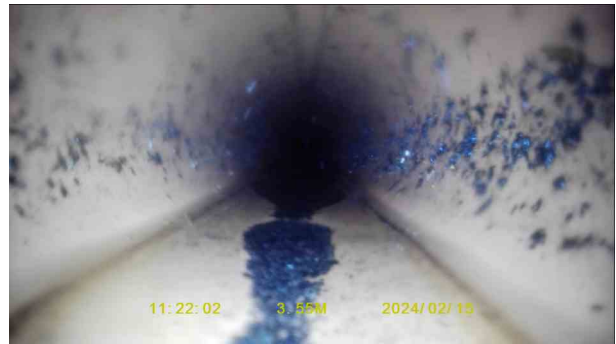
ed78403e-130b-4de6-bf97-45cb9d68f741.jpg, 00:00:45, 3.55 m
 Water level, 15% of the vertical dimension

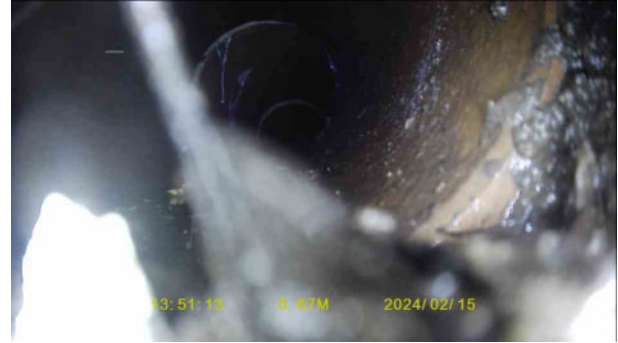
afcd81bb-6da3-4ec1-b5c4-cda859859e55.jpg, 00:00:23, 0.67 m
 Joint displaced, large

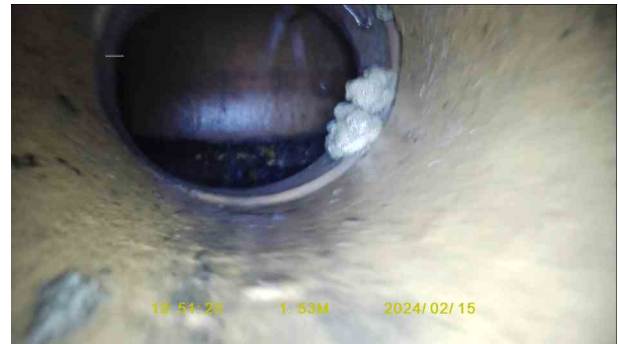
f1f2450b-46f3-4ac6-8aa2-235a2dc617f9.jpg, 00:00:34, 1.53 m
 Attached deposits, encrustation at joint from 3 o'clock to 4 o'clock, 15% cross-sectional area loss

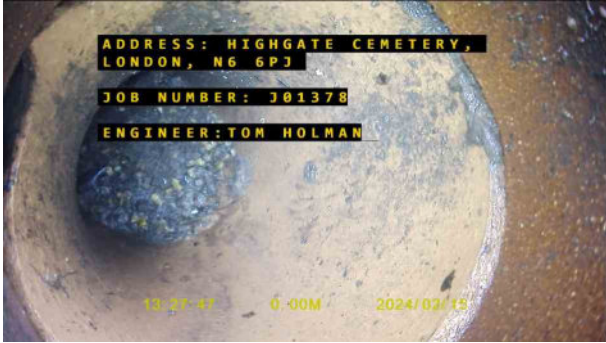
397b982f-a76e-453f-83c7-2e7946c7e29a.jpg, 00:00:01, 0.01 m
 Broken pipe at joint from 8 o'clock to 11 o'clock

Comments:
Recommendations: Recommend HPWJ/Resurvey

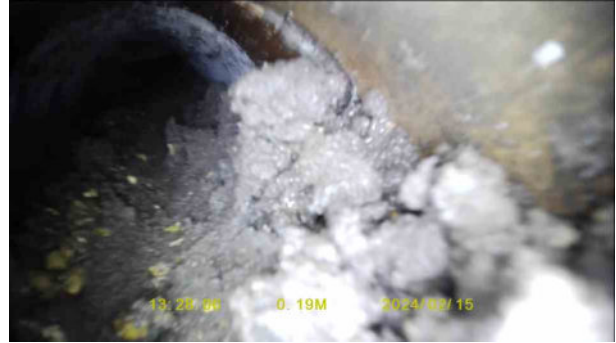
1c44eae0-37b6-4678-8aee-5aa4b04f4063.jpg, 00:00:20, 0.19 m
 Settled deposits, fine, 50% cross-sectional area loss, start

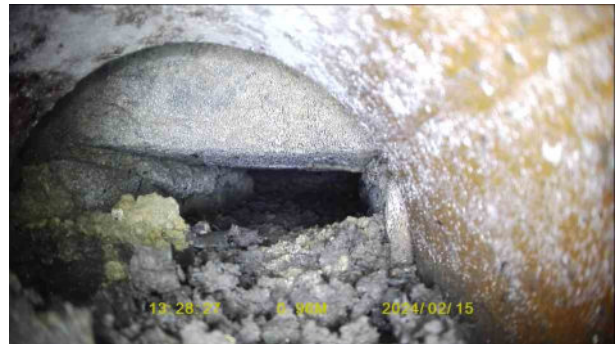
f0cc2763-8207-4804-a4ab-e36e04128bba.jpg, 00:00:41, 0.96 m
 Survey abandoned, Camera unable to push further

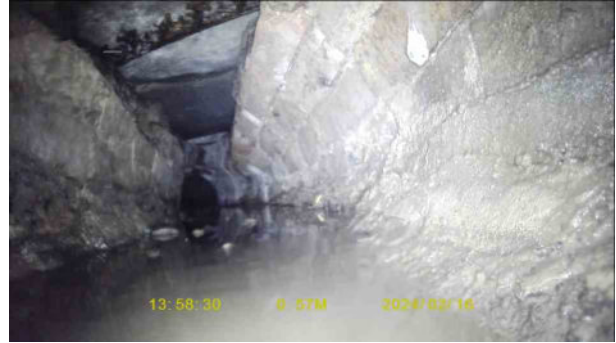
fe6ca740-4cf9-47e2-9136-ef9903ed7e3e.jpg, 00:00:09, 0.01
 m
 Hole in drain or sewer from 10 o'clock to 2 o'clock, start

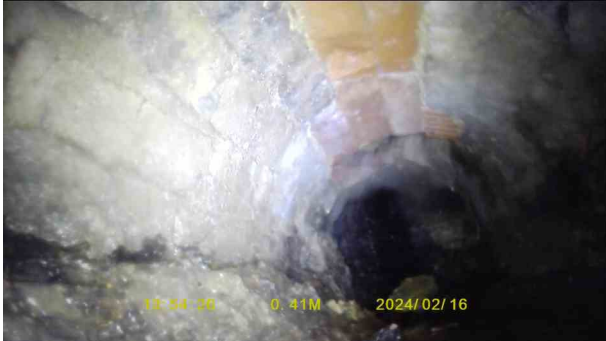
4ef6300e-2f9d-4306-95ef-b6cd0994d147.jpg, 00:00:14, 0.41
 m
 Broken pipe from 8 o'clock to 9 o'clock, start

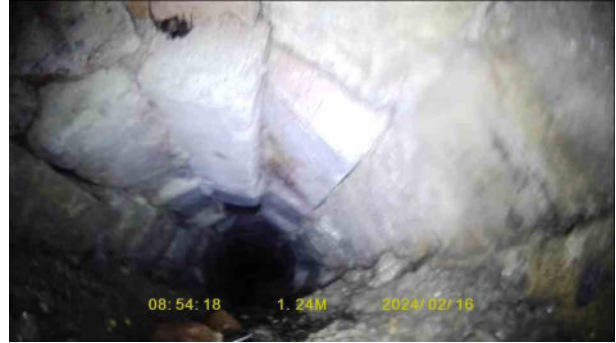
6dfa7ba2-8ce3-4a62-89f8-06e017bbc96c.jpg, 00:00:32, 1.24 m
 Displaced bricks, single brick false from 10 o'clock to 3 o'clock,

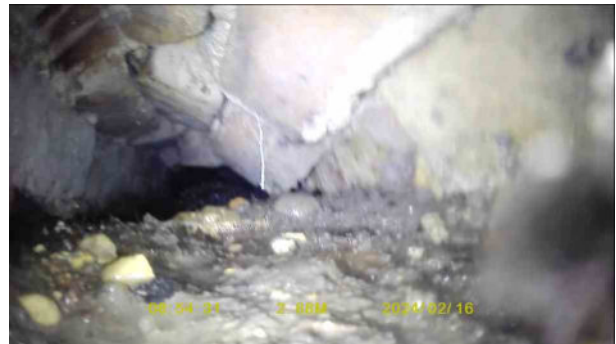
7935c141-1592-43c0-a41b-1905a285488e.jpg, 00:00:44, 2.69 m
 Displaced bricks, single brick False from 9 o'clock to 3 o'clock,

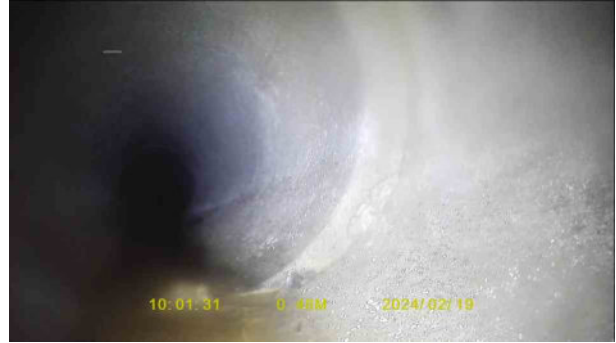
577c0377-0c71-499c-9544-72f3aa53bc83.jpg, 00:01:03, 0.38 m
 Joint displaced, medium

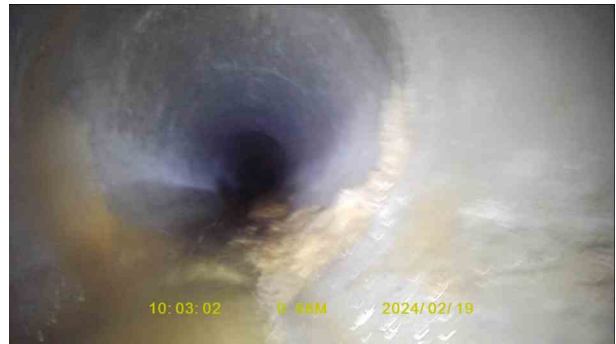
ec57c0d9-4e86-40a5-b827-5f5e43b77d41.jpg, 00:02:34, 9.68 m
 Attached deposits, encrustation at joint from 3 o'clock to 8

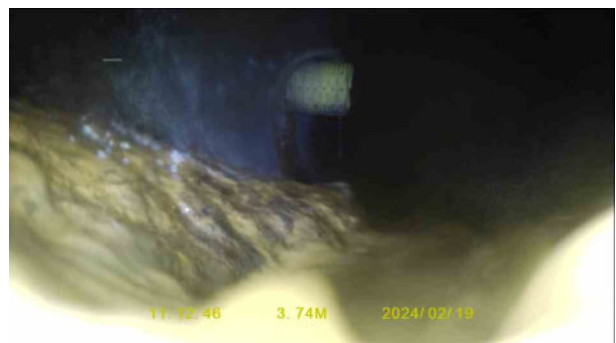
25429ab5-a586-4df5-9b40-2c0439df4630.jpg, 00:00:53, 3.74 m
 Connection defective, connecting pipe is intruding at 10

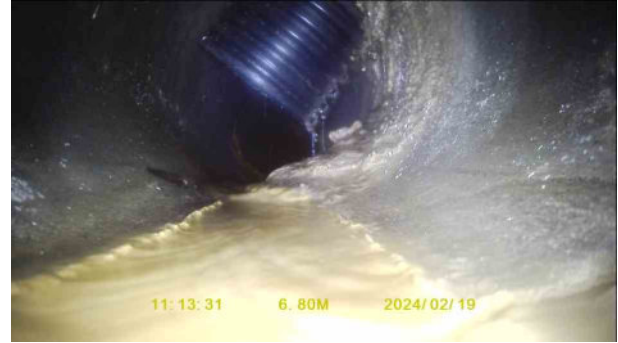
9fe7f2ed-5c9a-4730-af14-163464b89487.jpg, 00:01:37, 6.80 m
 Connection defective, connecting pipe is intruding at 1 o'clock,

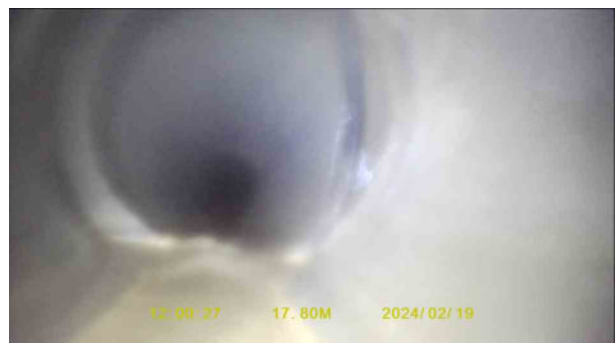
077590d8-4c9b-4e1f-9992-55e9dadfdb62.jpg, 00:02:08, 17.89 m
 Joint displaced, large

Comments:
Recommendations: Recommend HPWJ/Root cut/Relining

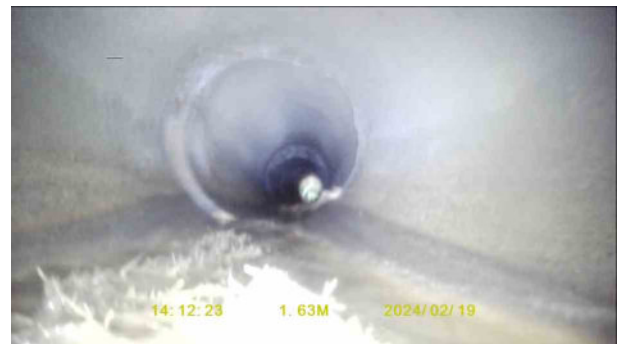
979dab86-6af4-43fd-83df-ea5f15483789.jpg, 00:00:39, 1.63 m
Joint displaced, large

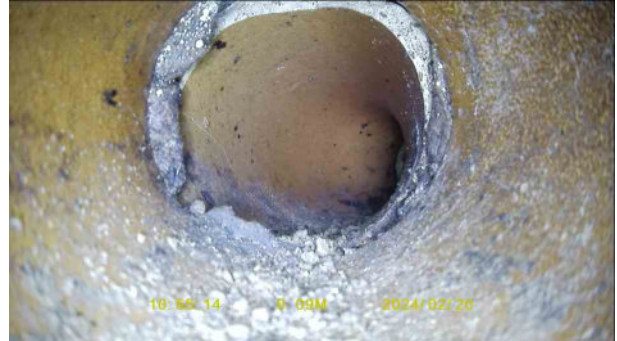
e02efbb9-b02d-404c-88dc-d7230a88ceff.jpg, 00:00:13, 0.09 m
Broken pipe at joint from 9 o'clock to 4 o'clock
