Our Ref: CAS / 25536

12<sup>th</sup> April 2024

Re: External inspection to Derby Lodge, Wicklow Street, London. WC1X

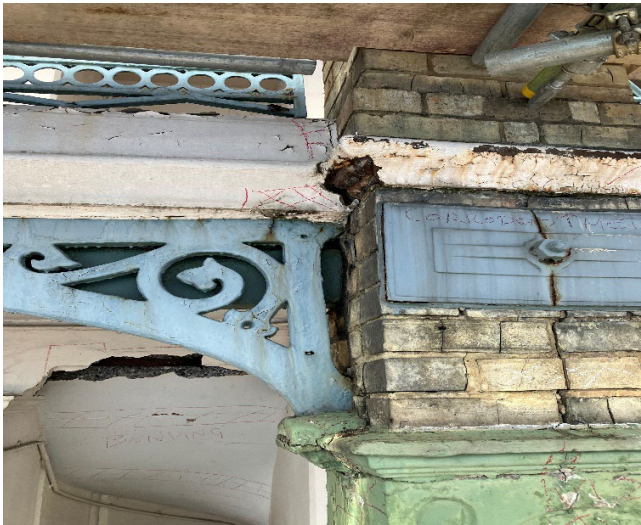
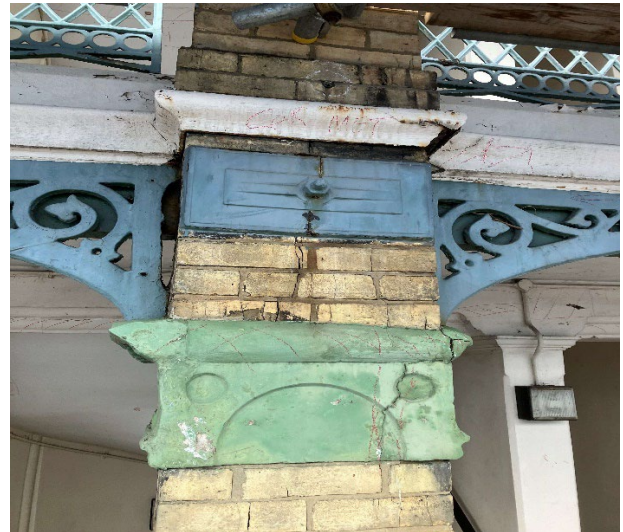
- On the fourth and fifth floors we found that the steel plates used to restrain the masonry piers have corroded and split. Therefore, they are not providing lateral restraint to the pier.
- There are concrete pads within the piers which are rendered.
- The ends of steel beams which support the landings are corroded. The original steel arches are pulling out of the piers. We found that brackets have been welded to the beams to provide additional supporting the arched steels. We could see that the steelwork is corroding.
- We found that the rendered panels over some of the windows on the fourth floor consist of sand and cement. The render is not sufficiently bonded to the wall.
- We found cracking within the brickwork under some of the windows.
- We found vegetation growing out of the structure.

Steel arches are pulling out of the pier. Split Patress Plate. Cracked brickwork.

- In our opinion the structure has not been maintained sufficiently, long term water ingress into the structure has caused the pattress plates to corrode and fail.
- The failed steel pattress plates need to be removed and replaced.
- The steel beams which support the landings need to be checked on a case-by-case basis. As discussed on site we recommend the steel to the underside of the landings for the top two levels are checked first to try and gauge the extent of the repair work. Once the beams are exposed we can determine if the beams can be repaired or if they need to be replaced. As detailed in our previous reports the landings will need to be fully propped.
- The cracked brickwork within the piers needs to be removed and replaced with class A engineering bricks.

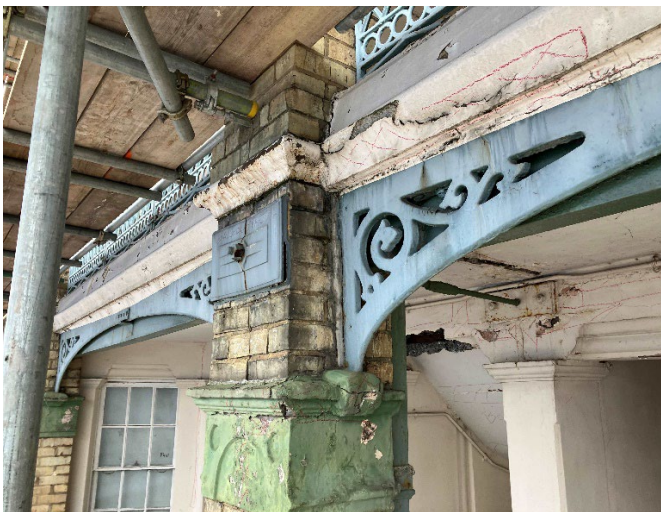
Steel patress plates have split.

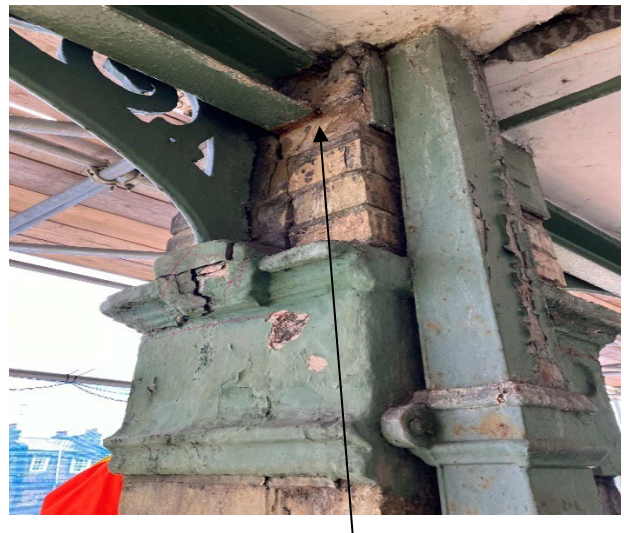
Beam ends are corroded.

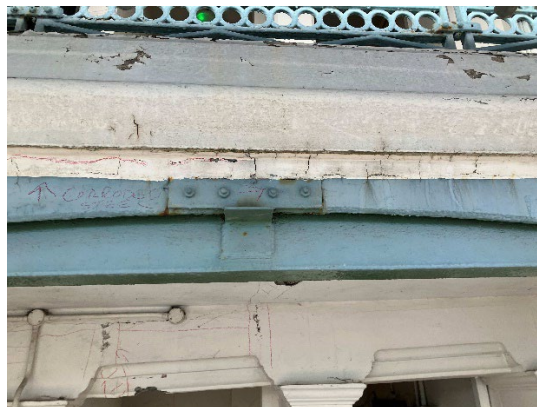
Brackets welded to the landing beams to support the steel arch.

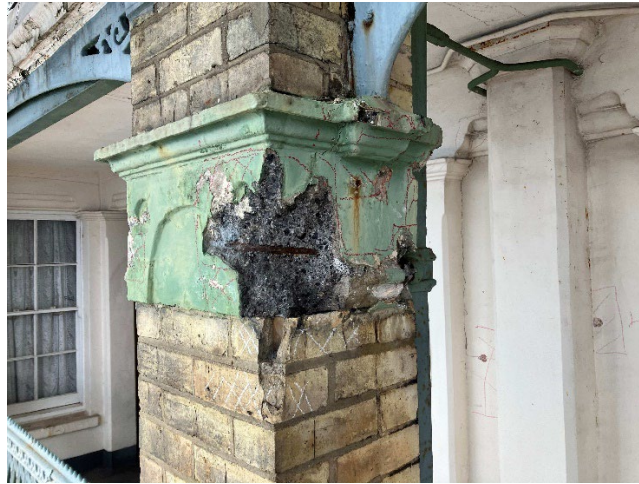
Concrete padstone constructed within the pier with rendered finish.

- Blown render over the windows to be removed and replaced. We recommend that E.M.L is fixed to the brickwork for provide a key for the render.
- Cracked brickwork under the windows to the be repaired with Helifix bars.
- Vegetation to be completely removed from the structure to prevent re growth.
- Concrete padstones to be repaired with Sika Products.

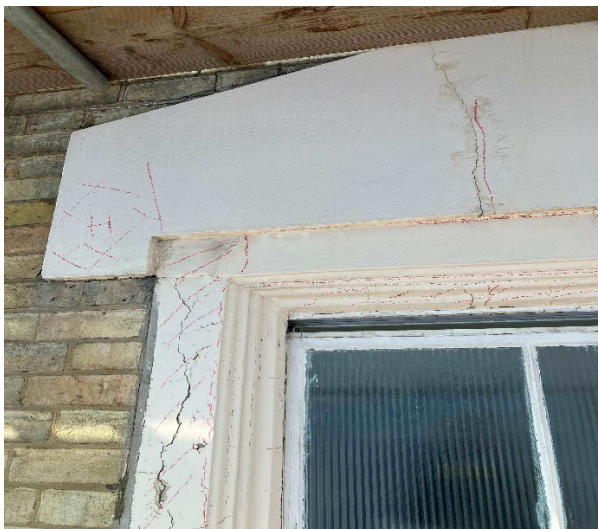
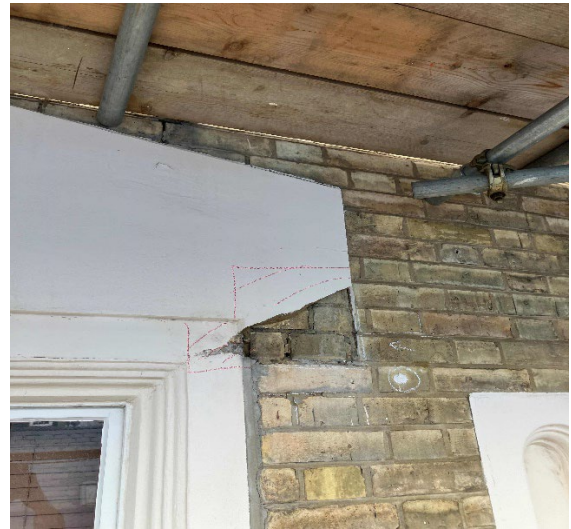
Render panels over the windows have blown.

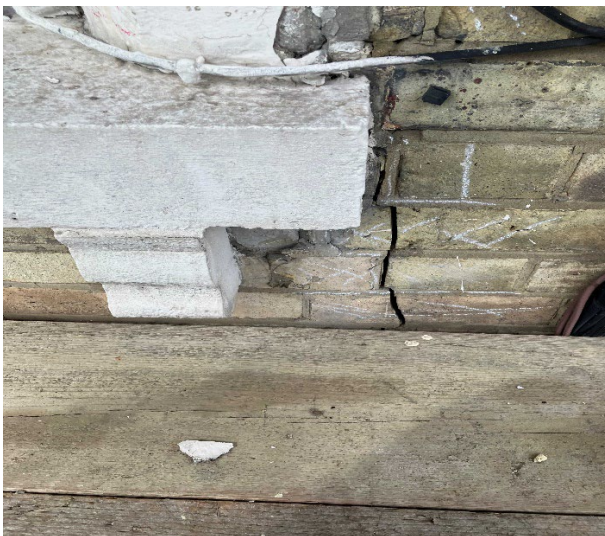
Cracking within the brickwork under the window.

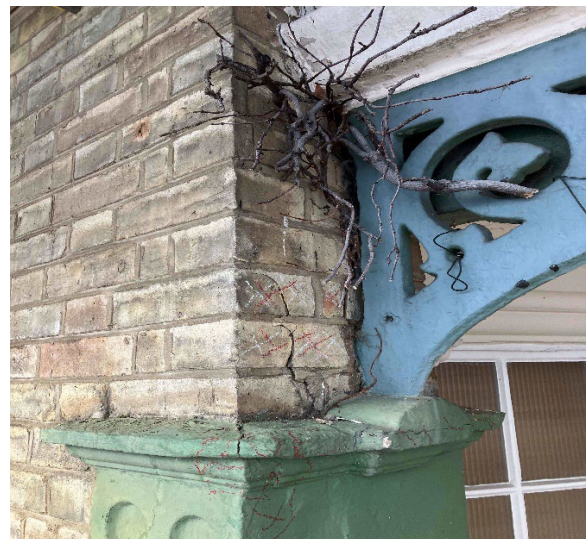
Vegetation growing out of the structure.

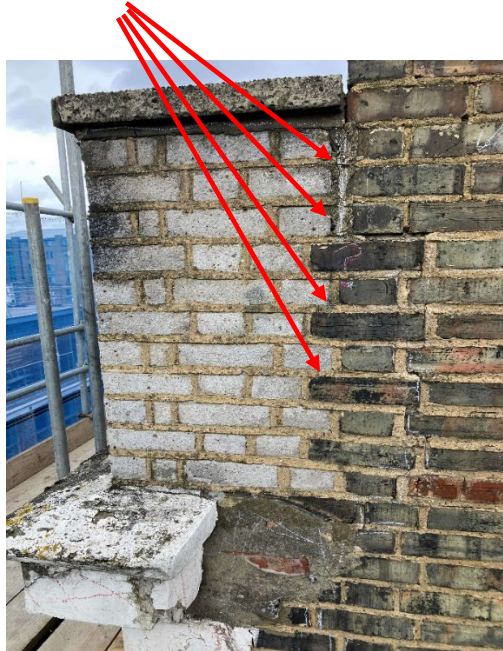
We found that movement between the parapet wall and chimney to the top right-hand side of the structure. We therefore recommend the wall is stitched back together with Helifix Bars installed every other course.

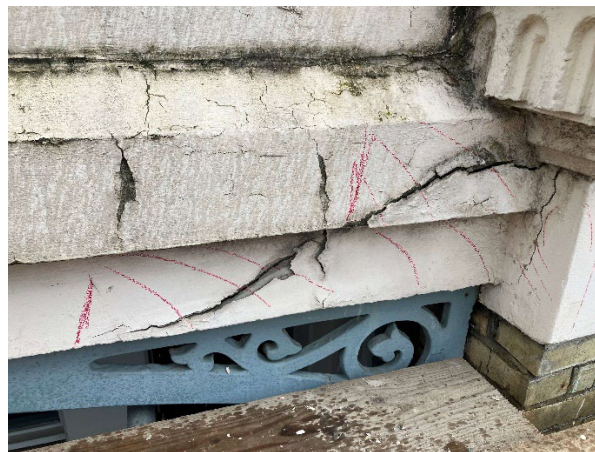
We found that the render applied to the structure at roof level has severely cracked. We recommend that the render is removed to expose the structure behind so the fully extent of the repair works can be determined.

Render applied to the structure has severely cracked. Render to be removed to determine fully extent of repair works.
