**Vale of Health Public Conveniences,
Hampstead Heath, London**

**Preliminary Diagnostic Non - Destructive
Environmental Timber Decay Survey**

Site Visit: 11th November 2024

Job No: HL/BC/3247/001
Reference: JS/pk
Date: November 2024

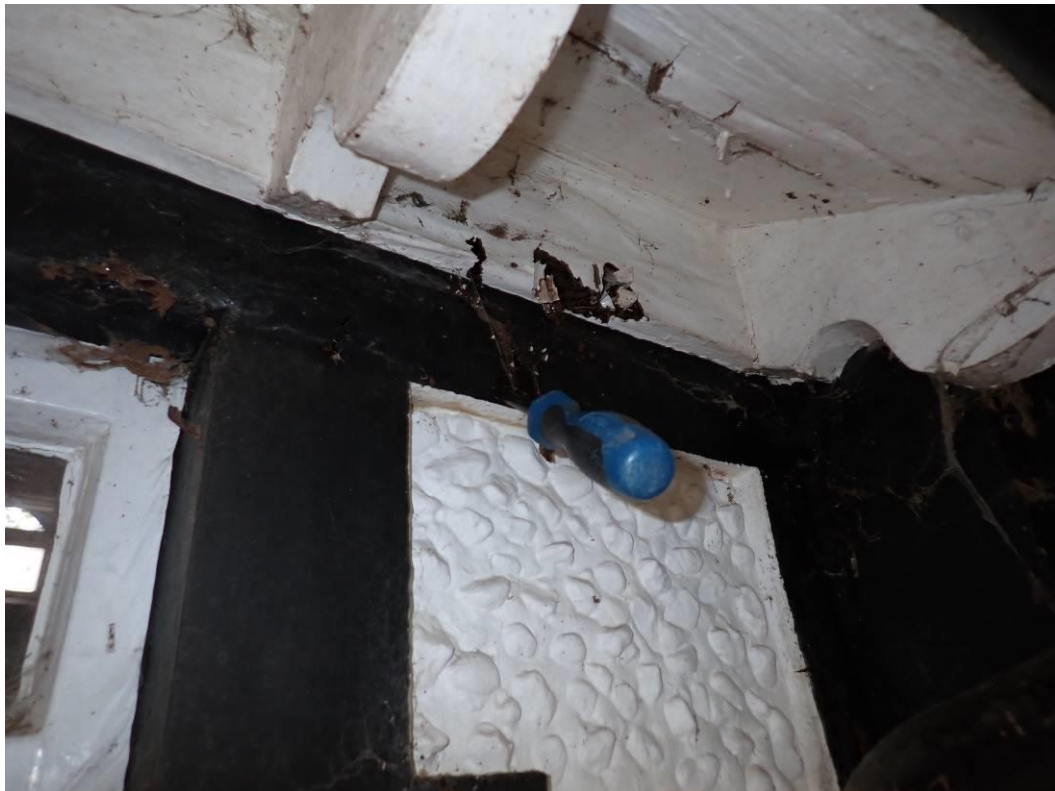
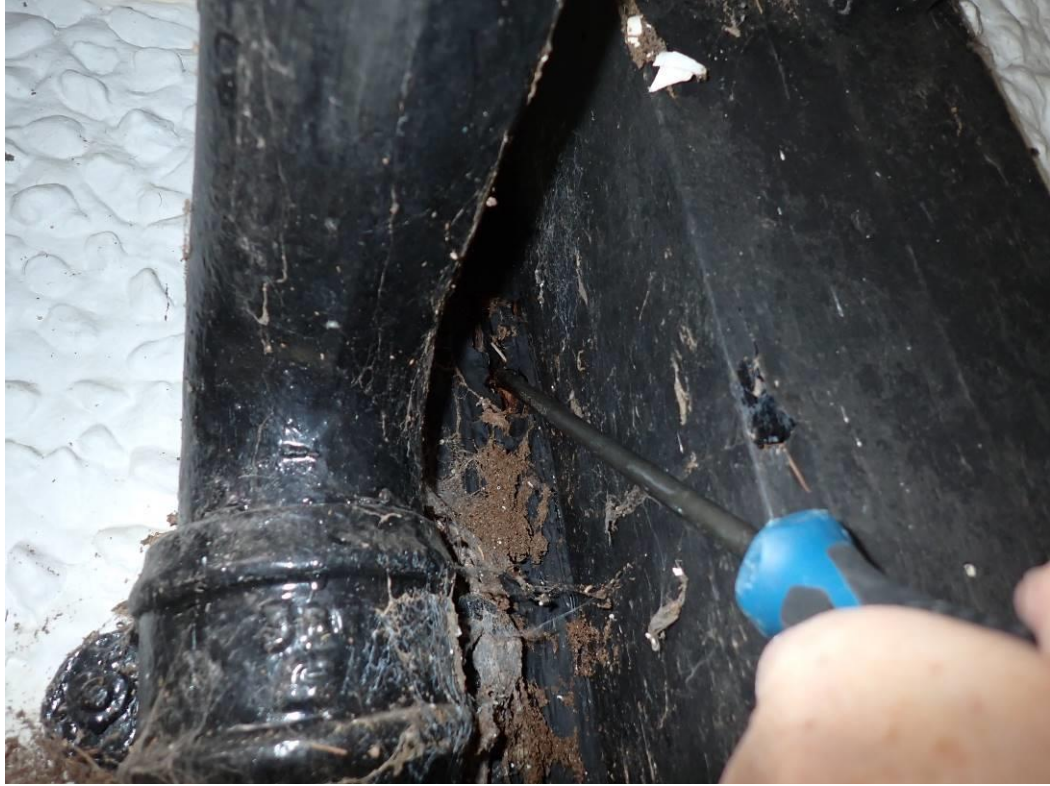
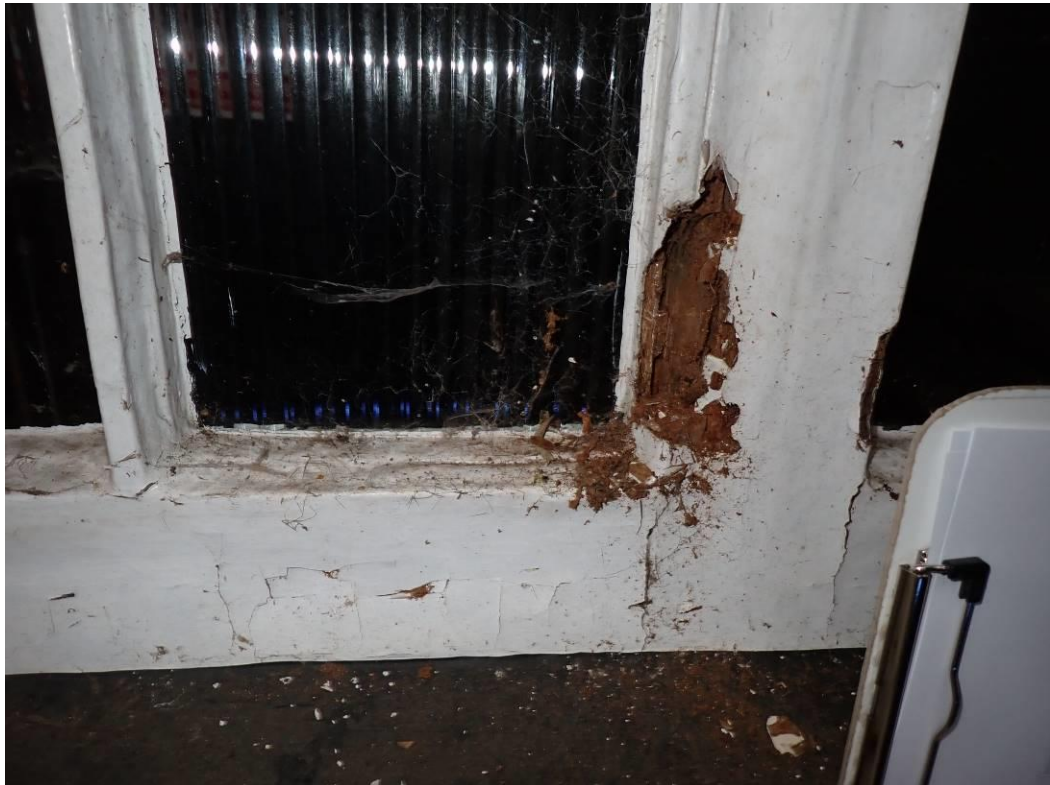
3.2 South Elevation

The timber frame was found to be structurally decayed by wet rot at the west side of the elevation, see plans for location. The type of decay was not identified as no fruiting bodies were found. The rafter ends above the west window were not accessible but could be decayed in the location shown on the plans. The west corner post was decayed at the base up to 150mm from the base, see plans and Resistograph drilling 103.

Allow for renewal of the decayed sections of the timber frame and west window, see plans for location. Expose the rafter ends above the decayed west window for inspection. Allow for partnering the rafter ends if decayed.

Allow for a splice repair to the base of the west corner post to 150mm from the base.

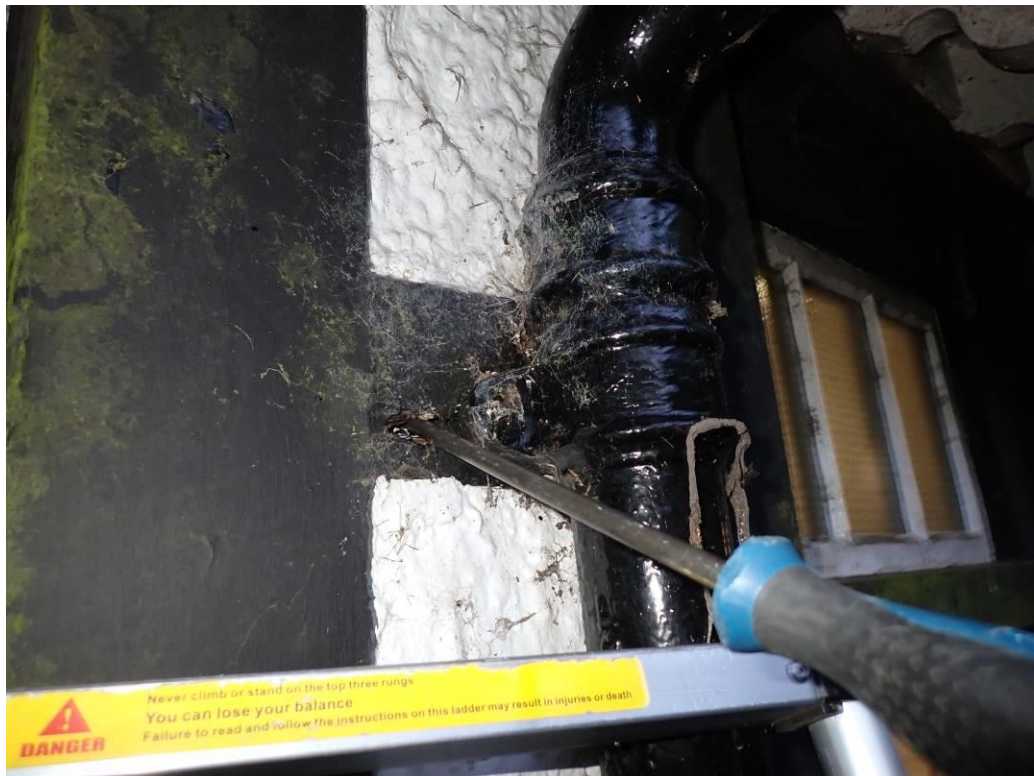
3.4 North Elevation

The sole plate to the timber frame was found to be structurally decayed centrally and a timber at high level east of the door behind the downpipe. see plans for location. The type of decay was not identified as no fruiting bodies were found.

Allow for renewal of the decayed section of the sole plate centrally and the timber at high level east of the door behind the downpipe, see plans for location.

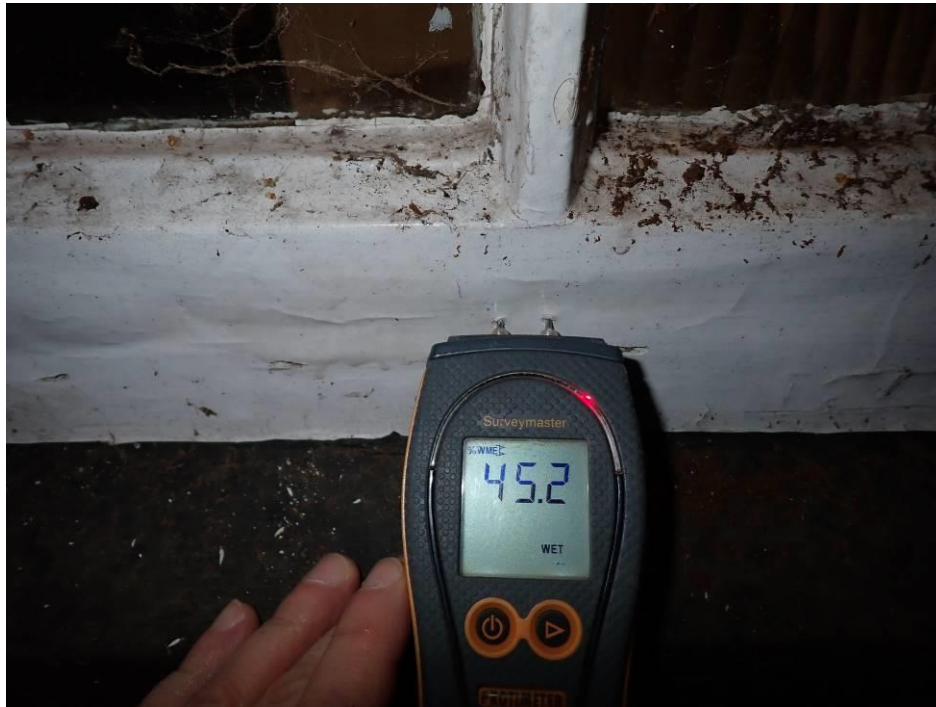
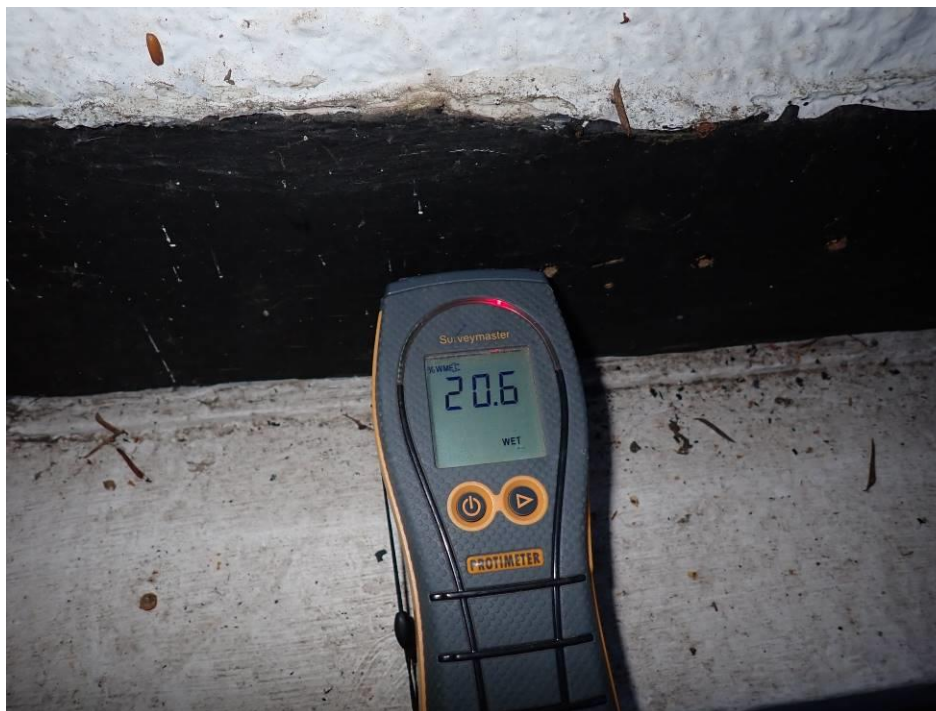
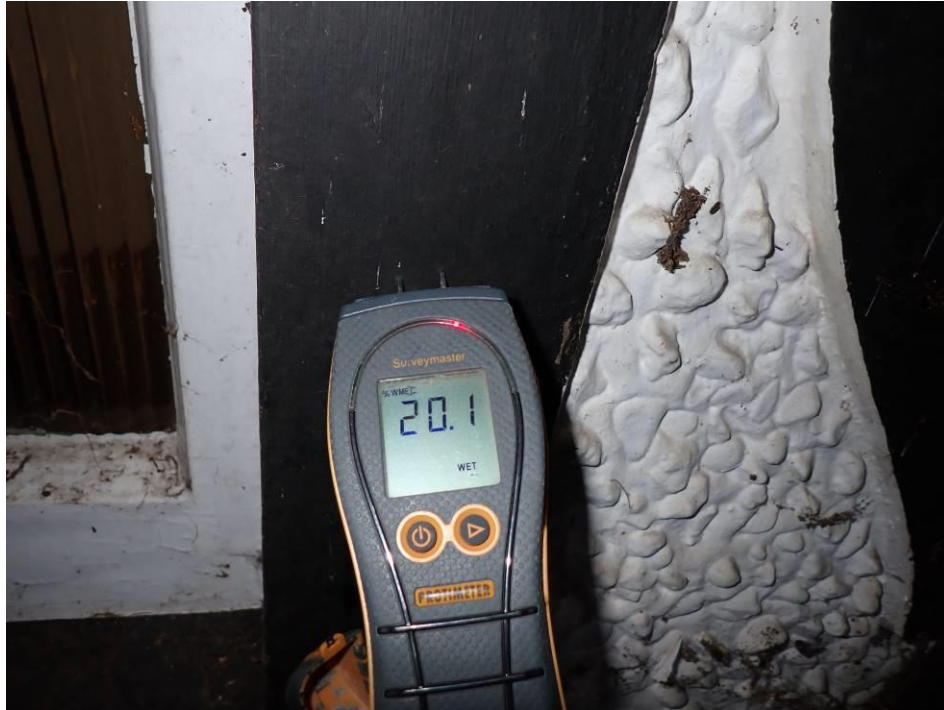
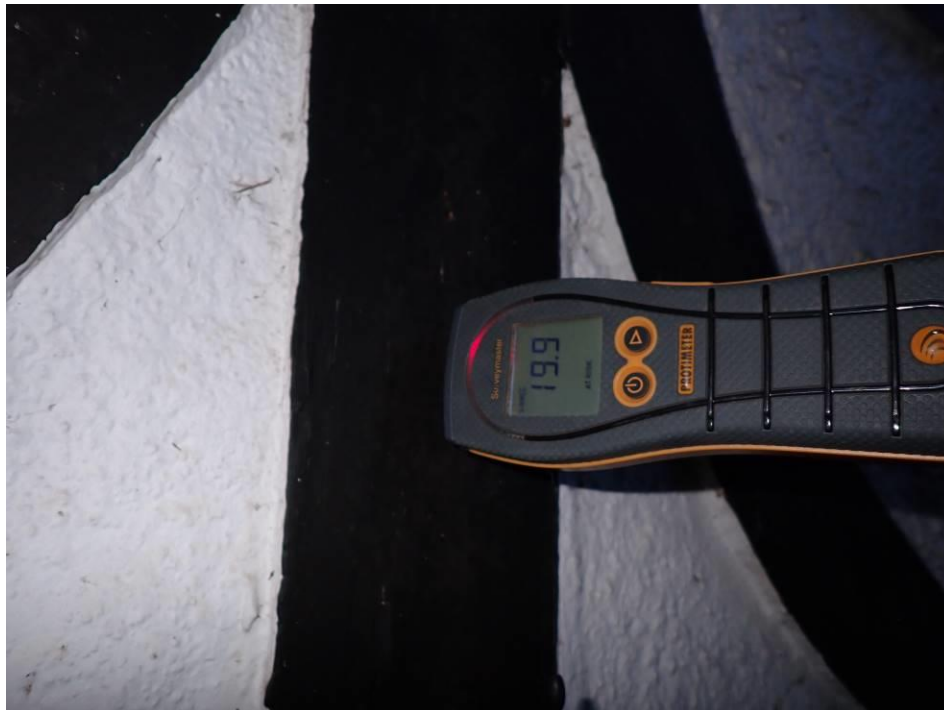
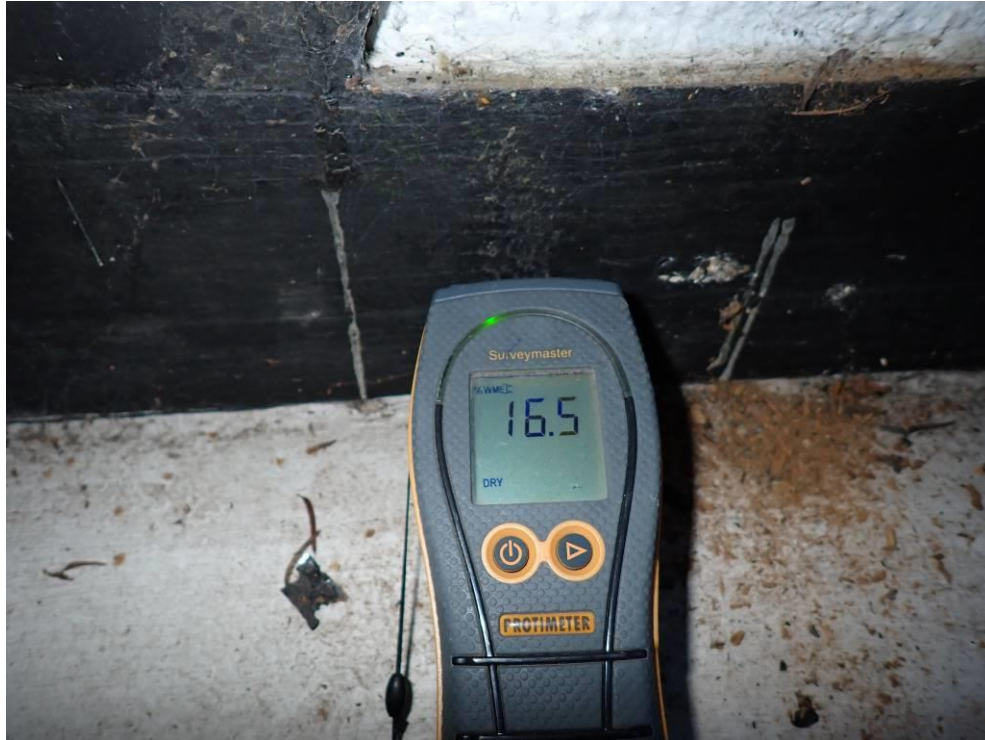
3.6 Moisture Contents

The timber moisture content was measured with a protimeter. The timbers were generally dry although up to 20% which would be expected for timber on the exteriors. The decayed window frame was saturated at 45%.
