TIMBER INVESTIGATION

VALE OF HEALTH PUBLIC TOILETS HAMPSTEAD HEATH LONDON

APRIL 2014

Timber Survey – Public Toilets, Vale of Health

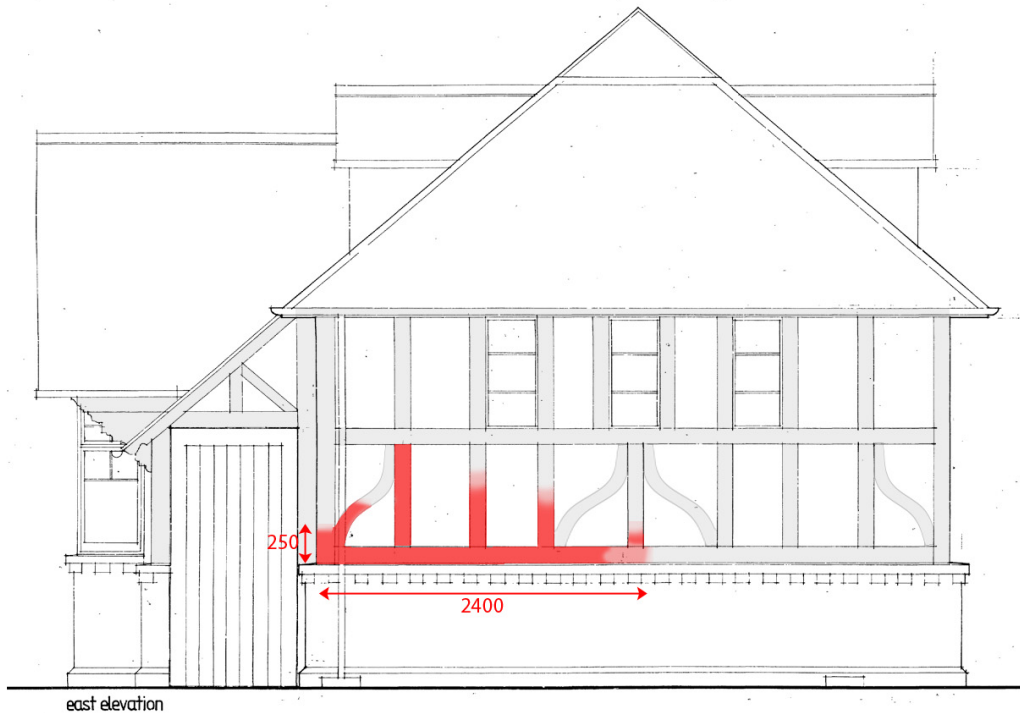
4.0 East Elevation

- 4.1 The areas of structurally significant degradation are shown in red in the sketch of the east elevation (above). The degradation is severe but very localised.
- 4.2 The actual degradation is caused by a brown rot, probably *Coniophora puteana*, commonly known as Cellar Rot. No fruiting bodies or mycelium were present, so positive identification could not be made.
- 4.3 The severely decayed zone has been colonised by ants, probably the common black garden ant *Lasius niger*. It is quite possible that the decayed timber had been previously colonised by a number of different insects, but it is undoubtedly the fungal attack that caused the initial damage, and which allowed subsequent colonisation by one or more species of insect.
- 4.4 The framing comprises of 150d x 120-150w softwood elements, the basic configuration of which is shown below

- 7.1 The significant degradation is localised and confined to an area of the east elevation. There is no obvious reason why this part of one relatively sheltered elevation should have degraded so severely when the rest of the building is generally sound.

- 7.2 One possible cause is a failure/blockage in the adjacent rainwater goods (gutter and/or downpipe).
- 7.3 A second possible cause might be long term saturation from the W.C. overflow pipes that discharge directly above the degraded area.

- 8.2 The degraded elements on the east elevation will need to be repaired or replaced.
- The lowest 300 of the south east corner post will need to be cut out and a new section inserted. It should be possible to do this without cutting complex scarf joints etc.

- The south half of the cill will need to be cut out and a new section inserted
 - The 3no. intermediate studs should be replaced.
 - The lowest 150mm of the central stud could probably be consolidated with a proprietary timber consolidant/filler.

- The lower half of the south-most curved brace could be cut out and a new section jointed in, or the whole element replaced.
- 8.3 With care, it should be possible to carry out the necessary timber repairs with minimal disturbance to the cast breeze infill panels and internal finishes, which could be retained. If this is not considered desirable, it would probably be better to use the same materials in the replacement work, rather than introduce new, and theoretically better, materials that might cause problems due to their differing performance.

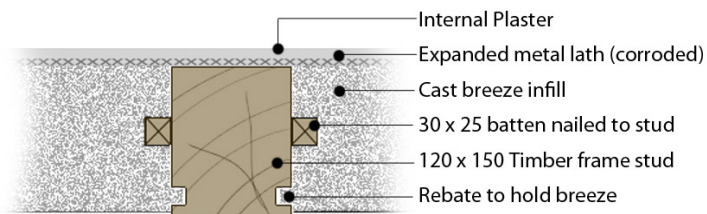
- 4.5 The curved braces are approximately 50mm deep. It seems likely that the breeze was cast with the braces *in situ*.
