COLES CONSERVATION
ARCHITECTS

P221 Hampstead Heath Vale of Health

Public Conveniences.

Outline Condition Survey

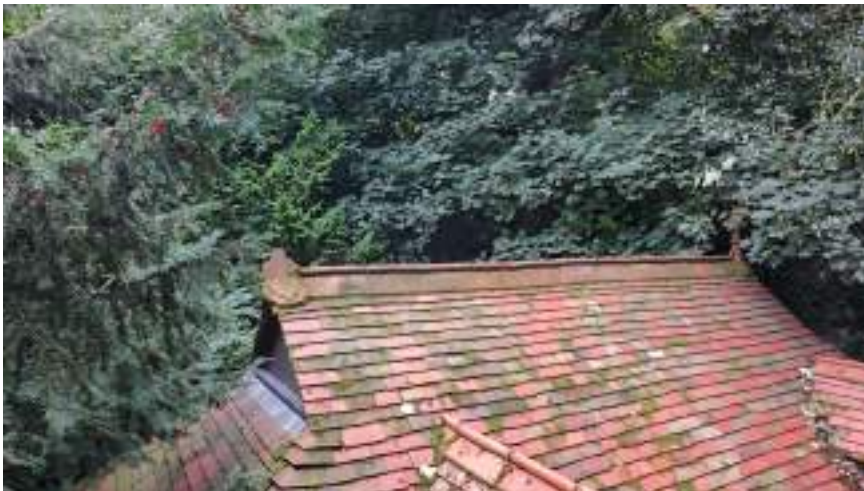
General view of the north roof pitch taken from UAV / drone – plain clay tiles with roll top to ridge terminating in decorative finials and roll top ridge tiles to dormers.

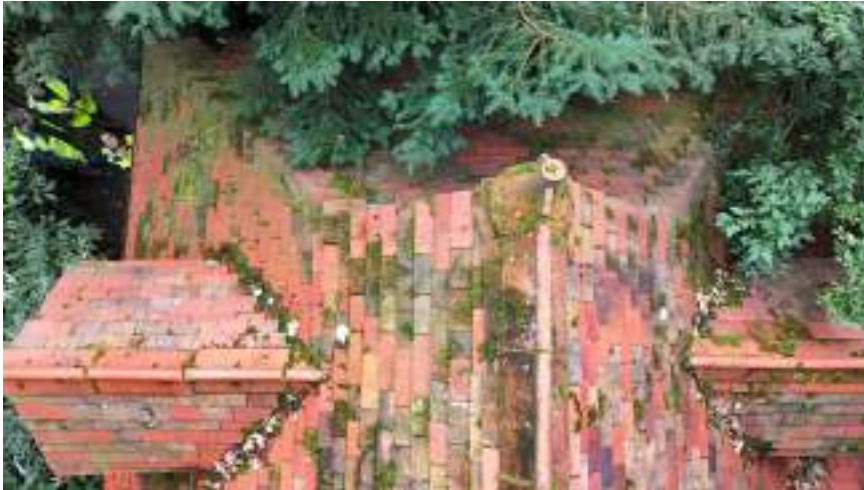
Photograph from UAV / drone showing missing finial from east end of ridge.

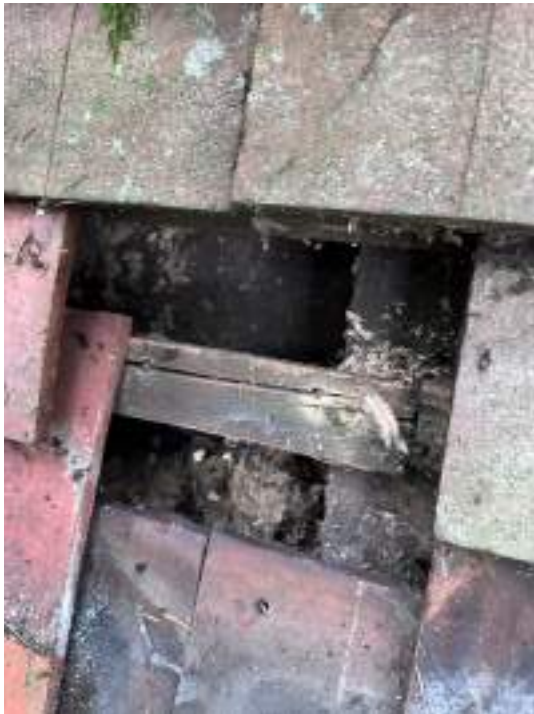
Roof open to void between rafters under tiles

The roof was opened up locally to inspect the substrate. The construction is s/w timber battens nailed directly to common rafters with a plain tiled finish. There are no sarking / closed boards, no insulation nor breather membrane. For the building's remote location, this build up is vulnerable. With mature overhanging trees and high risk of vandalism (or people climbing onto the roof), any damage to the tile finish results in rainwater ingress directly into the building, tracking down the timber match-boarding that is fixed to the underside and sitting on the wall plate at the head of the load bearing timber frame.

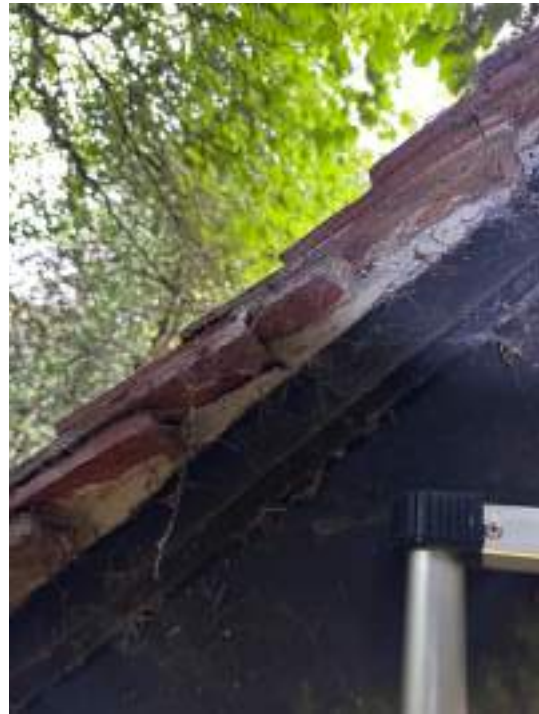
Inadequate lap on tile coursing

These issues are likely compounded by the poorly set out gauge of the tiles and use of tiles from a variety of manufacturers that are all slightly different dimensions, with different cambers and fixings. This has caused an ill-fitting finish of tiles in some areas, particularly at abutments, verges, valleys etc. The triple lap of the tiles was also noted as being less than the recommended 65mm in several areas (see right hand photo above).

- i) Patch repair and improve details wherever possible and within the budget. This will prolong the life of the roof but will not guarantee further deterioration in years to come.
- ii) Re-roof the building. This will provide the opportunity to improve all details across the roof – i.e. dormer cills, cheeks, valleys, gauge etc. One might also specify a vapour barrier and eaves carrier and possibly counter battens or, for a more robust finish, sarking boards with counter battens and battens over. Insulation might not be advantageous as the building is not inhabited. The choice of tile for re-roofing would be paramount – It would be best to not salvage and relay the existing, but more towards a more uniform handmade or machine made tile.

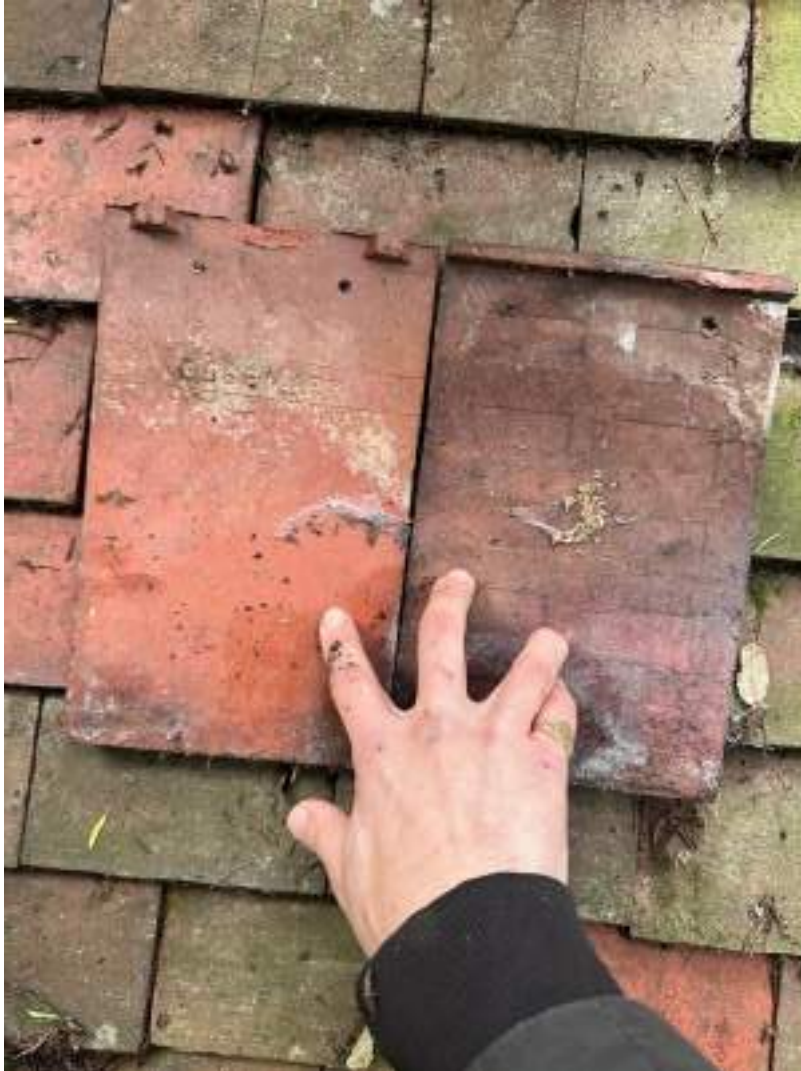
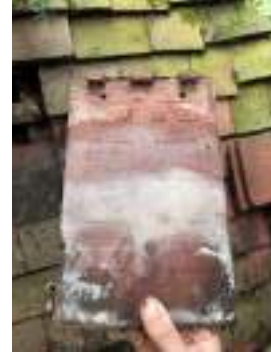
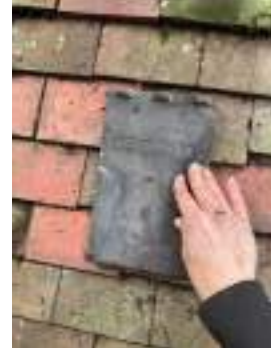
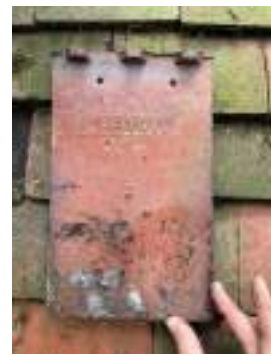
The above photos show some of the mixed tiles that have been used in the (fairly recent) re-roofing of the building. There are Redland Rosemary tiles with 3 nibs – majority in red, with some in blue as well as different types of other machine-made tile. Most of these are unbranded – some have three nibs and some have a continuous lip to upper edge.

It would appear that quite a few of the tiles have been salvaged from elsewhere and have been mixed with new tiles. Some have old damage / defects.

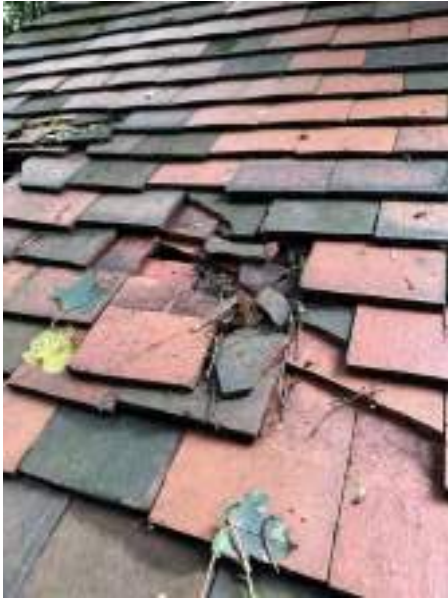
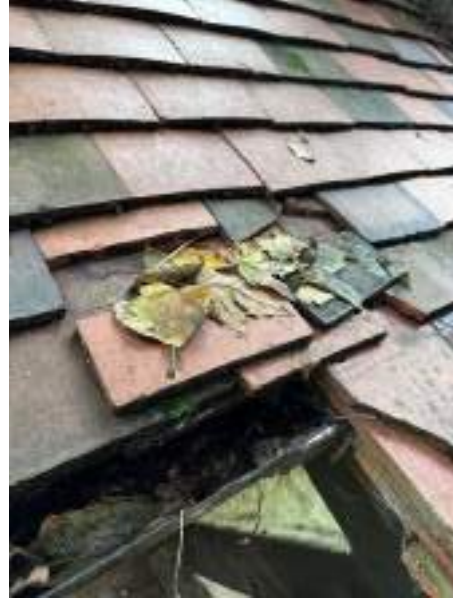
Damaged tiles – cracked or missing, most likely from impact – either from persons climbing on the roof or from falls of branches from the surrounding overhanging trees.

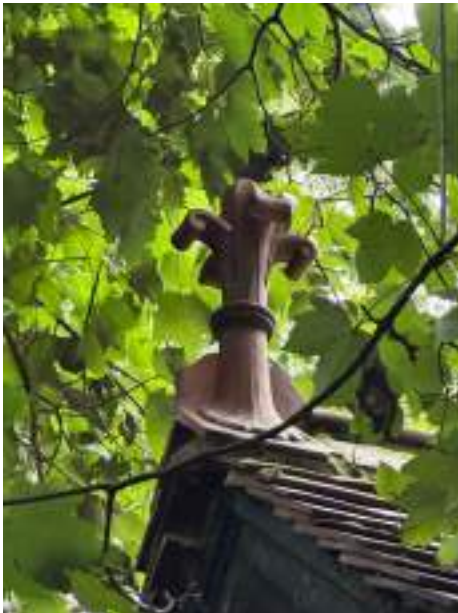
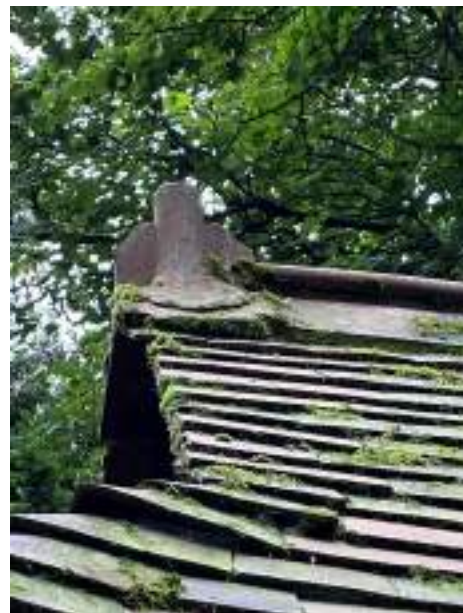
Apex end finial – one extant and one missing at east end of roof. The bonnet tiles terminate in end irons and one was noted as being missing.

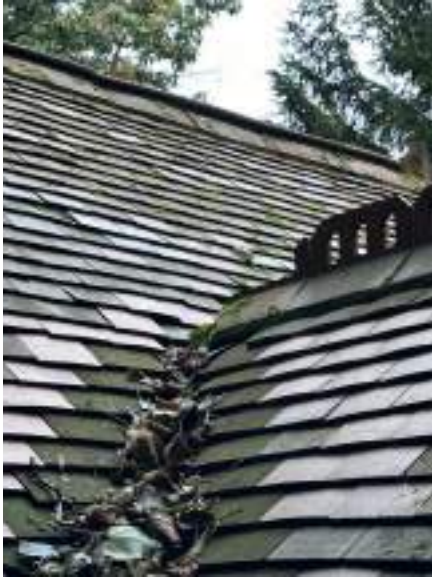
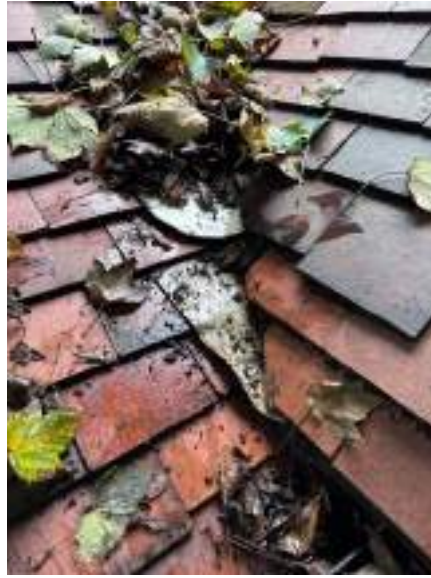
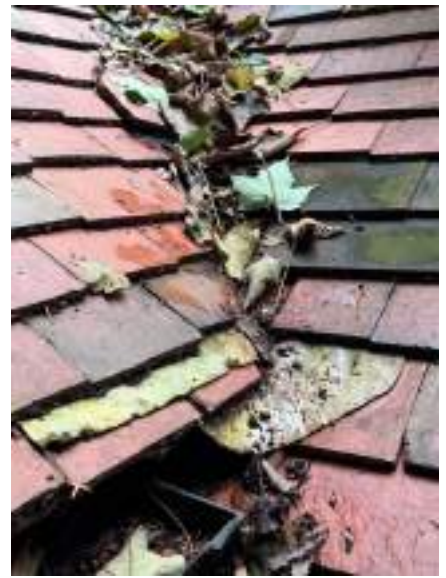
Laced valley could not be fully inspected as safe access was not in place to clear the leaves. However, the abutment at the courses that were able to be inspected lower down the valley were poor and did not seem to be sufficiently weathertight. Projecting lead soakers had been introduced in an attempt to adequately weather these areas.

There was also at least one crested ridge tile that was damaged, as photographed above (LHS).

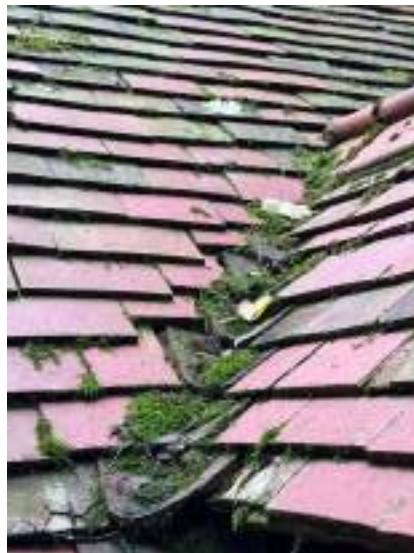
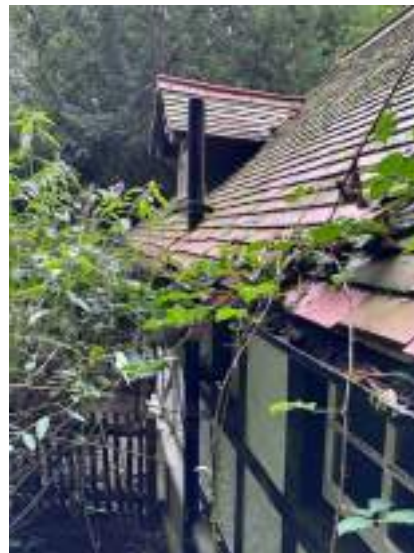
The valley tiles to dormer windows are ill fitting and there is a large build-up of detritus and organic matter. An amount of rainwater ingress at this abutment would be likely. On the north side, bramble, ivy growth and a large amount of buddleia plants are growing over the building in areas. This is detrimental to brickwork, tiles etc. as it can cause displacement.

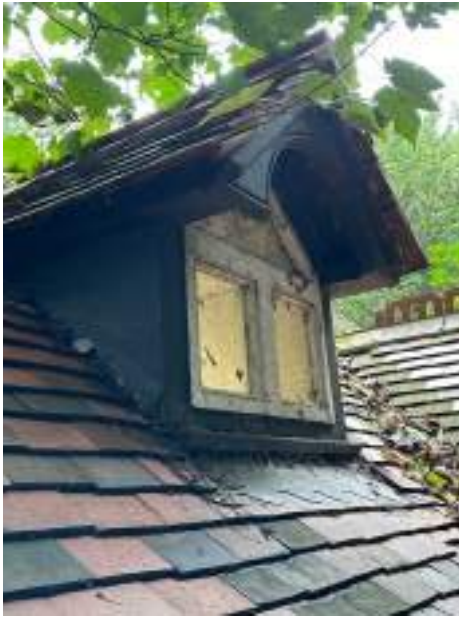
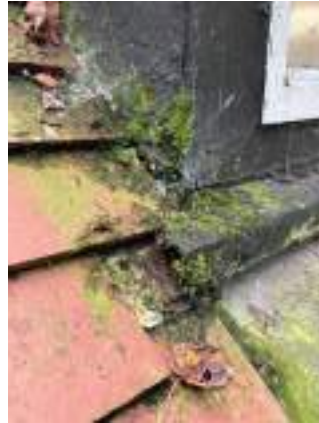
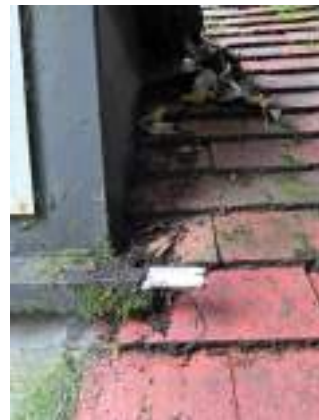
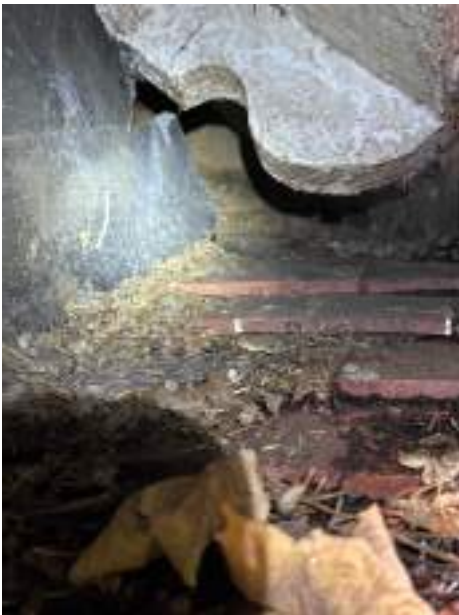
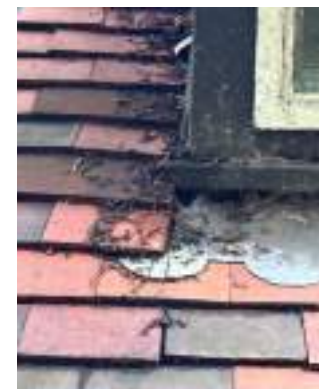
There are 4no. dormer windows with integral air vents in the apex, which are fitted with insect mesh. It was not possible to inspect the barge boarding for rot due to lack of safe access. There was wet rot fungus found in the timber cills however, predominantly at the ends, where end grain had had prolonged exposure to rainwater. This is resultant from lack of regular redecoration, but also due to the poor detail. The cills are tight on the roof, leaving inadequate room for a drip and consequently water ponds. All were found to be damp despite no rain the night before inspection.

There are some gaps below the eaves that are vulnerable to insect infestation or bat roosts – The photograph above is the RHS of the projecting bay, which is open with no mesh. In the area where roof tiles were removed, evidence of a bee hive was found (inactive).

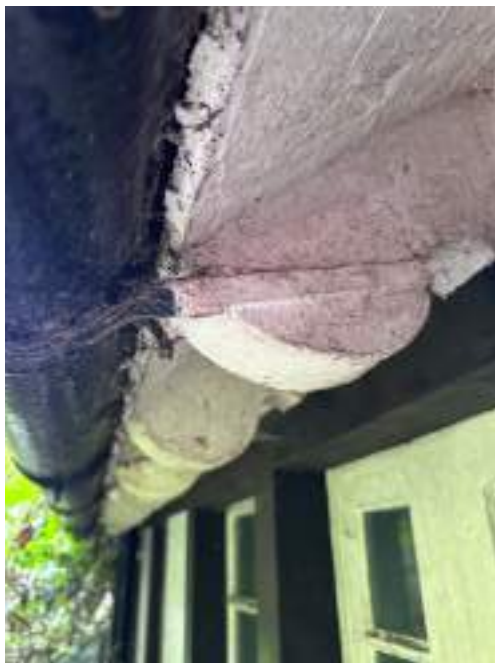
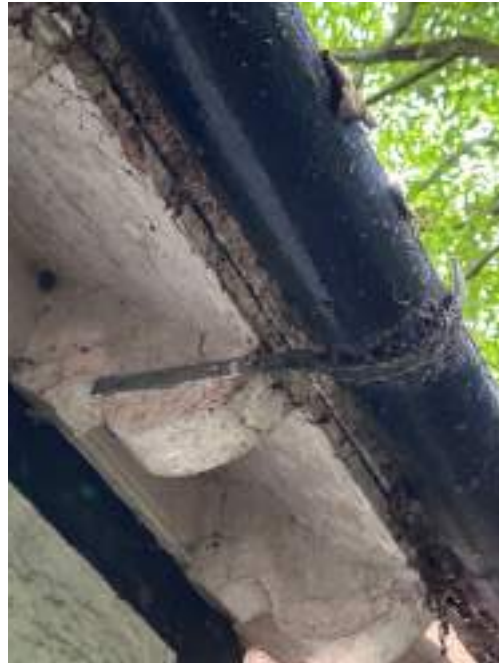
Rainwater goods are in cast iron with half-round gutters and round downpipes with swan-neck pipes to account for the overhanging eaves. They are supported on the timber rafter ends with purpose made brackets. Many of the older iron ones appear to have never been removed, with mechanical fixings decorated over many times. Where they have been removed, there are several modern replacement brackets in galvanised steel. These are ill-fitting to the gutter profile. The gutter was loose in several areas (not critically so).

We we're unable to see the operation of the gutters and downpipes on the day, but some connections were poor and likely leak between sections. The gutter and downpipes themselves did not seem in too poor condition. The backs of downpipes were inspected by hand (where they typically fail) and these generally seemed to be ok and fit for refurbishment.

There were a couple of minor areas of impact damage and these sections would require replacement with matching sections in imperial sixed profiles.

Rainwater goods should be carefully taken down, labelled, and restored. This might involve sand blasting existing paint finishes, replacing any defective lengths, reinstating with replacement brackets where necessary. The gutters can be caulked and redecorated and downpipes properly fixed back. Below ground drainage can be jetted out or lined to improve operation.

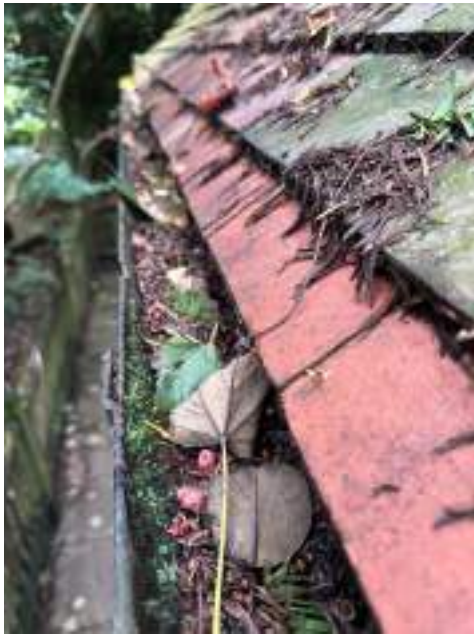
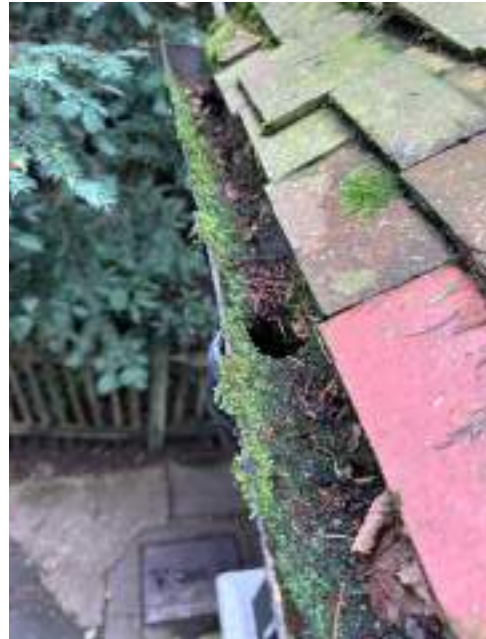
The principal issue with the operation of rainwater goods on the building is the amount of leaves, moss and other organic matter that collects. This dramatically impedes the operation of the gutter. Thankfully, the building has wide overhanging eaves and overspill is kept away from the wall face. Even still, there is one area where water ingress from defective rainwater goods has caused extensive wet rot of the primary structure – see section 5.4 – walls.

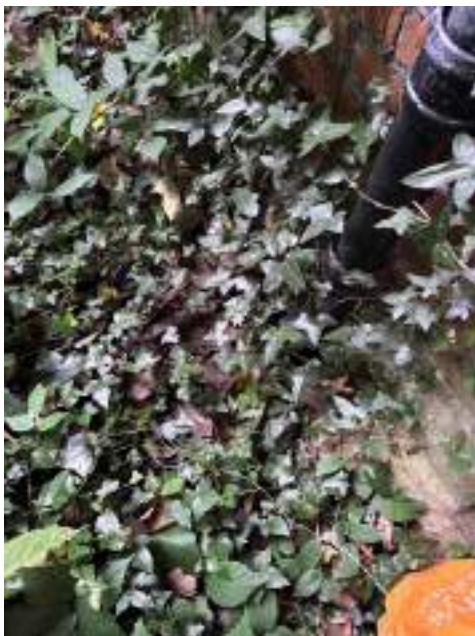
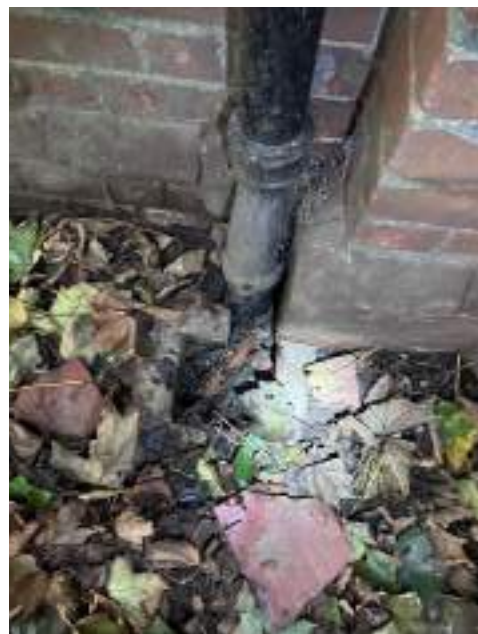
The downpipes are connected to below-ground gullies. We were unable to ascertain if these were free-flowing or where they discharged – i.e. soakaway (?). Several were overgrown with ivy.

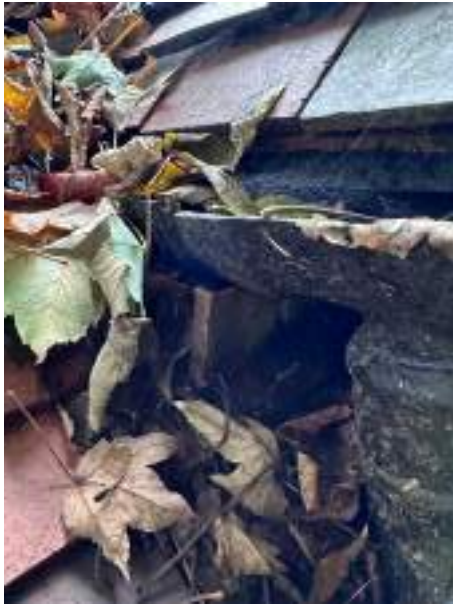
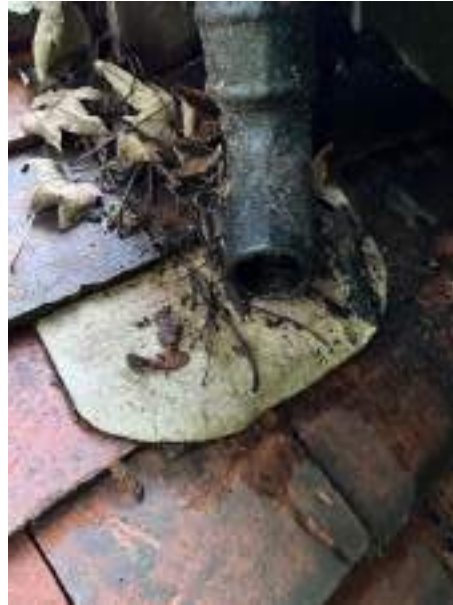
There is a short section of cast iron gutter either side of the projecting bay on the south side. On the LHS, the gutter was found to be "wedged" in place with a tile at the valley end. The gutter is fitted with a cast iron shoe which discharges rainwater over the last few courses of tiles and into the lower gutter. There is a projecting lead "soaker" which has been fitted below the shoe. It is clear that this arrangement has resulted in extensive rainwater ingress into the fabric of the building for a sustained period. Consequently, the structural timber frame and window below are extensively rotten.

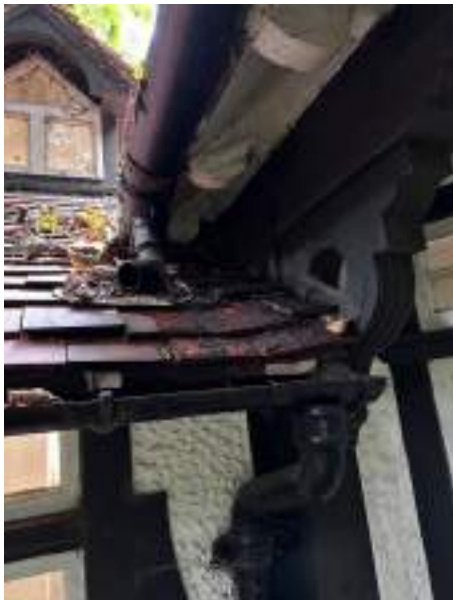
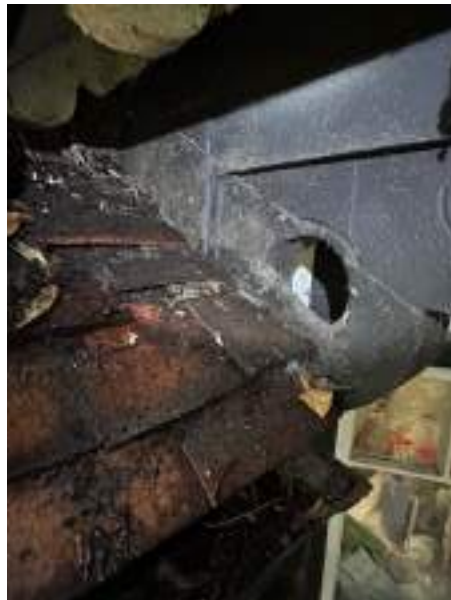
This corner adjacent the projecting bay was found to be very damp during the inspection – likely from uncontrolled discharge from the iron shoe, leaking gutter from the dormer and a back-fall and overspill where gutter has been "wedged" in place. The adjacent bracket had been fitted with a sheet of lead, which has largely protected it from rot. The same cannot be said of the timber below.

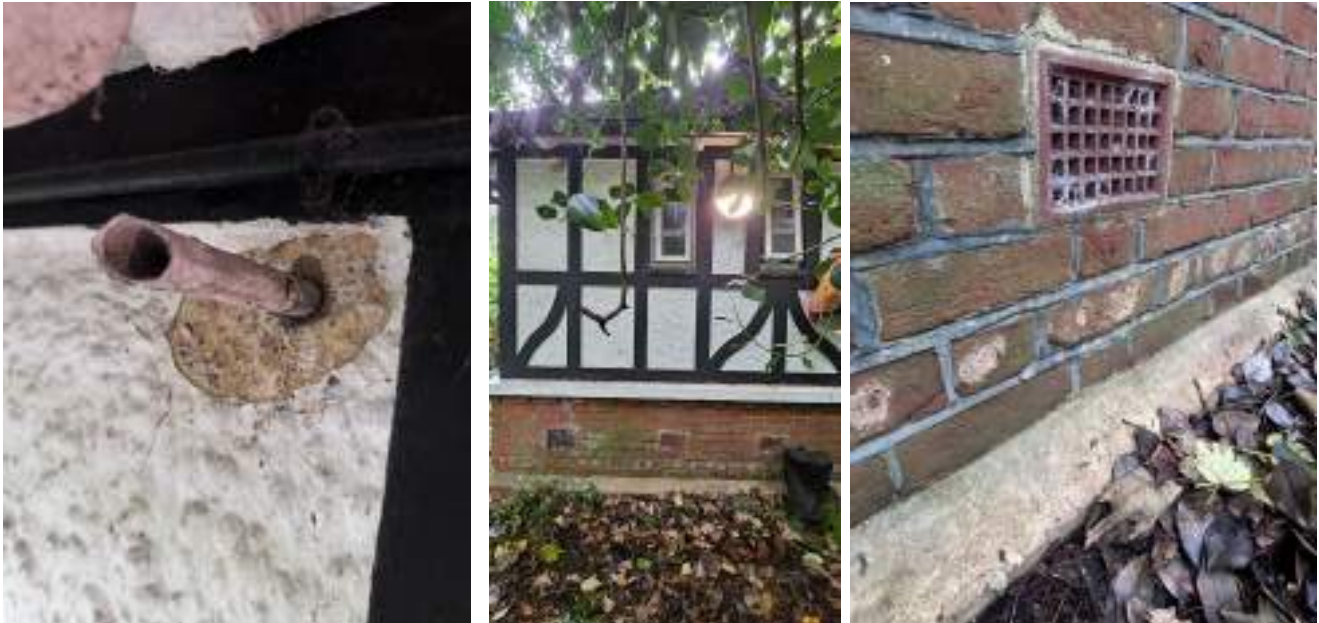
The above photo shows an area where an overflow spout has been drilled through an infill panel and damaged the decoration, revealing the substrate. There were no visible defects noted to the panels.

There has clearly been a history of damp within the building, evidenced by the previous interventions noted. Several ventilation bricks have been crudely cut into the wall and two courses above the chamfered plinth, a chemical DPC has been installed (note regular drill holes). Neither of these measures are likely to be effective means of addressing the damp as they are attempting to address the symptoms of damp and neither address the source of the problems.

Further damp analysis would be required to categorically identify the issues; however, it is likely that the rendered plinth and pointing mixes are keenly cementitious based and trapping moisture. In addition, un-maintained rainwater goods, unmaintained gullies and a high surrounding ground level can all contribute to damp fabric / environments.

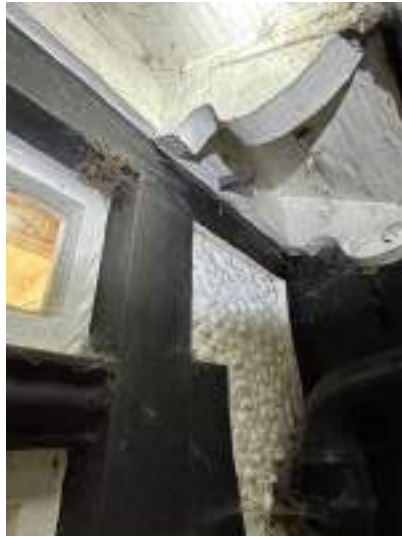
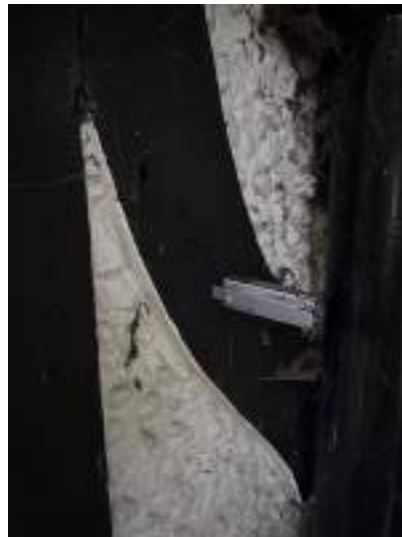
On the LHS of the projecting bay on the south side of the building, the defective gutter, cast iron shoe arrangement and cracked tiles has caused significant rot to the timber structure and window. The soffit, fascia, curved structural brace, adjacent post, window cill, sole and head plates around the opening are all rotten. These are beyond repair and will require wholesale replacement. We noted some deterioration of the plaster board and internal finishes, but the true extent of degradation will not become apparent until the repair is underway. It is likely that some rafters will be rotten where concealed in the roof and will require scarf repairs.

It is interesting to note that the panels in this area are noticeably different in appearance to elsewhere on the building, incorporating much larger aggregate – they appear to have been re-cast. Our supposition is that this part of the frame has rotted out in the past and has failed again.

Of greater priority than the roof is the cutting out and replacement of defective structural timber and replacement of the rotten window. The infill panels will need careful consideration as to what is put back.

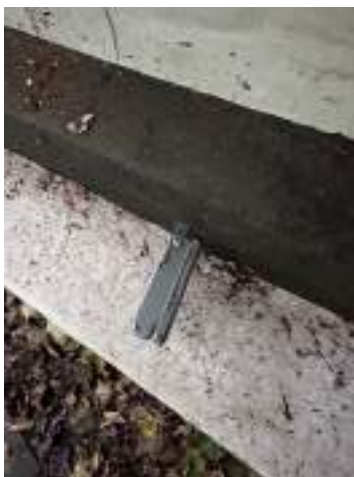
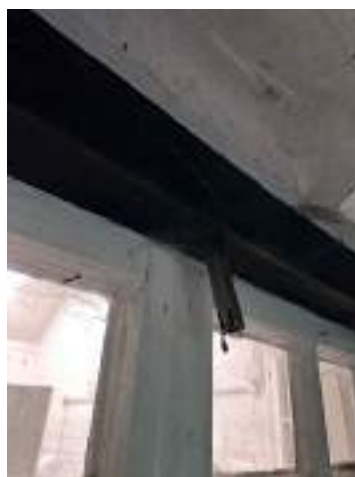
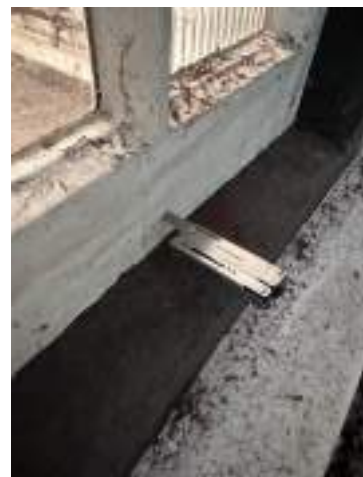
The photos above show full penknife penetration in structural timber. We tested as many areas as possible, but for a more accurate account of the extent of timber decay, a rot survey (micro drilling with resistograph) is recommended – see section 8.2.

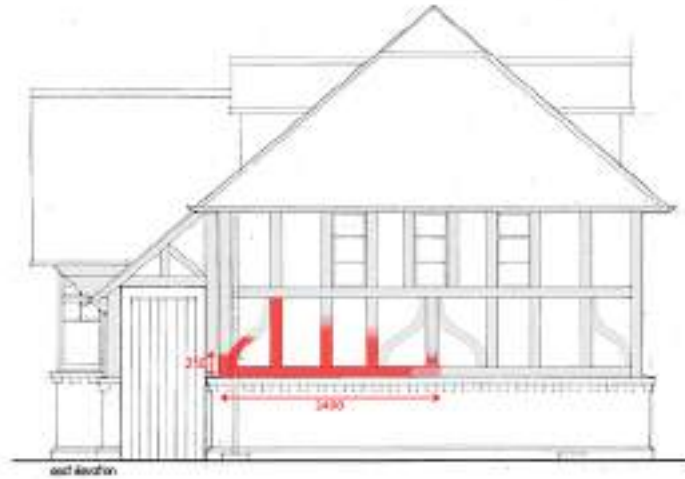
The other part of the building where extensive rot was located was on the east elevation. Again, there has been a historic problem here. The above diagram is an excerpt from an April 2014 report from Demaus Building Diagnostics Ltd. where structural timber was found to be rotten, cut out and replaced with new.

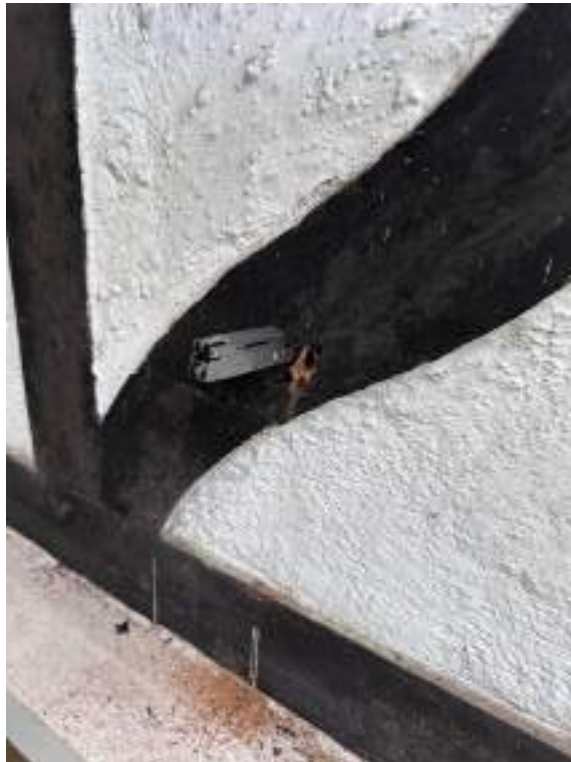
Perhaps the removal of rotten timber in this area did not go far enough at that time as we found one of the ogee timber braces to be badly decayed. The removal of rotten structural timber here and on the south side will require the replacement of the adjacent infill panels.

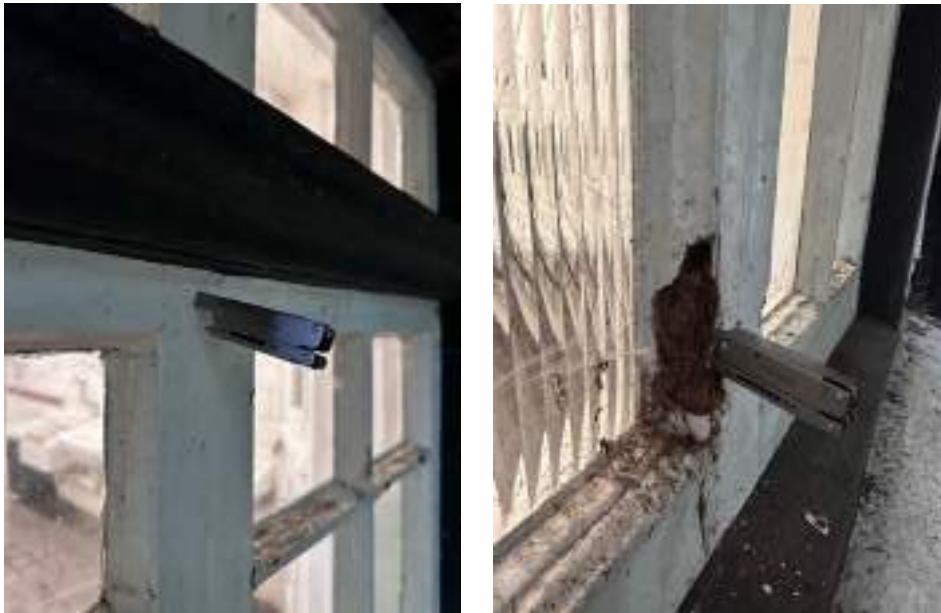
The large window to the women's WC on the south side is completely rotten and requires wholesale replacement like-for-like.

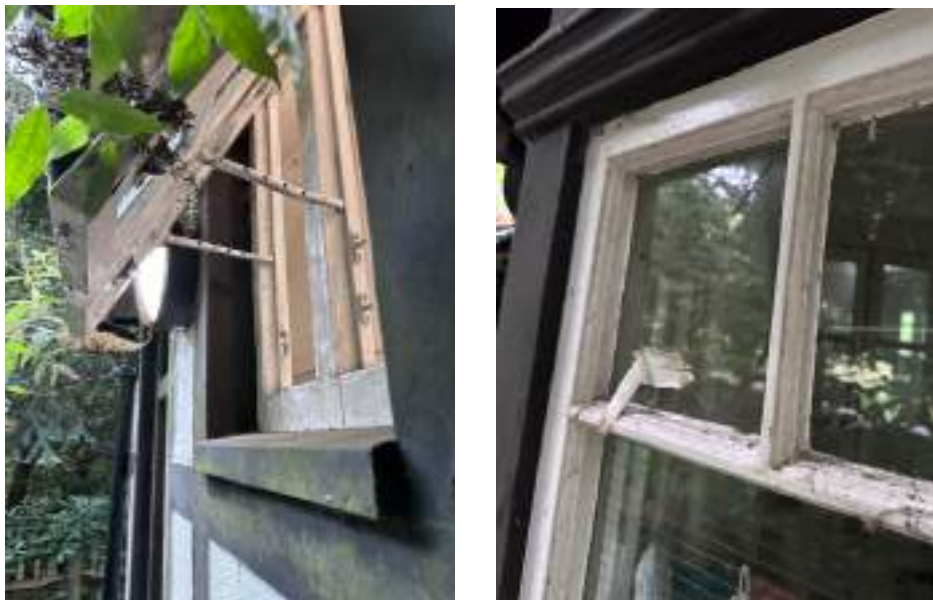
Ironmongery is generally modern but appears functional. Some windows are painted shut and there is at least one cracked pane of glass (to the bay window on the south side).

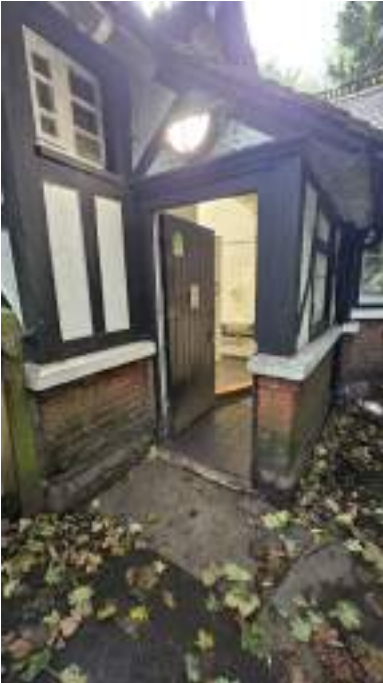
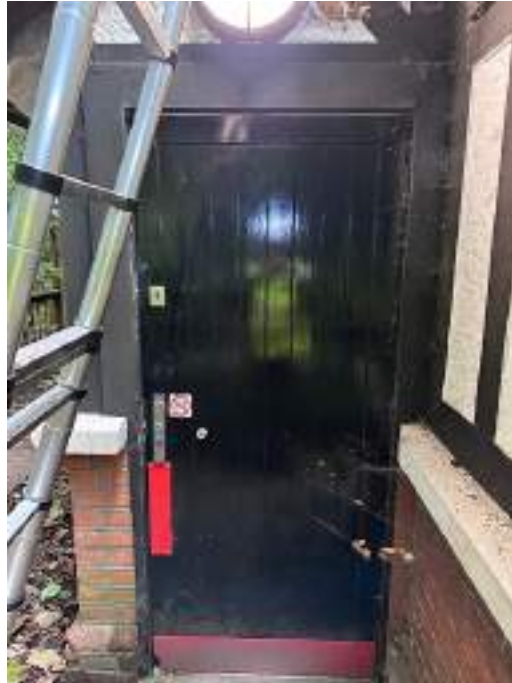
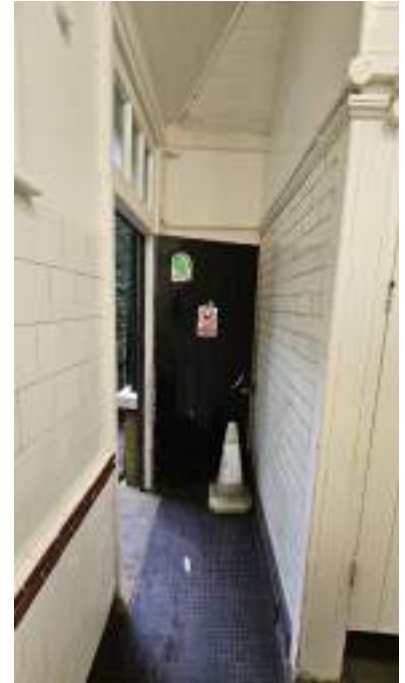
There are 3 external framed and boarded timber doors. The doors to the men's and women's toilets are both of some age, but with replacement ironmongery. The door to the accessible WC is in a design which apes the older doors, but it is modern – assumed to be installed when this part of the building was altered in 1997. There did not appear to be any functional issue with the doors.

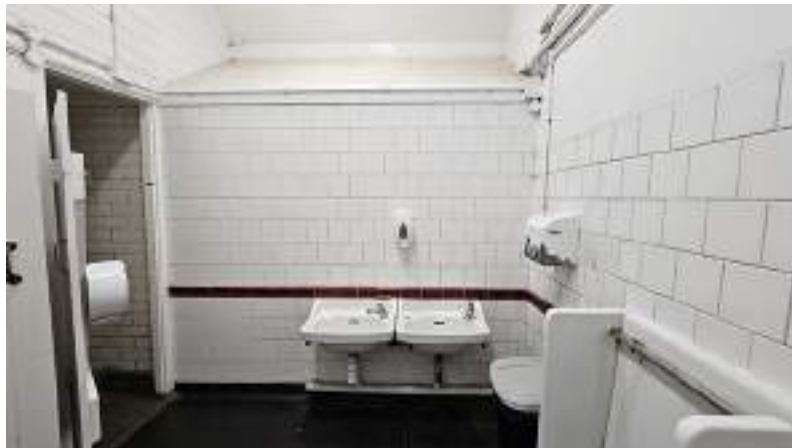
Walls are lined with white ceramic tiles and dark mauve coloured dado tiling. There are some areas of damage / defect, but generally acceptable.

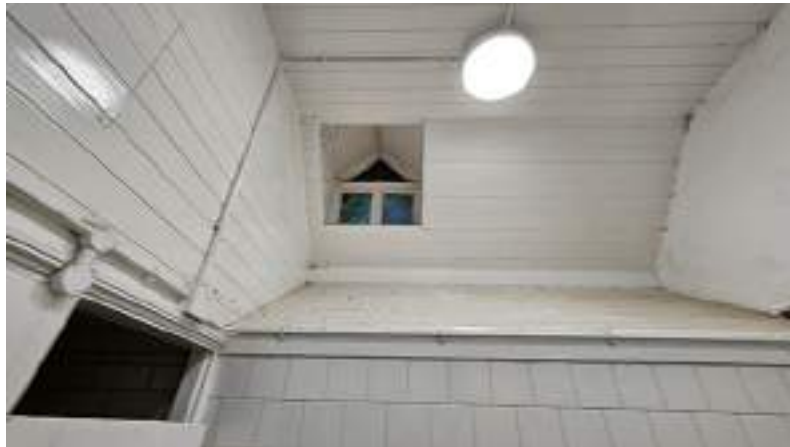
Ceilings and the void above the stalls are lined with timber match boarding, assumed to be the original internal finish. It was not possible to inspect the match boarding closely. It would be prudent to allow for some isolated repairs given the history of water ingress and roof finishes build up.

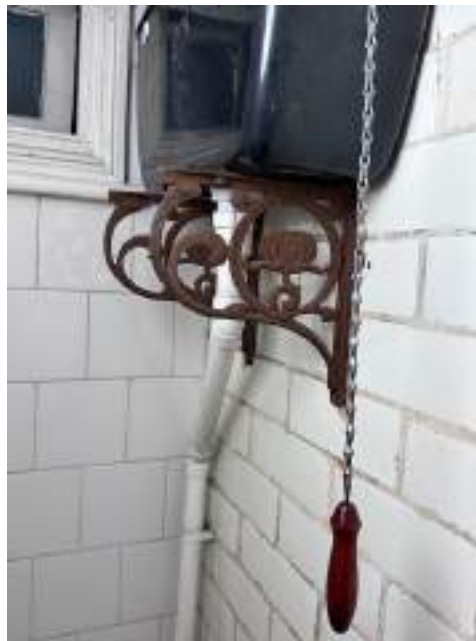
There are some old fixtures and fittings, including these brackets that support the cistern. The built in carpentry, including the stalls and stall doors all appears to be primary to the building. A few issues notes, but generally acceptable condition.

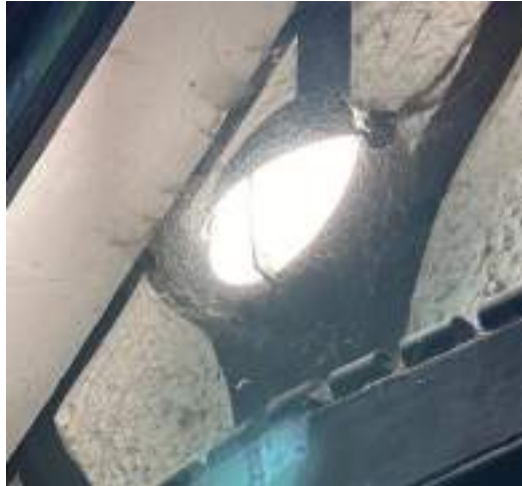
There are several modern external bulk head light fittings that are incongruous and detract from the architectural significance of the building. There are however, functional.

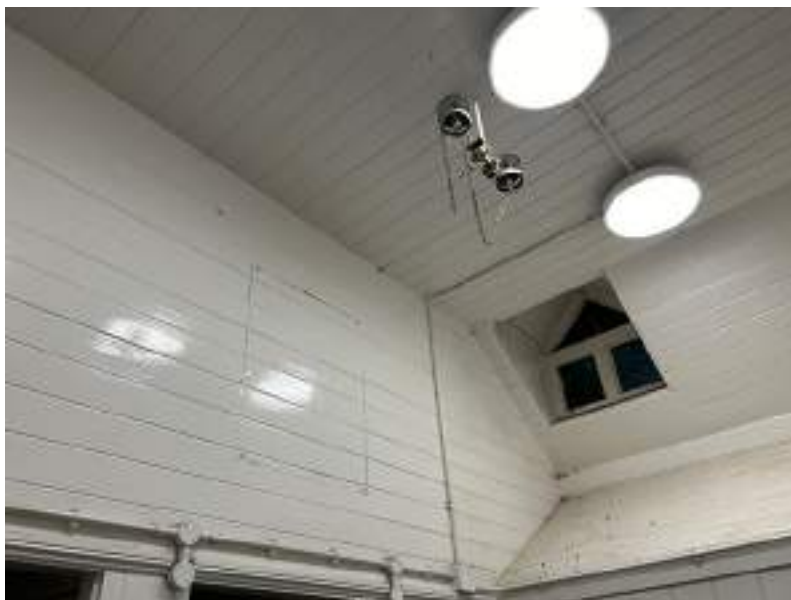
Internally, there are similar modern bulk heads and surface run modern conduit and junction boxes. There are old gasolier pendants and wall sconces which are of historic interest and should be retained.
